Preliminary Report RRD24FR009

# Norfolk Southern Train Collisions and Derailment

Easton, Pennsylvania  
March 2, 2024

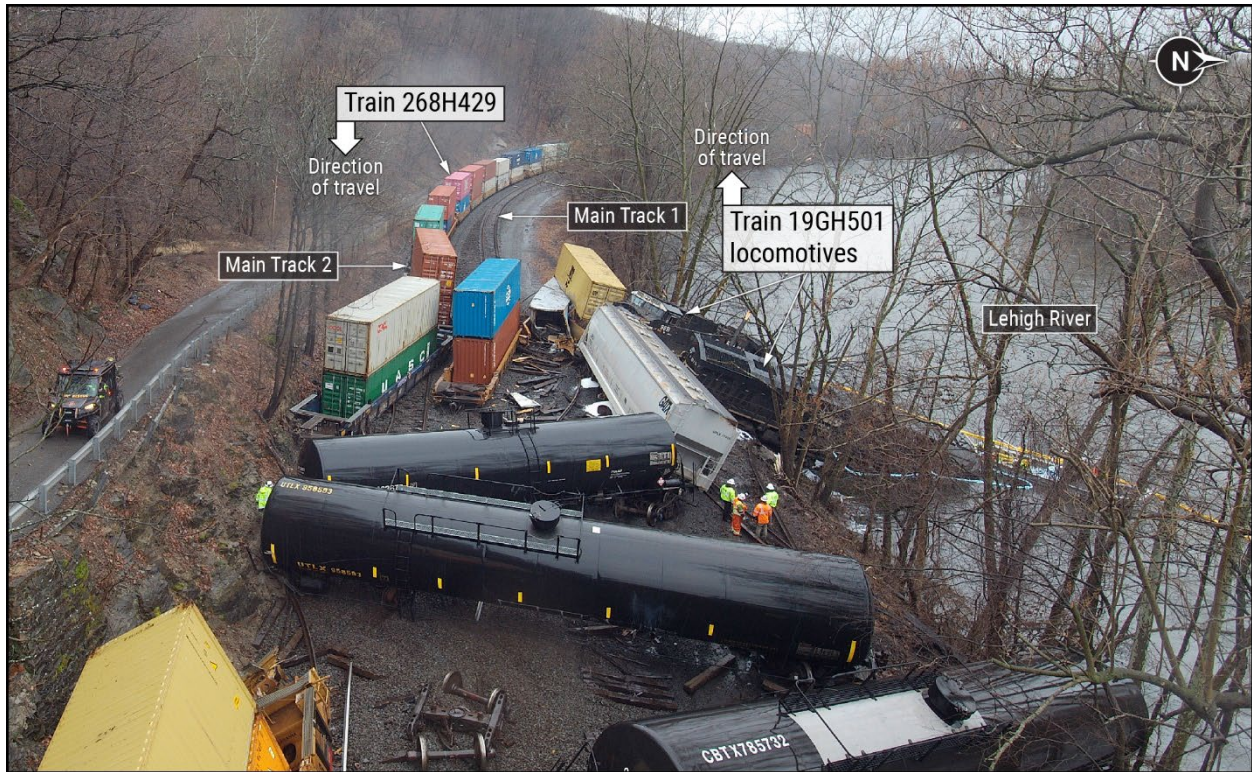
**Figure.** Site of the collisions. (Courtesy of Lehigh County Emergency Management.)
