Preliminary Report RRD24MR002

# Chicago Transit Authority Yellow Line Train Collision with Snow Removal Machine

Chicago, Illinois  
November 16, 2023

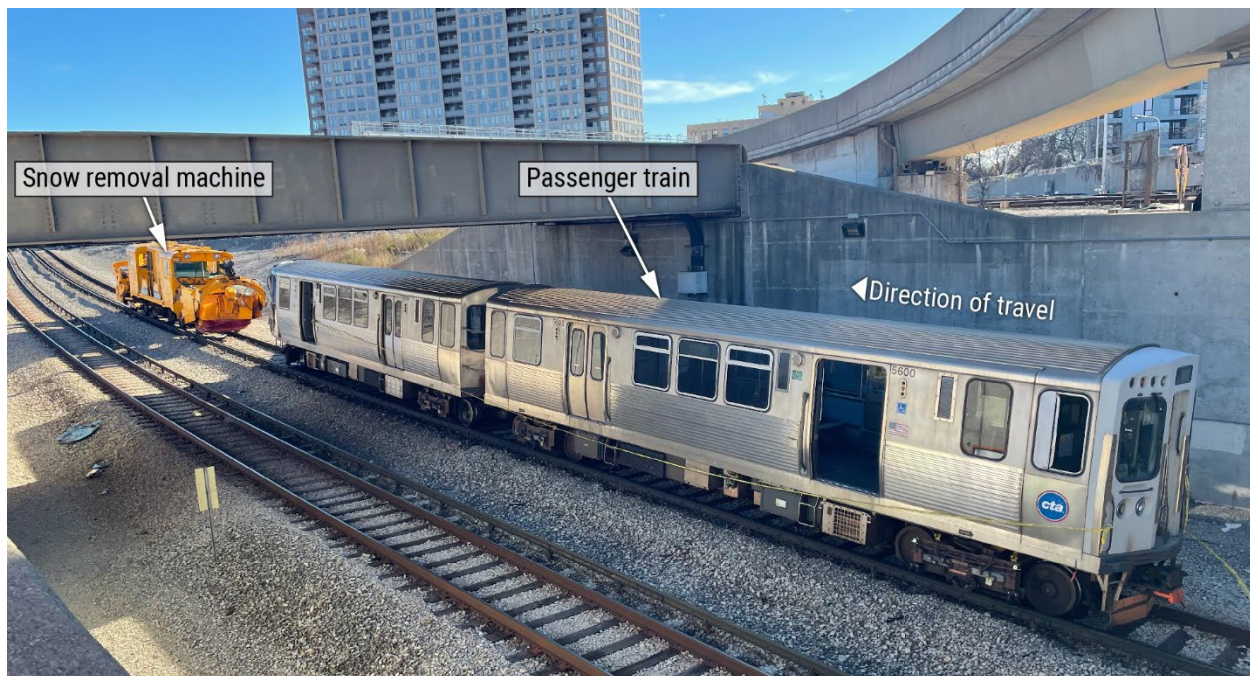
On November 16, 2023, about 10:30 a.m. local time, southbound Chicago Transit Authority (CTA) Yellow Line passenger train (run 593) collided with a stationary CTA snow removal machine (S-500) on south Skokie track 1 and derailed.<sup>1</sup> (See figure.) The train was carrying 1 operator and 30 passengers. There were six CTA employees on board the snow removal machine. Sixteen people were transported to a hospital, treated, and released. Three people were critically injured. There were no fatalities. The train remained upright following the collision. CTA estimated damages to equipment to be about \$8.7 million. At the time of the accident, visibility conditions were daylight and clear; the weather was 61°F with no precipitation.

**Figure.** Accident site.
