National Transportation Safety Board

RPH24MR002

SIGNAL AND TRAIN CONTROL

Group Chair's Factual Report

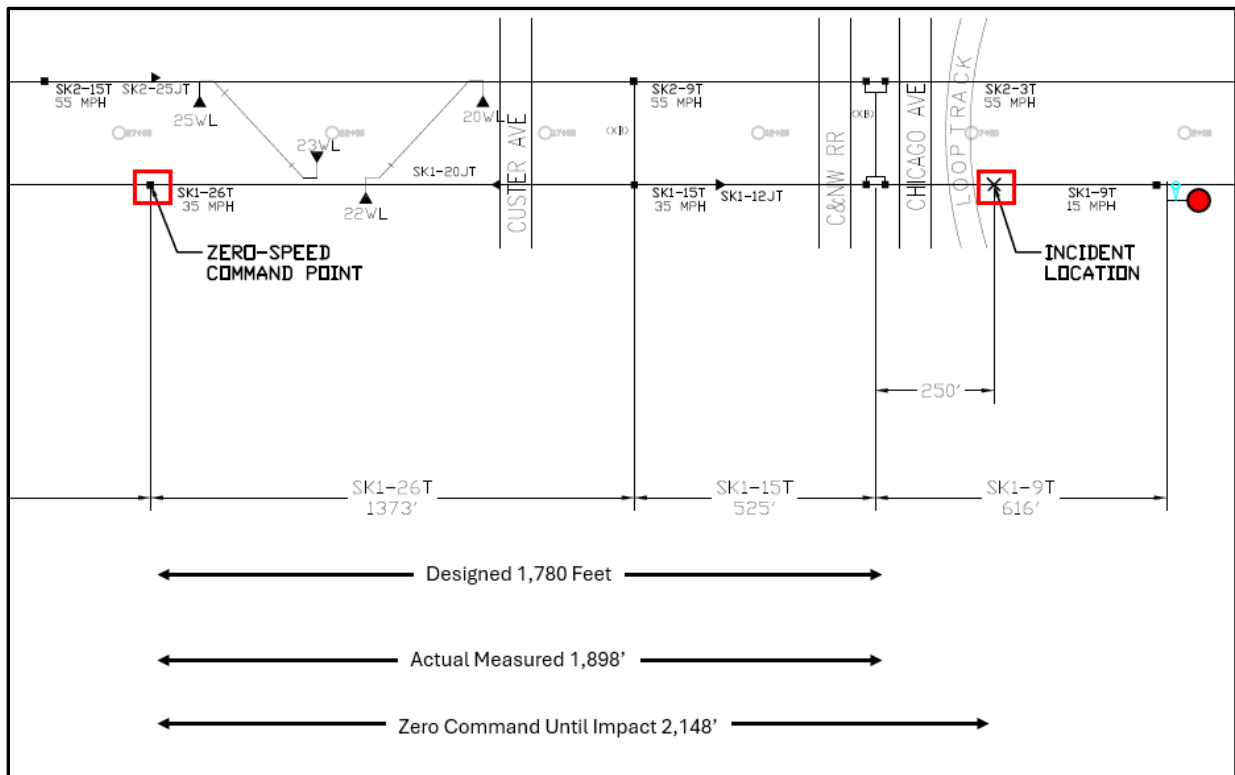
Figure 5: Diagram of signal design and impact distances

After review of the ATC download investigators began to focus on and verify the signal field equipment as the approximate distance of 1,125 feet during the incident as it did not match design. According to current field design the accident

train should have received the zero cab code approximately 2,148 feet prior to impact.

Field signal design for the accident train should have received a zero cab code on the 26, 15, and 9 track circuits. The signal design allowed 1,780 feet of stopping distance before arriving at the 9 circuit in which the equipment was occupying at the time of the accident.

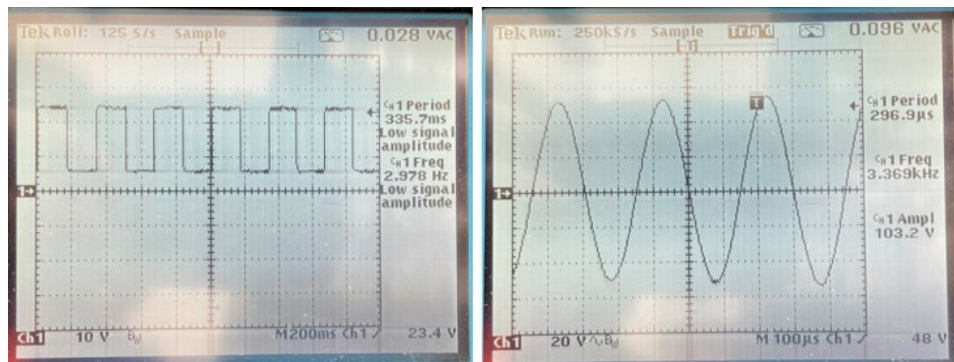
Figure 6: Oscilloscope examples of testing of cad code

All cab code equipment was tested on circuits in question, circuits 26 and 15. Circuits were tested for transmit and receive accuracy. All circuit tested per specification as below.

Signal personnel simulated the train movements that occurred during the accident and all equipment performed as designed and transmitted the proper code to the proper circuits with no erroneous frequencies detected.

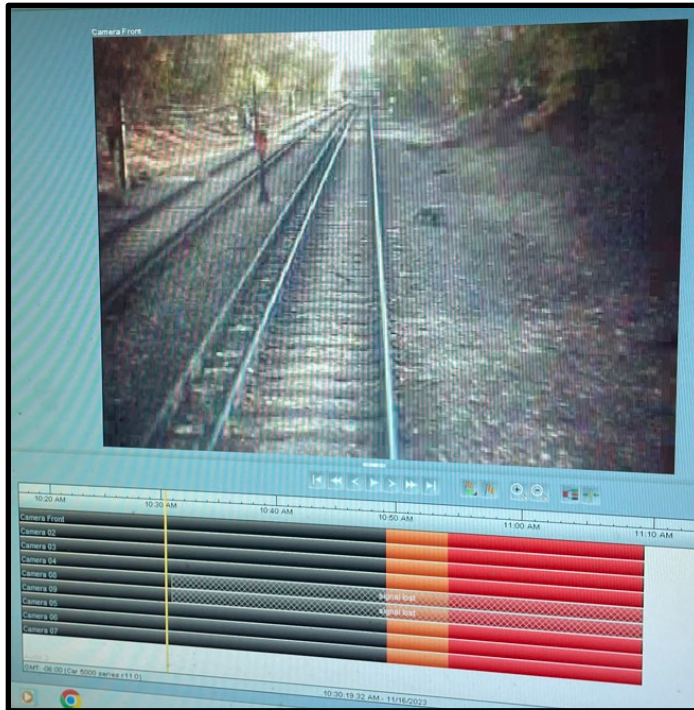
Figure 7: Outward facing camera view of location operator received 0 code.

After investigators determined the new approximate location that the accident train received the 0 code they determined that was in the area of the start of the 26 circuit, that the operator' should have received the zero code. Investigators then viewed the outward facing camera to the timestamp of 10:30:22 to verify that the accident train did in fact receive the zero cab code in the correct location, 26 circuit.
