## **Survival Factors Photographs**

**Randolph, New Hampshire**

**HWY19MH010**

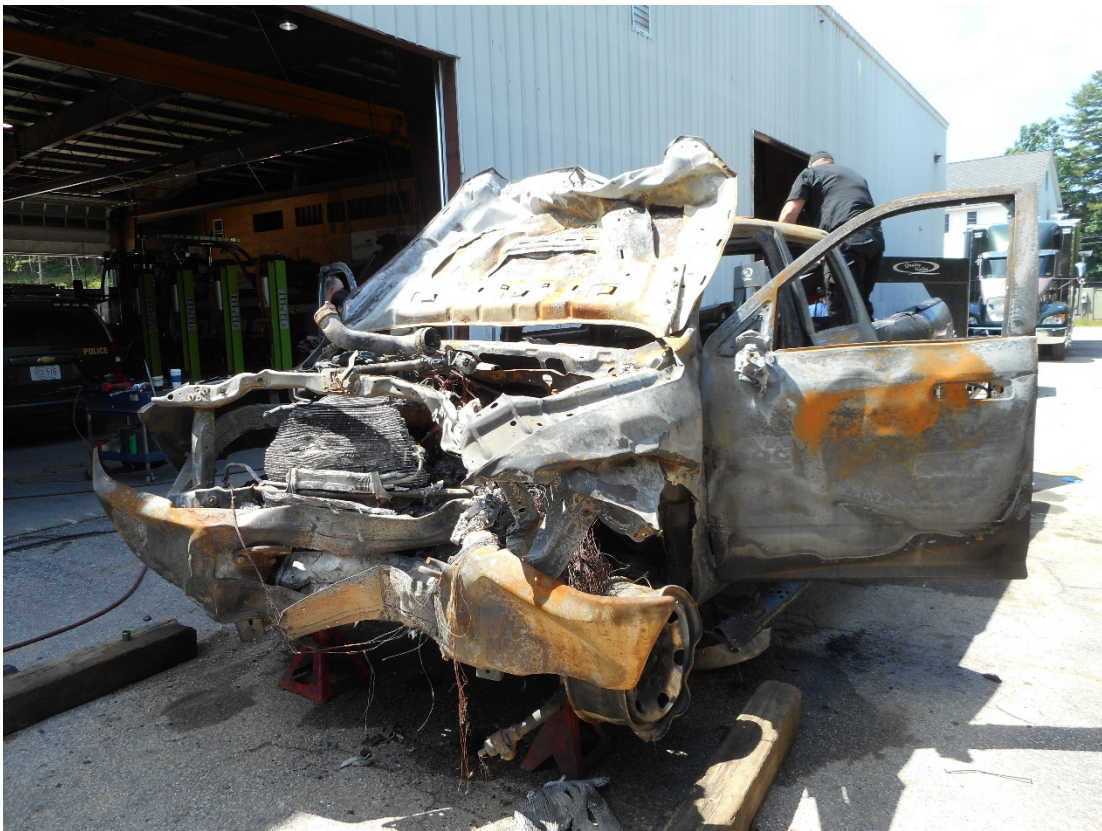
Photo 1 – Frontal left angle view of deformation to front of 2016 Ram 2500 pickup truck.

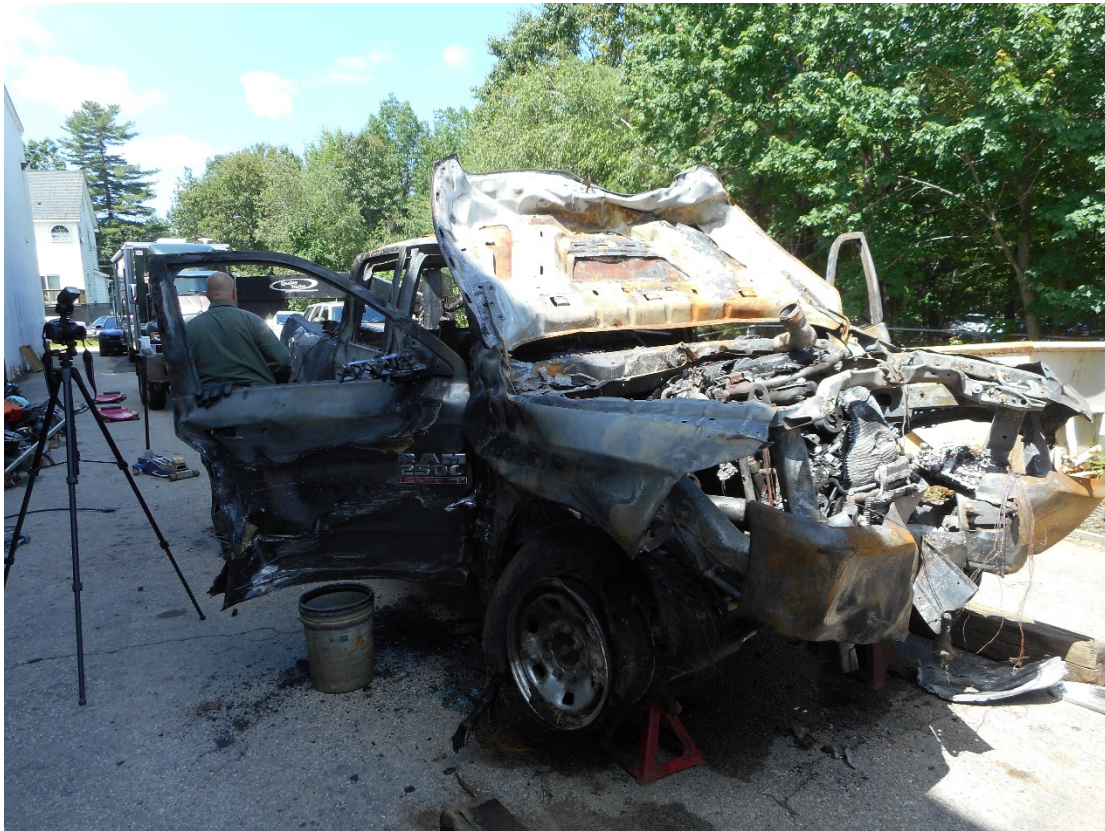
Photo 2 – Front left angle view of deformation and fire damage to front and right side of 2016 Ram 2500.

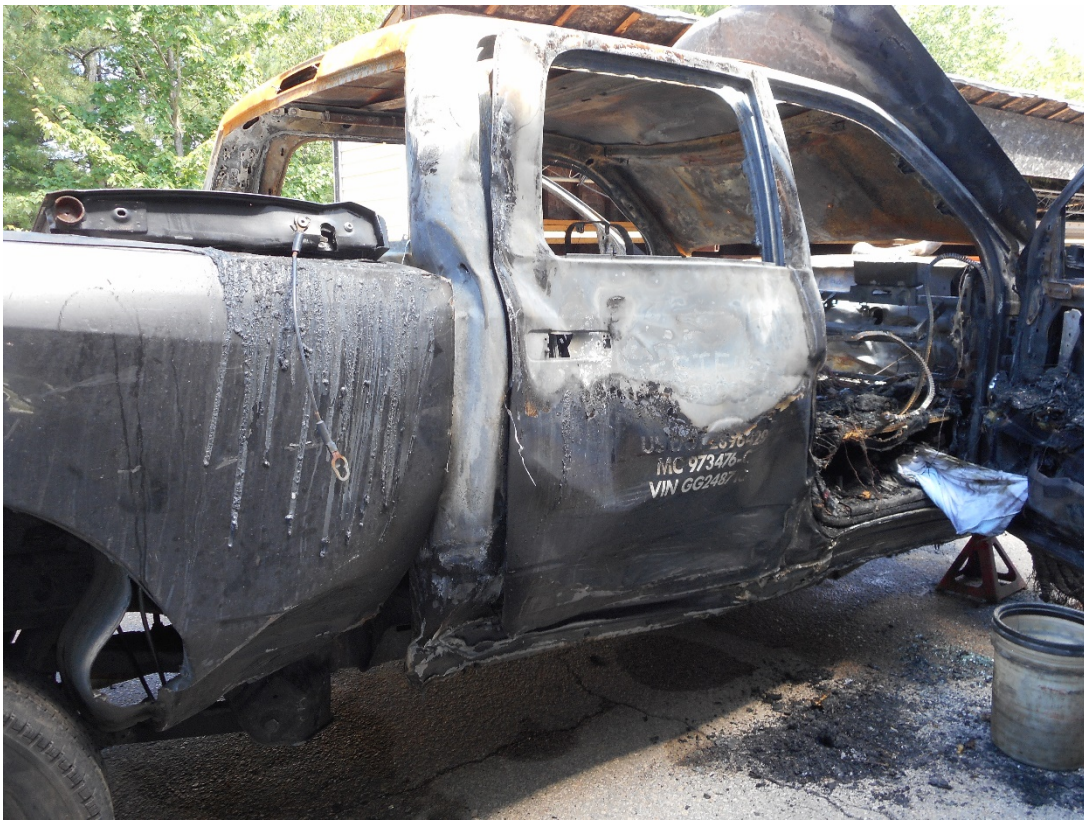
Photo 3 – Right side view of damage and deformation to 2016 Ram 2500.

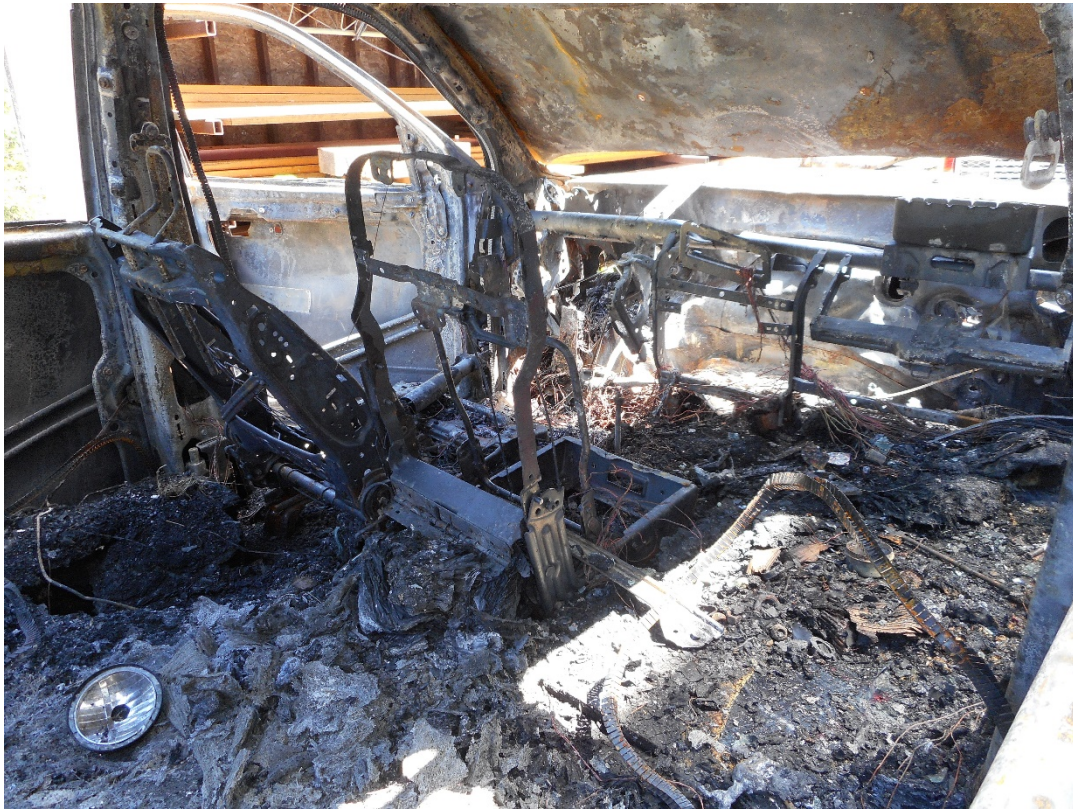
Photo 5 – Interior view from outside right rear passenger window of postcrash fire damage to interior of 2016 Ram.

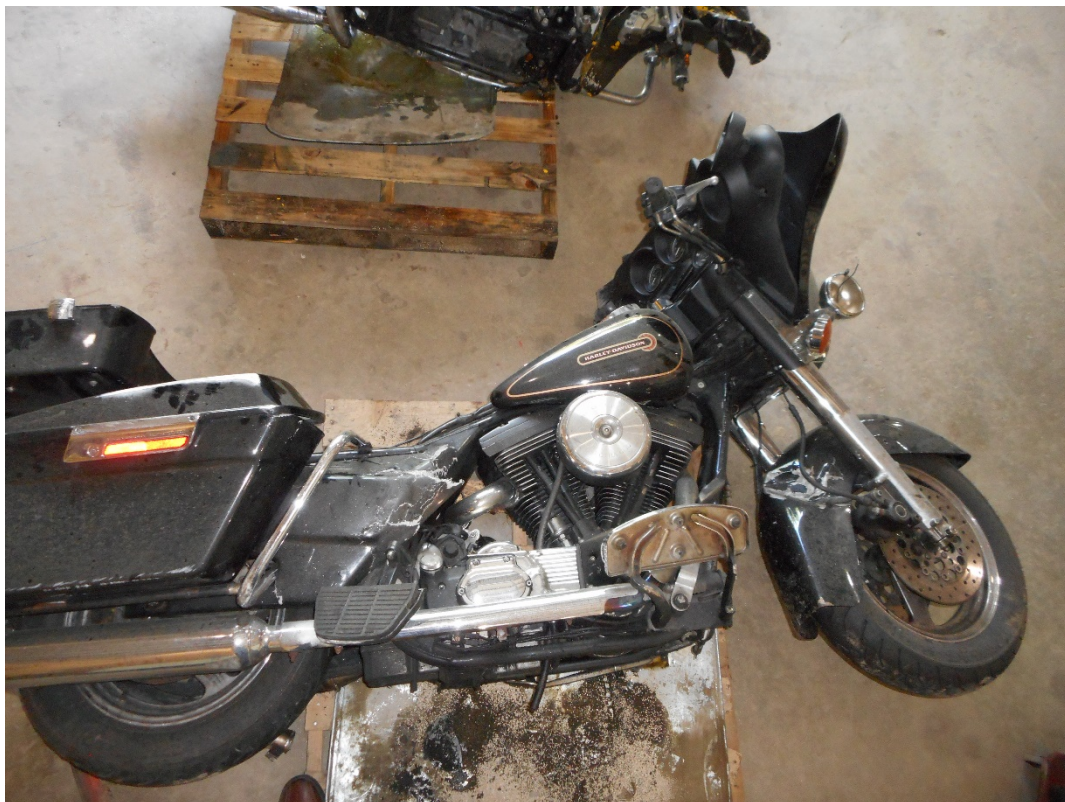
Photo 6 – Right side view of deformation to 1998 Harley Davidson Electric Glide FLHT.

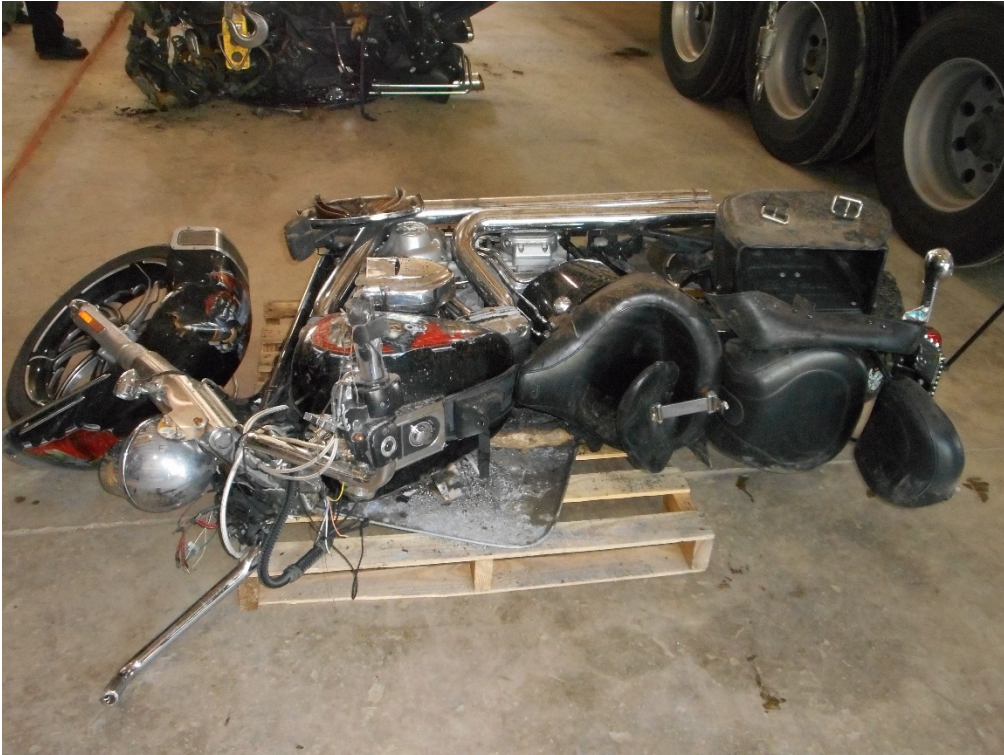
Photo 7 – View of deformation to 2006 Harley Davidson Heritage Softail FLSTI.

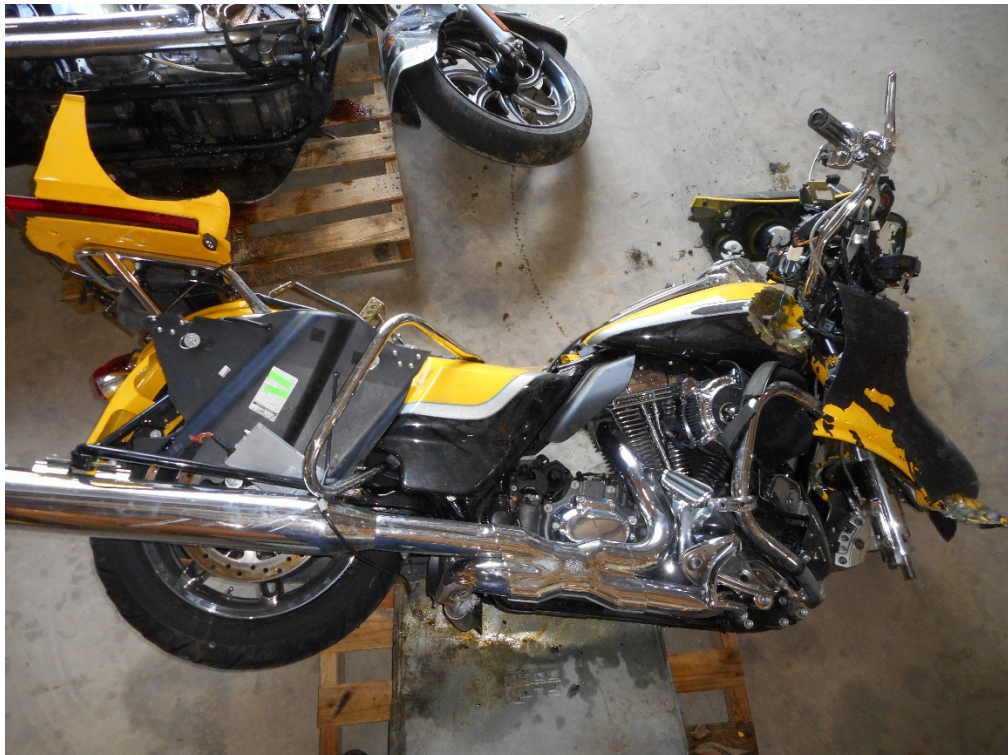
Photo 8 – View of front-end deformation to 2012 Harley Davidson FLHTKCUSE7.

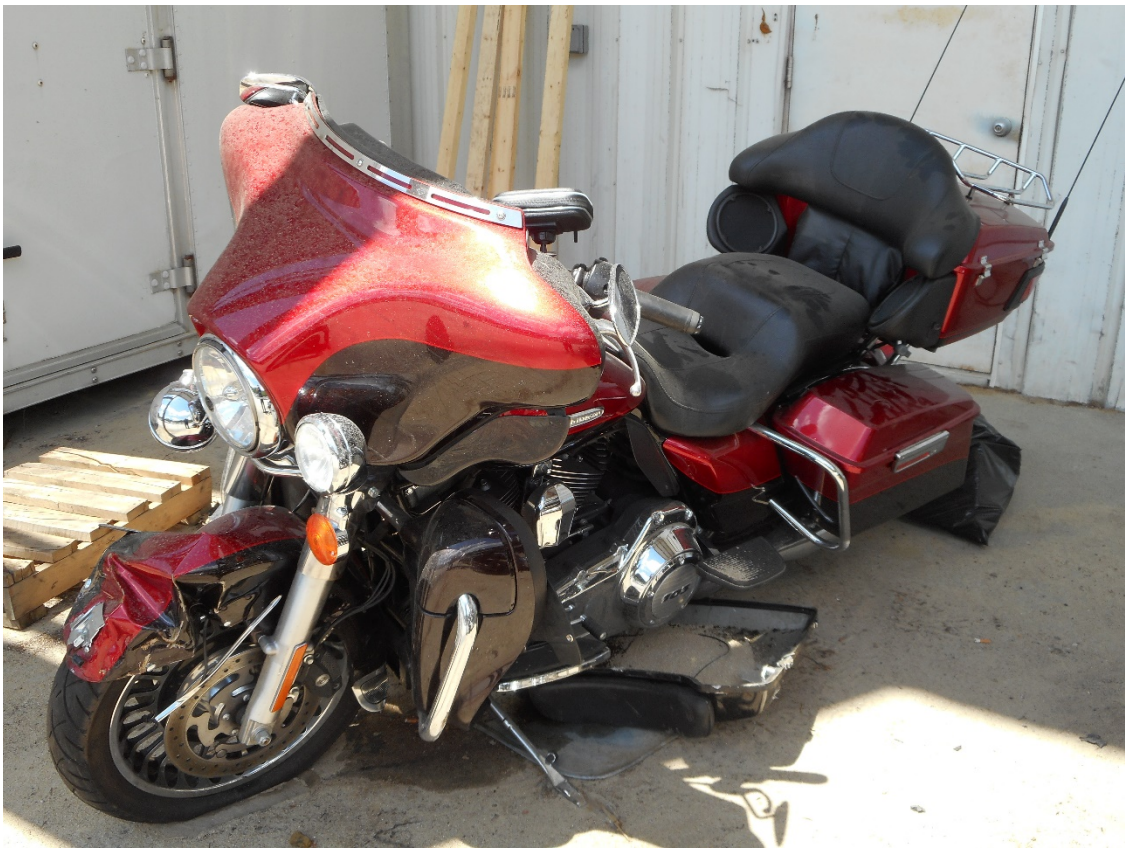
Photo 9 – View of damage to 2012 Harley Davidson Electra Glide Ultra Unlimited FLSTI.

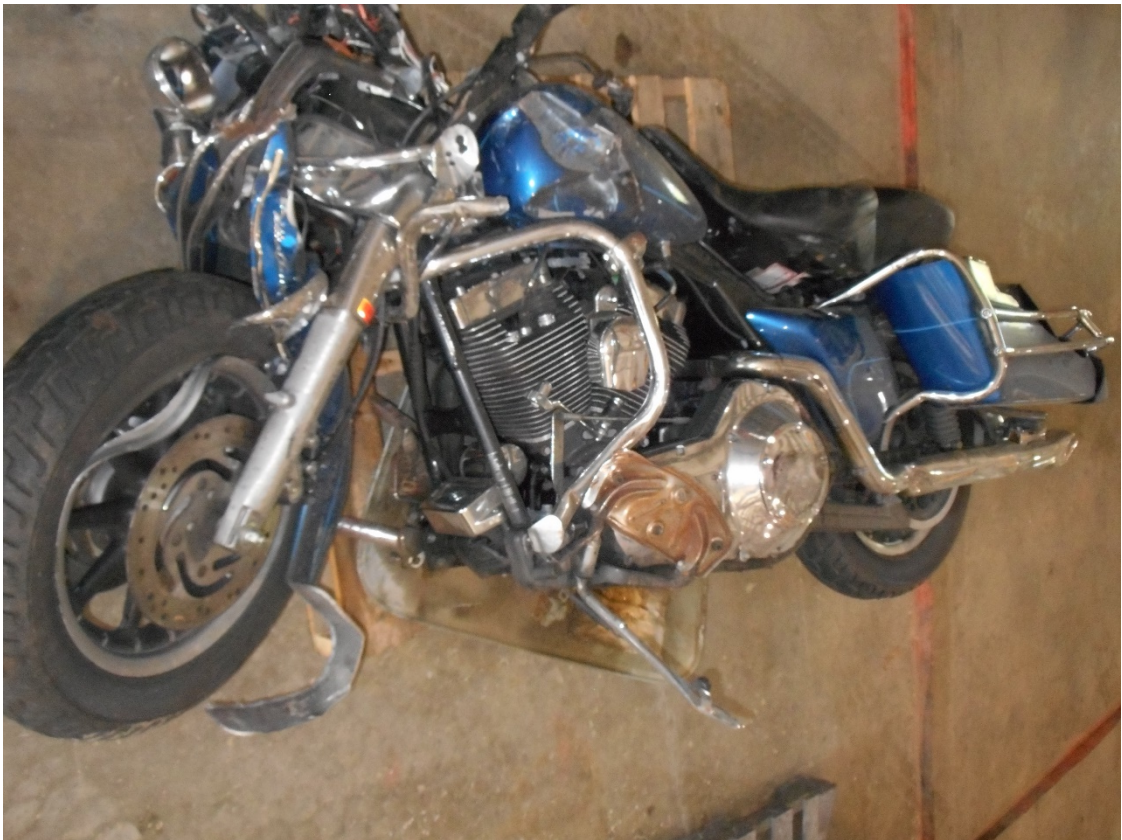
Photo 10 – View of deformation to 2005 Harley Davidson Electra Glide Ultra Classic FLHTCUI.

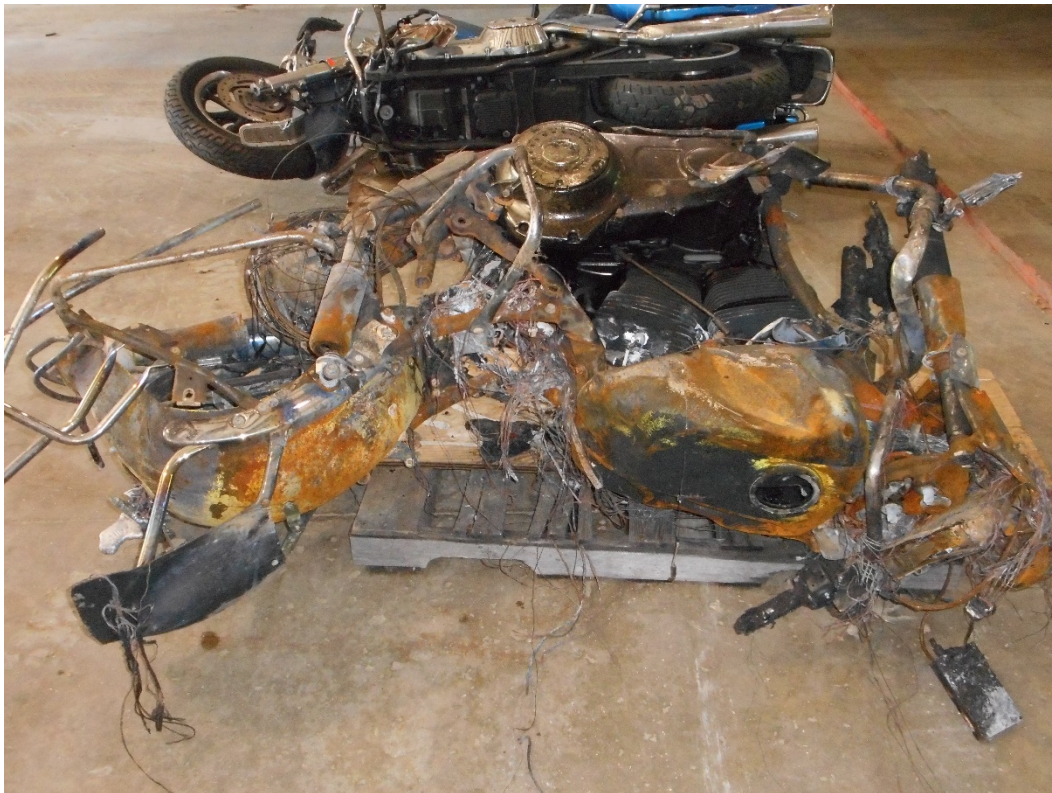
Photo 12 – View of damaged and burned 2012 Harley Davidson Electra Glide Ultra Limited FLHTK EL.

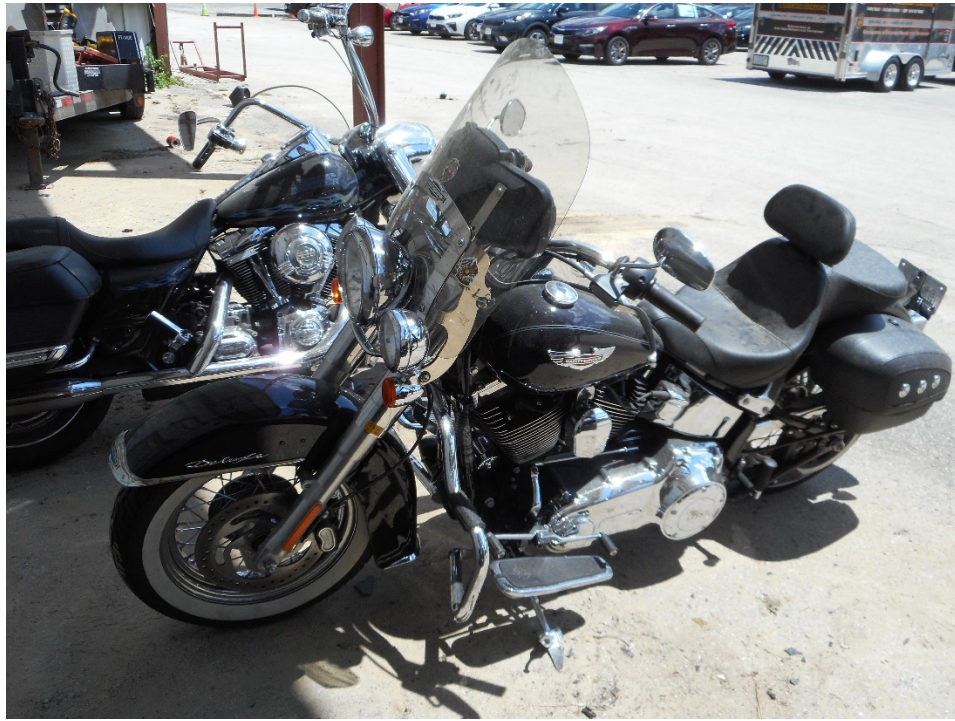
Photo 13 – View of minor damage to 2015 Harley Davidson Softail Deluxe FLST.

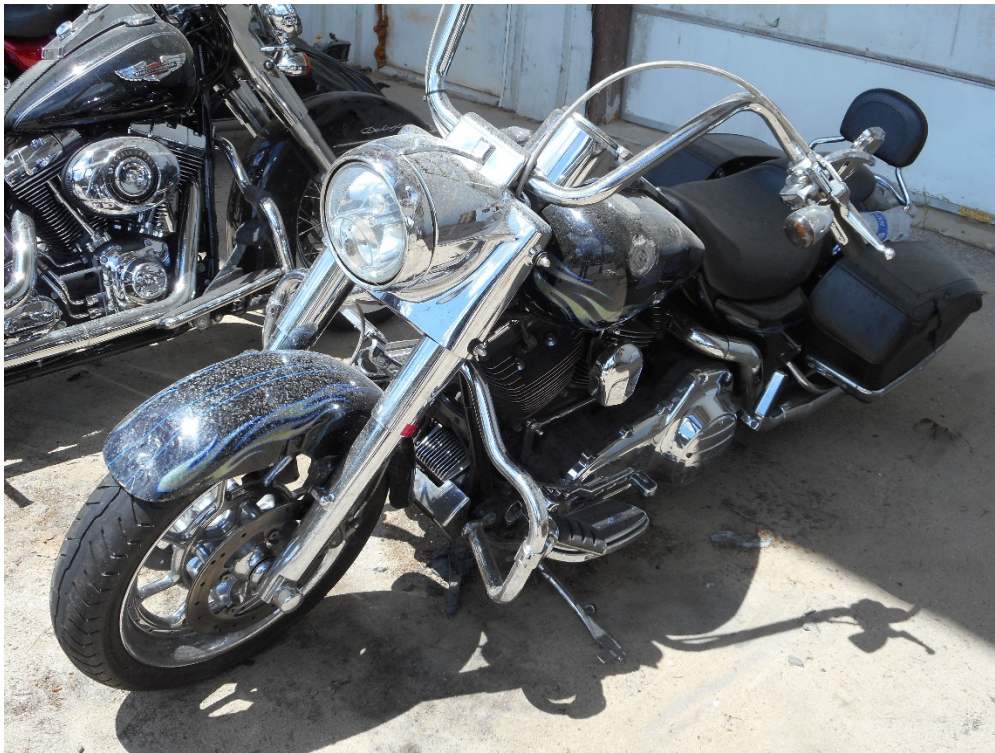
Photo 14 – View of minor damage to 2007 Harley Davidson CVO Road King FLHSE3.
