**NATIONAL TRANSPORTATION SAFETY BOARD
OFFICE OF HIGHWAY SAFETY
WASHINGTON, D.C.**

**VEHICLE FACTORS GROUP CHAIRMAN'S
FACTUAL REPORT**

Passenger #9: 42-year-old female (deceased)
Vehicle #10: 2015 Harley Davidson FLST
Operator #10: 52-year-old female (injured)
Vehicle #11: 2007 Harley Davidson FLHRSE3
Operator #11: 51-year-old male (injured)
Vehicle #12: 2019 Harley Davidson FLXH
Operator #12: 53-year-old male (no injuries)
Vehicle #13: 2006 Harley Davidson FLTRI
Operator #13: 70-year-old male (injured)
Passenger #13 69-year-old female (injured)
Vehicle #14: 2015 Harley Davidson FLHXS
Operator #14: 46-year old male (injured)
Passenger #14: 48-year old female (injured)
Date: Friday, June 21, 2019
Time: 6:26 p.m. Eastern Daylight Time
NTSB #: **HWY19MH010**

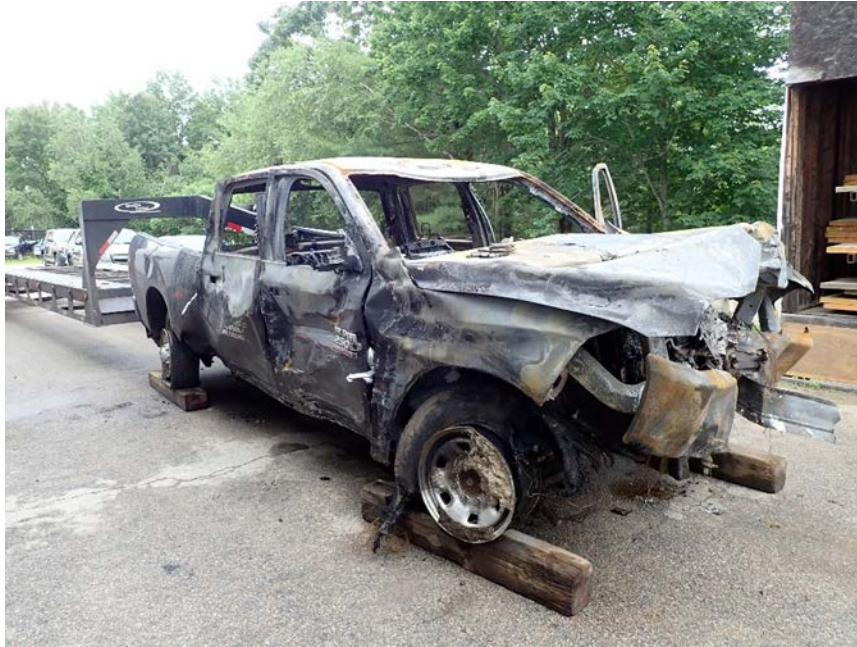
Figure 1: 2016 Ram 2500 Tradesman

The entire vehicle was severely fire damaged. During the crash sequence, two of the struck motorcycles remained connected to the Ram as it traveled to final rest. The fuel tank on one of these motorcycles was ruptured, and the leaking fuel subsequently caused a post-crash fire.

There was contact damage to the entire front end, with the deepest penetration slightly to the left of center, approximately 32-inches wide and 16-inches deep. The front of the left frame rail had shifted to the left. The front bumper was deformed and damaged from side to side. All windows were missing. The right front fender was deformed and showed induced damage. The right front passenger door had contact damage across the bottom of the door which extended down the right side including the rear passenger door and the front portion of the truck bed. This damage ended at the right rear wheel well. There were indentations to the tops of both sides of the truck's bed rails. There was a missing step rail on the right side of the truck. The left side step rail was intact and in place. The hood was deformed, showing both contact and induced damage. Both driver and passenger mirrors were missing. **Figure 1** shows the damage to the Ram from the right front corner.

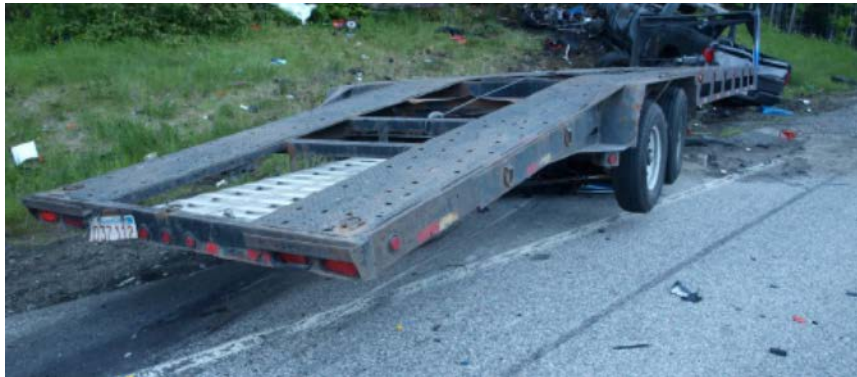
Figure 2: 2015 Quality Trailer at Final Rest. Photo courtesy of New Hampshire State Police.

The 2015 Quality trailer had damage to the front axle. Minor post-crash fire damage was evident on the pig-tail connector. No other damage was found on the trailer. **Figure 2** shows the trailer at final rest at the scene.

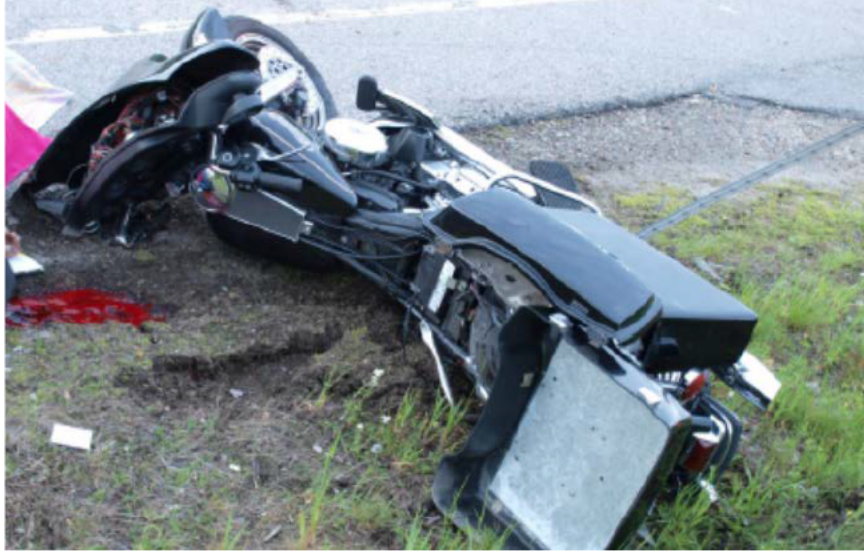
Figure 3: 1998 Harley Davidson Electric Glide. Photo courtesy of the NHSP.

The auxiliary driving light on the right side was missing its lens and was twisted in its mount. The windshield was missing, as was the right rearview mirror lens. The right floorboard was displaced upward. The front fender had contact damage to the right side and to the rear. The motorcycle was missing its seat. The left handlebar was folded in half. The right rear floorboard was displaced downward. The fiberglass fairing on the right side was damaged and torn. The top saddlebag was missing its lid, and there was damage to the lid of the right-side saddlebag. The left side saddle bag was missing. The left floorboard and crash bar were displaced, and the left side tailpipe was detached. There was damage to the left side of the fuel tank. The transmission cover on the left side was fractured. **Figure 3** shows the damaged 1998 Harley Davidson Electric Glide at final rest.

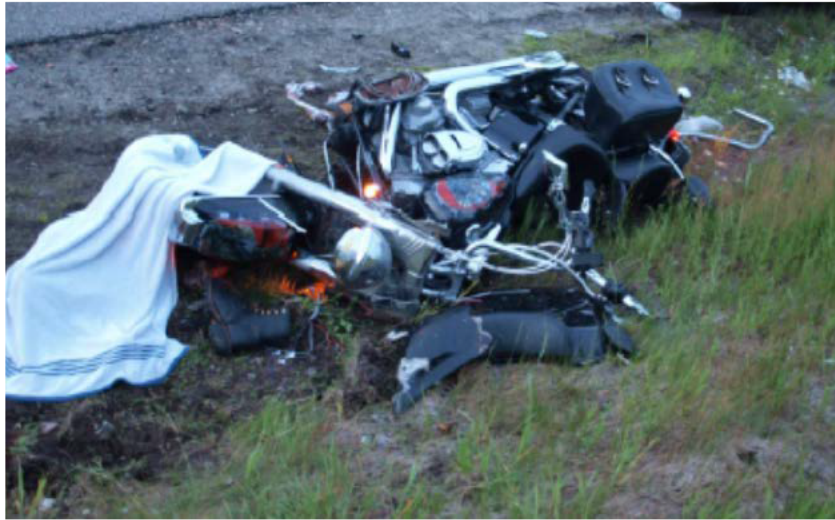
Figure 4: 2006 Harley Davidson Heritage Softail. Photo Courtesy of the NHSP.

The left handlebar was sheared off. The headlight assembly was broken, and the right mirror was torn from its mount. The throttle control on the right handlebar was broken. The right front turn signal was sheared off its mount. The right floorboard was displaced upward. The front fender was torn and deformed. The rear fender was also damaged and dented. The left rear turn signal was sheared off. The back of the passenger seat was displaced. The kickstand and gearshift were both sheared away from the frame. The left side of the transmission housing was fractured. The left rear saddle bag was torn and damaged. **Figure 4** shows the 2006 Harley Davidson Heritage Softail at final rest at the scene.

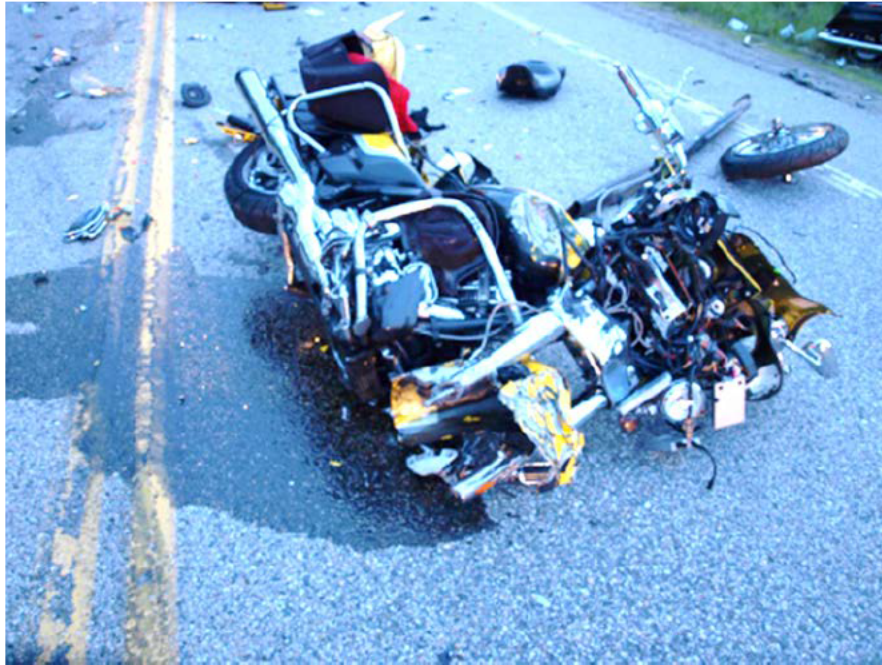
Figure 5: 2012 Harley Davidson CVO Ultra Classic Electra Glide. Photo courtesy of the NHSP.

The front tire was missing from the motorcycle and the lower section of the front fork assembly was fractured. The instrument cluster was displaced from its mount. The handlebars were twisted and deformed. The right crash bar was displaced rearward and the right floorboard was displaced upward. All saddle bags were broken or displaced. The left front brake handle was

twisted. The windshield was missing from the bike. **Figure 5** shows the damaged 2012 Harley Davidson CVO Ultra Classic Electra Glide at final rest at the scene.

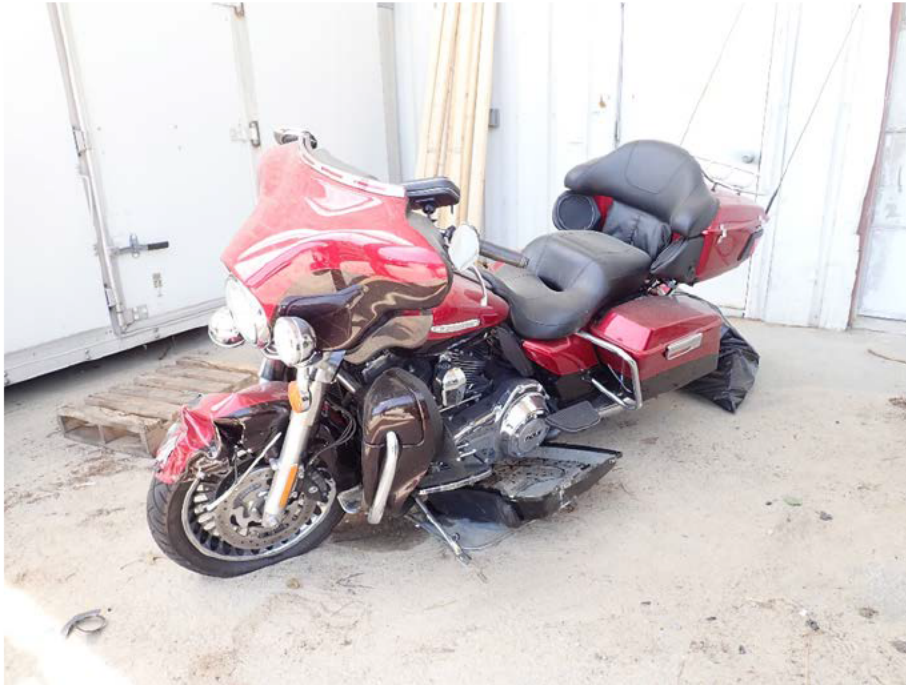
Figure 6: 2012 Harley Davidson Electra Glide Ultra Unlimited

The motorcycle was missing its windshield. The right front turn signal and light were broken away from their mount. There was contact damage to the front fender and the front tire pressure was low. **Figure 6** shows the damaged 2012 Harley Davidson Electra Glide Ultra Unlimited at inspection.

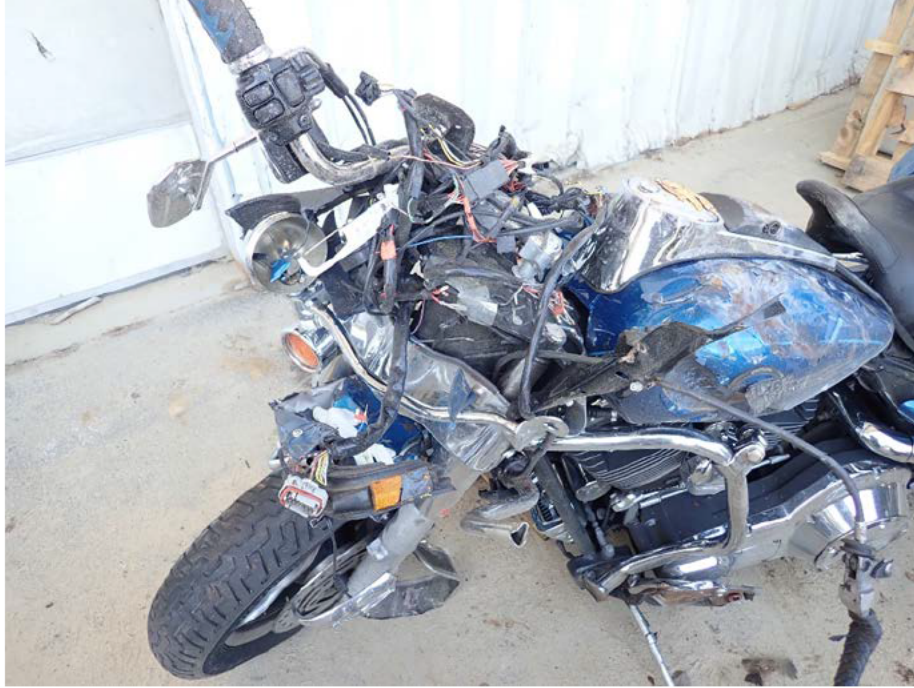
Figure 7: 2005 Harley Davidson Electra Glide Ultra Classic

The front fender was torn and severely damaged. The left handlebar was sheared off and missing. The left floorboard was displaced upward and there was contact damage to the left and right sides of the fuel tank. The left tail pipe was damaged. The seat was torn from its mount and the left saddlebag was fractured and missing the lid. The instrument cluster was missing and torn away from the handlebars. The headlight was missing, and both turn signals were torn from their mounts. The front rim was deformed, and the tire was flat. The right floorboard was displaced upward. The clutch assembly was missing, and the left crash bar was displaced rearward. The left side transmission case, muffler, and highway peg were scratched. The left rear turn signal was missing. The right-side saddle bag was damaged. The right rear passenger floorboard was deformed. **Figure 7** shows the damaged 2005 Harley Davidson Electra Glide Ultra Classic at the time of inspection.

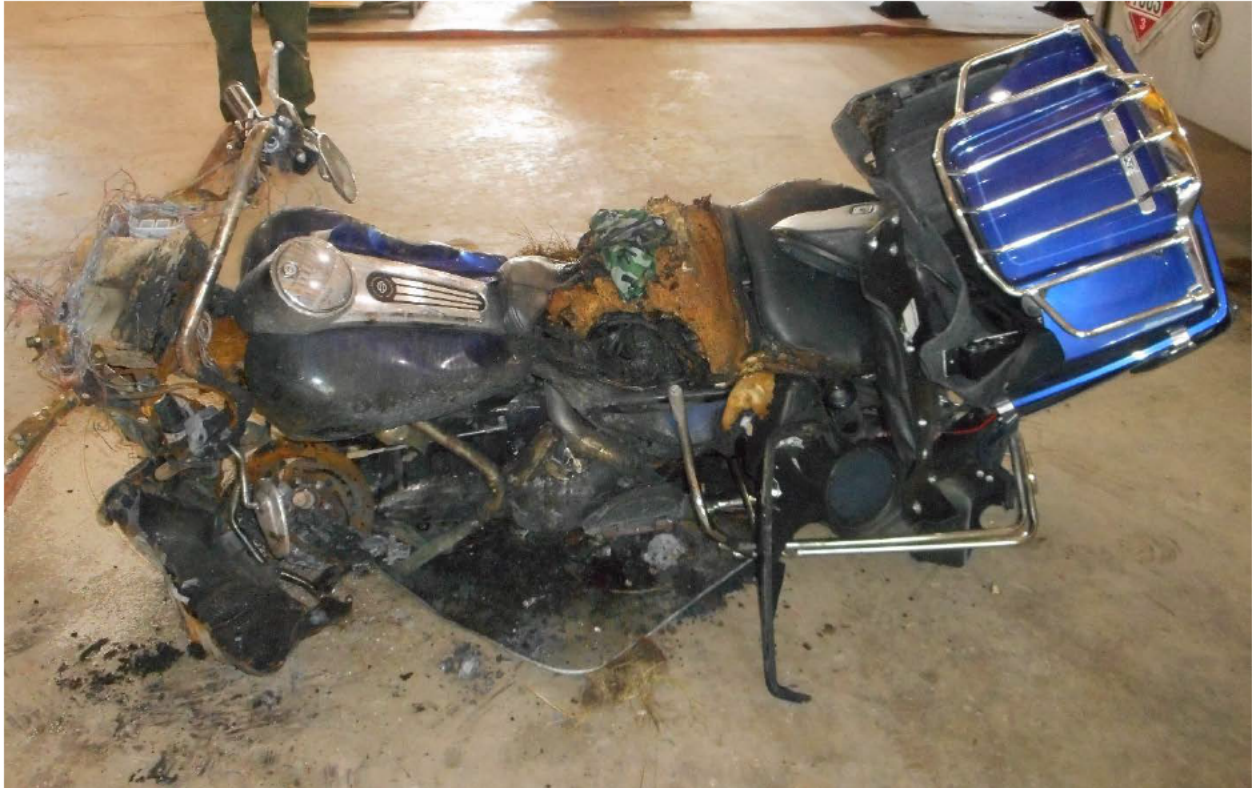
Figure 8: 2007 Harley Davidson Electra Glide Ultra Classic

The front of this motorcycle sustained burn damage in the post-crash fire. The front tire and wheel assembly were missing and fractured at the lower section of the fork. The seat was partially melted. The rear tire sustained fire damage. The left crash bar was displaced inward to the frame. The left floorboard was displaced upward. The instrument cluster was burned to the point only wiring was left. The motorcycle was missing its windshield. The rear passenger back rest was torn from the bike. All saddle bags were broken, fractured. The fuel tank was damaged. Both handlebars were sheared from the frame. **Figure 8** shows the damaged and partially burned 2007 Harley Davidson Electra Glide Ultra Classic.

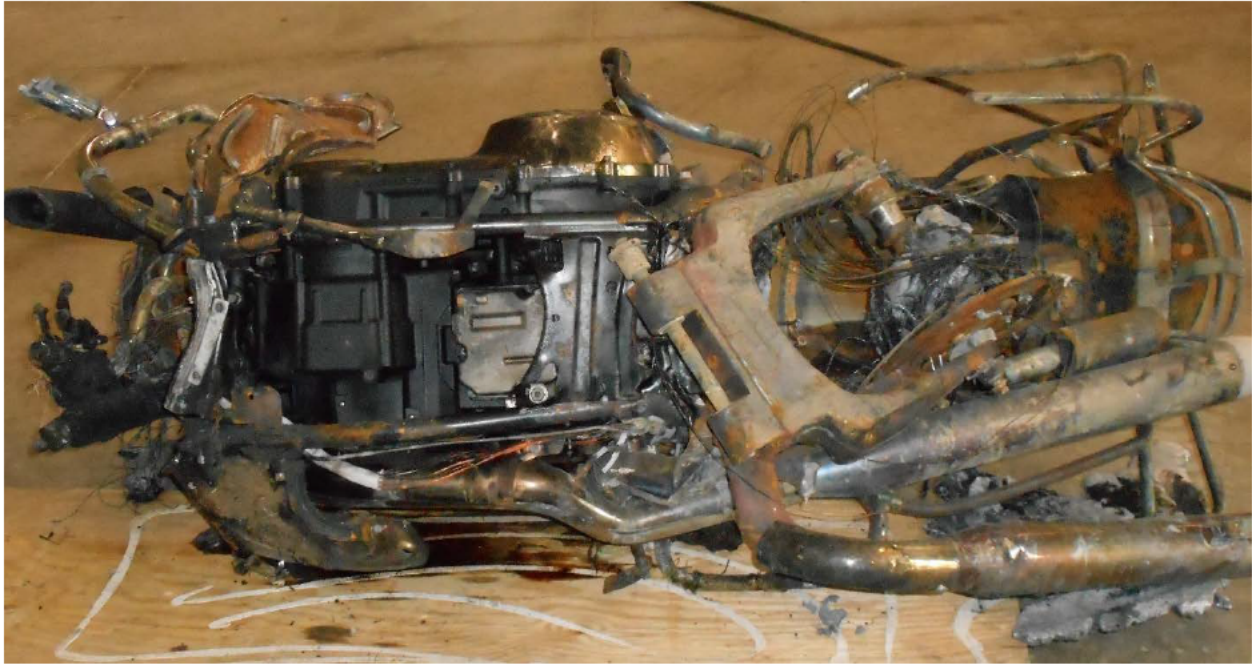
Figure 9: 2012 Harley Davidson Electra Glide Ultra Limited.

This motorcycle was severely damaged in the crash and the post-crash fire. It was missing its front tire and wheel assemble entirely. The forks were sheared off at the shock absorbers. The instrument cluster was burned to the wires. There was damage to all sides of the fuel tank. The seat was consumed in the fire. Both side crash bars were displaced and deformed. The rear tire was consumed in the fire. **Figure 9** shows the damaged and burned 2012 Harley Davidson Electra Glide Ultra Limited.

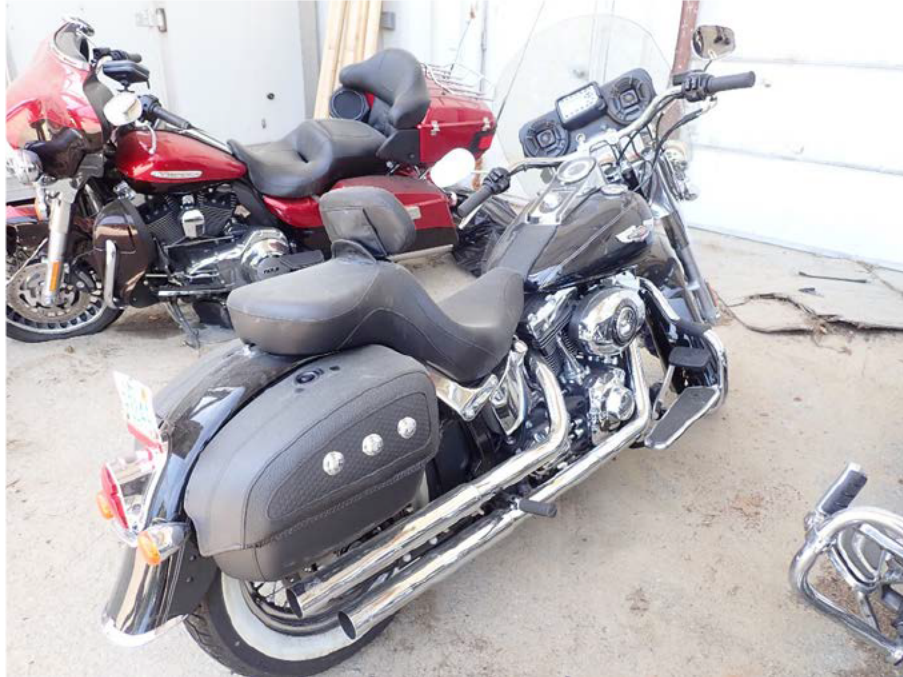
Figure 10: 2015 Harley Davidson Softail Deluxe

There were minor scrapes to the right brake handle and right crash bar. The headlight lens, windshield, right saddle bag, and right mirror also sustained minor scrapes. There was a minor dent in the front fender. **Figure 10** shows the damaged 2015 Harley Davidson Softail Deluxe at inspection.

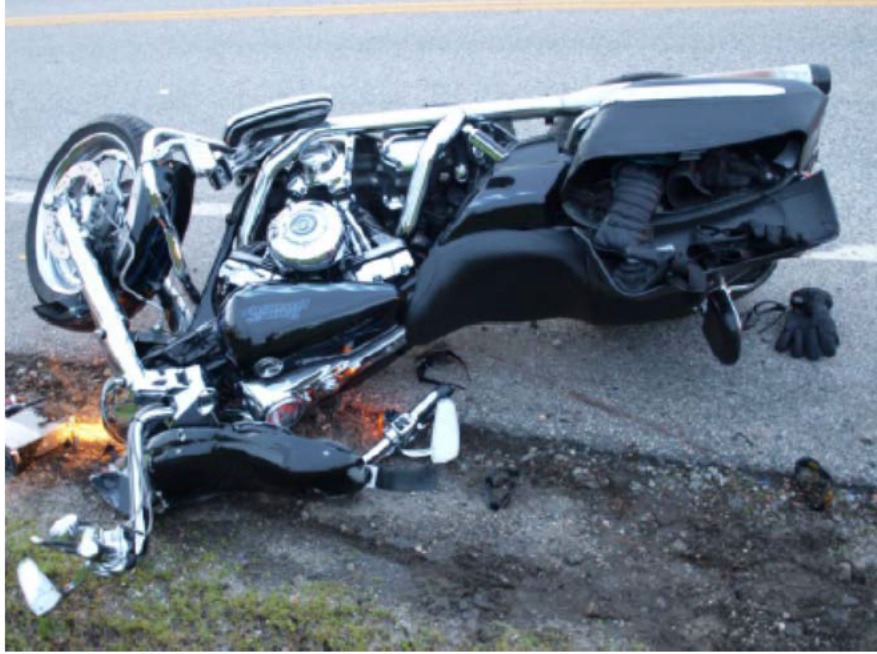
Figure 11: 2007 Harley Davidson CVO Road King 3. Photo courtesy of the NHSP.

The left clutch handle sustained damage. The left side of the fuel tank had a dent and scratches. There was damage to the front fender and a dent in the headlight area. The handlebars were twisted out of position and had several scrapes on the right handlebar. The clutch cable was torn. The left foot peg was displaced inward. The left rear saddle bag was damaged. **Figure 11** shows the damaged 2007 Harley Davidson CVO Road King 3 at the scene.

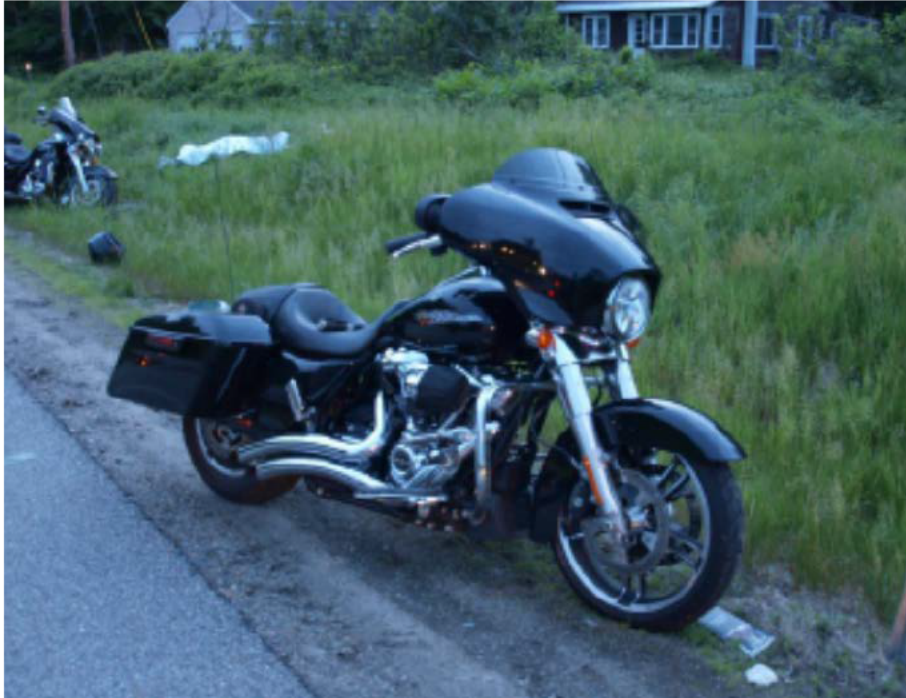
Figure 12: 2019 Harley Davidson Street Glide at controlled final rest. Photo Courtesy of NHSP.

This motorcycle was driven from the scene and not available for post-crash inspection. **Figure 12** is the 2019 Harley Davidson Street Glide at controlled final rest.
