# National Transportation Safety Board

## **TANK CAR DERAILMENT DAMAGE FACTUAL REPORT**

**March 30, 2023, Derailment of BNSF Railway Freight Train  
L-TWI8801-29 and Subsequent Hazardous Materials Release**

**RRD23LR009**

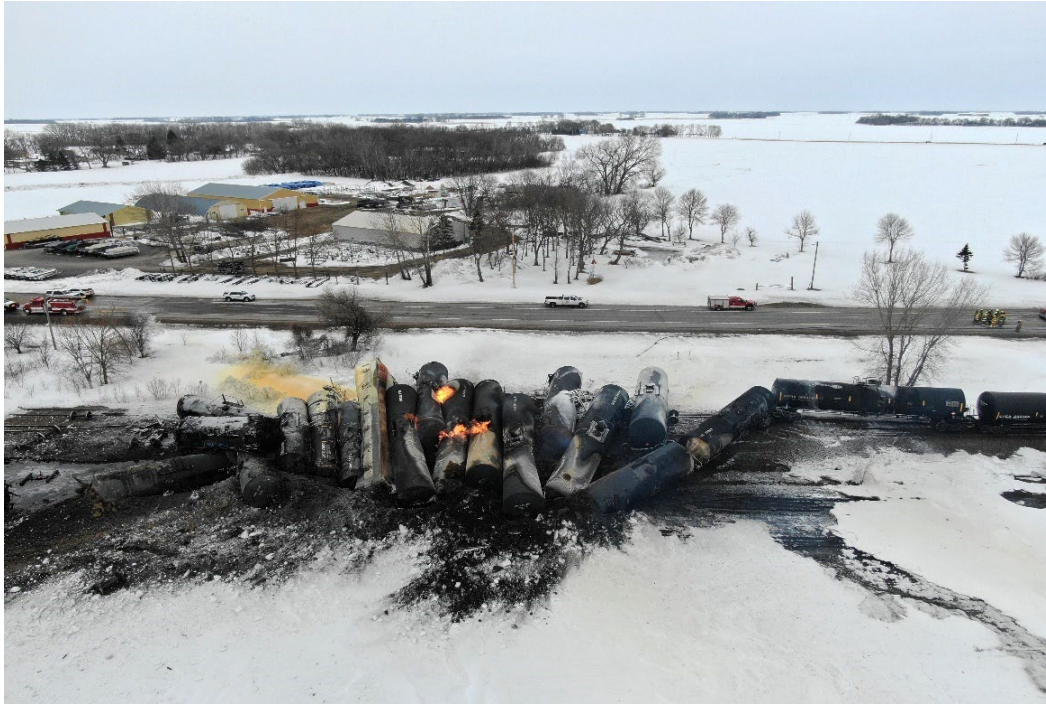
**Figure 1. Photo of derailed train** (courtesy of BNSF)

Post-accident inspections revealed that a catastrophic broken rail event occurred along the straight main rail portion of the switch.

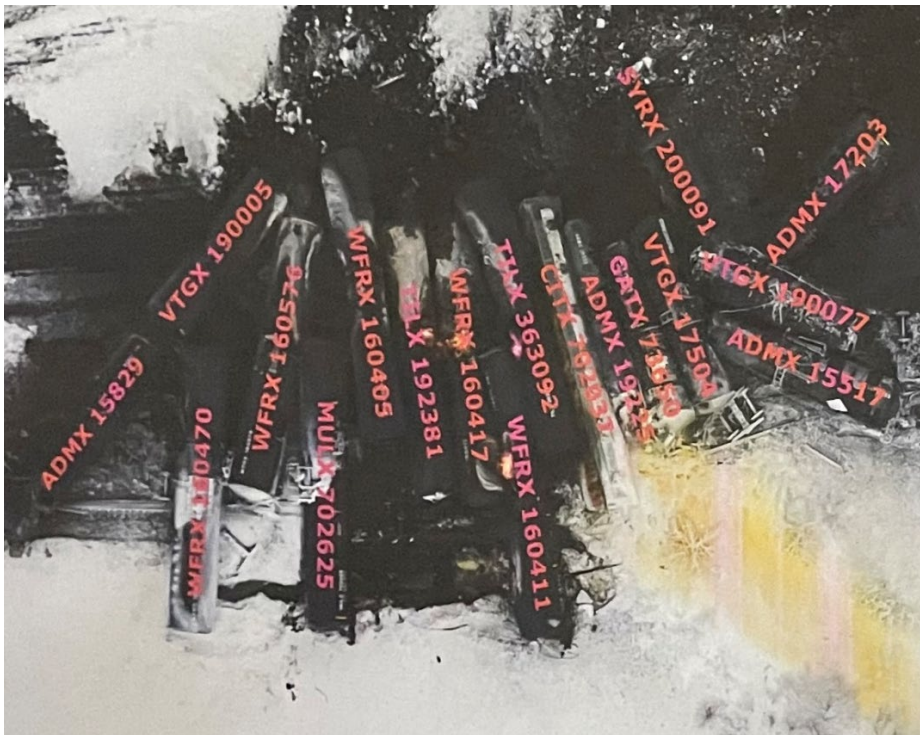
**Figure 2. Labeled Derailment Photograph** (Courtesy of BNSF)

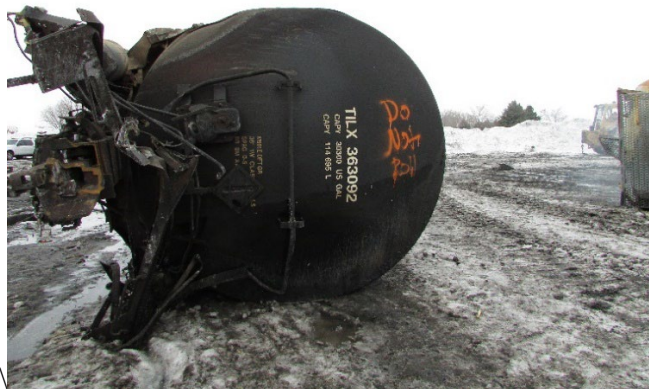
Consist order	<b>22</b>
Orientation in the consist	Unknown.
Derailed resting position	Unknown, car was in staging yard for inspection.
Heads	The A-end and B-end heads had no impact damage.
Shell	Puncture damage, 62 inches high by 44 inches long, right side middle, fire exposure
Bottom outlet valve	No damage.
Top fittings, PRD and Manway	There was no damage to the top fittings protective housing or the manway. The manway swing bolt? at the 10 o'clock position was loose and could be turned by hand.
Stub sills and couplers	Sub-sills attachments were not fractured.

1(a) B-end head, damage to head at 7 to 8 o'clock position.

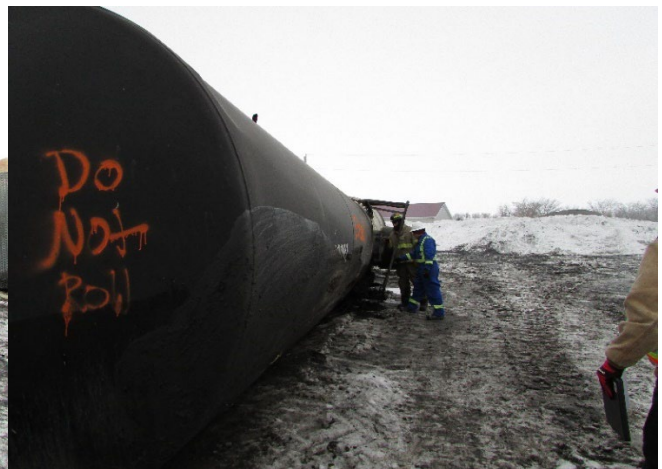
1(b) B-end trailing head, looking down the top of rail car.

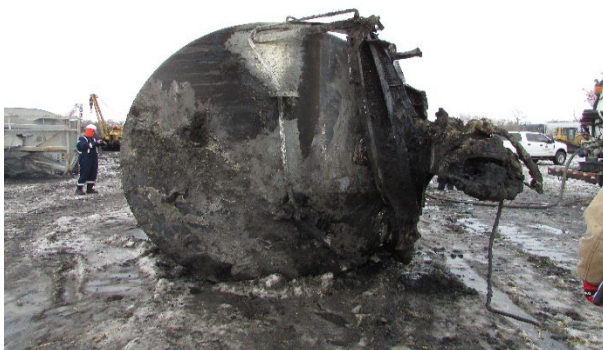
1(c) A-end head, minor damage to head at approx. 6 o'clock position

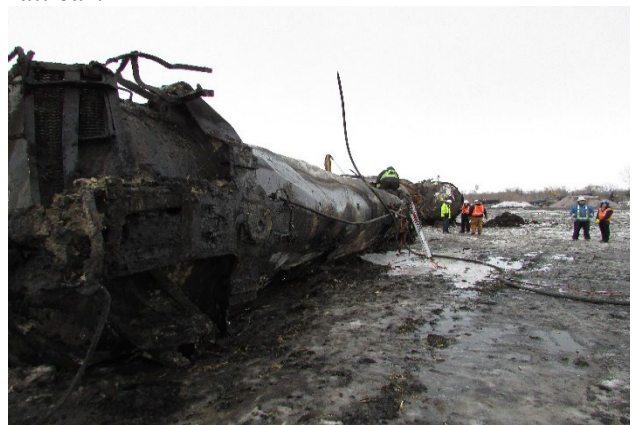
1(d) A-end head looking toward B-end along bottom. Impact damage on right side.

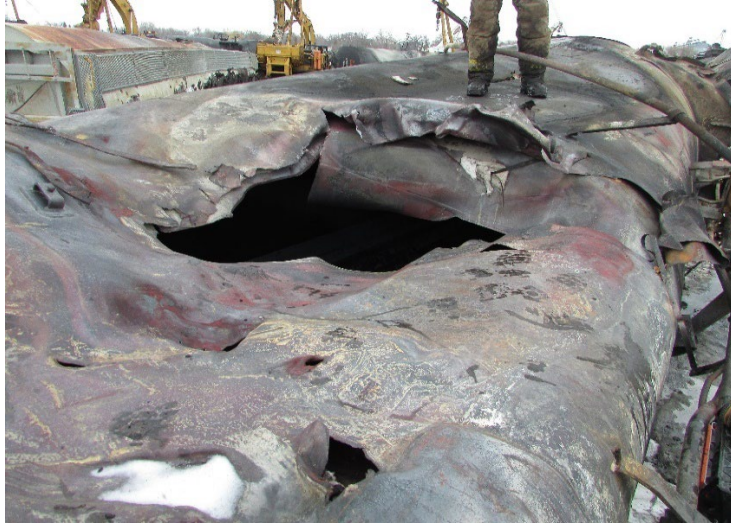
*1(e) Right side of car. Triangle shaped puncture.*

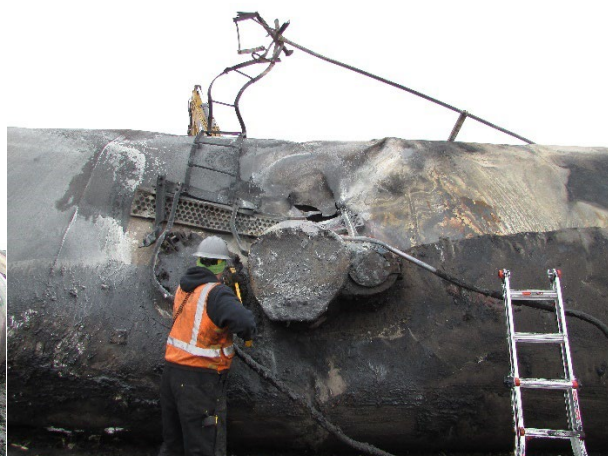
Consist order	<b>23</b>
Orientation in the consist	Unknown
Derailed resting position	Unknown, car was in staging yard for inspection.
Heads	Various dents to upper-right B-end head. B end head shield missing (possibly during post derailment handling).
Shell	Multiple impact damages. About 65% of the shell/jacket surface was thermally damaged.
Bottom outlet valve	No damage.
Top fittings, PRD and Manway	Protective housing was impacted by rollover and contact. No breaching damage to top fittings or manway.
Stub sills and couplers	Stub sills remained attached to head pad.

2(b) Shell puncture damage near protective housing

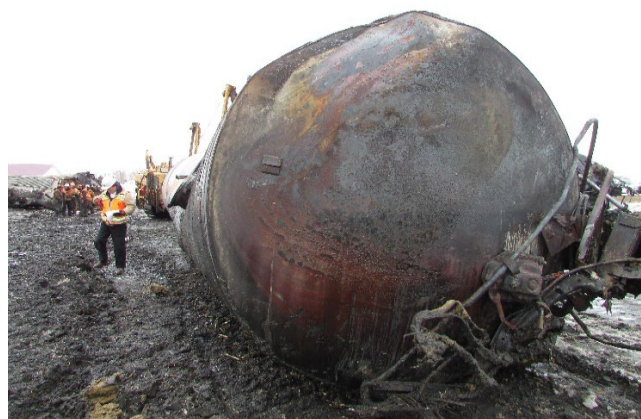
2(c) B-end showing missing head shield and damage at 1 o'clock position

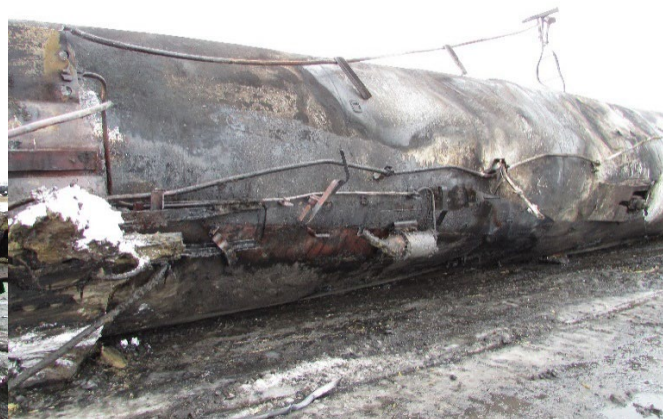
2(d) Bottom, showing fire damage and bottom outlet.

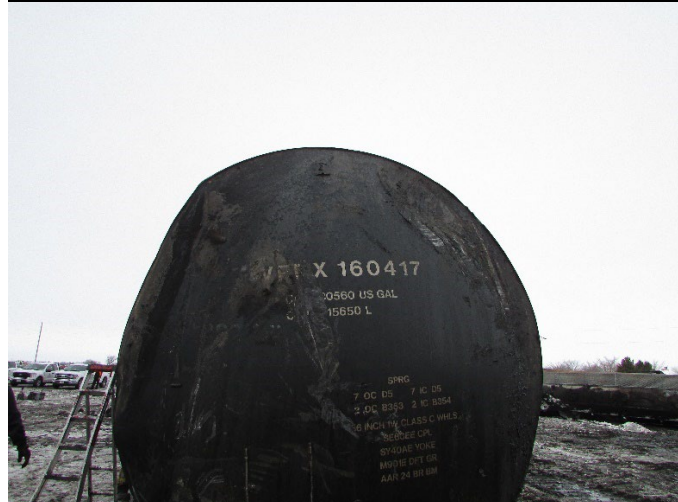
Consist order	<b>24</b>
Orientation in the consist	Unknown.
Derailed resting position	Unknown, car was in staging yard for inspection.
Heads	A-end missing (possibly during post derailment handling), damage to B-end at 9 o'clock.
Shell	Thermal damage and evidence of multiple impact.
Bottom outlet valve	No damage.
Top fittings, PRD and Manway	Thermal damage to manway gasket.
Stub sills and couplers	A-end coupler pushed upward 90-degrees, tearing into stub sill top plate. B-end coupler was broken at the striker plate.

3(a) B-end, showing damage at 9 o'clock

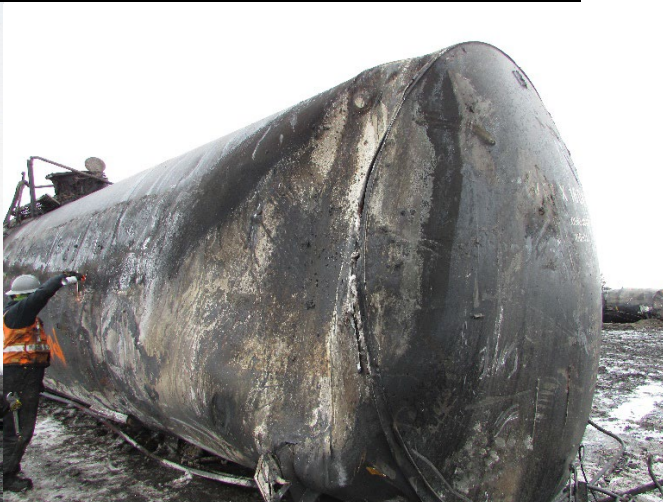
3(b) B-end damage looking on left side.

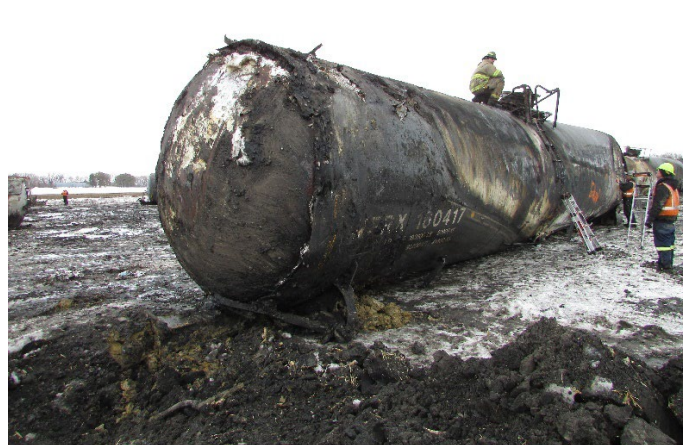
3(c) A-end looking along right side. A-end head shield missing

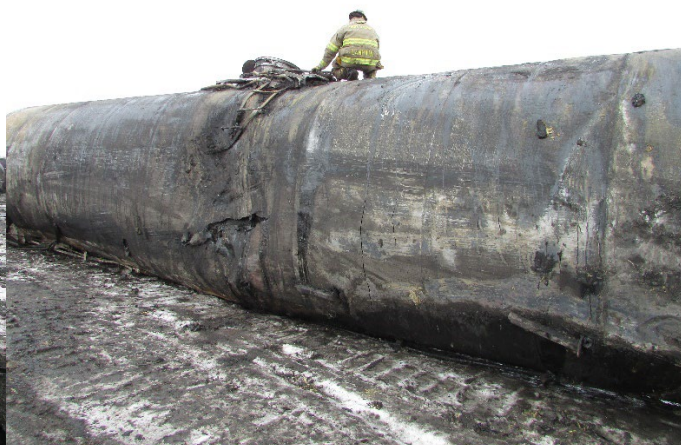
3(d) Left side of car from A-end showing damage to heat shield.

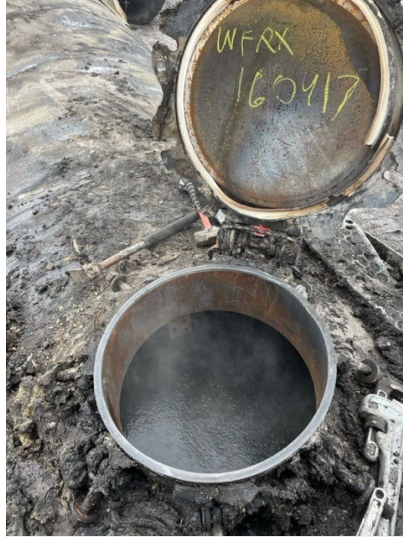
NTSB investigators found the nitrile manway gaskets on 3 of the derailed cars were thermally damaged (see Tables A-3 - A-5 near the end of this report for further details).

*3(e) Showing thermal damage to manway gasket.*

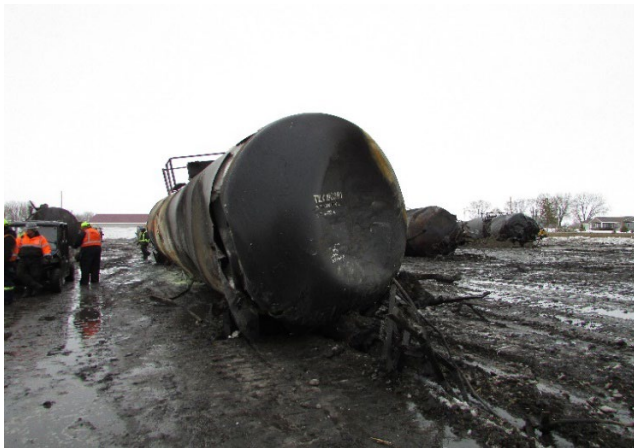
Consist order	<b>25</b>
Orientation in the consist	Unknown.
Derailed resting position	Unknown, car was in staging yard for inspection.
Heads	Dent to center of A-end head, B-end minor scraping.
Shell	Damage at A-end where head shield was welded to tank jacket.
Bottom outlet valve	No damage.
Top fittings, PRD and Manway	Thermal damage, Manway was leaking from damage to gasket.
Stub sills and couplers	Stub sills remained attached to head pad.

4 (a) A-end, showing impact damage.

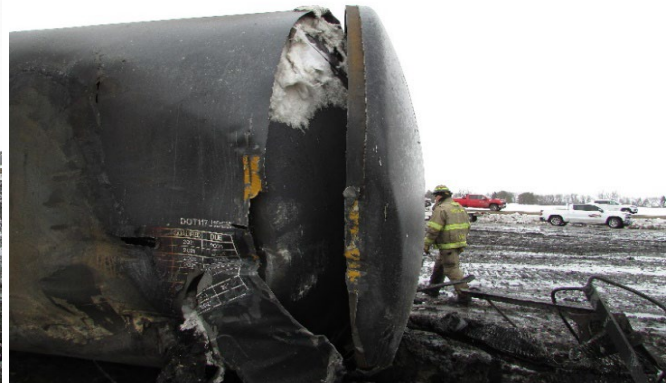
4 (b) A-end left side showing head shield separation and impact damage.

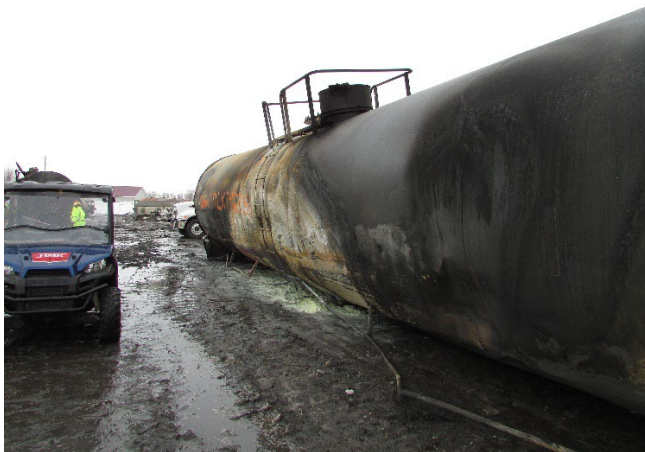
4 (c) left side from A-end showing thermal damage.

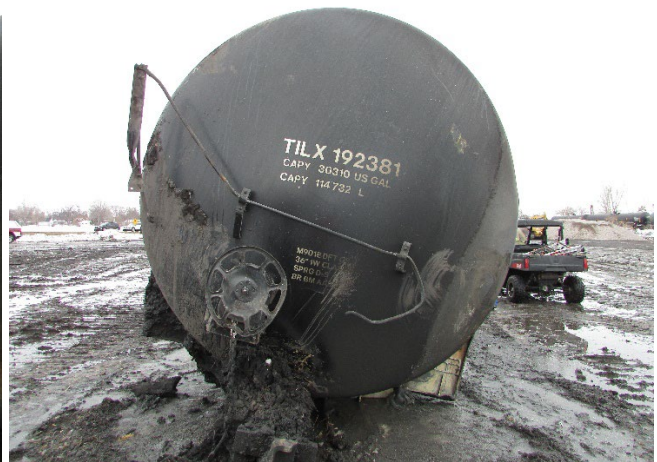
4 (d) B-end, damage.

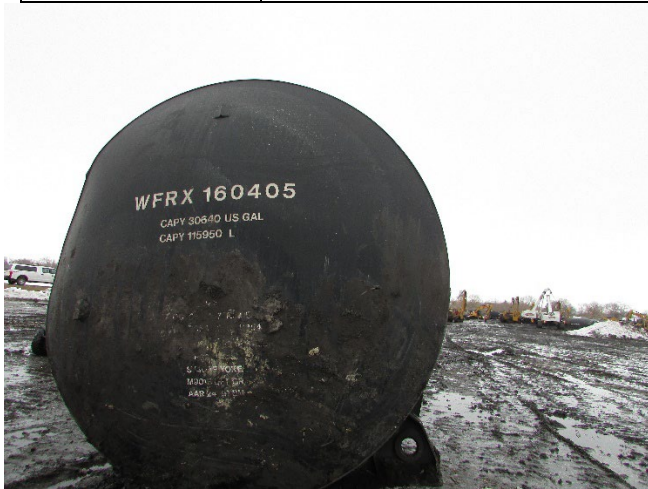
Consist order	<b>26</b>
Orientation in the consist	Unknown.
Derailed resting position	Unknown, car was in staging yard for inspection.
Heads	A-end head dent at 9-10 o'clock, B-end head shield weld was fractured.
Shell	About 65% of shell/jacket surface was exposed to fire, left side thermal damage.
Bottom outlet valve	Bottom outlet valve gasket thermally damaged, leaking through valve.
Top fittings, PRD and Manway	Thermal damage to manway gasket.
Stub sills and couplers	Stub sills remained attached to head pad.

5(a) A-end showing damage to head at 9 to 10 o'clock.

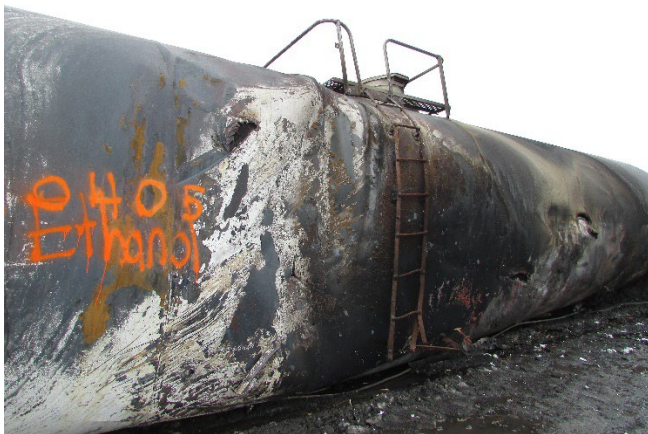
5(b) Right side showing thermal damage.

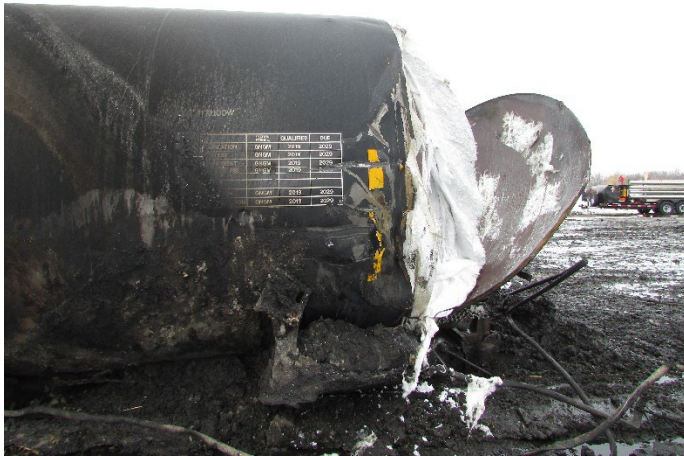
5(c) B-end, showing certification dates and damage to head shield.

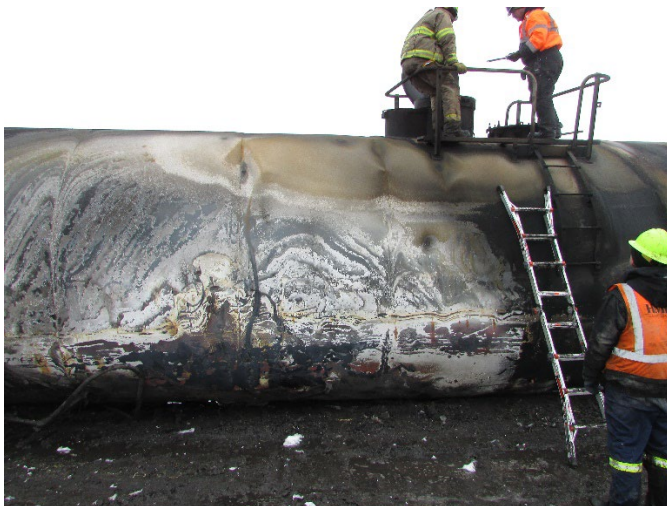
5(d) left side thermal damage.

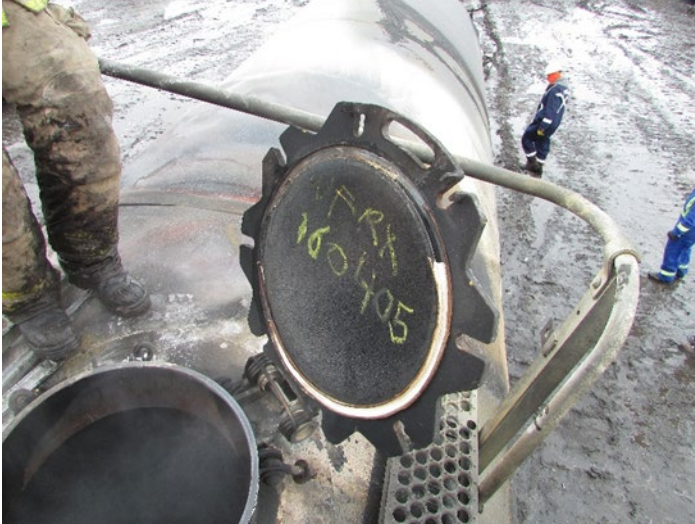
*5(e) Thermal damage to manway gasket.*

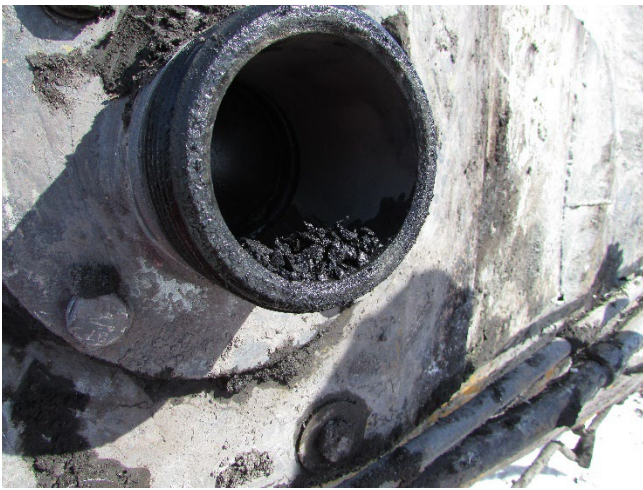
*5(f) Bottom outlet valve gasket thermally damaged.*
