RECORD OF CONVERSATION

Date: March 9, 2022
Person Contacted: Mark Alan Craig
NTSB Accident Number: ERA22LA125

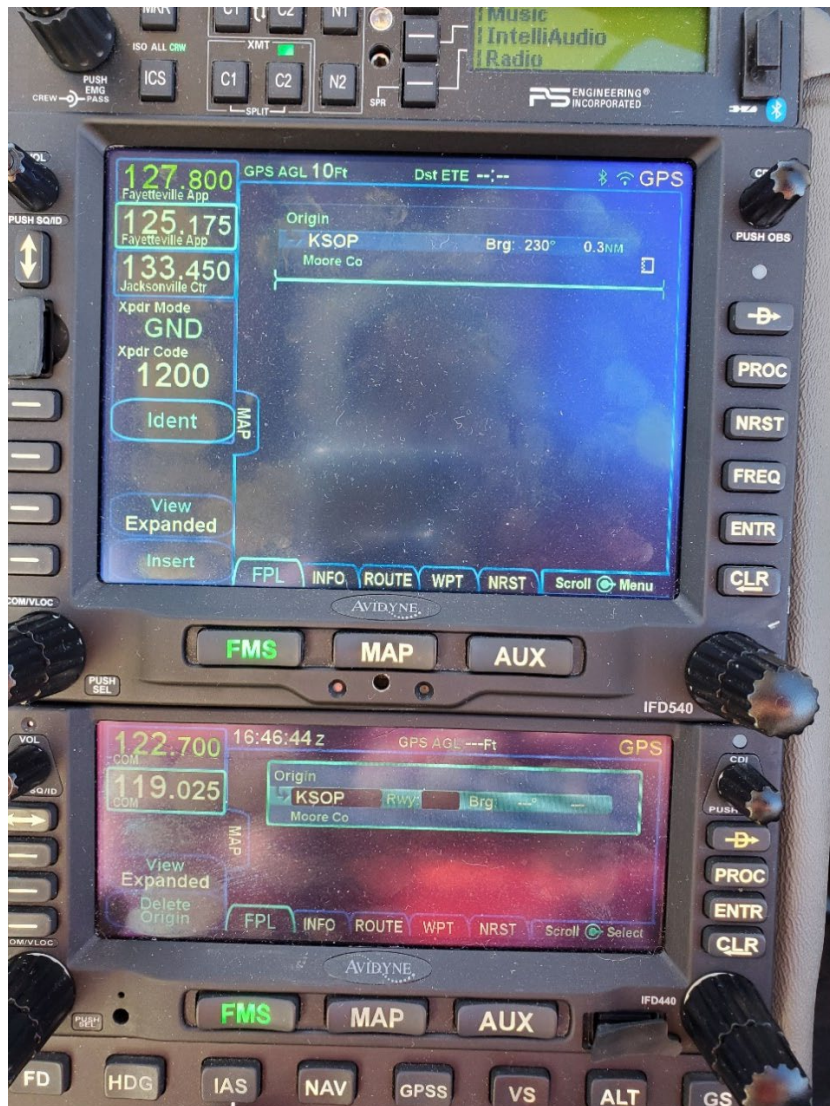
He was informed by email from FAA inspector Corey Paczkowski of the Greensboro North Carolina FAA Flight Standards District Office that post accident, the number two radio which he had been using to communicate on the CTAF was still on the HRJ frequency of 122.7 MHz. And that was the reason why he was unable to turn on the runway lights. He indicated that he had been monitoring Fayetteville approach on 127.8. The FAA inspector has digital photographs of the frequency selected (Figure 1). Inspector Paczkowski work phone number is [REDACTED]

Yes, he had no reason to believe that anybody changed the number two radio transmit frequency. It didn't occur to him that he was on the wrong frequency when he tried to turn on the runway lights using the CTAF frequency and they did not turn on.

Figure 1: Photograph Taken by AMF Personnel⁸. View Depicting The Comm #2 Radio Active Frequency set to 122.700 MHz and the Transmitter Set to the #2 Comm Radio. The photograph was taken 2/10/2022 at 1146 local.
