## RECORD OF CONVERSATION

**Date: October 25, 2022**  
**Person Contacted: Warren Robert Eyring**  
**NTSB Accident Number: ERA23FA033**

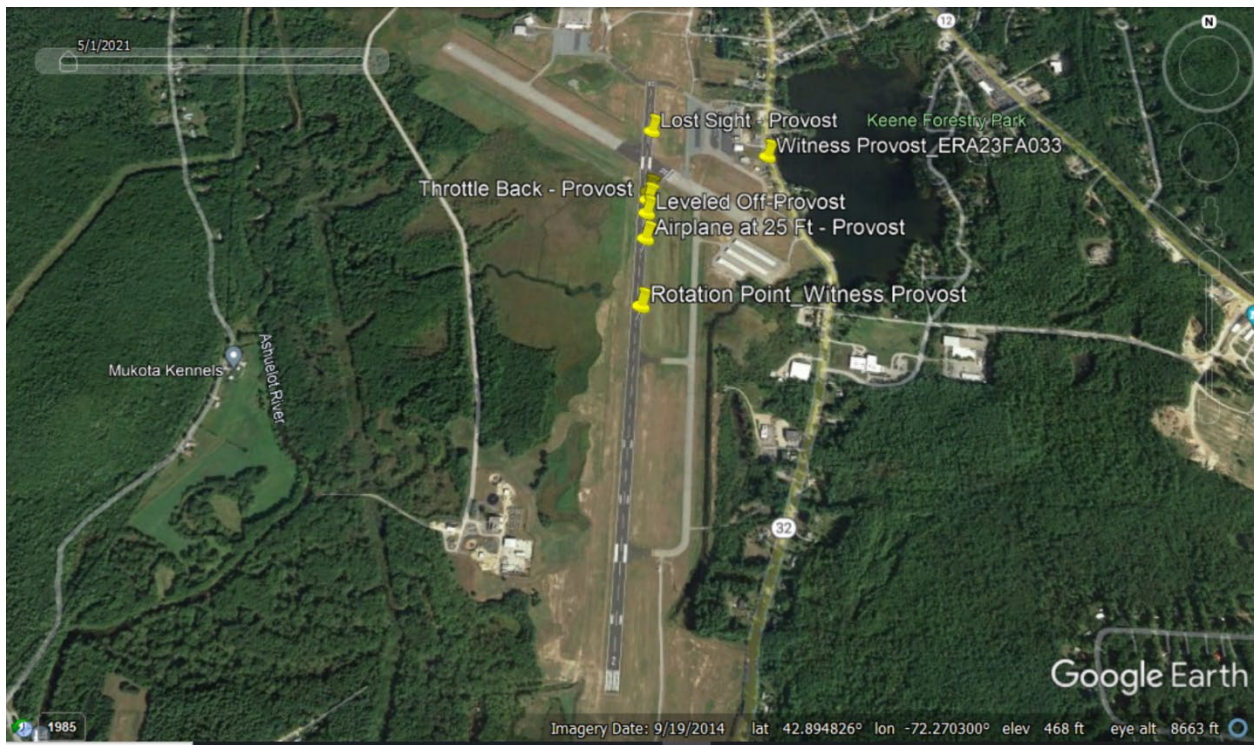
Throttle Forward Point – 42.899847° north latitude and -72.269877° west longitude. That location when plotted on Google Earth was located 1,607 ft before the departure end of the runway.

Lost Sight of the Airplane – 42.901916° north latitude and -72.269736° west longitude. That location when plotted on Google Earth was located 845 ft before the departure end of the runway.

Figure 1: Provost Determined Locations Plotted on Google Earth.

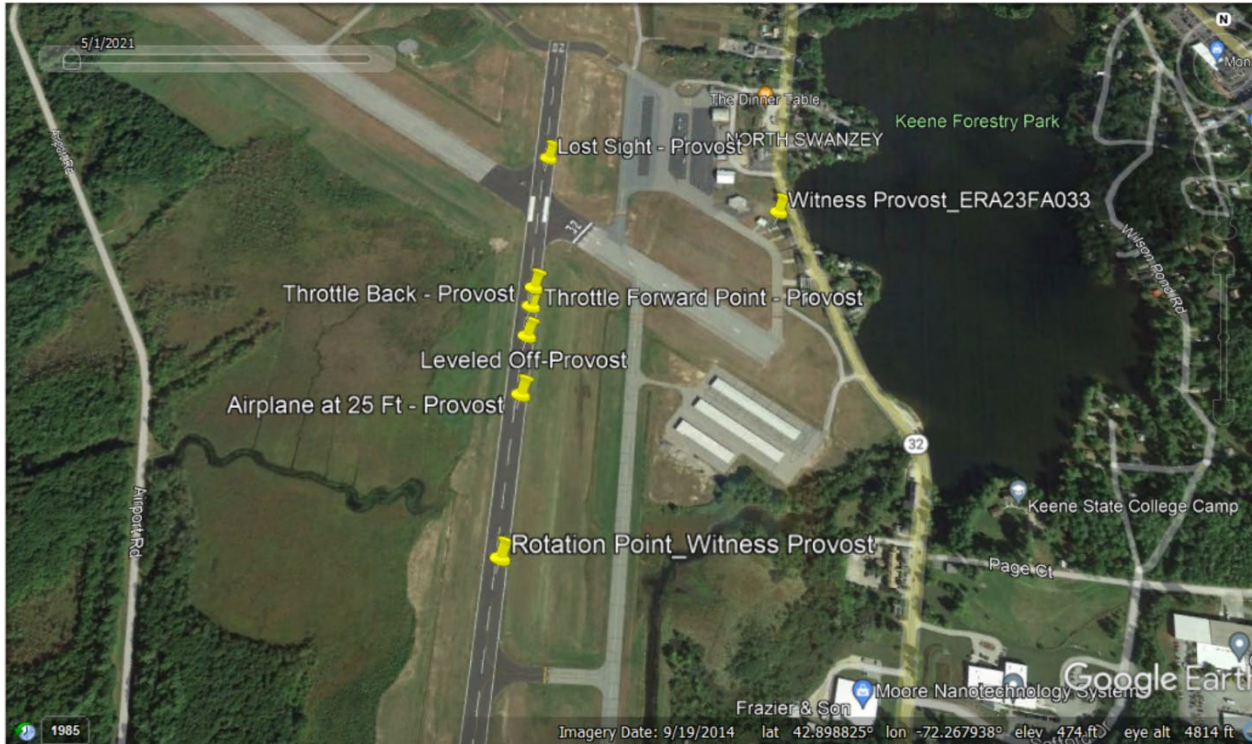
Figure 2: Provost Determined Close-Up Locations Plotted on Google Earth.

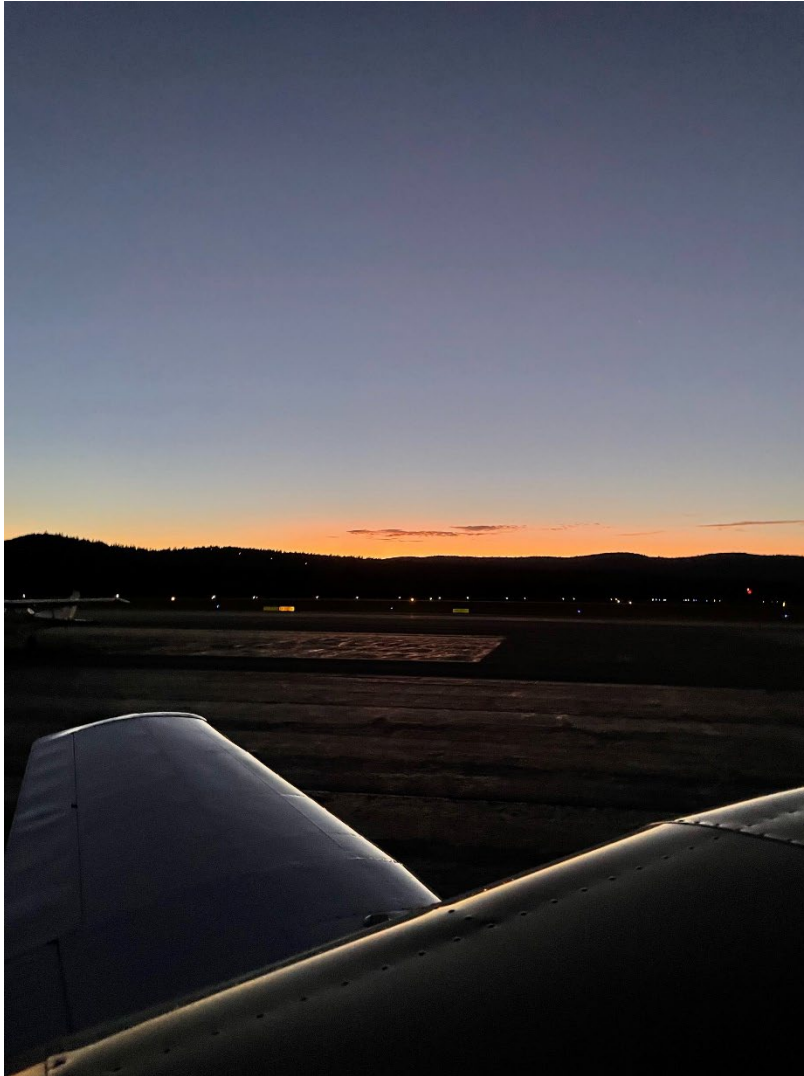
Figure 1: Digital Photograph taken by Student of Daniel C. Wagner. View Showing Lighting and environmental conditions while he opened the Hangar.

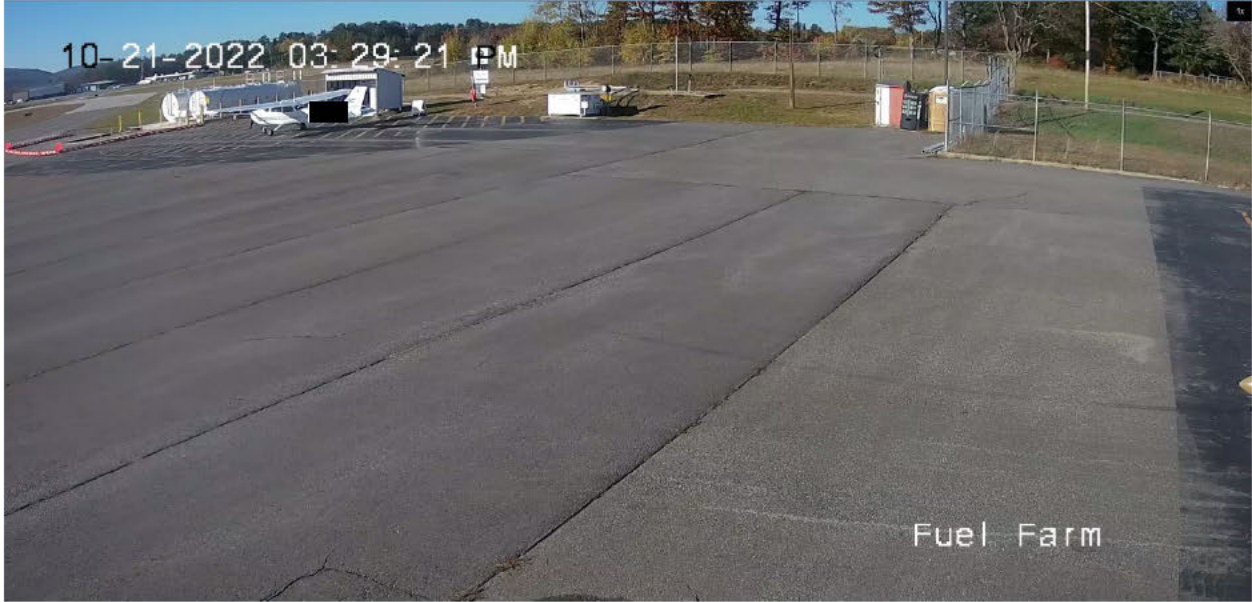
Figure 1: Airport Video ScreenShot Depicting N [REDACTED] at the Self-Service Fuel Pump.
