RECORD OF E-MAIL CORRESPONDENCE

Date: April 19, 2022
Person Contacted: Cheryl M. Villa (FAA)
NTSB Accident Number: WPR22LA147

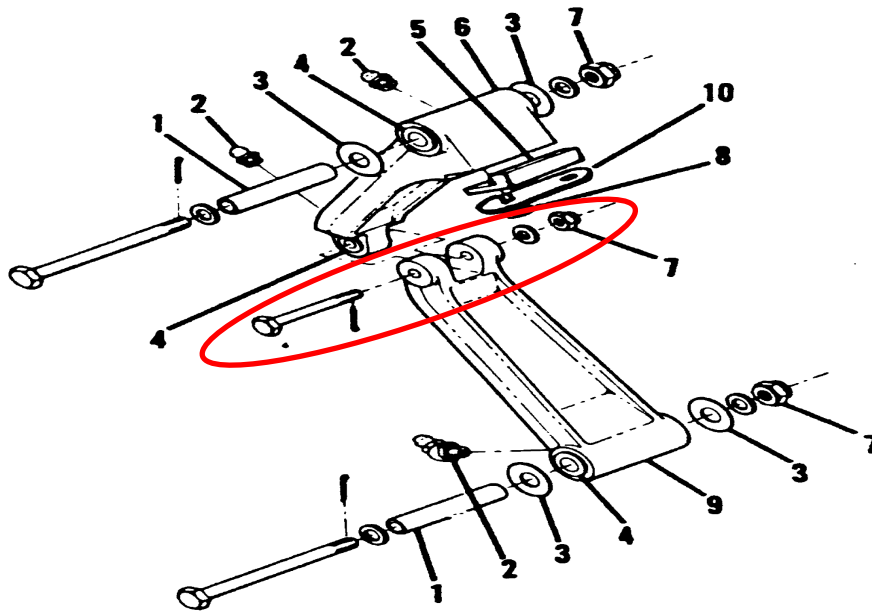
Figure 1: Diagram of nose gear torque links (photo courtesy of the manufacturer)

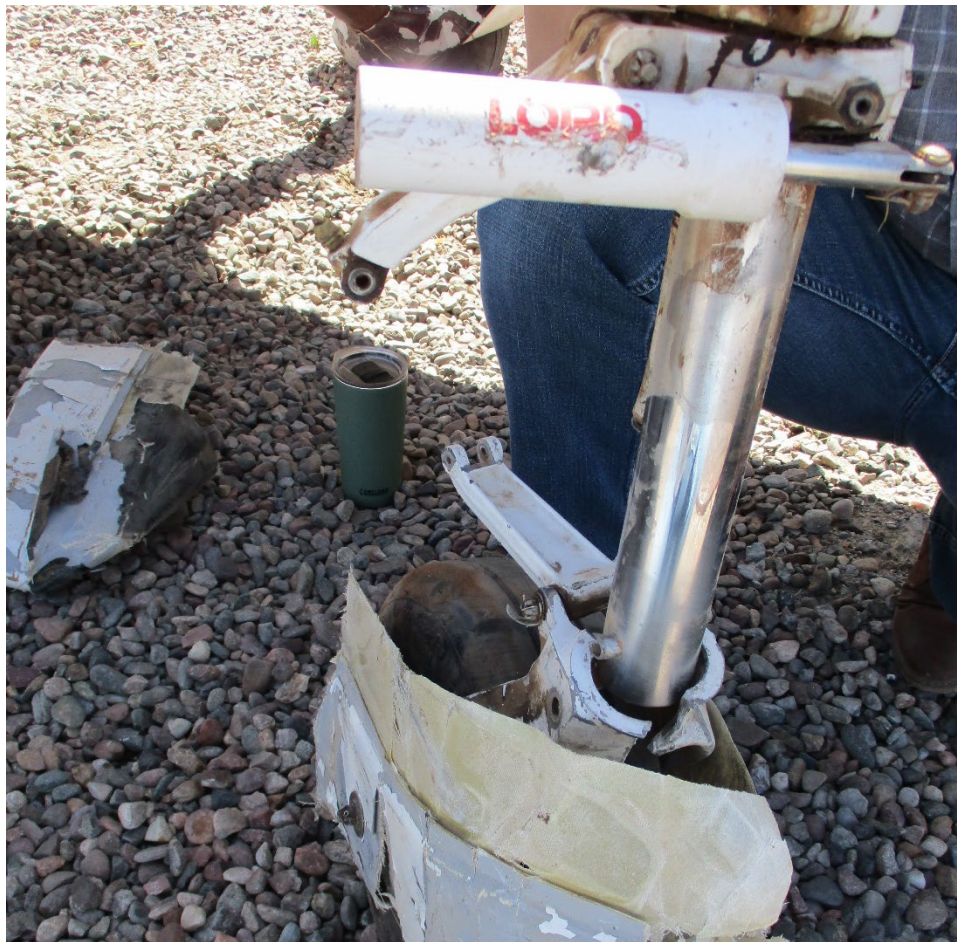
Examination of the recovered airframe revealed both wings had been removed by the recovery organization for transport. The forward section of the fuselage, near the cockpit was impact damaged and the nose landing gear was separated. The damage to the nose gear was consistent with a deflection to the right at or about the time of separation. The bolt, spacer, and nut connecting the upper torque link and the lower torque link was missing and not observed with the wreckage. No damage to the area where the upper torque link and the lower torque link connect was observed. Damage to the nose gear and the right main gear appeared to be consistent with impact damage when the airplane exited the runway and impacted a ditch.

Figure 2: View of nose landing gear (photo courtesy of the FAA)

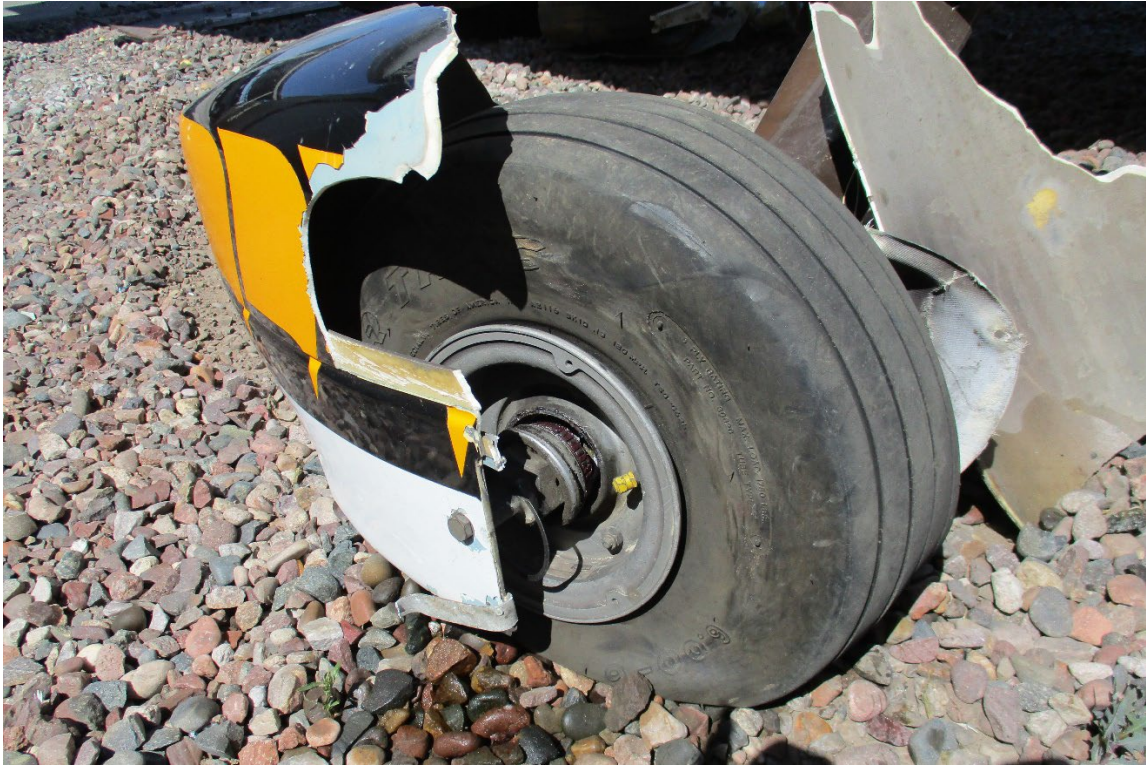
All three tires showed no indication of rubbing or skidding except for a small flat spot on the right main tire.

The right main tire was flat, and the hub was dislodged from the bearing which appeared to occur post-accident.

Figure 3: View of right main landing gear (photo courtesy of the FAA)

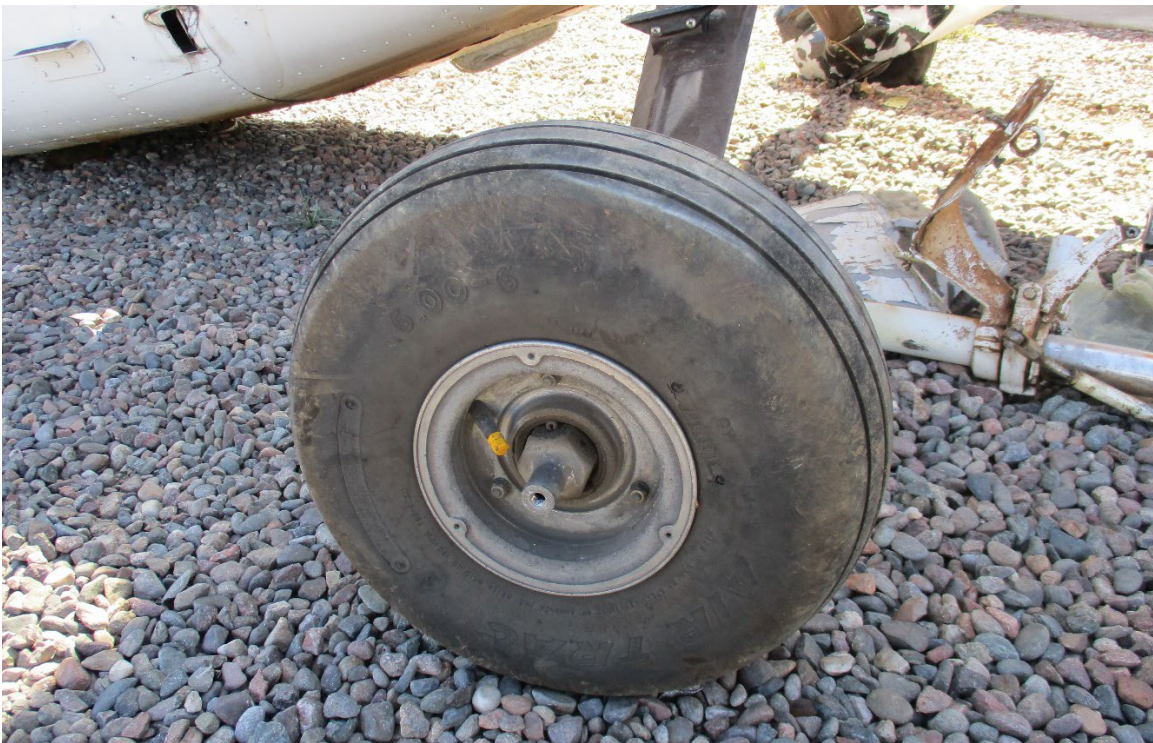
Figure 4: View of left main landing gear (photo courtesy of the FAA)
