National Transportation Safety Board

DCA22FA132

AIRCRAFT PERFORMANCE STUDY

July 7, 2023

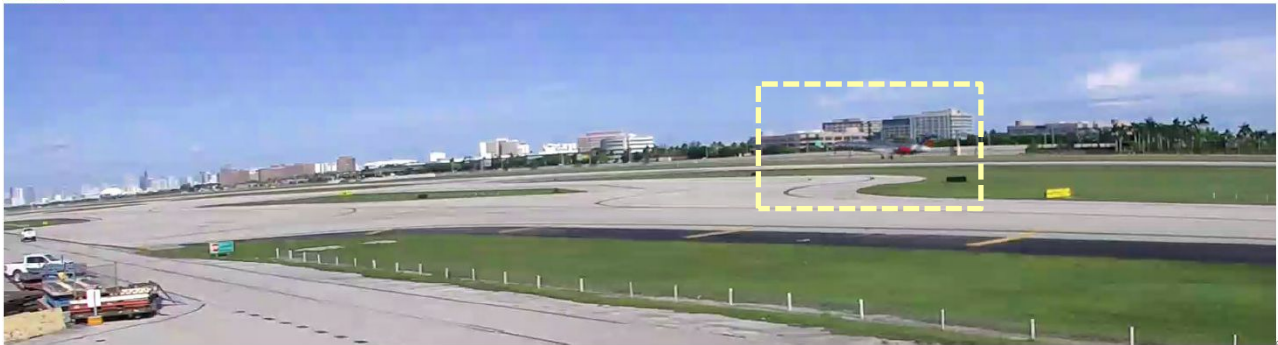
"SW Gate CAM01" Camera, Attachment 4

Figure 2: Excerpt of cropped and enlarged image sequence extracted from "SW Gate CAM01" surveillance camera recording. Airplane is moving right to left toward main gear touchdown point.

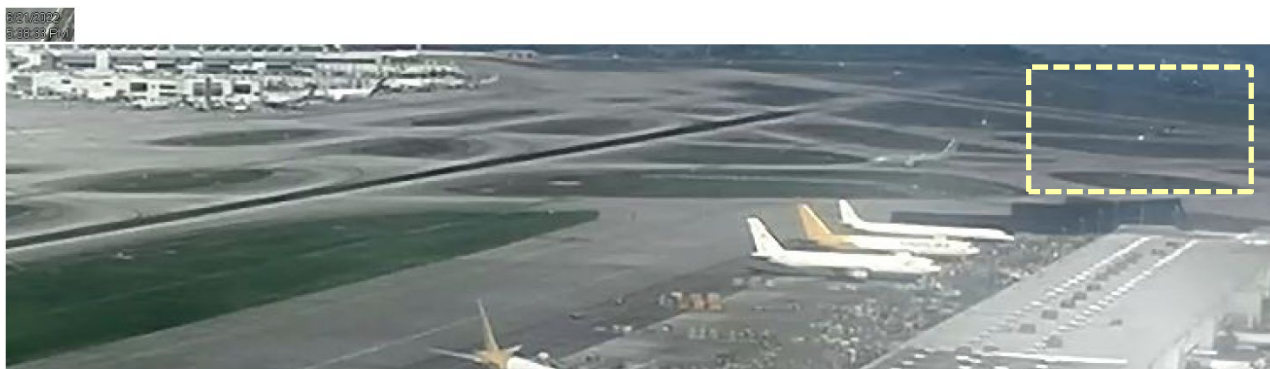
"FAA Tower AOA TRK PTZ 2 S" Camera, Attachment 9

Figure 7: Excerpt of cropped and enlarged image sequence extracted from "FAA Tower AOA TRK PTZ 2 S" surveillance camera recording. Airplane is moving right to left, approaching position of final rest.

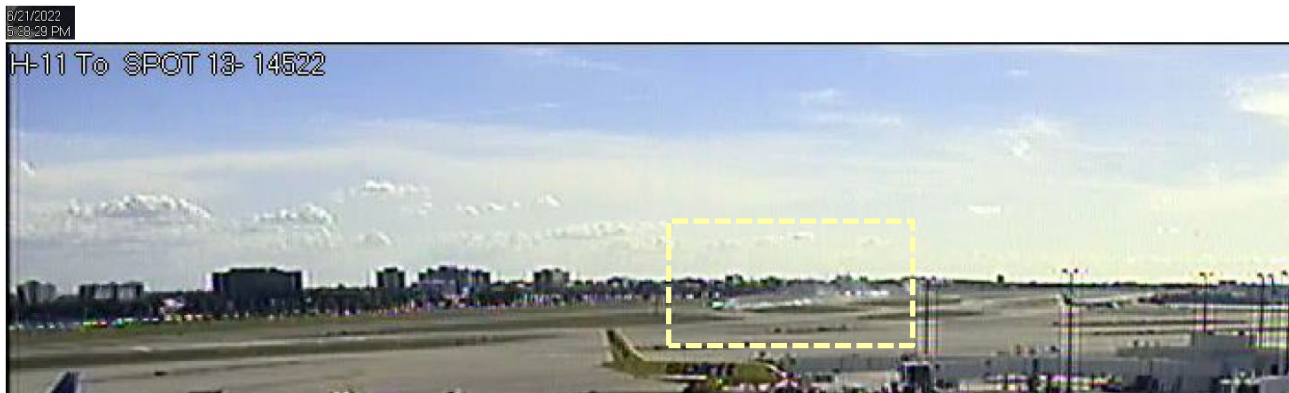
"Spot 13" Camera, Attachment 10

Figure 8: Excerpt of cropped and enlarged image sequence extracted from "Spot 13" surveillance camera recording. Airplane is moving right to left, approaching position of final rest.

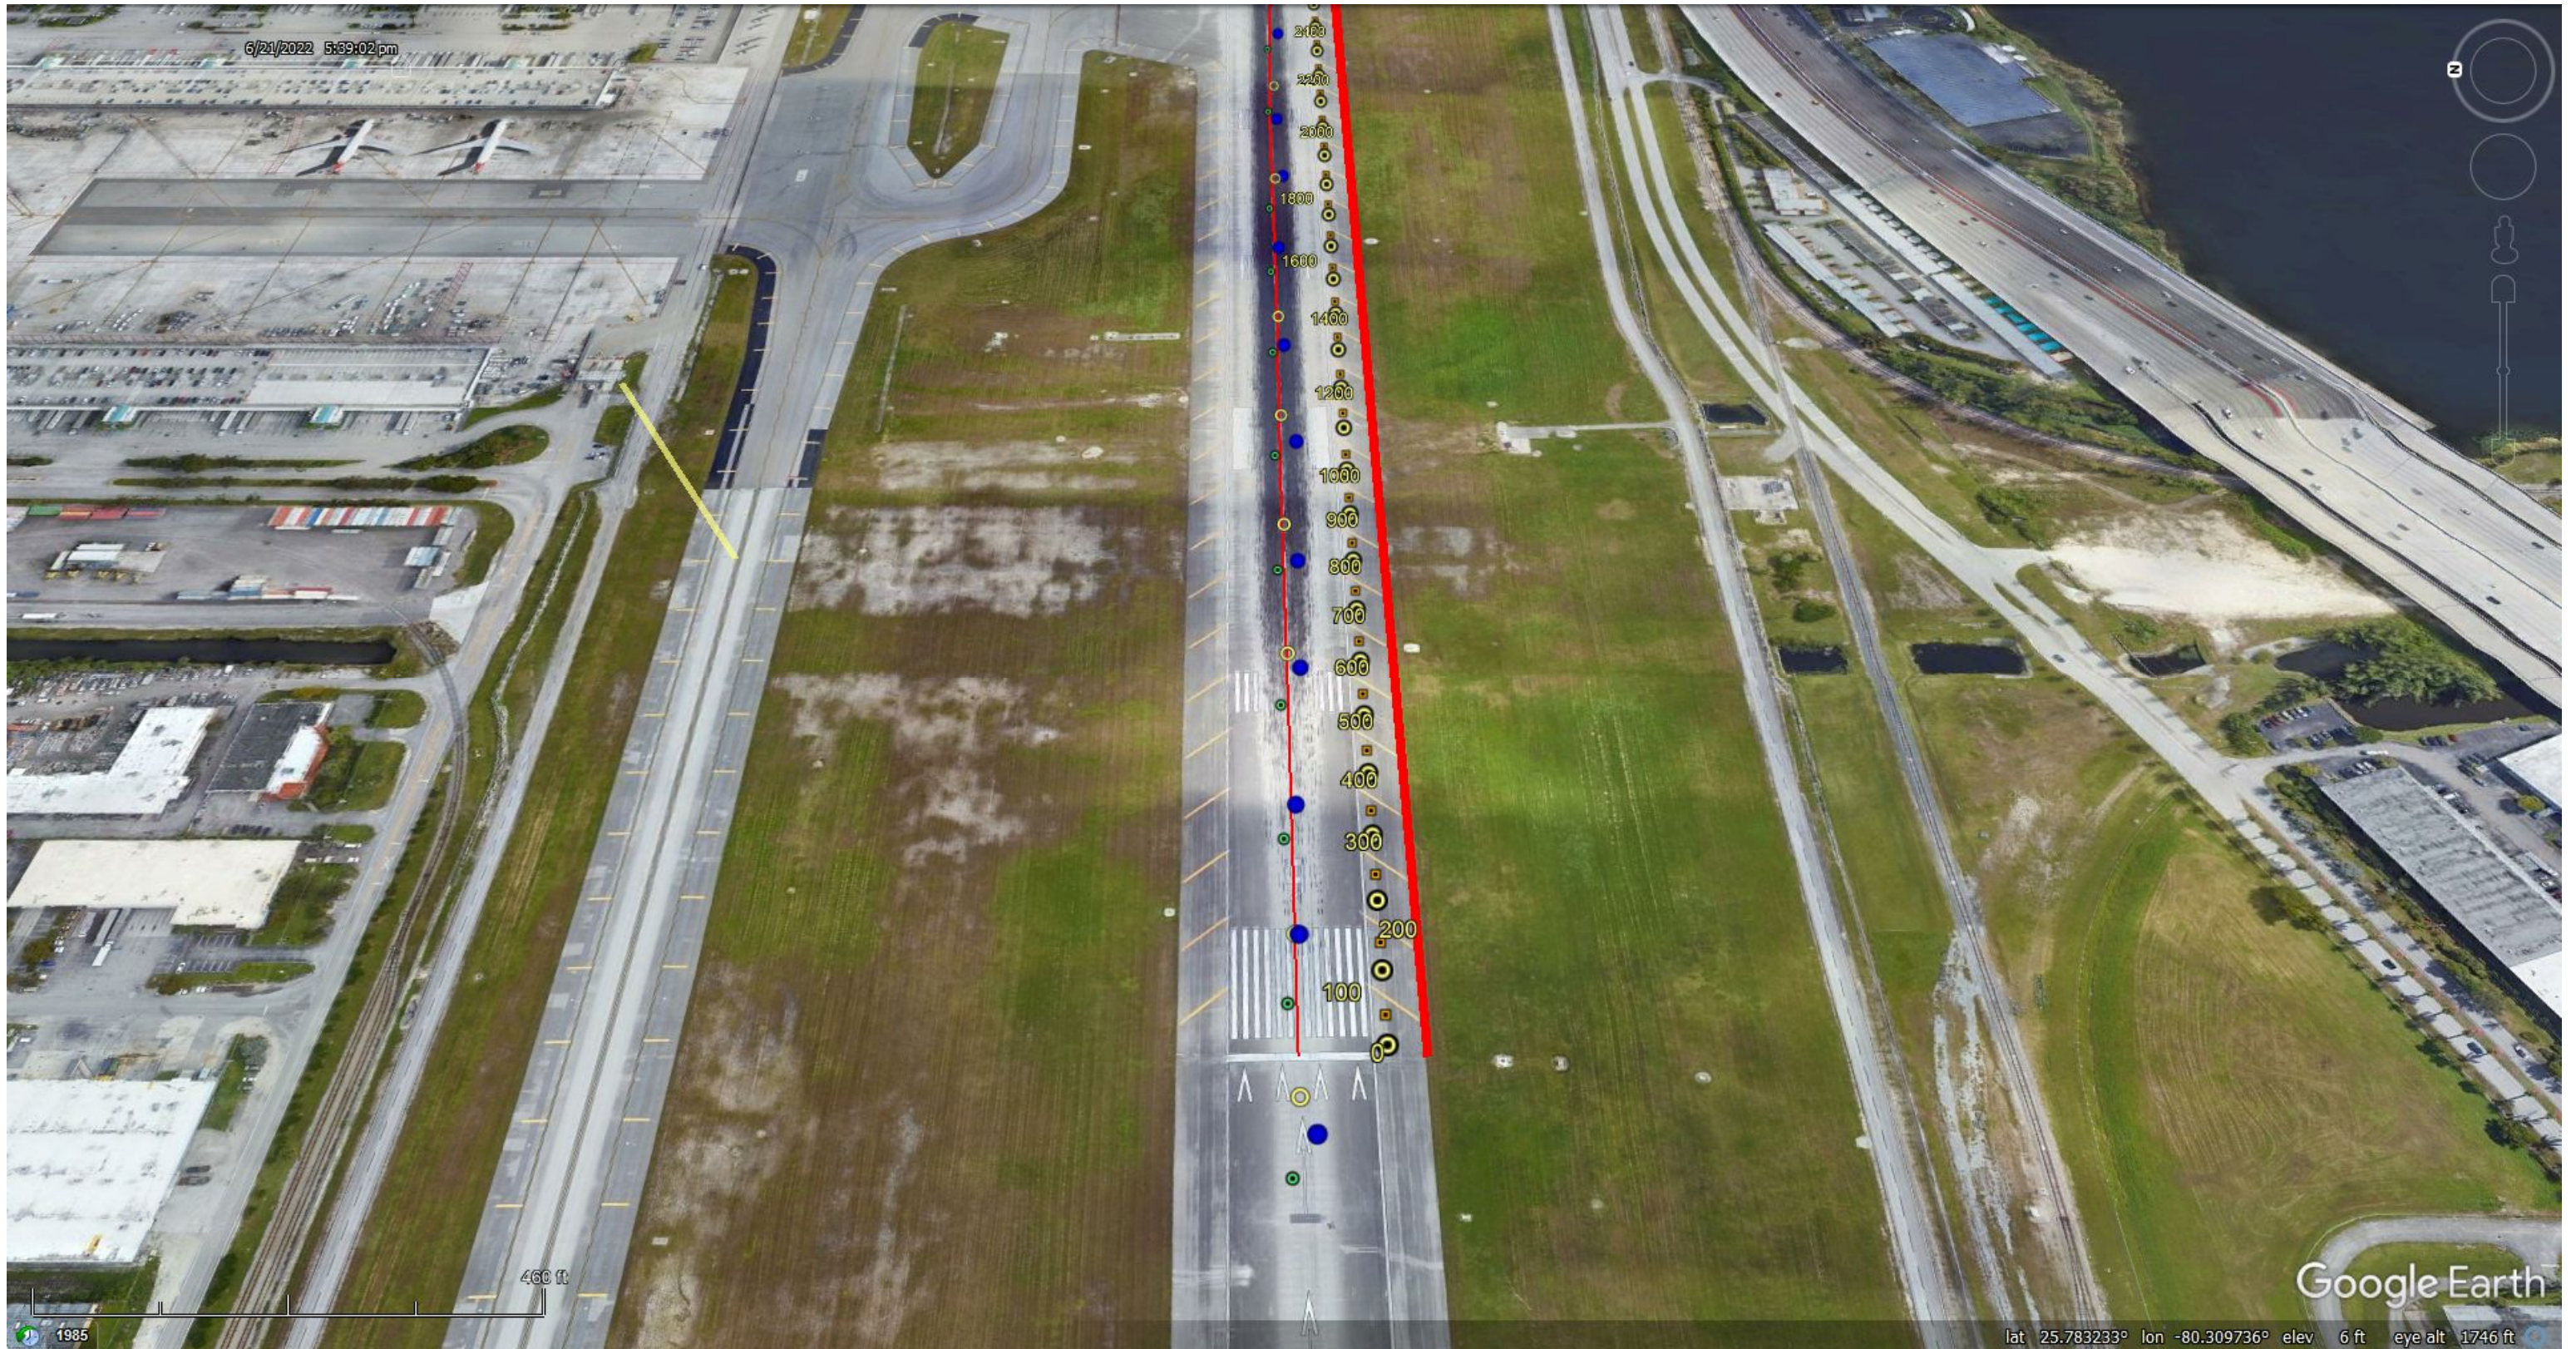
Figure 10: Example of HI1064 accident flight path reconstruction looking toward the runway 9 displaced threshold, showing 0 to 2,400 feet along the runway. Ground track reconstruction is based on ADS-B, FDR, paraphrased CVR, video, and runway witness mark evidence. Aircraft direction of travel is toward the top of the page. FAA ADS-B data recorded for HI1064 are identified by blue symbols. Green symbols depict NTSB flightpath calculated by integrating FDR accelerometer data. Distance beyond the runway 9 displaced threshold is annotated in feet. This image is a duplicate of Attachment 14, Figure A14.3.

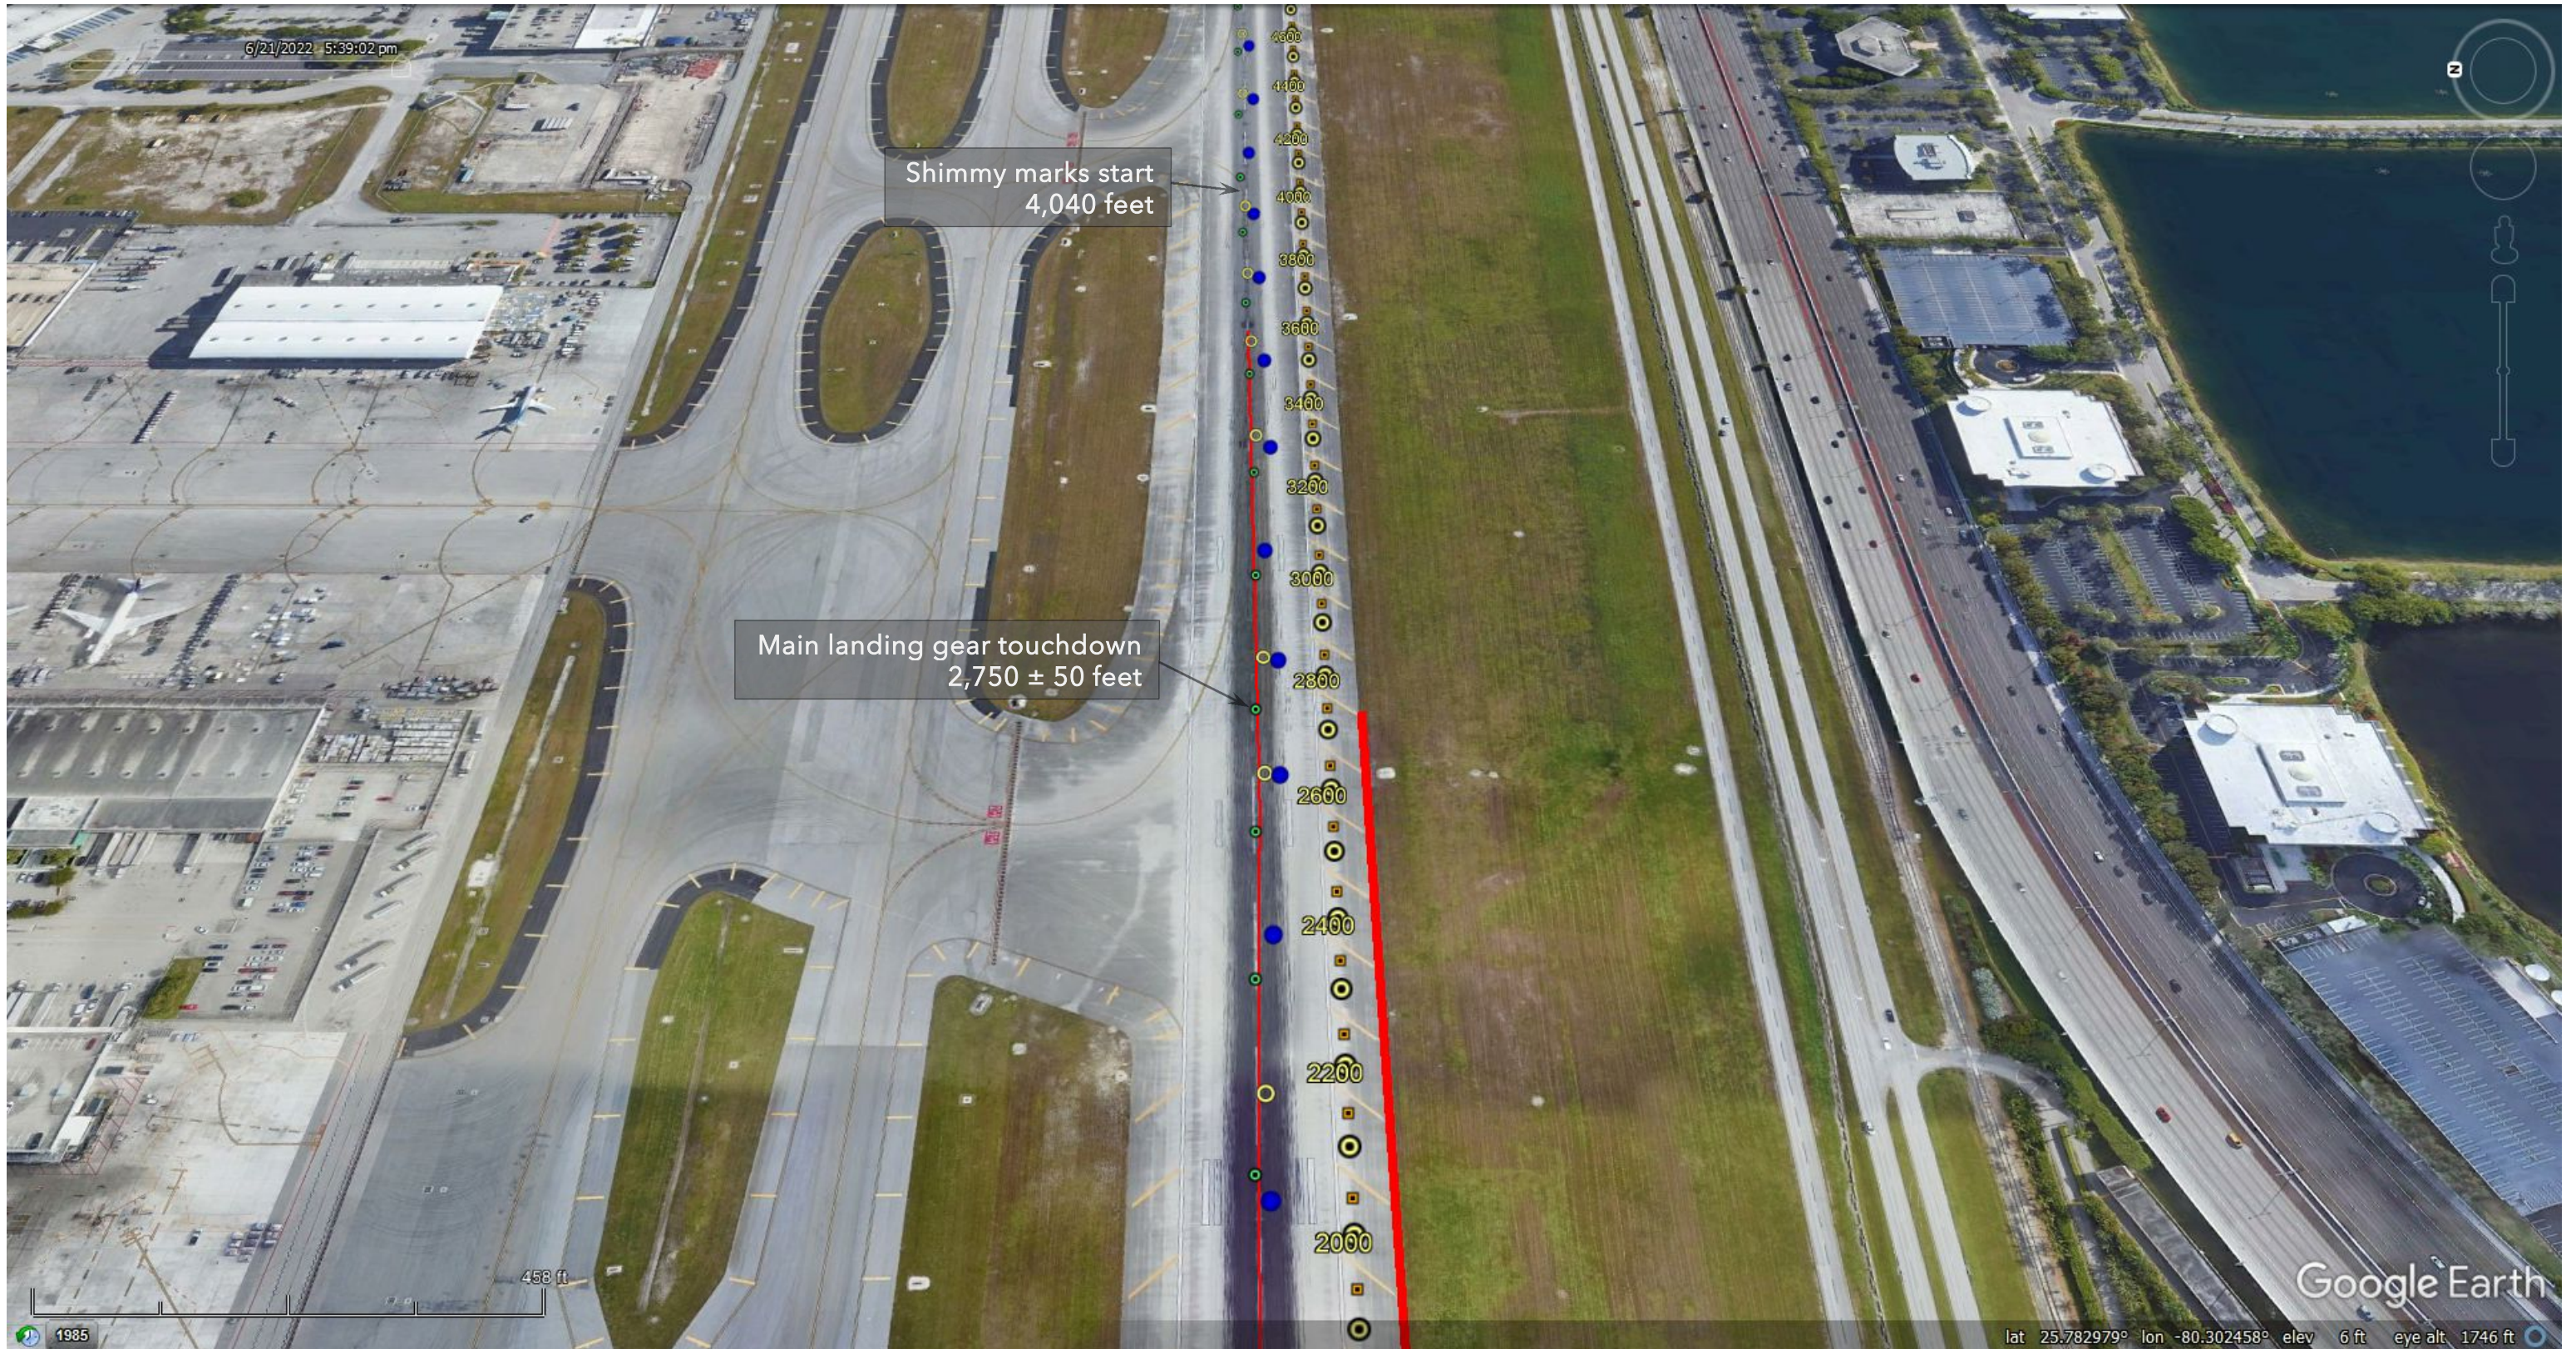
A review of the available ADS-B, FDR, CVR, video and survey factual evidence indicated that HI1064 main landing gear touchdown occurred about $2,750 \pm 50$ feet beyond the runway 9 displaced threshold, which was within the first third of the landing distance available. Image sequence summaries extracted from eight (8) external surveillance cameras and one (1) passenger cellular telephone that documented the airplane flight path during the final approach and landing rollout are included in the attachments to this study.

Figure 11: HI1064 accident flight reconstruction 2,000 to 4,600 feet beyond the runway 9 displaced threshold. Ground track reconstruction is based on FAA ADS-B, paraphrased CVR, FDR, video, and runway witness mark evidence. Aircraft direction of travel is toward the top of the page. FAA ADS-B data recorded for HI1064 are identified by blue symbols. Green symbols depict NTSB flightpath calculated by integrating FDR accelerometer data. Distance beyond the runway 9 displaced threshold is annotated in feet. Additional text annotations indicate location of main landing gear touchdown and start of left main landing gear shimmy marks. This image is a duplicate of Attachment 14, Figure A14.5.
