**Tank Car Derailment Damage
FACTUAL REPORT**

**June 24, 2023, Derailment of Montana Rail Link Freight Train
M-LAUMIS1-23A and Subsequent Hazardous Materials Release**

Reed Point, Montana

HMD23LR002

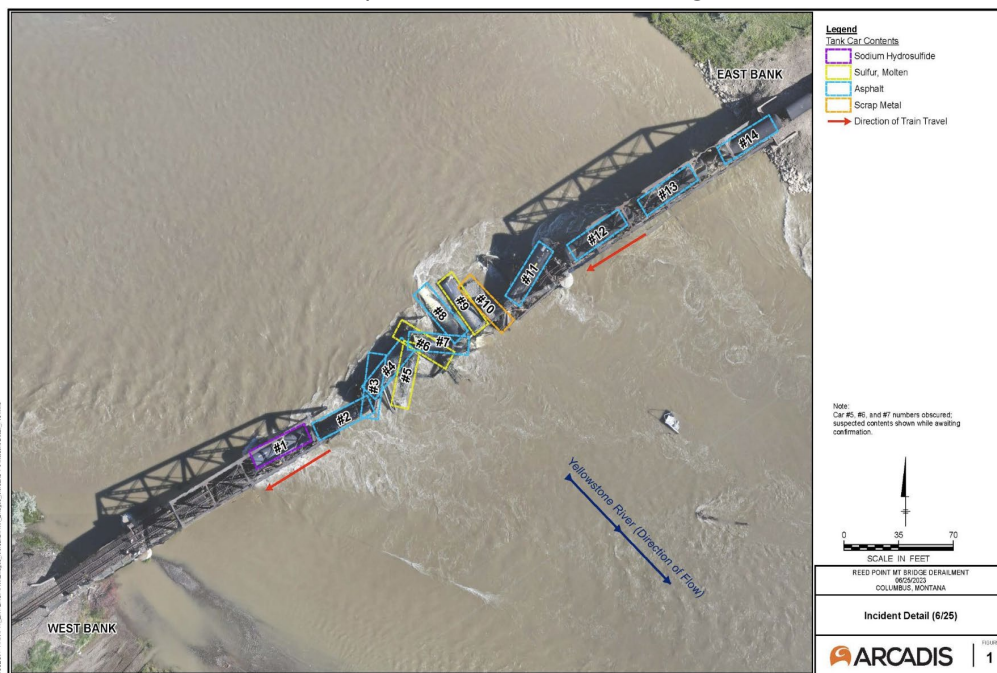
The resting locations of all the breached tank cars was not able to be determined due to the depth of the river. (See Figure 3)

Figure 3. Derailment showing tank car locations. Submerged tank cars are #2-#10. Tank cars and contents are approximate. Drone photo credit: Rapid Response Systems on behalf of Montana Rail Link¹⁰

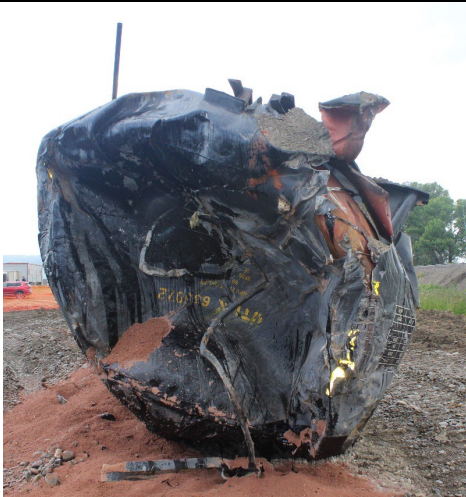
Consist order	38
Orientation in the consist	A-end leading.
Derailed resting position	The car came to rest partially submerged in the river.
Heads	The A-end and B-end heads had extensive damage. A-end stub sill fractured and separated at the head brace.
Shell	Multiple areas of damage. A-end buckled at inboard end of the stub sill, creased and folded under.
Bottom outlet valve	No damage.
Top fittings, PRD and Manway	Unable to view.

1(a) A-end head with two punctures.

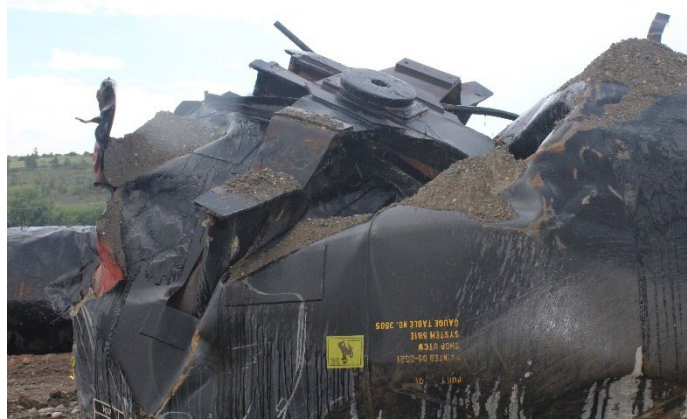
1(b) A-end, bottom buckled at inboard end of the stub sill.

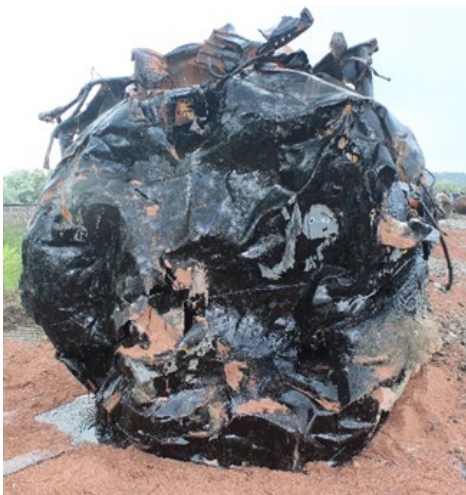
1(c) B-end trailing head with multiple breaches.

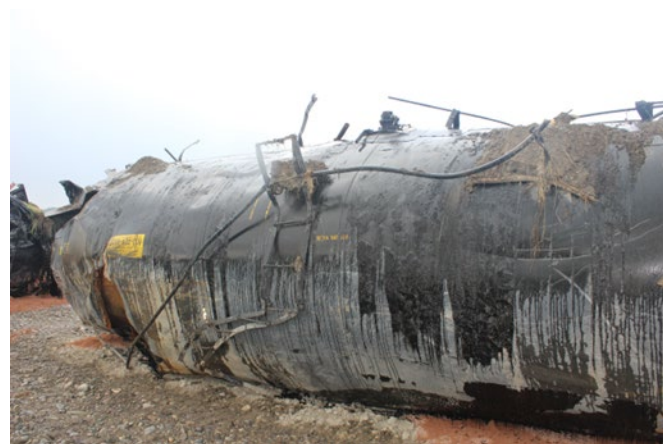
1(d) Bottom outlet valve is in-tact.

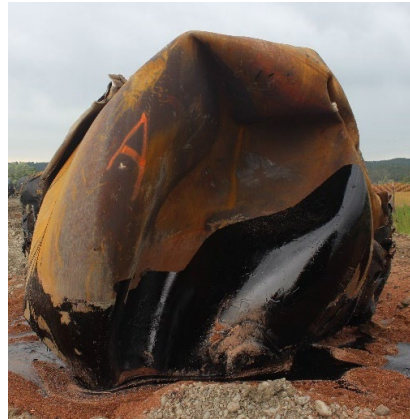
2(b) B-end leading. Shell was intact while in river.

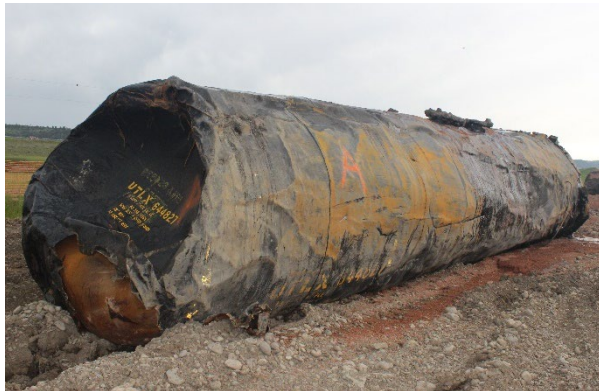
2(c) A-end and top showing valve sheared off.

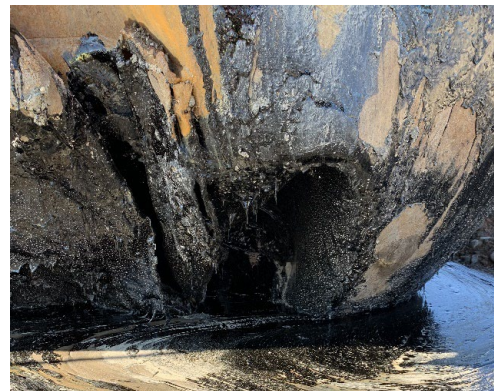
Consist order	39
Orientation in the consist	B-end leading.
Derailed resting position	The car came to rest partially submerged in the river.
Heads	Rounded dent to upper A-end head, B-end with a deep crease.
Shell	Multiple areas of damage with a breach on the B-end.
Bottom outlet valve	Not able to view.
Top fittings, PRD and Manway	Protective housing was missing. No leak from top fittings or manway noted. Valves sheared off.

2(d) B-end left side breach.

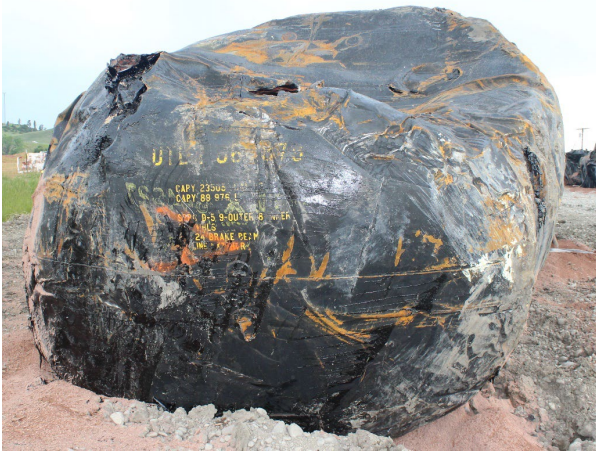
3(a) A-end leading, UTLX 644827 imprinted on head. Head is crushed from the top.

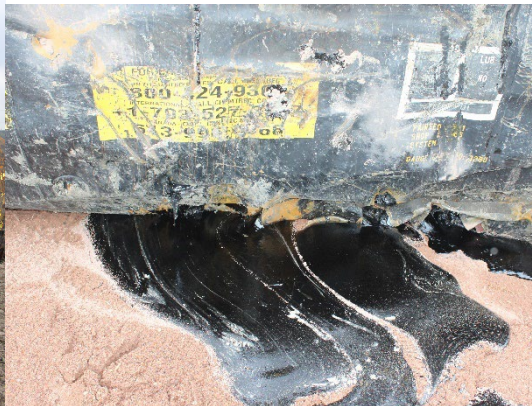
Consist order	40
Orientation in the consist	A-end leading.
Derailed resting position	The car came to rest partially submerged in the river.
Heads	Heads were crushed.
Shell	Tank was punctured on bottom of B-end on tank car and crushed.
Bottom outlet valve	Sheared off.
Top fittings, PRD and Manway	Valves were sheared off and manway opened during derailment. PRD was good.

3(d) Breach on bottom of B-end.

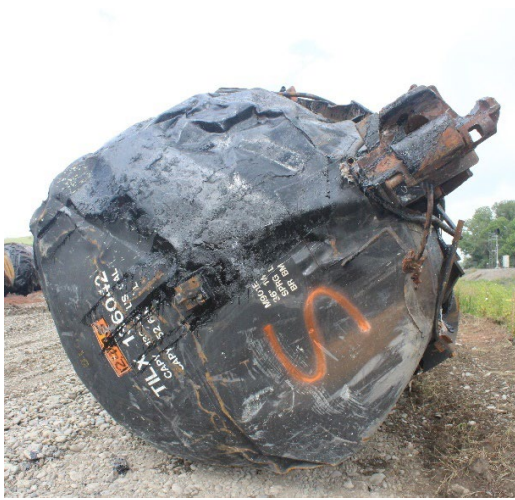
4(a) A-end

Consist order	41
Orientation in the consist	Unknown
Derailed resting position	The car came to rest partially submerged in the river.
Heads	Dent to center of A-end head is 54" x 63".
Shell	Shell puncture near the bottom centerline of the B-end is 11" x 7".
Bottom outlet valve	Valve was intact.
Top fittings, PRD and Manway	Manway had lid torn off. No PRD.

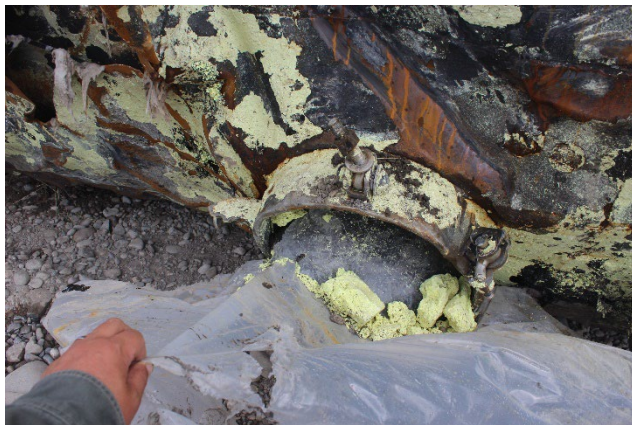
4(c) Open Manway

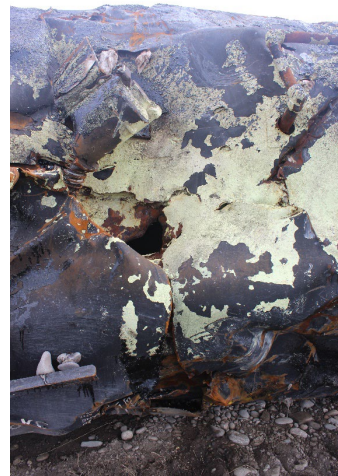
4(d) Puncture on B-end bottom.

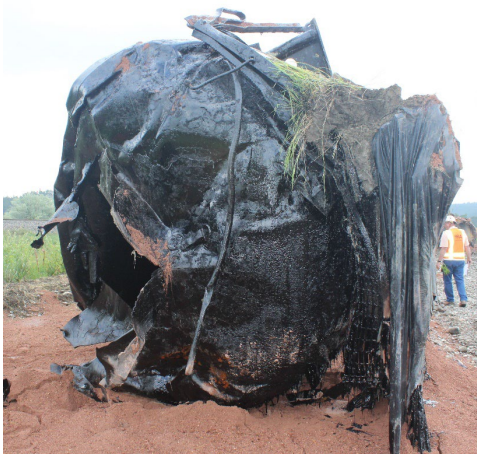
Consist order	42
Orientation in the consist	Unknown
Derailed resting position	The tank car came to rest upright on top of partially submerged tank cars and bridge wreckage.
Heads	A-end head breach is 71" x 70".
Shell	The bottom was crushed and dented from one end to the other. Top of A-end breached.
Bottom outlet valve	The BOV nozzle was sheared off. The valve remained closed.
Top fittings and Manway	Remained closed.

5(a) A-end breach

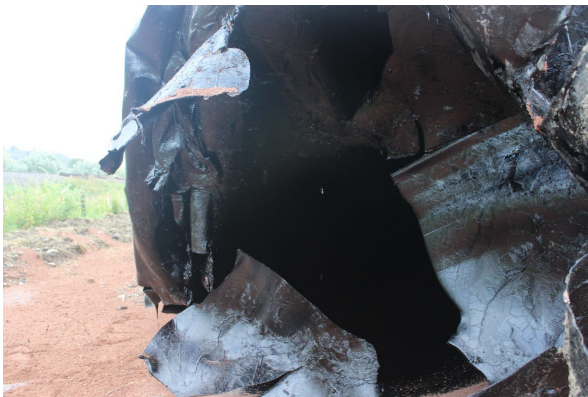
5(c) A-end breached area.

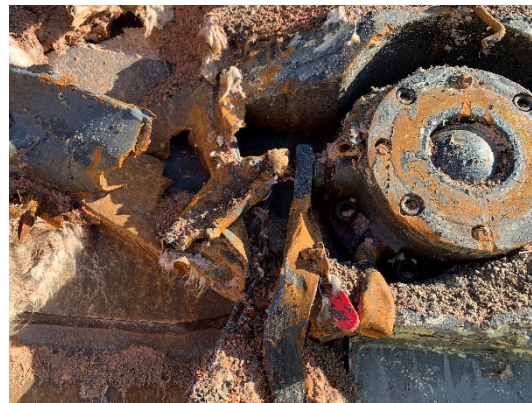
5(d) Bottom valve closed.

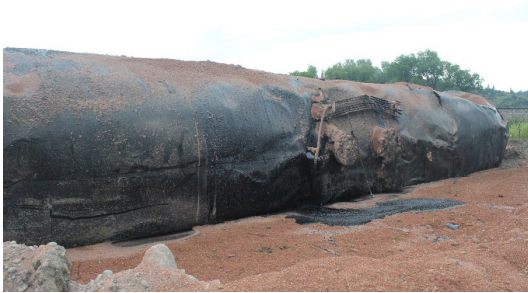
Consist order	43
Orientation in the consist	A-end leading.
Derailed resting position	The car came to rest partially submerged in the river.
Heads	Both heads were dented.
Shell	Shell had extensive damage and breached on top center and B-end.
Bottom outlet valve	Intact
Top fittings, PRD and Manway	Manway was intact. PRD was sheared off.

6(c) Top PRD sheared off

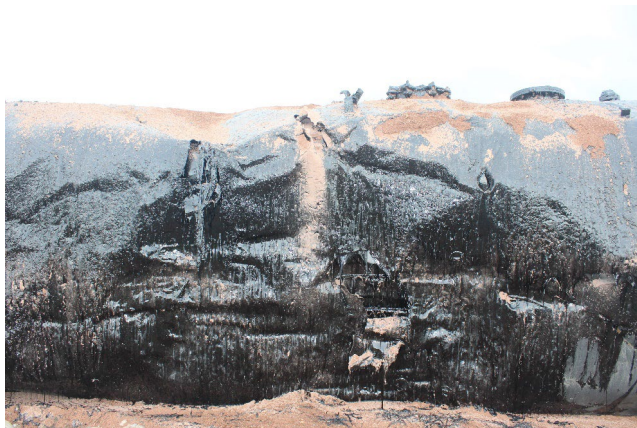
7(c) Manway intact

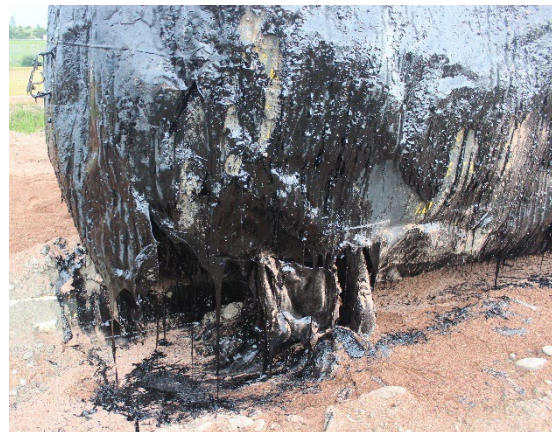
Consist order	44
Orientation in the consist	A-end leading.
Derailed resting position	The car came to rest partially submerged in the river.
Heads	A-end dented, B-end has considerable jacket damage and a rip on left side.
Shell	Large amount of shell damage believed to have occurred during recovery. Rip on B-end of shell.
Bottom outlet valve	Sheared off.
Top fittings, PRD and Manway	Top fittings/manway intact.

7(d) Left side B-end tank rip location

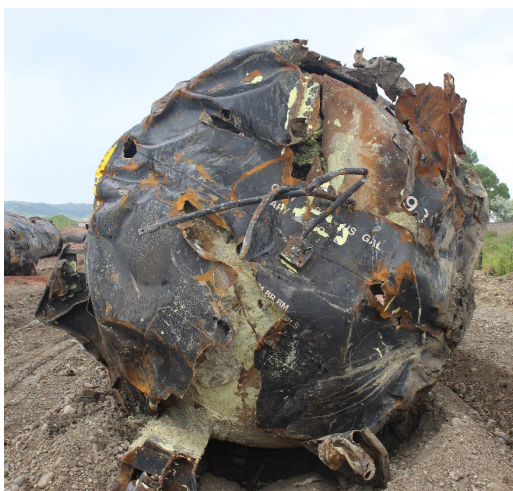
Consist order	45
Orientation in the consist	Unknown
Derailed resting position	The car came to rest partially submerged in the river.
Heads	Puncture in A-end head. B-end head dented.
Shell	Jacket was torn off from the middle to the B-end head.
Bottom outlet valve	Appeared intact.
Top fittings, PRD and Manway	Manway cover missing.

8(a) A-end head with jacket tear and head puncture.

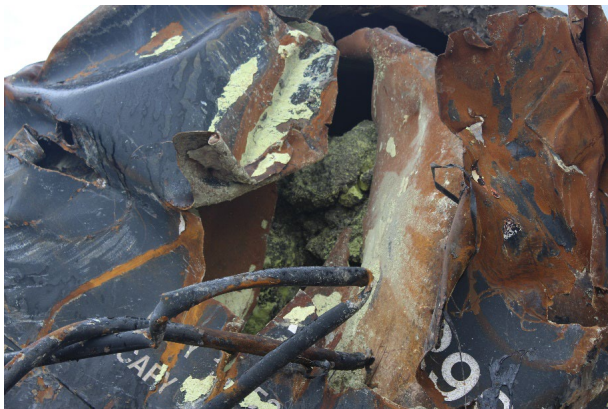
8(c) Puncture in top of A-end head.

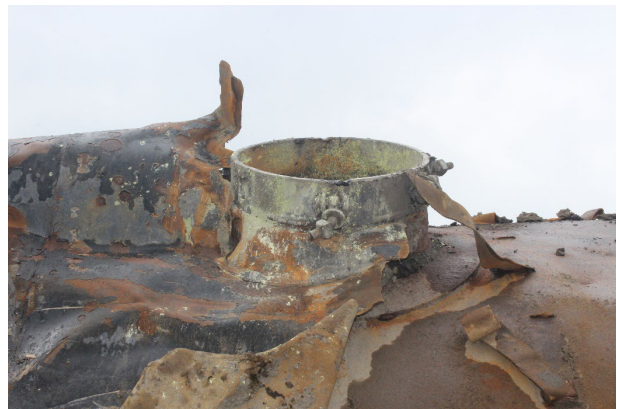
8(d) Manway cover missing.

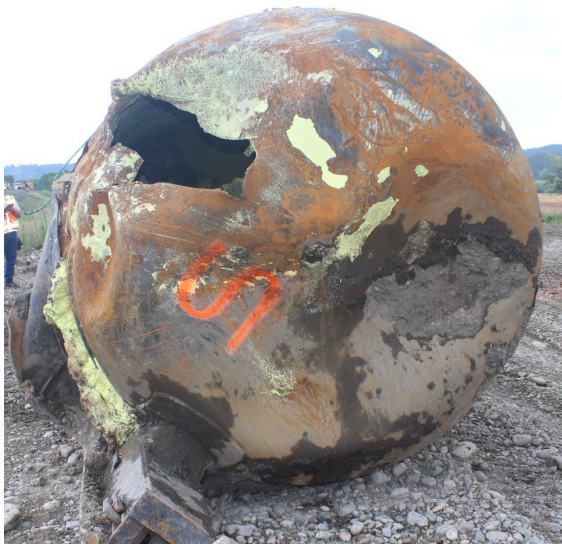
46	CGTX 13864	Manway and PRD missing. A-head punctures are 54" x 28" and 10" x 2". Top of the A-end has a puncture that is 13" x 9"

Consist order	46
Orientation in the consist	A-end leading.
Derailed resting position	The car came to rest partially submerged in the river.
Heads	A-end head with breach, B-end head dented.
Shell	Damaged with sleeve tears.
Bottom outlet valve	Intact
Top fittings, PRD and Manway	Manway cover missing, no PRD.

9(a) A-end with head breach

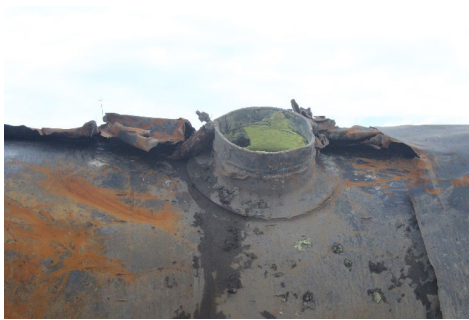
9(c) Manway with missing cover
