National Transportation Safety Board
Office of Railroad, Pipeline and Hazardous Materials Investigations
Railroad Division
Washington, D.C. 20594

Survival Factors

Group Chairman's Factual Report of the Investigation

NTSB Accident Number:	RRD22LR003
Date of Accident:	December 8, 2021
Time of Accident:	11:20 a.m. (Local time)
Equipment:	Spiker Machine #2
Operator:	Norfolk Southern Railway Company
Employee:	National Salvage and Service Corporation
Injuries:	1 Fatality Contract worker
Location of Accident:	Main track 1 NS Buffalo Line BR Milepost 295.1

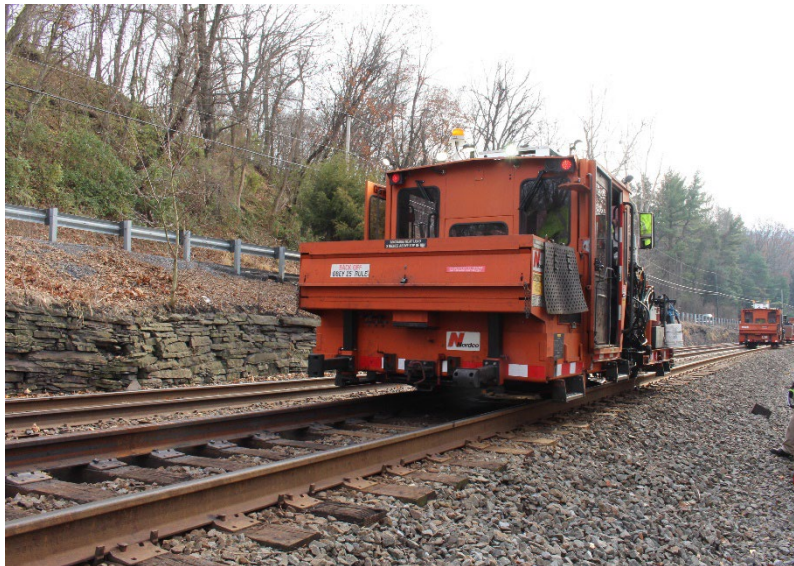
During the on-scene investigation, the accident spiker machine was examined for evidence related to the worker's point of contact with the equipment and the directionality of the worker's body as it traveled underneath the equipment. **Figure 2** is a photograph of Spiker #2 at its final rest position on the scene.

Figure 2 Looking southward down main track one at the rear of Spiker #2 at final rest on the scene. Spiker #1 is seen in the background. (Source: NTSB)

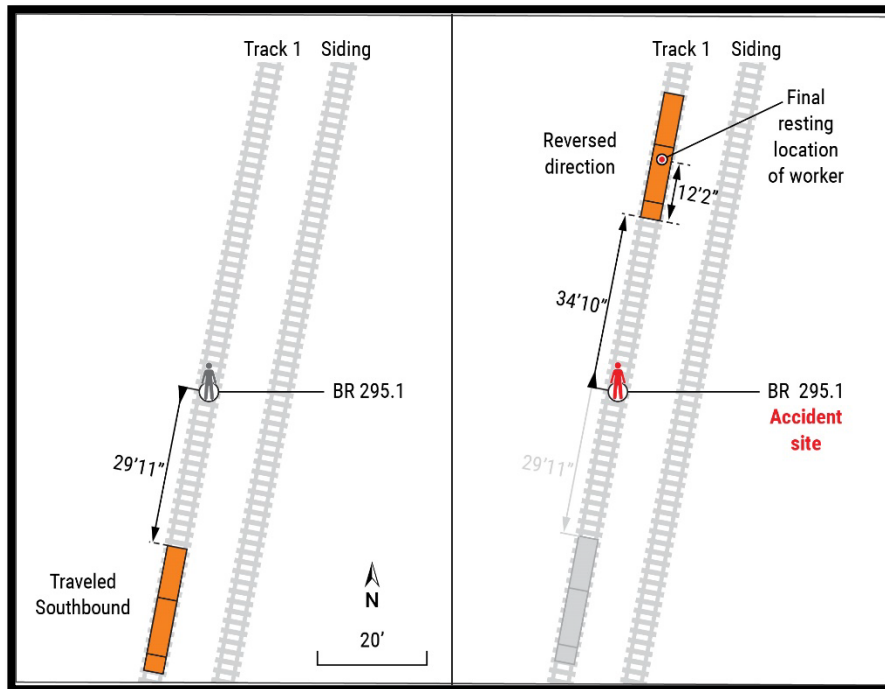
The fatally injured worker was identified as a 27-year-old male employed by National Salvage. At the time of the accident, the worker was standing within the gage of the track when the operator of Spiker #2 reversed direction and while traveling northward struck the worker. Investigators on the scene determined that the machine continued northward, finally stopping 34 feet 10 inches from the initial point of contact. Measured from the rear of Spiker #2, the worker had traveled approximately 12 feet 2 inches underneath the equipment as it reversed over him. **Figure 3** is a graphic of the accident showing the final rest position of the worker.

Figure 3 Graphic of accident scenario showing distances traveled by both equipment and worker and the final rest position of both. (Source: NTSB)

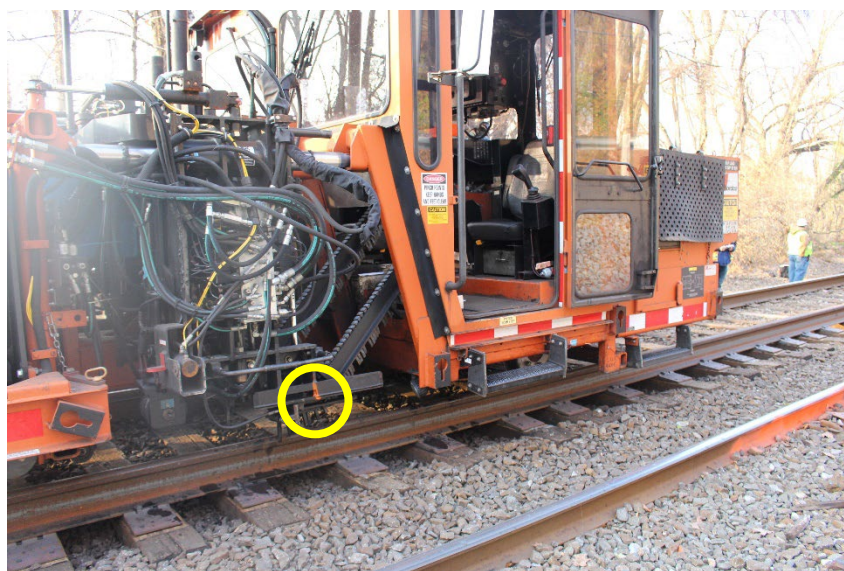
Additional measurement taken by investigators on the scene found that 11 feet 7 inches from the rear of the machine, biological material was found under the equipment on the main frame and the solid hydraulic line located in front of the turntable cylinder which showed contact with the worker's head. Green paint, from a spray can carried by the worker on his utility belt, exploded during the impact with the spiker machine and was found spattered and smeared on the underside of Spiker #2. Additional paint was found on the front and bottom portion of the black backpack worn by the worker, which was the likely source of the paint transfer from the worker's person to

the spike machine. The directionality of the paint, found under the machine, matches the movements of the worker underneath the equipment. Measurements taken underneath the equipment showed that its highest point, the clearance underneath the machine between it and the track bed was only 17 inches. The solid hydraulic line was found to be only 15 inches above the track surface. The location of the frame and the hydraulic line was 40 inches inward from the outside edge of the equipment. **Figure 4** Photograph of the state police paint mark (circled in yellow) documenting the final rest location of the worker under the machine at final rest.

Figure 4 A photograph taken from the left side of the equipment showing distance traveled by the worker underneath the equipment and his final rest location circled in yellow. (Source: NTSB)

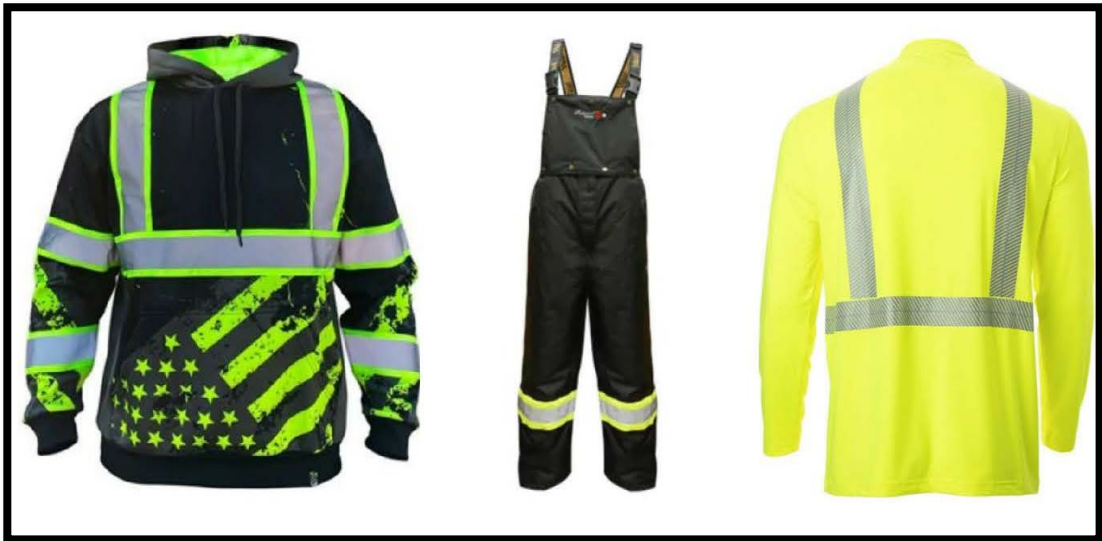
The worker's clothing was recovered and examined to determine compliance with the railroad and the industry's safety standards. The worker's outer wear includes a customized black coat with reflective stripping consisting of one two-inch band around the chest, two bands around the arms and a band that extended up from the chest band, crossed over the tops of the shoulders and continued down the back on each side. The lower portion of the garment was a stylized American Flag in florescent yellow reflective material. The interior of the coat was a florescent yellow color with a gray hood attached. The worker wore a pair of insulated coveralls, black in color, with one two-inch reflective band around the lower portion of each leg. The worker also wore a long sleeve, florescent yellow Tee-shirt. The shirt contained a two-inch reflective band that encompassed the torso and crossed over top of the shoulders on each side. **Figure 5** is a photograph, taken from the manufacturer's website, showing an exemplar coat, insulated pants and shirt worn by the worker at the time of the accident. It was noted by the coroner's office, the Pennsylvania State Police and the first arriving EMT, that the yellow work shirt was found underneath the coat.

Figure 5 Photograph of examples of the PPE worn by the worker at the time of the accident. (Source: Safety Shirtz, Viking Wear and Artic Quest Hi-Viz websites)

The investigators attempted to determine if the outer coat, worn by the deceased worker and not in compliance with the railroad safety regulations, could have been acquired by accident, mistake or unknowingly by the worker, in a belief that the garment met the required safety standards. The style of coat is a patented design that is manufactured by the company "Safety Shirtz," and sold under their SS360 clothing line, "American Grit". On their website, the manufacturer clearly marks all garments that are ANSI certified. An examination of the ANSI

certified garments found that the only version of this coat available for purchase and meeting the required ANSI standard is offered in fluorescent yellow or orange and is clearly marked as ANSI compliant. The “gray/black” version of the coat, which was worn by the worker, is sold as a customized “Enhanced Visibility American Grit Stealth Zip-Up Safety Hoodie.” This version of the coat is not ANSI certified nor is it identified as such in the product description (specifications) listed for the garment.

NS has issued additional training to all Program Maintenance Supervision on NS Safety Rule 1044 to address the requirements of the railroad and outline ANSI Class 2 and Class 3 standards. The training not only addresses the required level of PPE, but it also addresses the appropriate method of wear and the need for supervision to include contractors to ensure compliance with the regulation. The training is being provided to all Program Maintenance employees and will also address training of contractors in the need to train and supervise their employees on the PPE policy.

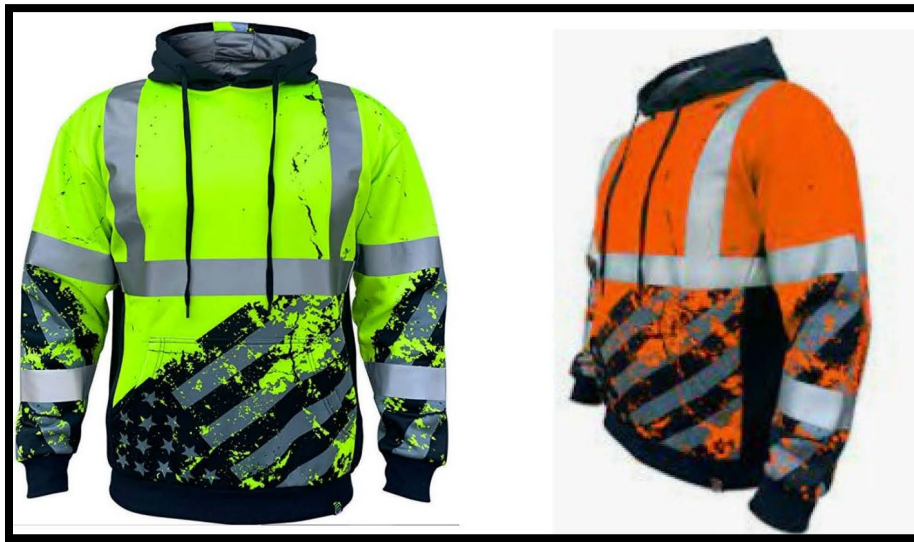
ANSI Class II garments are intended for use in activities where greater visibility is necessary during inclement weather, or in environment with risks that exceed those for Class 1. Garments in this class are used by workers who perform tasks that divert attention to approaching traffic or place the worker near passing vehicles traveling at 25 miles per hour or more. Railway workers is just one of the professions that according to the ANSI standard require a Class 2 garment. The standard outlines the composition of the garment to include the requirement for a full jacket with a hood and sleeves. The background should consist of a fluorescent color that stands out conspicuously but is not required to be reflective. The standard suggests that the fluorescent color be yellow/green, orange/red, or fluorescent red. The colors must contrast with the environment and any vehicle or machinery present. The garment must have a minimum of 201 square inches of retro-reflective material to include 8.373 linear feet of 2-inch tape or 12.2 linear feet of 1 3/8 inch of reflective tape. Reflective material must be 1.375 inches in width for every 4 yards of material or 2 inches in width for 2.8 yards of material. At least one reflective band must encircle the torso providing 360-degree visibility. Reflective bands must be separated by at least two inches. A two-inch reflective band between the elbow and shoulder on the sleeve with another 2 or more-inch band located from the cuff. **Figure 6** is a photograph showing the ANSI certified version of the coat worn by the worker.

Figure 6 Photograph of the ANSI Certified versions of the coat worn by the worker. (Source: Safety Shirts website)

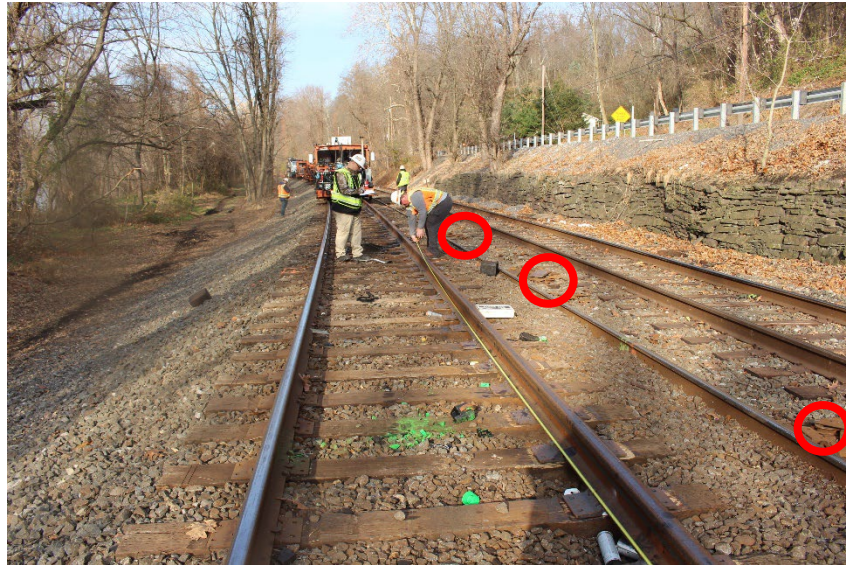
An inspection of the track environment found that on the east of the track and in the ‘six-foot,’ space that separated the accident track from the siding, revealed debris piles containing used spikes, anchors and other track material. The presence of these material created a potential slip, trip or fall hazard; however, it was not believed to be causal in this accident. To the west of the main track, the terrain falls away from the track and the ballast also presents a slip, trip or fall hazard to workers. **Figure 7** is a photograph taken during the on-scene investigation showing the

Figure 7 Photograph, looking north, of the track environment to include debris piles (circled in red) lying on the east side of the track and the sloping descent of the terrain on the west side of the track. (Source: NTSB)
