National Transportation Safety Board

DCA22LA132

COMPUTED TOMOGRAPHY

Specialist's Factual Report

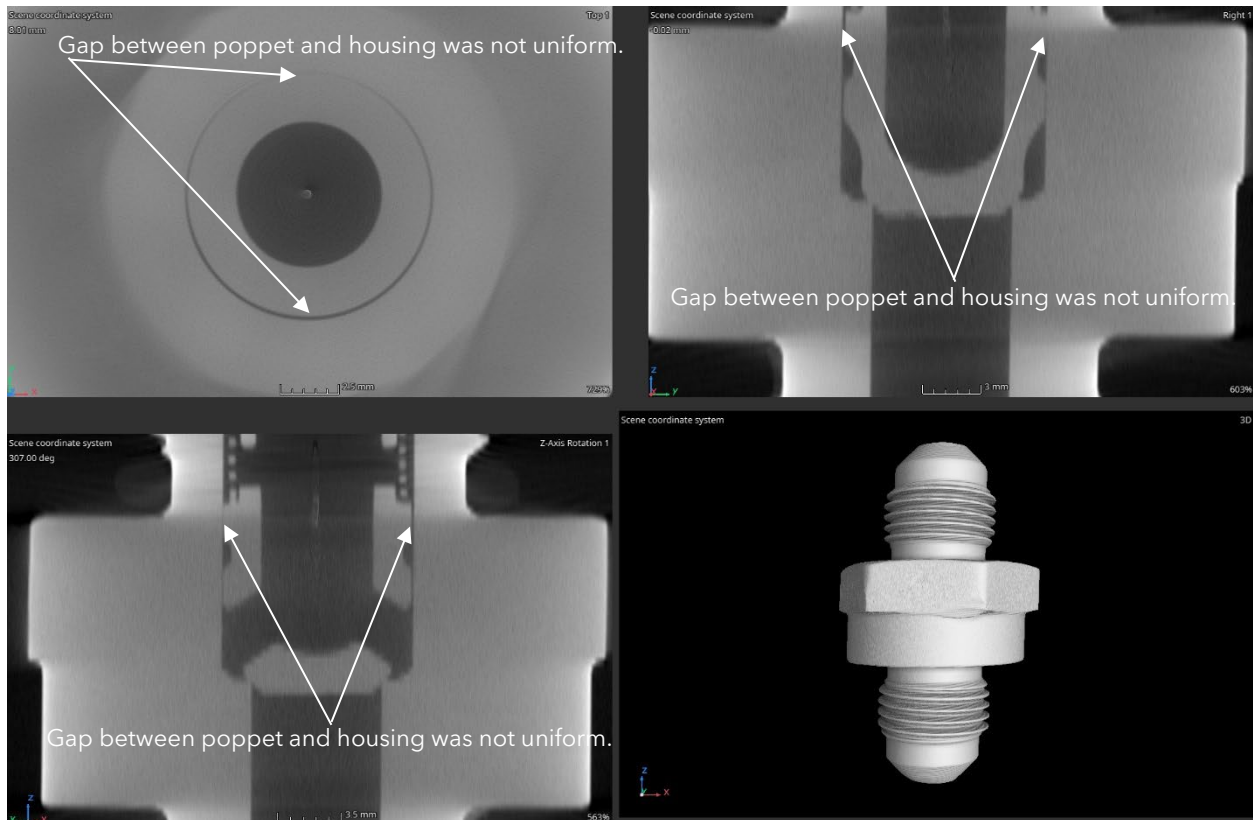
1. Poppet was not centered. (**Figure 2**)
2. Spring was not centered, and spring coils overlapped² at top of spring near the retainer end. (**Figures 3-6**)
3. Spring was intact. (**Figure 6**)
4. There were no indications of foreign objects or debris in the check valve.

Figure 2. CT images illustrating the poppet is not centered in check valve.

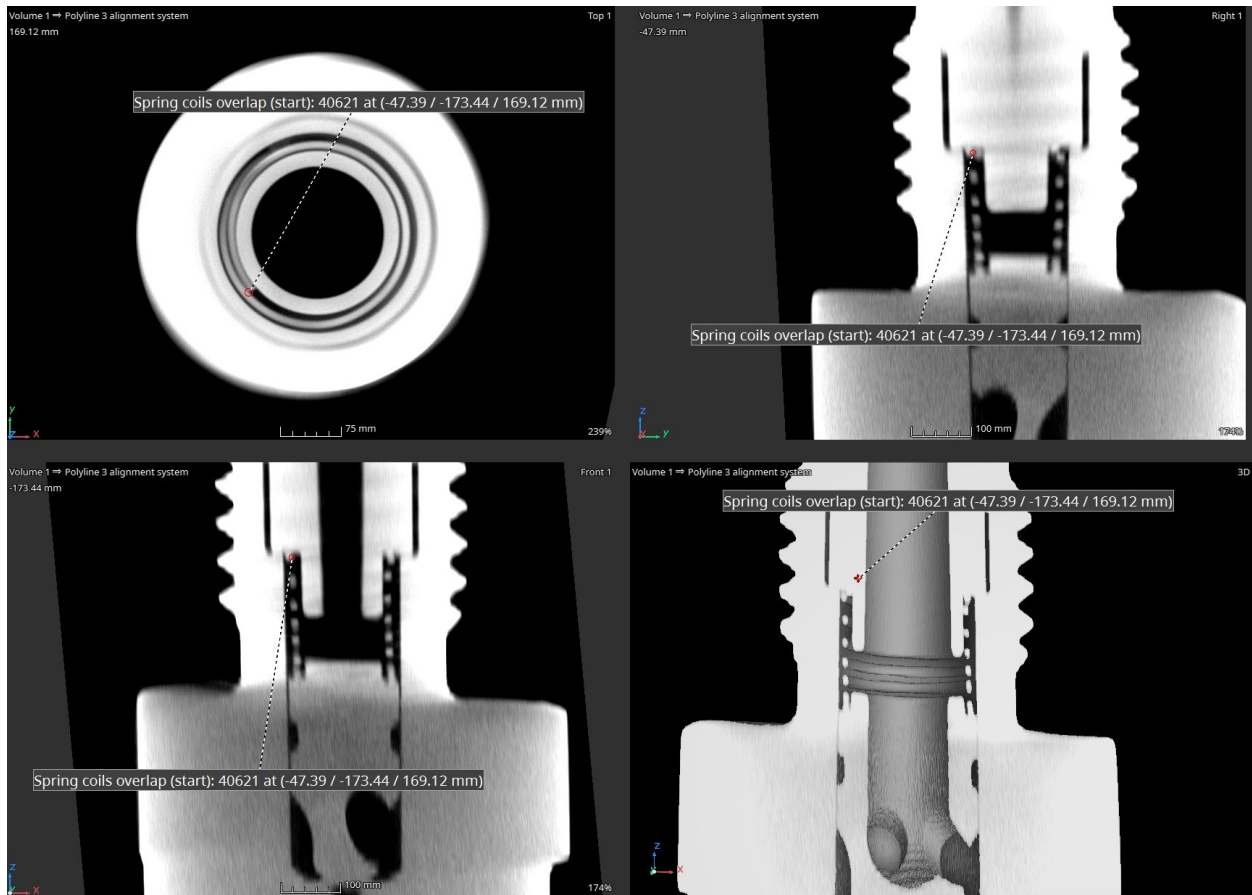
Figure 3. CT images illustrating the start of the overlap of spring coils near the retainer.

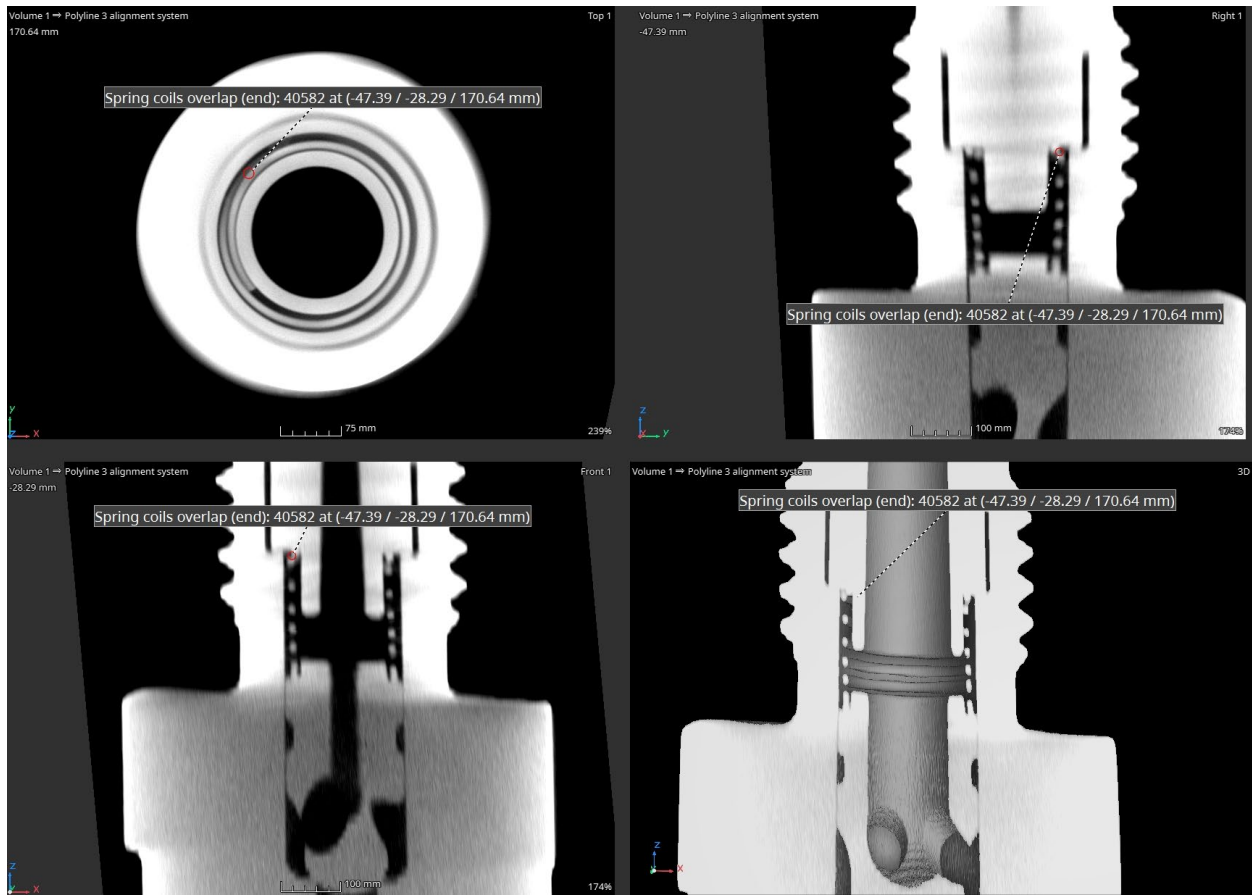
Figure 4. CT images illustrating the end of the overlap of spring coils near the retainer.

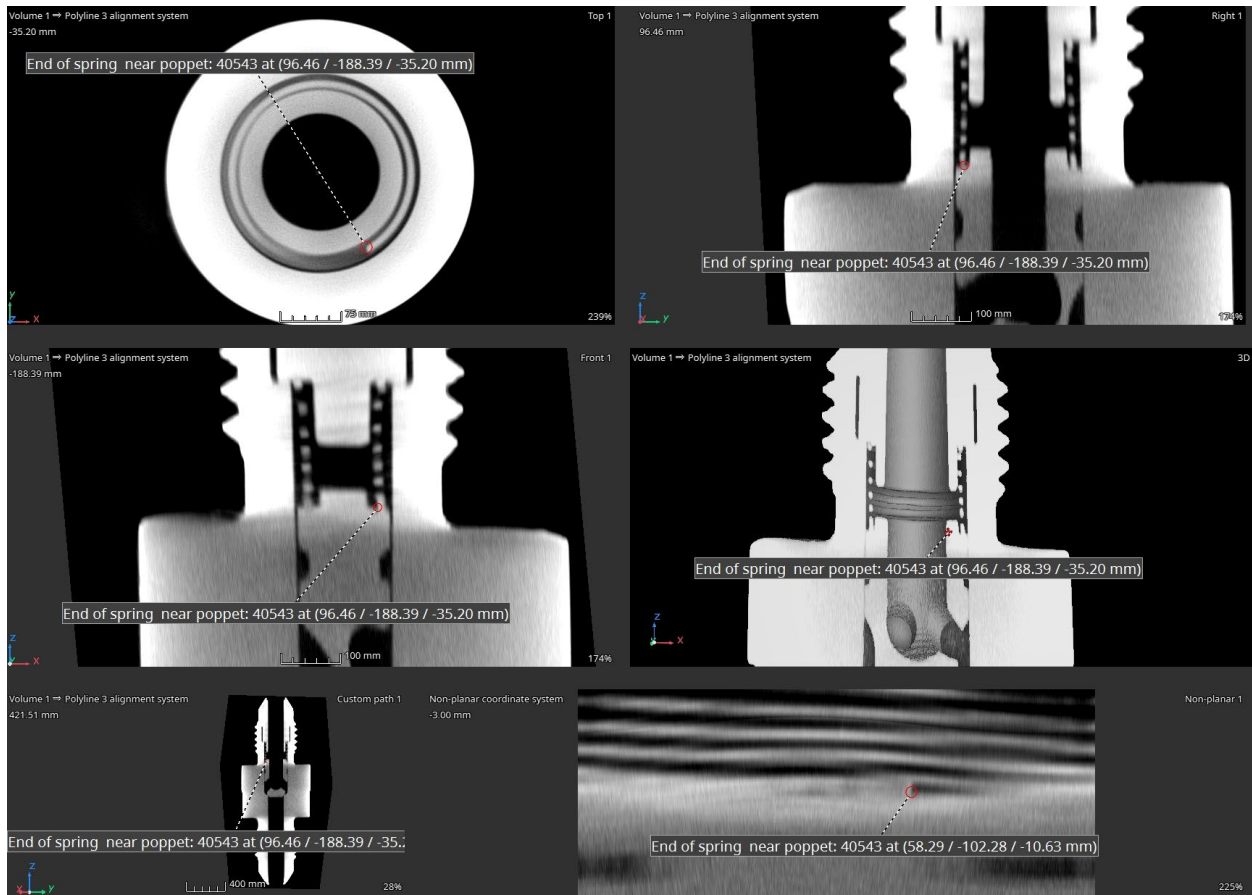
Figure 5. CT images illustrating the end of the spring coil near the poppet.

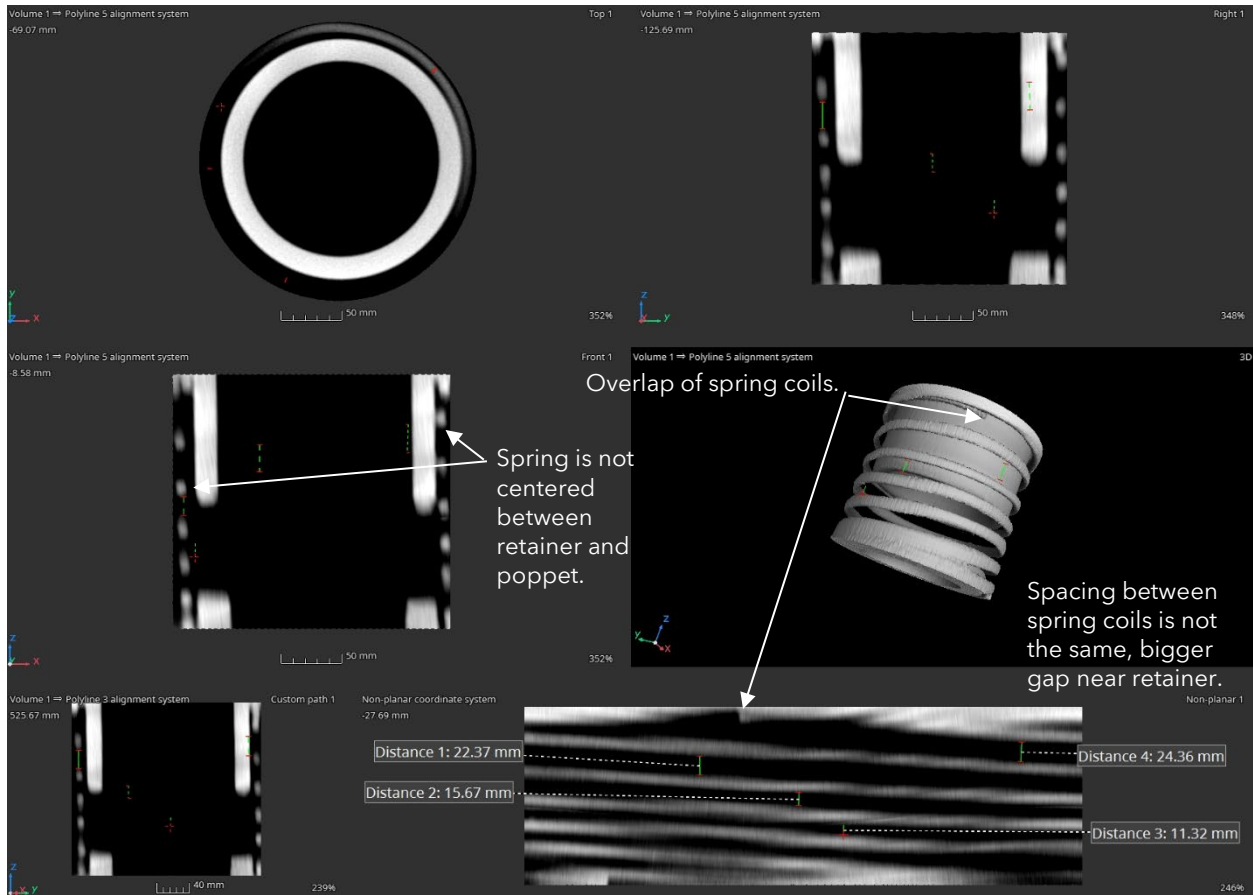
Figure 6. CT images of the shimmy damper check valve spring with remaining check valve digitally removed.
