Aviation Investigation Final Report

| Location: | Juneau, Alaska | Accident Number: | ANC15FA049 |
| Date & Time: | July 17, 2015 13:18 Local | Registration: | N62AK |
| Aircraft: | Cessna 207A | Aircraft Damage: | Substantial |

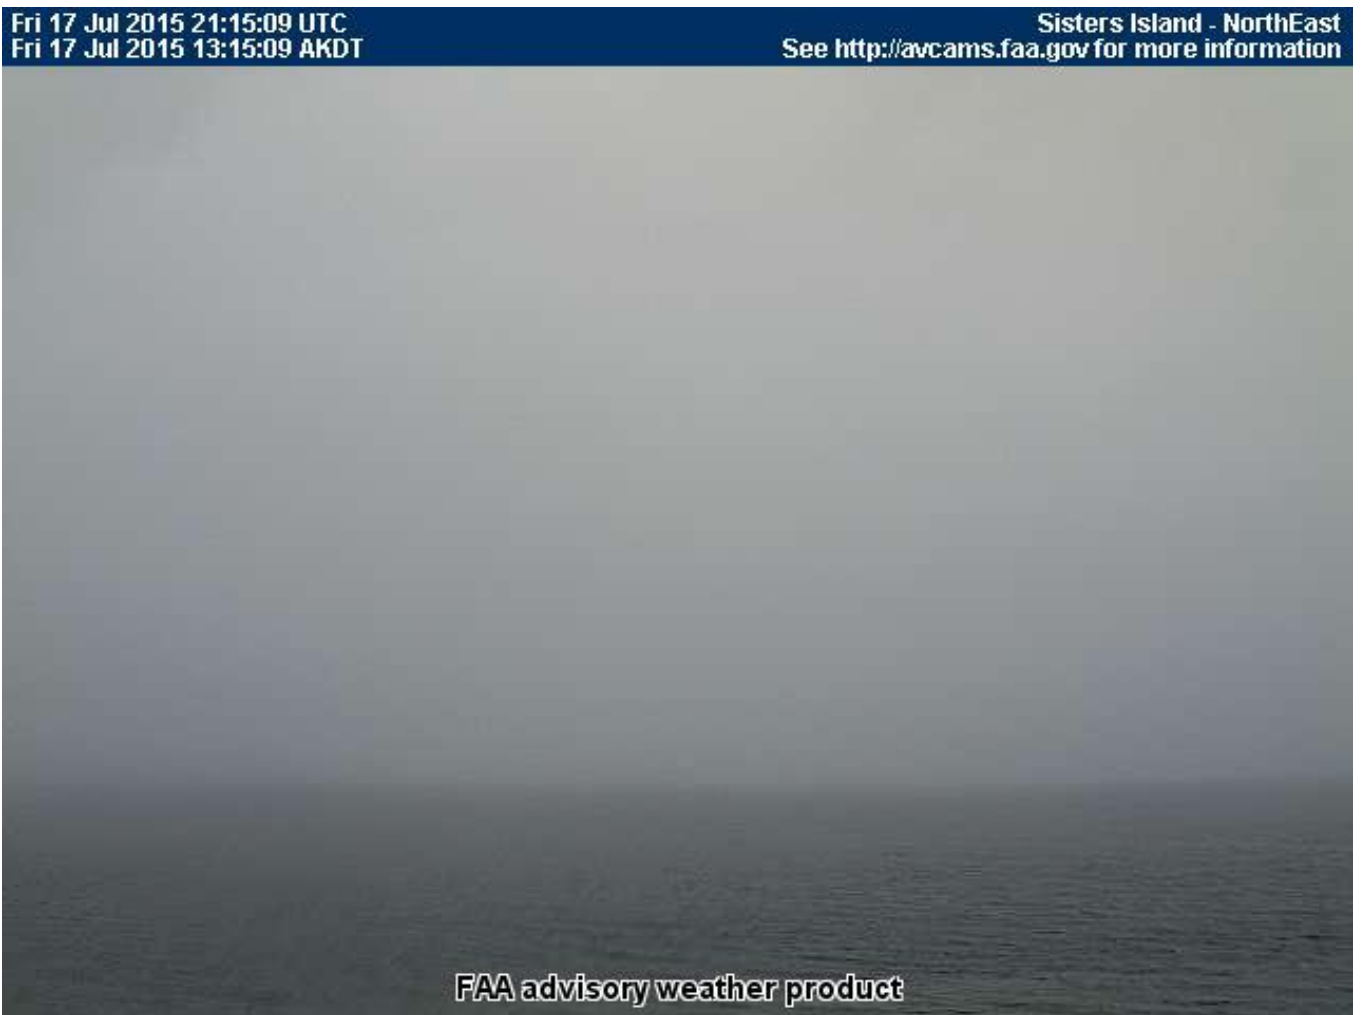
Figure. A video camera image showing visibility conditions at Juneau Airport about 5 minutes before the estimated accident time, facing the direction of the accident location.
