## Revisions to original narrative

### HISTORY OF FLIGHT

On August 2, 2018, about 1705 Pacific daylight time, a Mooney M20J, N56039, was substantially damaged when it impacted terrain during an approach to Lopez Island Airport (S31), Lopez Island, Washington. The flight instructor and private pilot receiving instruction were fatally injured. The airplane was registered to and operated by the pilot as a Title 14 *Code of Federal Regulations (CFR)* Part 91 personal flight. Visual meteorological conditions prevailed and no flight plan was filed for the flight, which departed Friday Harbor Airport (FHR), Friday Harbor, Washington at an unknown time.

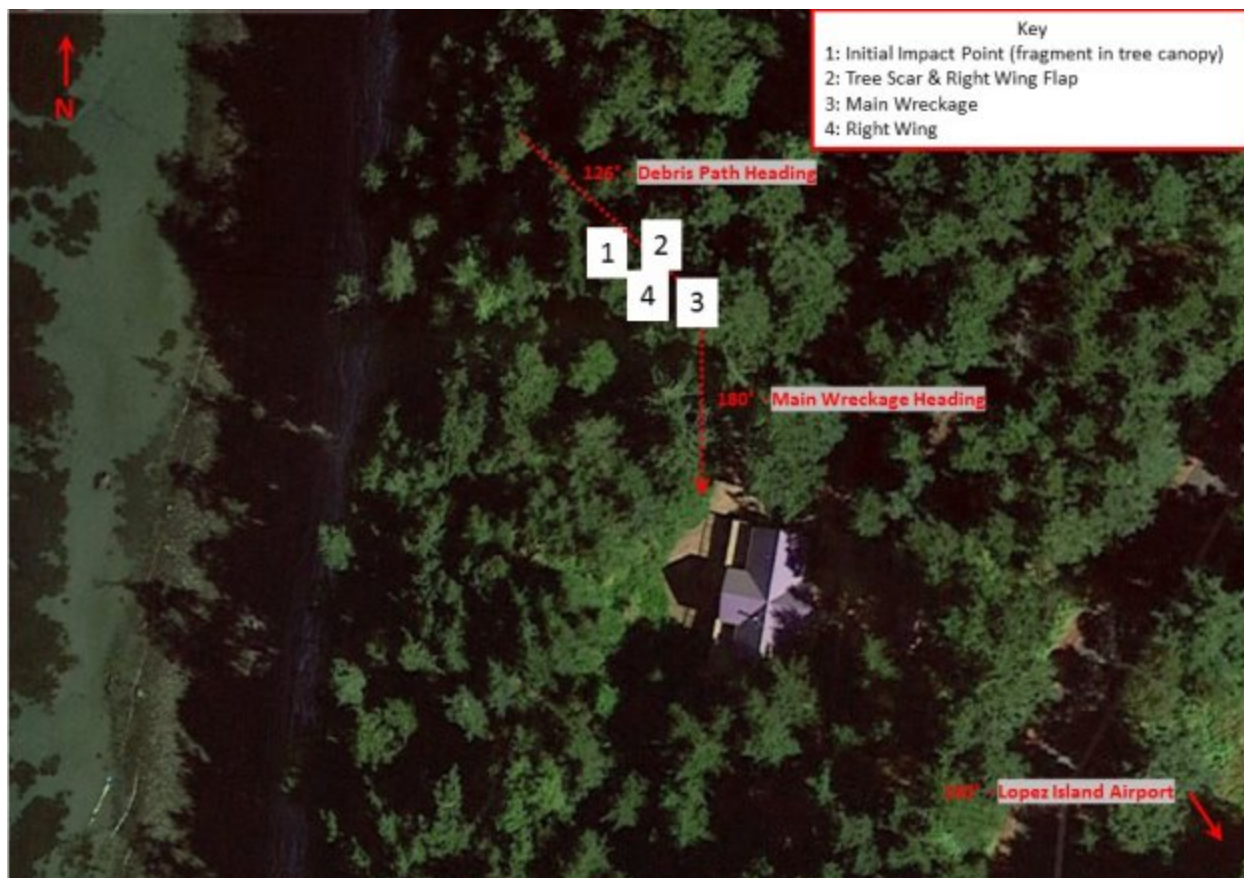
*Figure 1: Wreckage Diagram*

The airplane came to rest in wooded area about 400 ft from the western shore of Lopez Island and about one half nm northeast of S31. An initial impact point (IIP) was identified by an airframe fragment in the canopy of a tall tree. A tree scar that measured about 5 ft was observed about halfway up a 100-foot tall tree. The main wreckage, which comprised the empennage, left wing, right wing root, fuselage, and engine, was located a few feet forward of the scarred tree oriented on a magnetic heading of 180°, and marked the end of the debris path. The debris path was oriented on a heading of 126° magnetic and the distance between the IIP and the main wreckage was about 60 ft. The right wing separated at the wing root and was found in the debris path a few feet to the right of the main wreckage, also near the scarred tree. The inboard top skin of the right wing displayed brown and yellow transfer signatures consistent with tree contact. Both propeller blades remained attached to the propeller hub, which remained attached to the engine. Refer to Figure 1 for an illustration of the debris path.
