Allision GROUNDING SUPPLEMENT

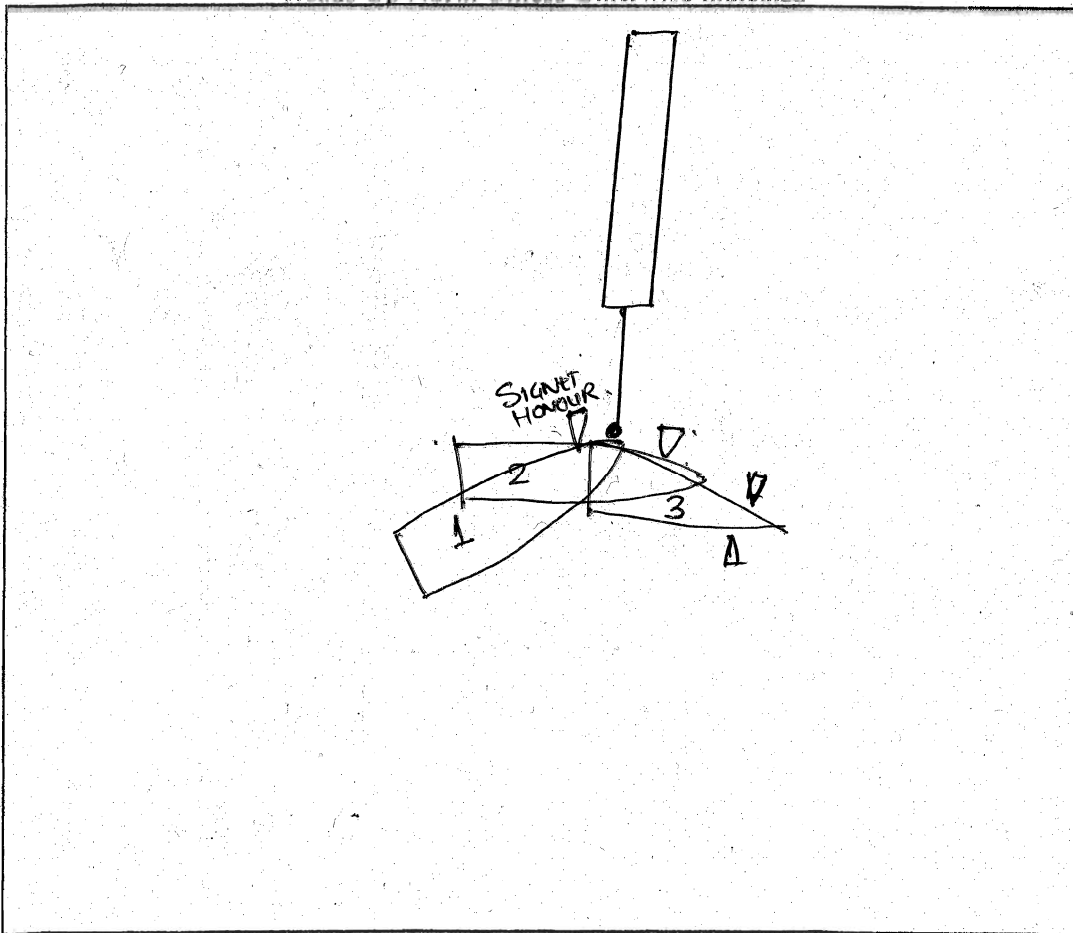
Describe what part or section of vessel is/was aground:	<u>ALLISION</u>	<u>PORT BOW SECTION</u>
Channel width:	<u>0.08 nm</u>	Water depth: <u>14.9 m</u>
Last fix:	<u>EP</u>	Time of last fix: <u>12:50 LT</u>
Method used to determine last position:	<u>DGPS & CONTINUOUS MONITORING BY PI</u>	
Courses and speeds from last position:	<u>COURSE: 078° SOG: 7.5 KNOTS TO 5.8 KNOTS</u>	
Set and drift calculations:	<u>SET: 165° DRIFT: 0.5 KNOTS</u>	
Equipment failure(s):	<u>MAIN ENGINE FAILURE</u>	
Attempts to free vessel:	<u>NA</u>	
Length of time aground:	<u>NA</u>	
Assistance rendered? [<input checked="" type="checkbox"/> or N]	Channel Blocked? [<input type="checkbox"/> or <input checked="" type="checkbox"/>]
