SURVEY STATEMENT NARRATIVE ANNEX

Name of vessel: **RIVERSIDE**
Owner: **Glory Riverside Navigation Ltd.**
IMO Number: **9412464**

PSC Follow up Survey

Narrative Report

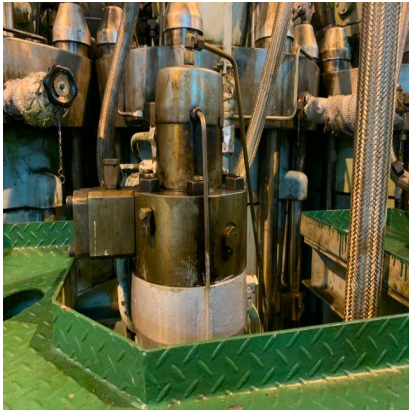
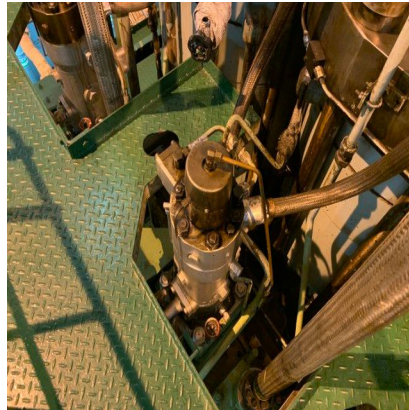
Deficiency No. 02
PSC Code 13101
Action Code 30 a/c

Precautions shall be taken to prevent any oil that may escape under pressure from any pump, filter or heater coming into contact with heated surfaces. Main diesel engine was found to have fuel leaking from #1 and #5 fuel oil pumps. PSCO observed excess amount of fuel oil collecting on top of the main diesel engine. Leaking over the #1 and #5 fuel oil pumps, and expending onto the main engine A-Frame.

Repaired / Rectified: The leaking fuel oil pump was overhauled by crew, the damaged seal was replaced. The fuel oil pump was inspected by attending surveyor during engine trail and no leaking was observed.

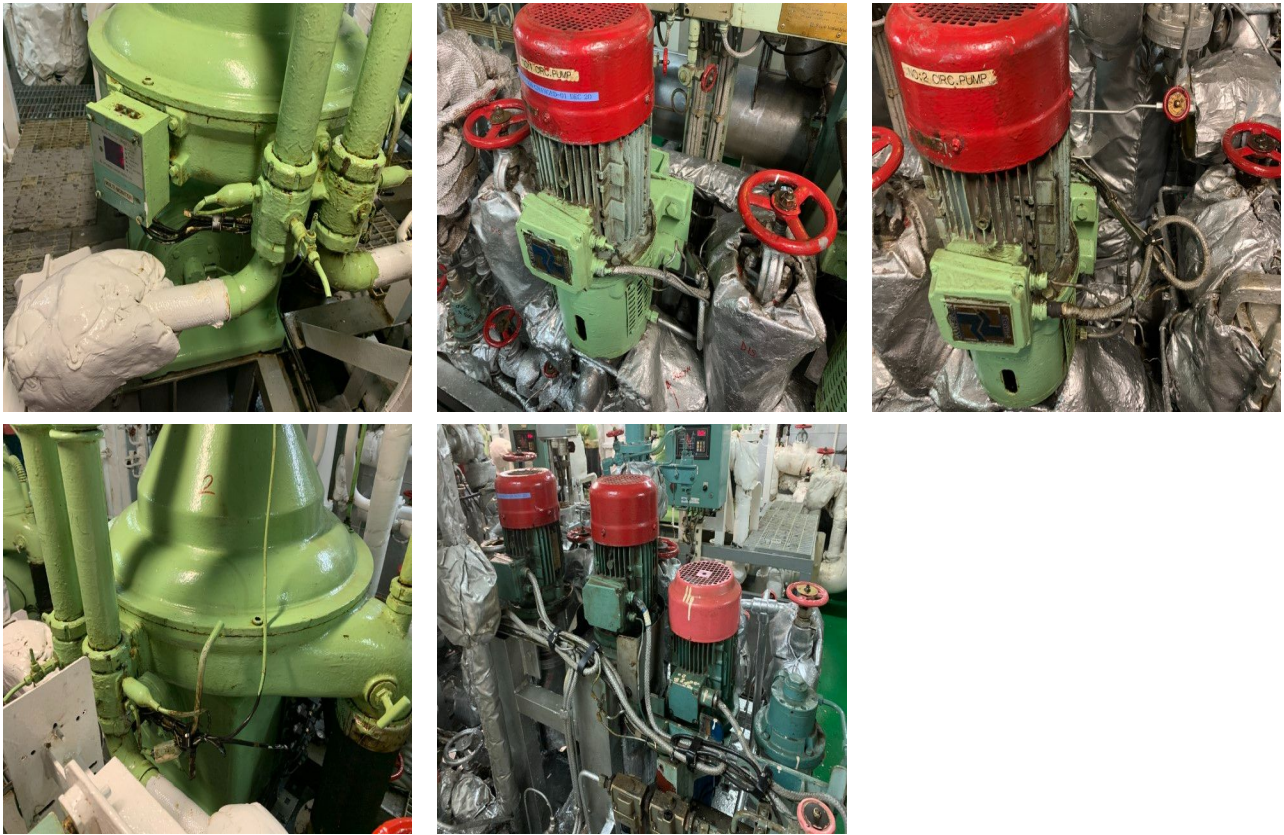
Deficiency No. 04
PSC Code 02108
Action Code 17 a/c

Where cable which are installed in hazardous area introduce the risk of fire or explosion in the event of an electrical fault in such areas, Special precautions against such risks shall be taken to the satisfaction of the administration. Cabling from the fuel circulation pumps in the fuel oil purifier room was found to be exposed and not properly secured.

Repaired / Rectified: The repair was carried out by crew and verified by attending surveyor, the affected cable are reconnected and cable gland are tightened, the loose cable are secured on the support.

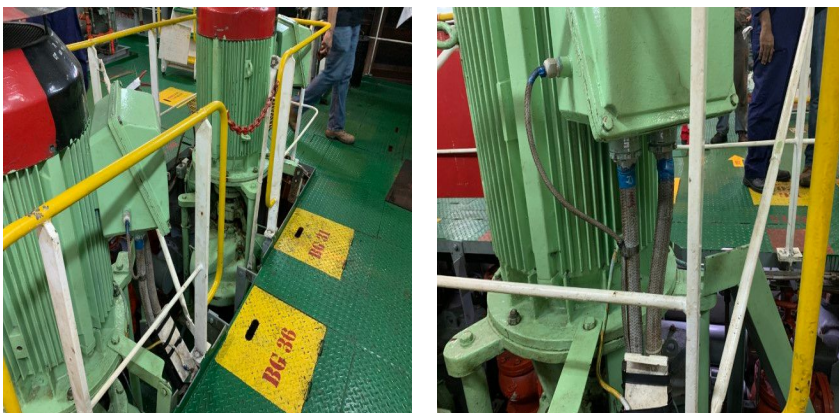
Deficiency No. 05
PSC Code 02108
Action Code 17 a/c

Cables and wiring shall be installed and supported in such a manner as to avoid chafing or other damage. Cabling for General Service/Fire and Fire/Bilge pumps were found to be exposed and improperly fastened to cable glands.

Repaired / Rectified: The repair was carried out by crew and verified by attending surveyor, the affected cable are reconnected and cable gland are tightened, the loose cable are secured on the support.

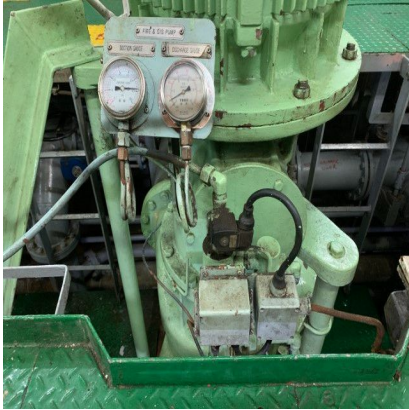
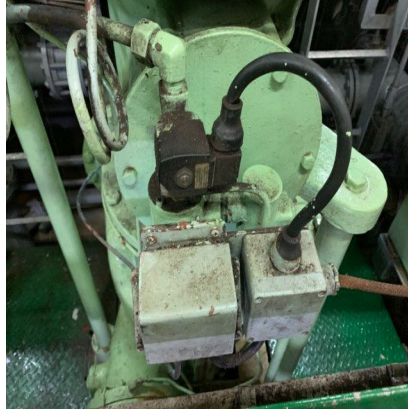
Deficiency No. 06
PSC Code 02108
Action Code 17 a/c

All electrical apparatus shall be so constructed and so installed as not to cause injury when handled or touched in the normal manner. Electrical junction boxes for General Service / Fire and Fire/Bilge pumps were found to be hanging loosely and without proper support.

Repaired / Rectified: The repair was carried out by crew and verified by attending surveyor, the loose cable and junction box are secured on the support.
