Service Report

Riverside

Thome Ship Management Pte Ltd

29 March 2021

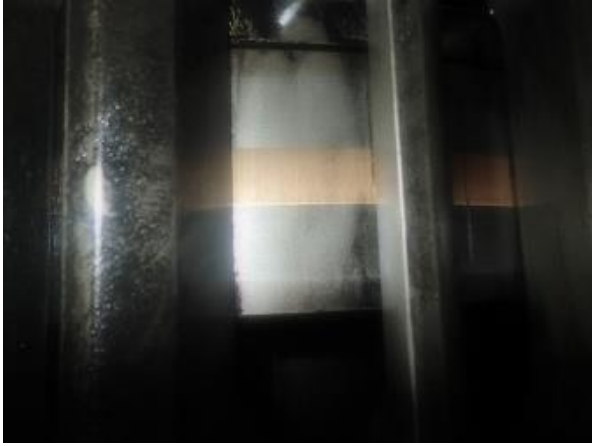
Piston Skirt

Scavenge port inspection showed good cylinder condition. All rings found intact. Wave cut pattern still visible up to just below the cylinder lubrication oil quills (See Enclosure 5)
