RIVERSIDE

STX MAN B&W 6S60MC

YARD SUPERVISION OF MAIN ENGINE MAINTENANCE

Preliminary service report

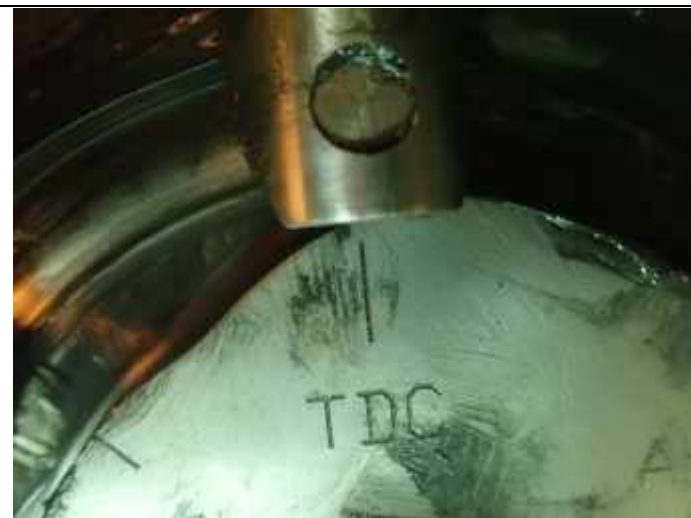
- Starting air distributor was checked & overhauled.
 - Starting air distributor was overhauled, all units check & found satisfactory. Some wear down was observed on the liners & piston but same were within limits.
 - Piston valve position inspected by engine turning and found normal position.

Piston valve position check

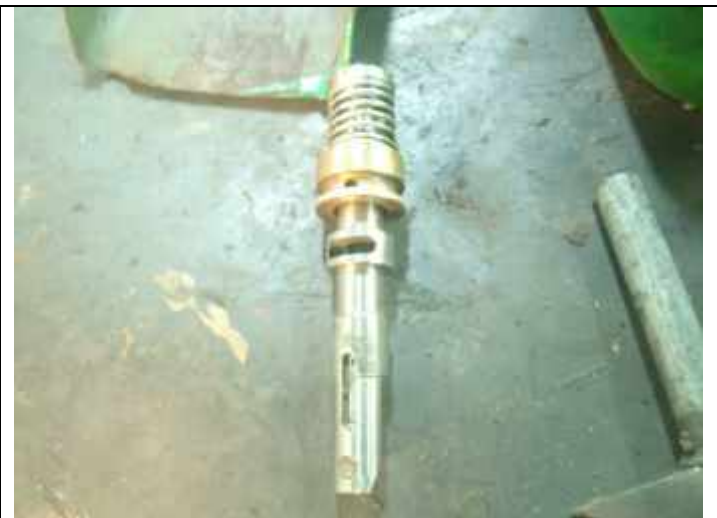
Dismantled No.:1 piston valve condition (cleaned and normal)

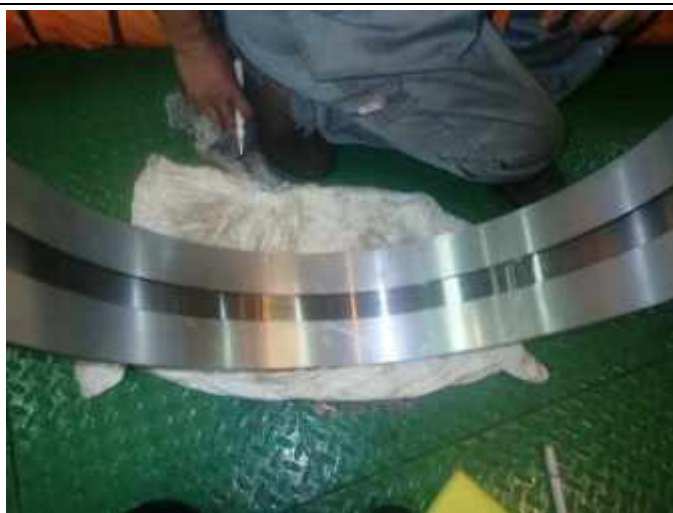
- Carried out open inspection of main bearing/crosshead bearing/crank pin bearing as under
 - No.:2 and 4 crank pin bearings
 - No.:2 main bearing
 - No.:2 crosshead bearing
 - Found all in acceptable condition.

No.:2 crank pin bearing

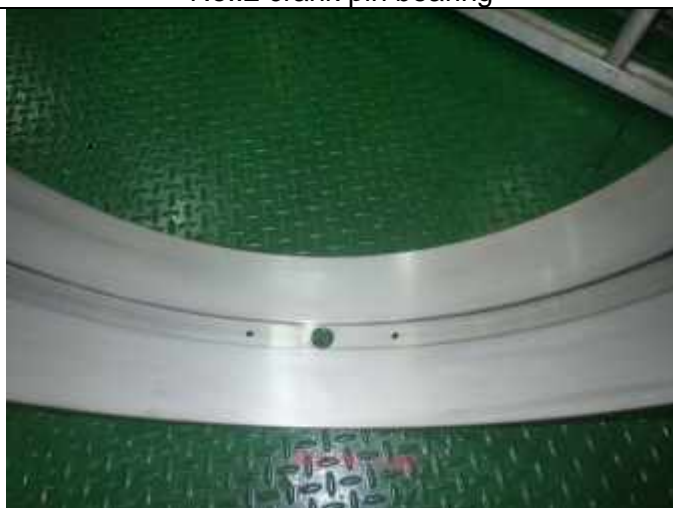
No.:2 main bearing

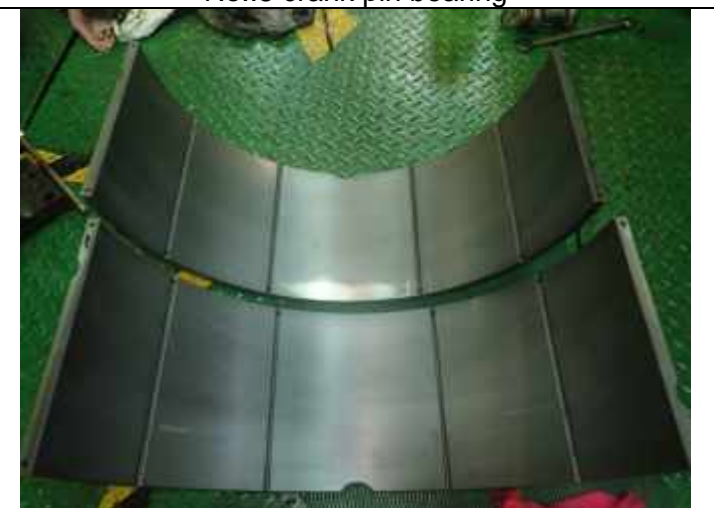
No.:2 crosshead bearing

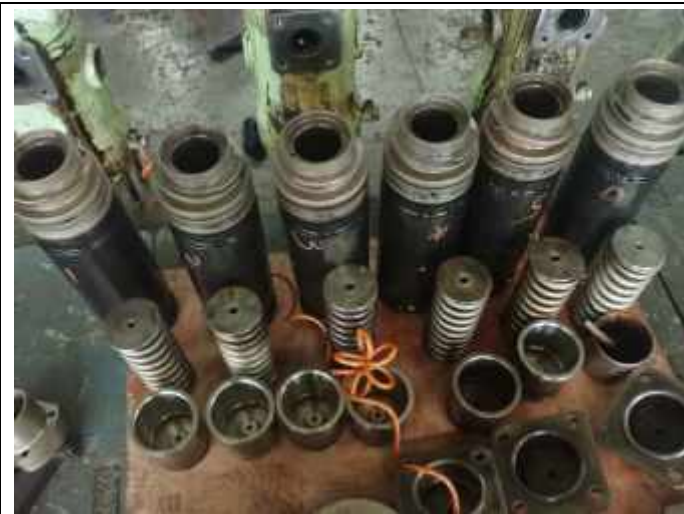
- Overhauling of all fuel injection pumps as under
 - Replaced all sealing rings of barrel/suction valve/puncture valves
 - Measured all plunger and barrel dimension
 - Replaced all plug screws.
 - Measured all fuel injection timing. (cam lead value)
 - All plunger and barrel were re-used due to lack of spare parts
 - Regarding shock absorber, replaced all sealing and wearing rings, but pistons couldn't be replaced due to lack of spare parts.
- Detail service report will be sent with measurement record

Dismantled plunger and barrels

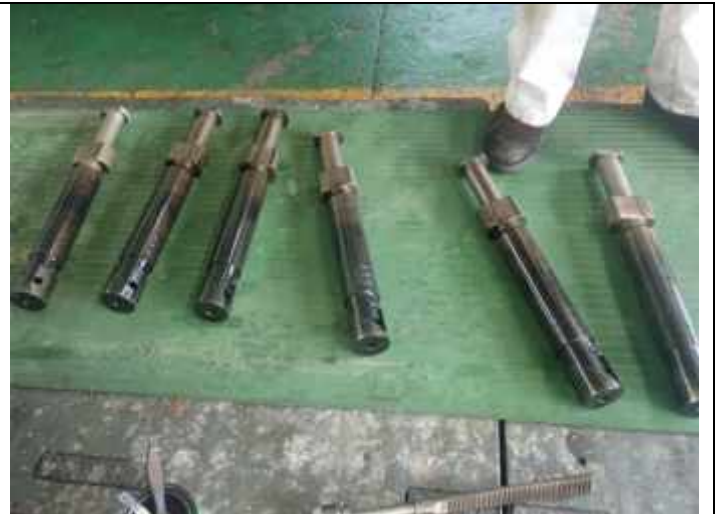
Plunger condition

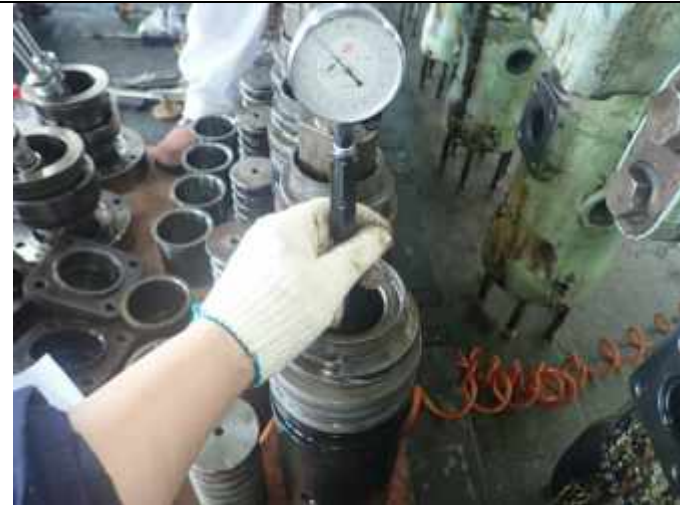
Measured dimension

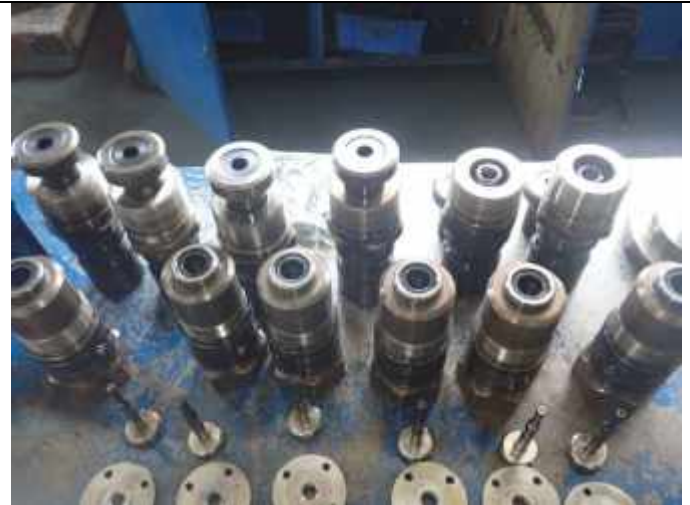
Maintained suction and puncture valves

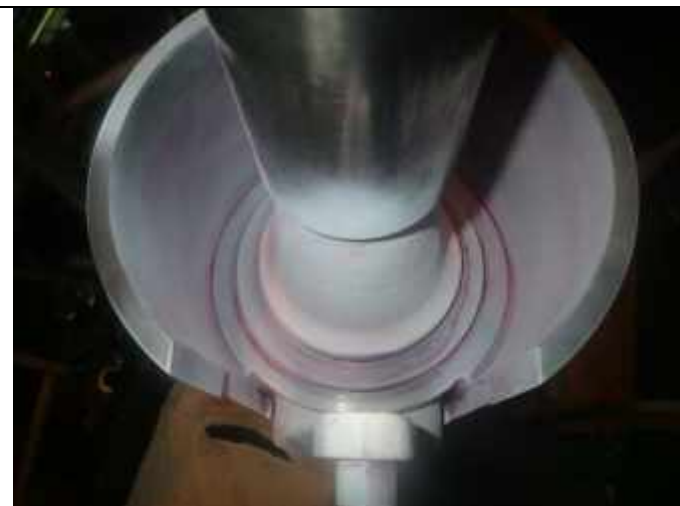
- Open inspection of no.:2 and 4 roller guides was carried out as under
 - Penetration check was carried out and found no any cracks
 - Roller and bush clearance were measured and found all in good condition

Penetration test of roller guide

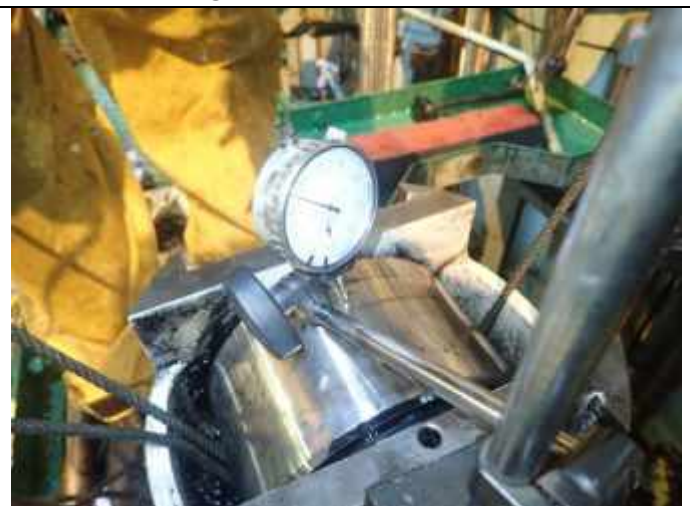
Measured clearance of roller guide

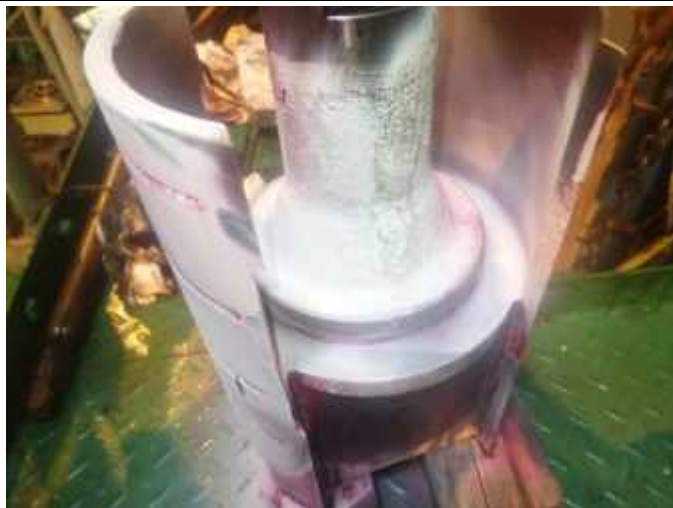
- Open inspection of no.:2 and 4 roller guides was carried out as under
 - Penetration check was carried out and found no any cracks

Penetration test of roller guide

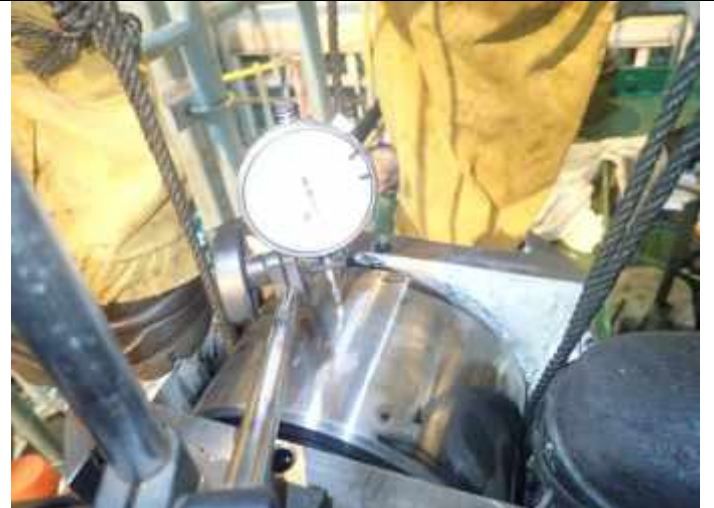
- Roller and bush clearance were measured and found all in good condition
- Oil piston rings of no.:2 and 4 pistons were replaced with new one.
- Diameter of oil cylinder was measured and found all in good condition.

Measured clearance of roller guide

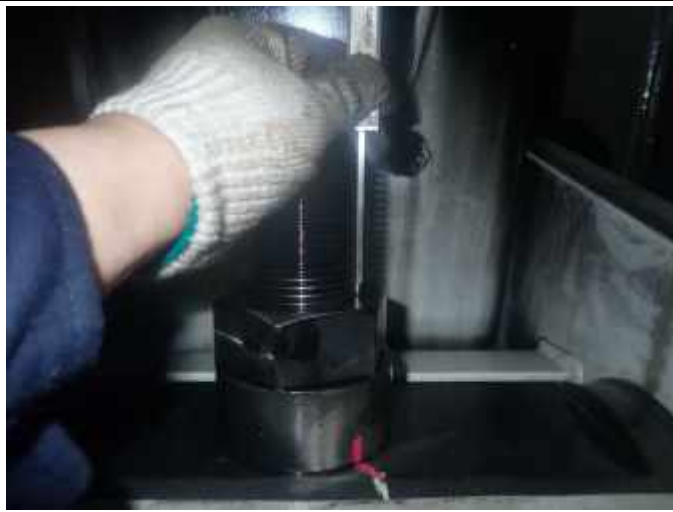
- Chain tighter was re-tightened according to maker' guide and found all in normal condition as under
 - Before tightened stud length: 83.56 mm
 - After tightened stud length: 83.85 mmDetail service report will be sent with measurement record

Stud length measured

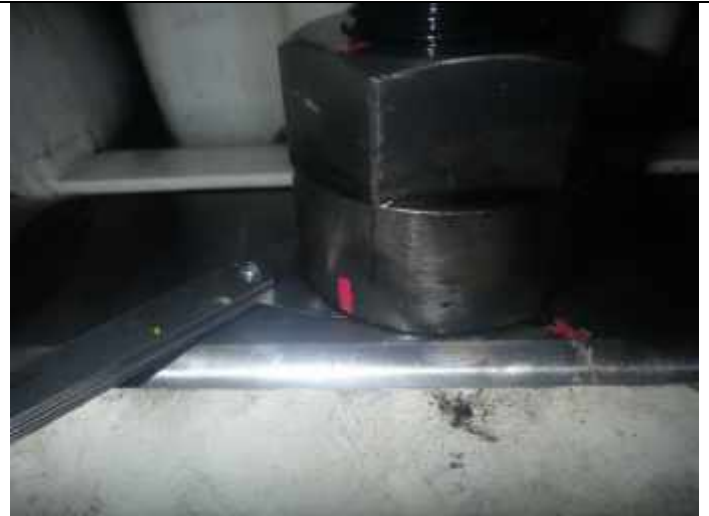
Initial clearance setting

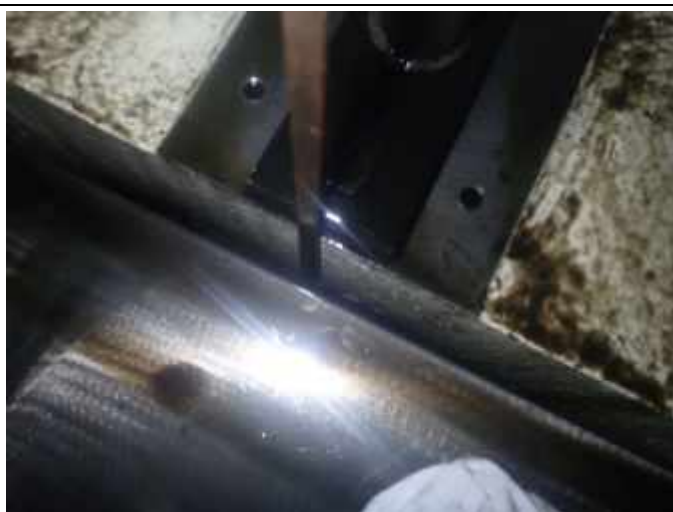
- Crankcase inspection was carried out as under
 - Measured all main bearing top clearances
 - Measured all crosshead top clearances
 - Measured all crank pin bearing bottom clearances
 - Visual inspection of crank case was carried out and found no any defects
 - Visual inspection of guide shoes was carried out and found all in acceptable conditionDetail service report will be sent with measurement record

Main bearing clearance measured

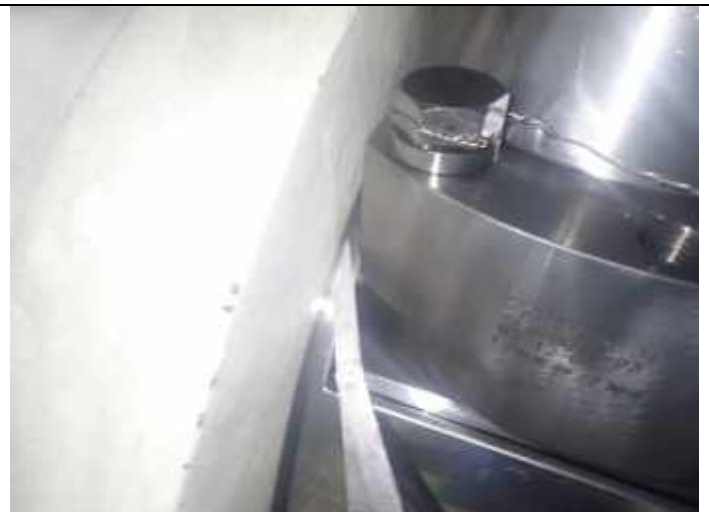
Crosshead bearing clearance measured

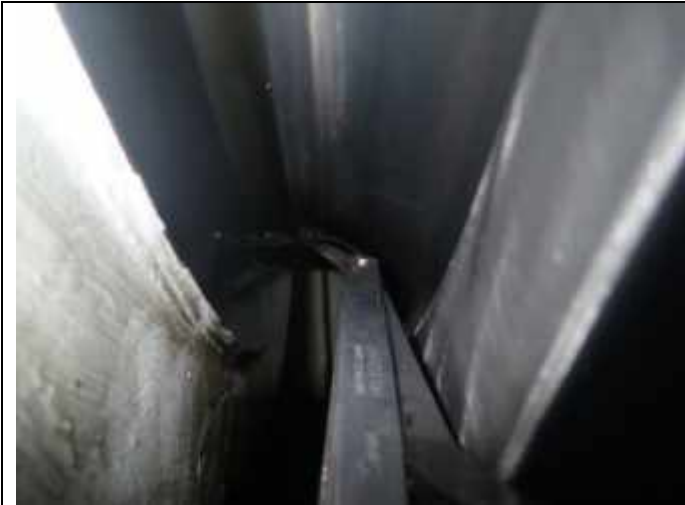
Crank pin bearing measured

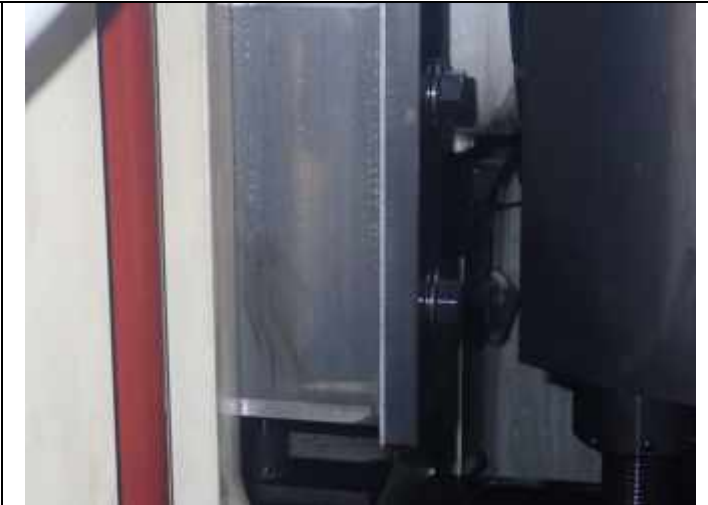
Guide shoe inspection

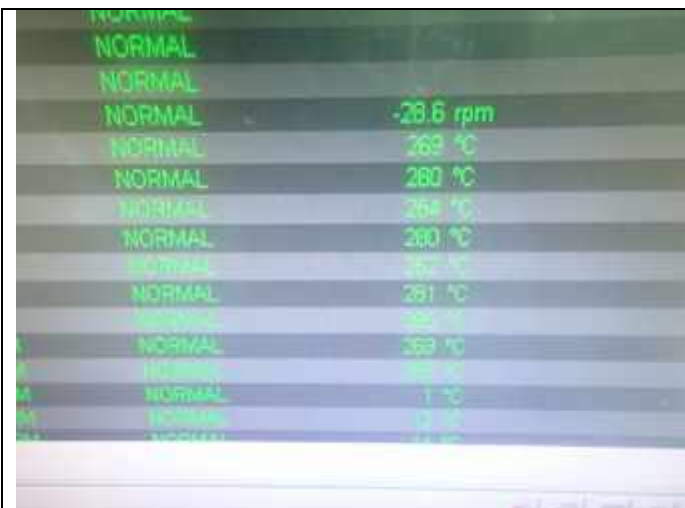
- Engine trial was carried out during vessel's transportation from shipyard to anchorage as under
 - Test starting of ahead/astern and found all in good order.
 - Engine condition of dead slow operation was checked and found all in normal parameter.
Detail service report will be sent with measurement record

Engine condition of astern operation
