SURVEY STATEMENT NARRATIVE ANNEX

Name of vessel: **RIVERSIDE**
Owner: **Glory Riverside Navigation Ltd.**
IMO Number: **9412464**

Hull Damage

Narrative Report

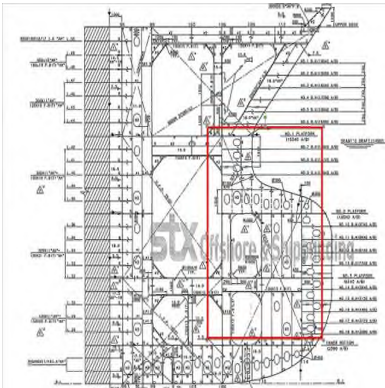
Contact damage

Side shell plates, port side in way of Void space was found heavily indented due to collision between frames 106 and 114 iwo longitudinals 25 to 39. No cracks were observed.

The side longitudinals 26, 27, 28, 29, 30, 31 and 37 found heavily deformed

The web frames Nos. 106 and 110 found heavily deformed.
