Rolls-Royce Engine Investigation Report

Wreckage Exam Date: 4AUG2020
Wreckage Exam Location: MP Aviation Hangar, Standpoint, ID
Aircraft Type: MD600N
Aircraft Reg: N208MP
Engine Model: M250-C47M
Engine S/N: 847850
Engine Rating: 650 shp (takeoff)

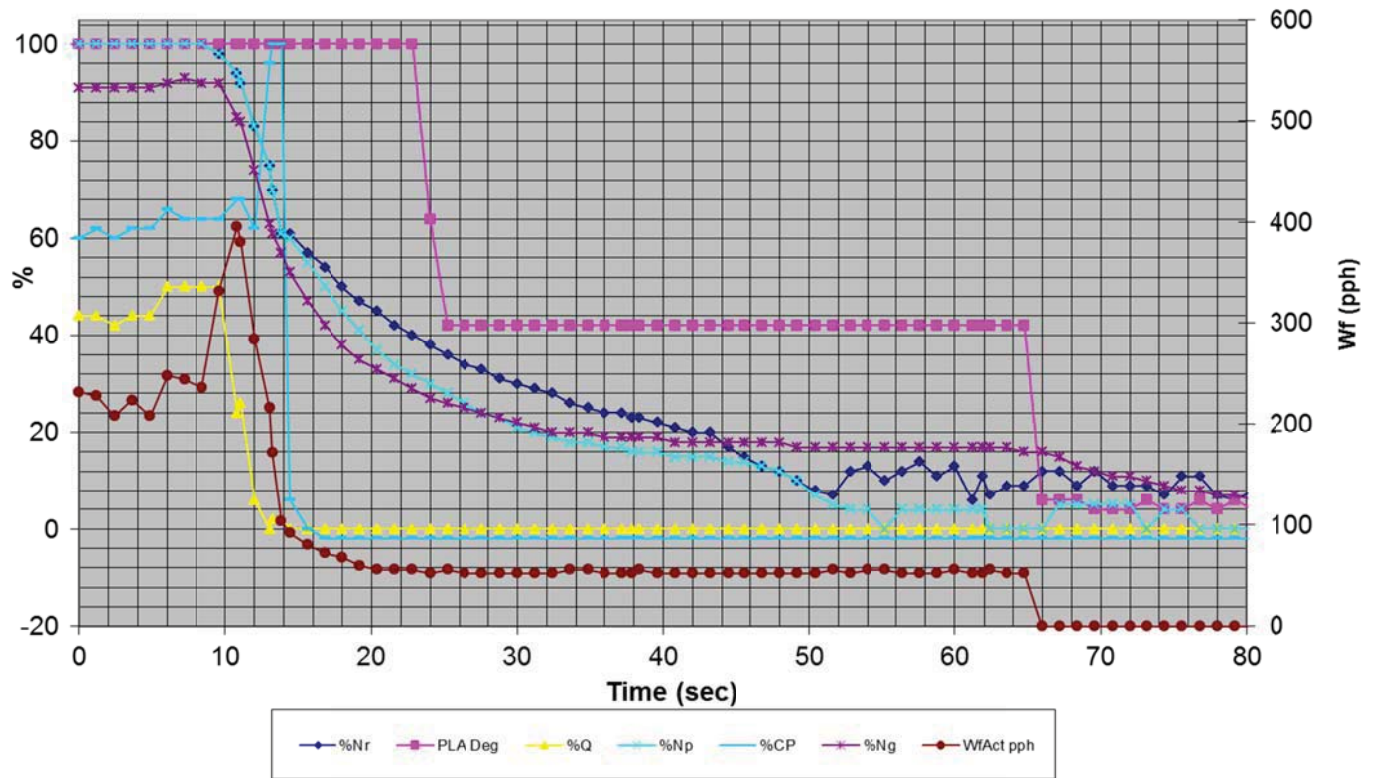
Appendix A ECU Incident Recorder Data

The engine Electronic Control Unit (ECU) retains data in non-volatile memory, which was downloaded during the wreckage exam. The ECU includes an incident recorder function, which begins capturing engine and input parameters upon trigger actuation and records a line of data (“record”) every 1.2 seconds (Appendix A). The recorder captures twelve seconds of data prior to the triggering event (ten records) and forty eight seconds of data (forty records) post trigger. The initial incident recorder triggering event was low rotor RPM (Nr Droop), which fell below the 92% threshold. Then, within 3 seconds, the incident recorder captured the Flameout and Ng Low triggers. The FADEC system attempted to re-light the engine for the next 53 seconds until the PLA was rolled to cut-off; however, the engine did not re-start.
