Report of Findings

Date of accident: 21-APR-2019
Location of accident: Shirley Williams Airport (44TE), Kingsland, TX
Aircraft registration: N25TX
Aircraft type: [Rans S-7 Courier](#)
Engine type and S/N: 912ULS s.n 5644978
NTSB or TSB file number: CEN19FA122
Date of Report: July 9th 2019
File number: 2019-046

Preliminary engine inspection

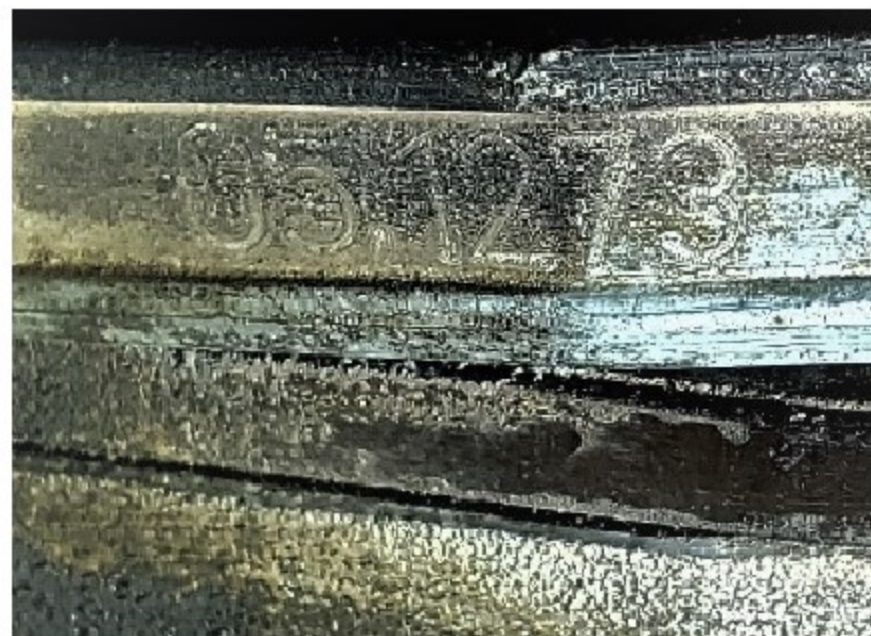
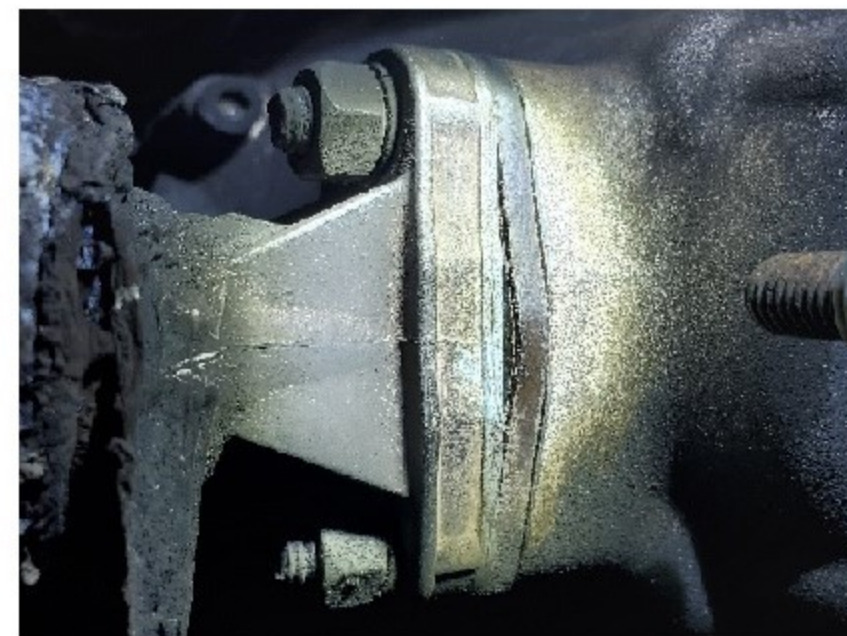
- System had a fuel return line incorporated within the fuel system. Unknown if the fuel returned back to the fuel tank.
- No blockages seen within the fuel distribution manifold
- Fuel lines consumed by post impact fire
- Fuel pump P.N 996 593 S.N 05.1273 Pierburg (should have been replaced)
- Both carburetors displaced from intake manifolds and substantially damaged from the post impact fire. Both float bowls consumed by the post impact fire. Both carburetor main jets are 155 size.

COMPONENT TYPE	ENGINE	PART NUMBER	SERIAL NUMBER	VALID FROM	VALID TO
Propeller Shaft	5645088	837285	05.1273	02.06.2005	31.12.2999
Fuel Pump Assy.	5644978	996593	05.1273	03.05.2005	31.12.2999
Camshaft Assy.	4430149	837417	05.1273	07.06.2005	31.12.2999

General note The fuel pump must be replaced every 5 years.
