NATIONAL TRANSPORTATION SAFETY BOARD

Rotorcraft Condition Monitor – Recorded Flight Data

Specialist's Factual Report

Location: Eden, North Carolina
Date: April 28, 2021
Aircraft: Bell 429
Registration: N53DE
Operator: Duke Energy Business Service LLC
NTSB Number: ERA21FA195

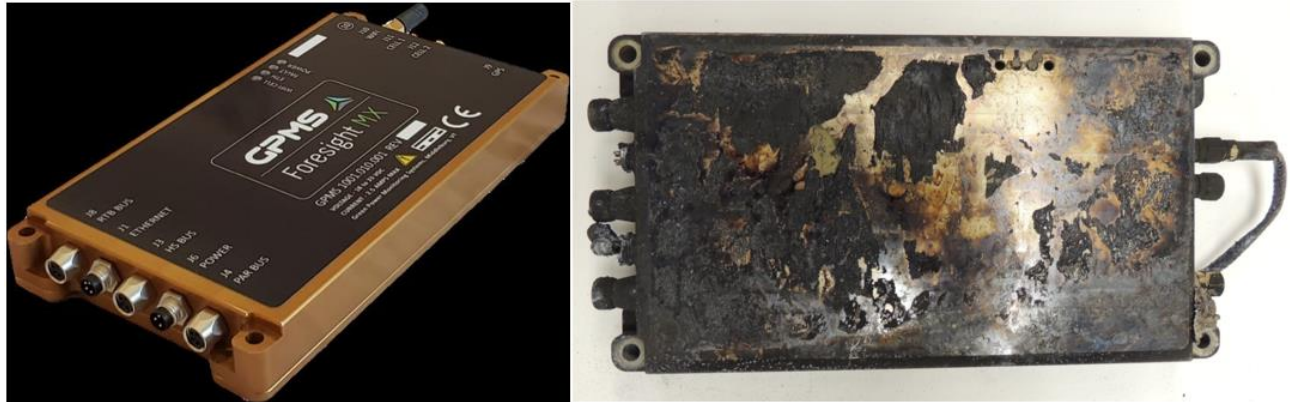
Figure 1 shows the condition of the GPMS Foresight MX OBCU as received by the Vehicle Recorder Division. The unit had sustained severe post-crash fire damage. The flash memory module was removed from the unit, and corrosion was found on the memory module, as

Figure 1: Undamaged OBCU vs. OBCU as received.

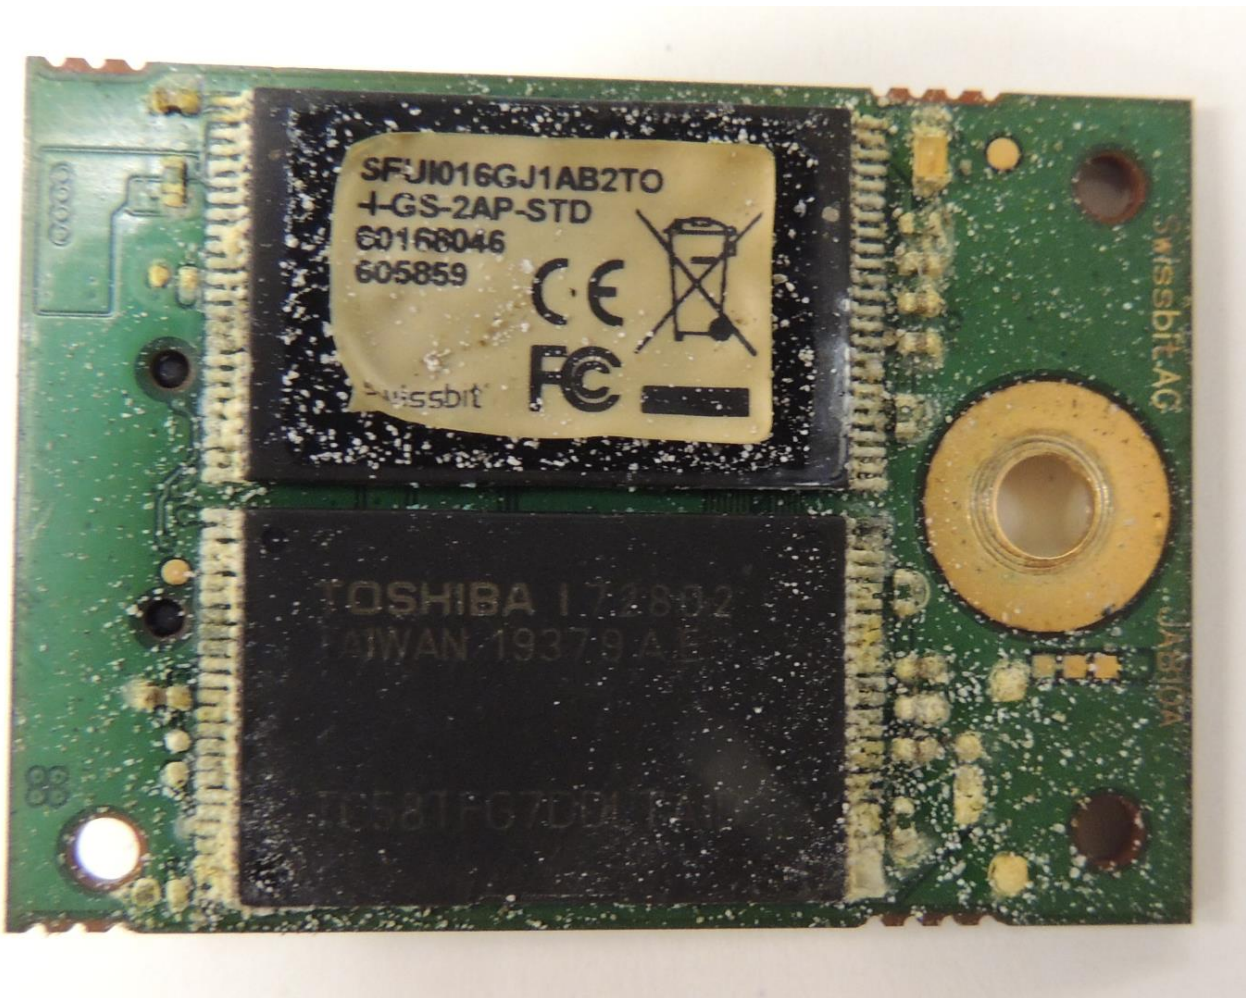
shown in Figure 2. The memory module was cleaned, and data were read out using hardware provided by the manufacturer. The data were then sent to the manufacturer for decoding.

Figure 2: Flash memory module removed from the OBCU.

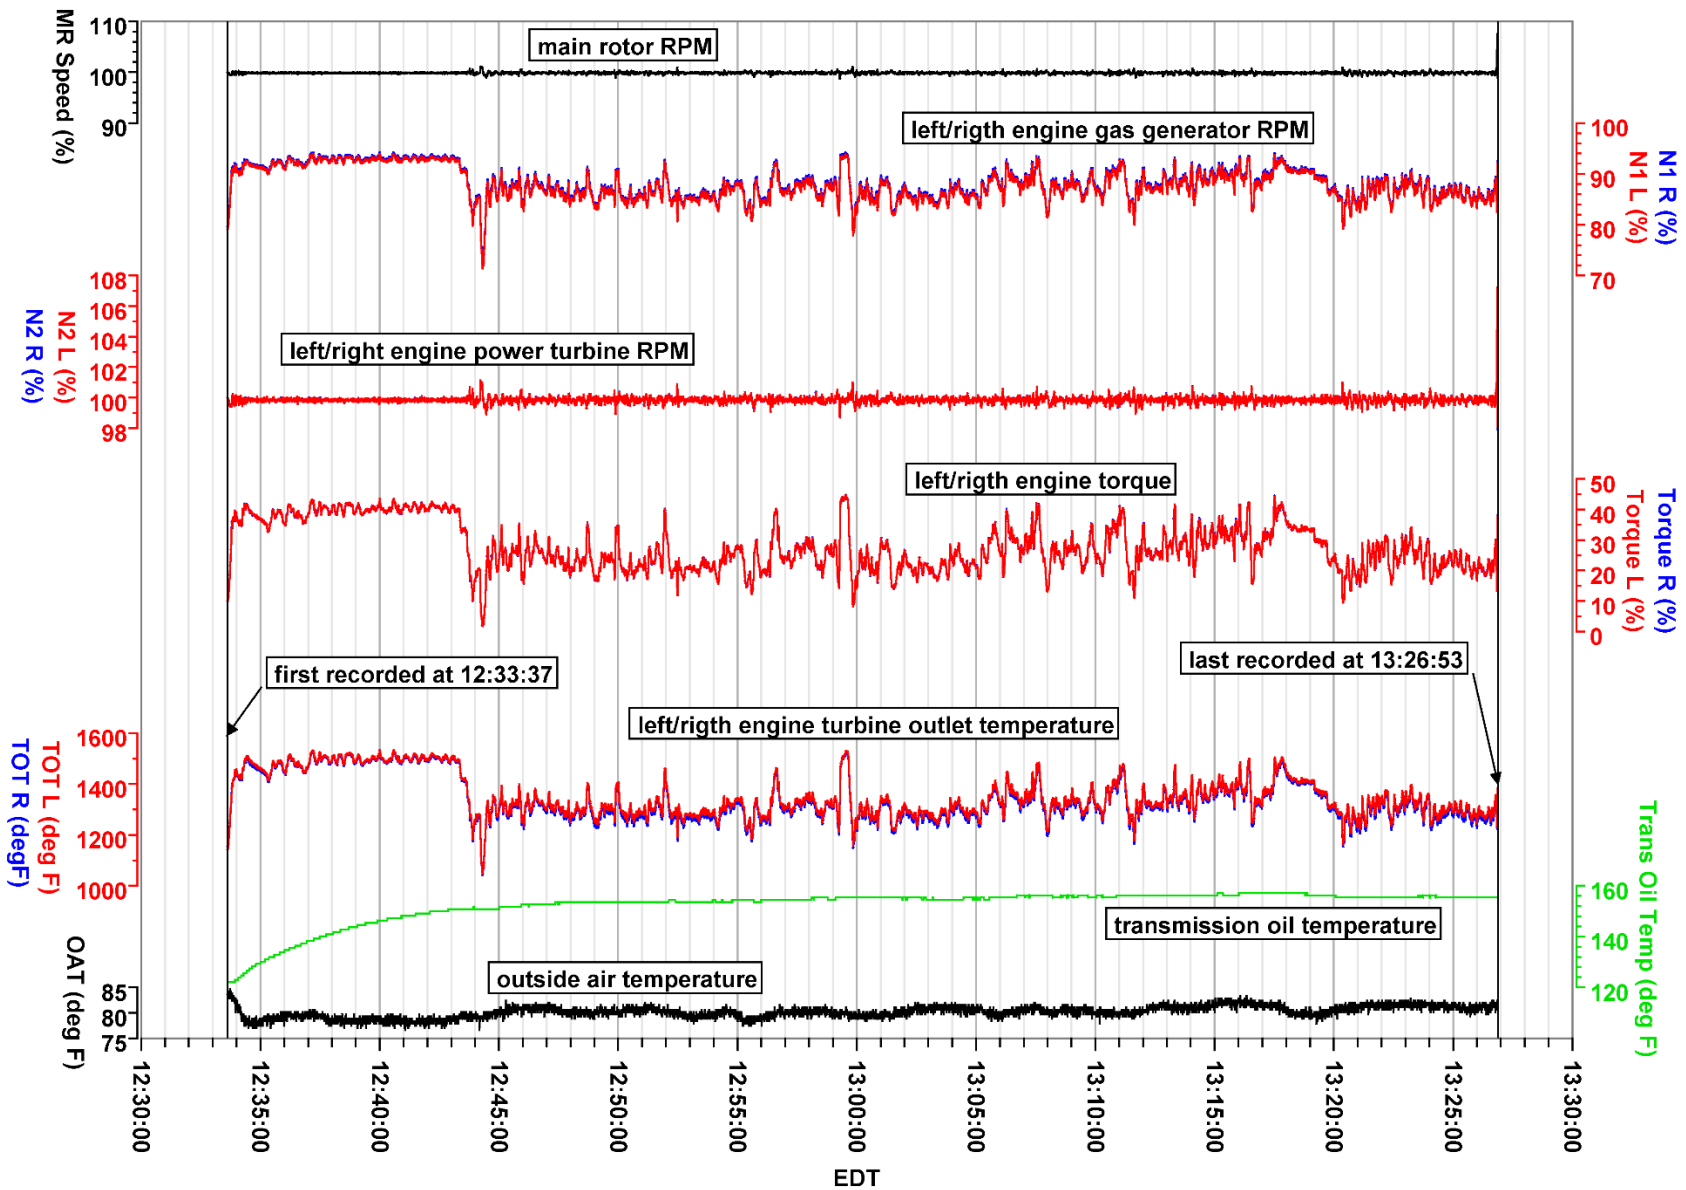
Figure 3 is a plot of the engine parameters for the entire accident flight. The time interval displayed is 12:30:00 to 13:30:00 EDT.

Figure 3: Plot of engine parameters for the entire accident flight recorded on April 28, 2021.

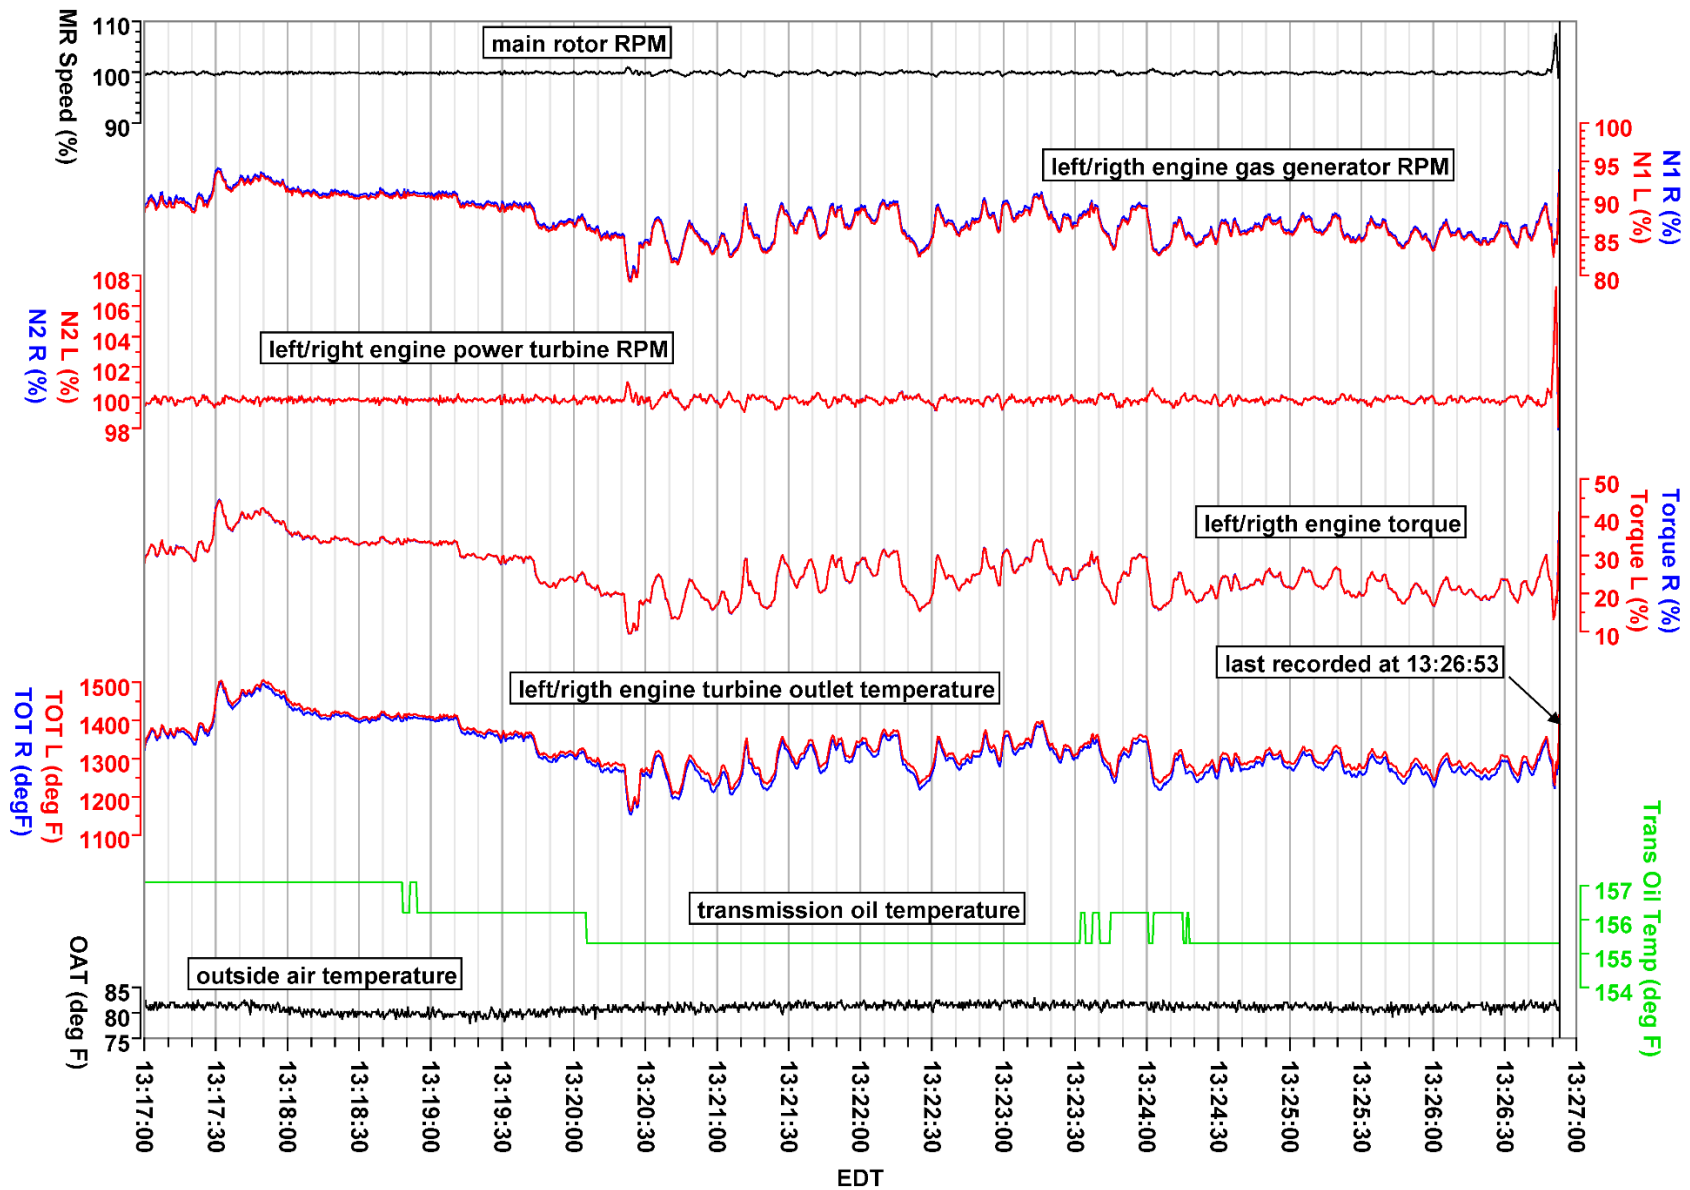
Figures 4 and 5 show the plots of the engine parameters for the last 10 minutes and last 1 minute of the accident flight.

Figure 4: Plot of engine parameters for the last 10 minutes portion of the accident flight.

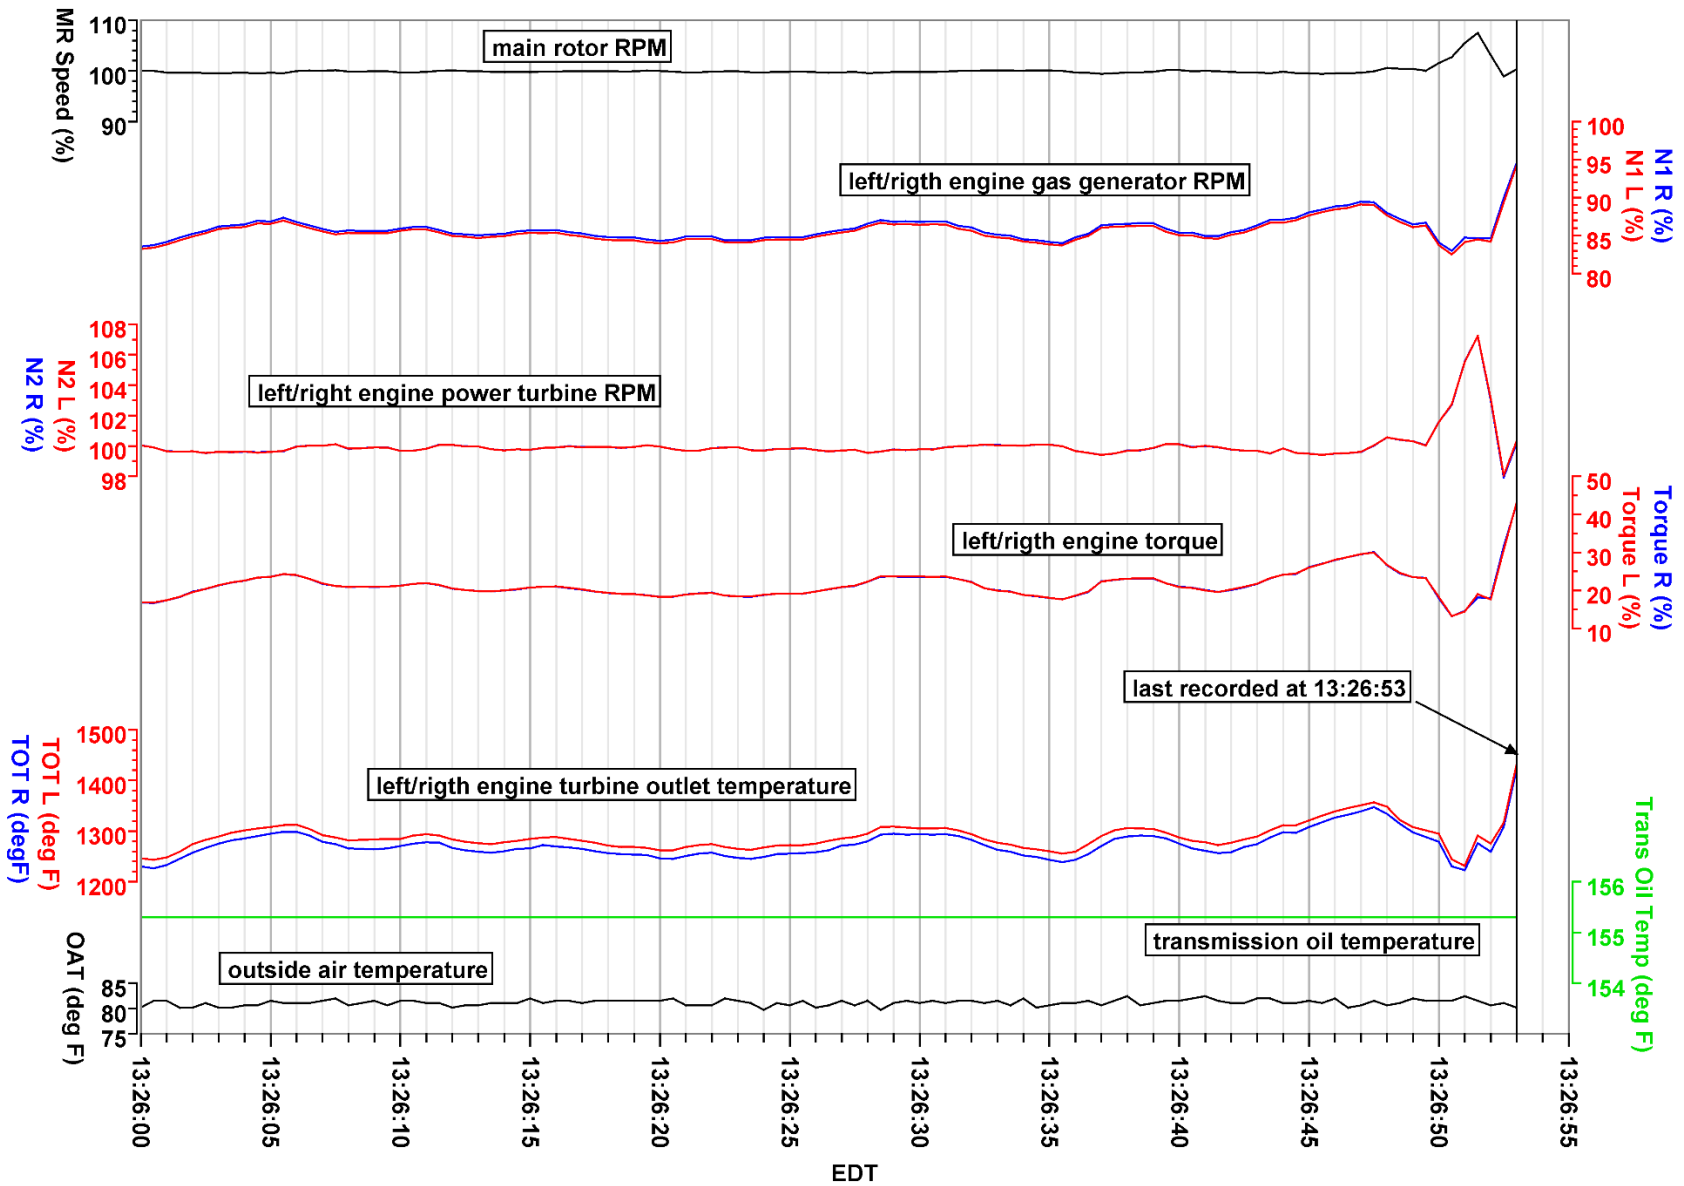
Figure 5: Plot of engine parameters for the last 1 minute portion of the accident flight.

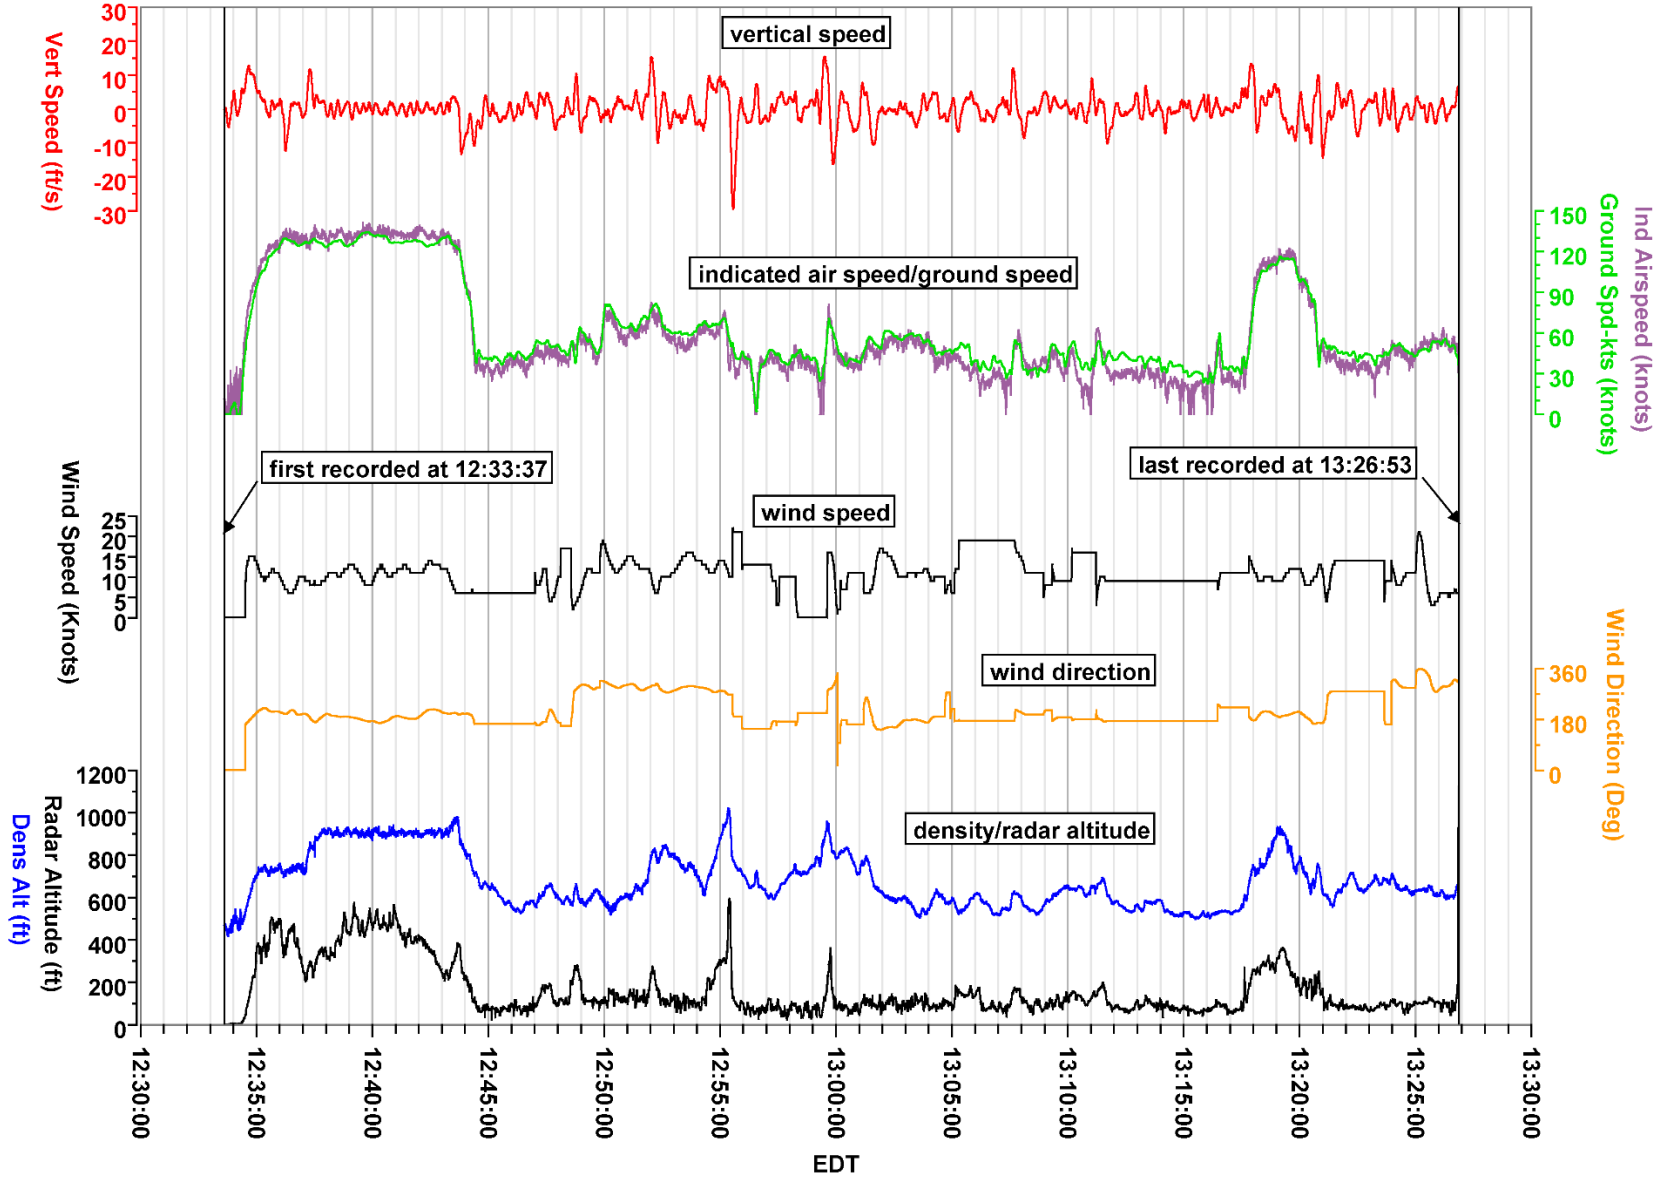
Figure 6 is a plot of the operational parameters for the entire accident flight. The time interval displayed is 12:30:00 to 13:30:00 EDT.

Figure 6: Plot of operational parameters for the entire accident flight recorded on April 28, 2021.

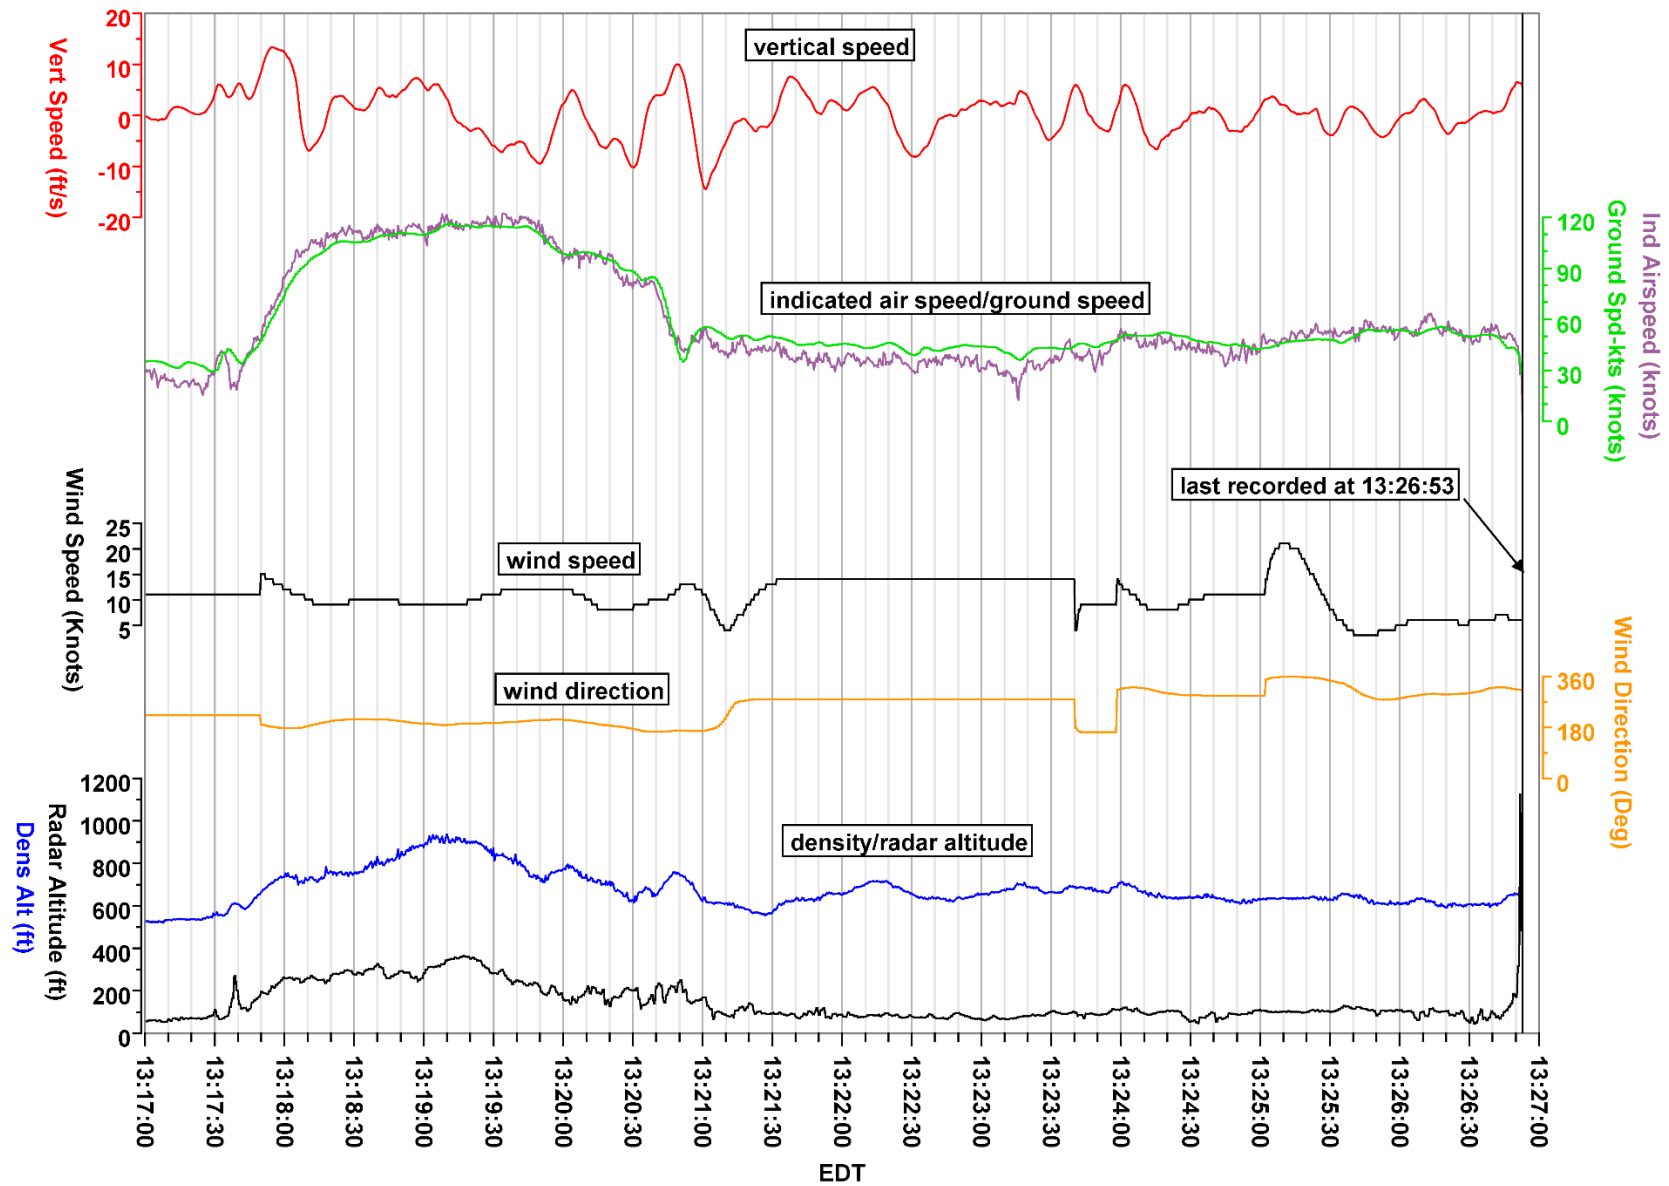
Figures 7 and 8 show the plots of the operational parameters for the last 10 minutes and last 1 minute of the accident flight.

Figure 7: Plot of operational parameters for the last 10 minutes portion of the accident flight.

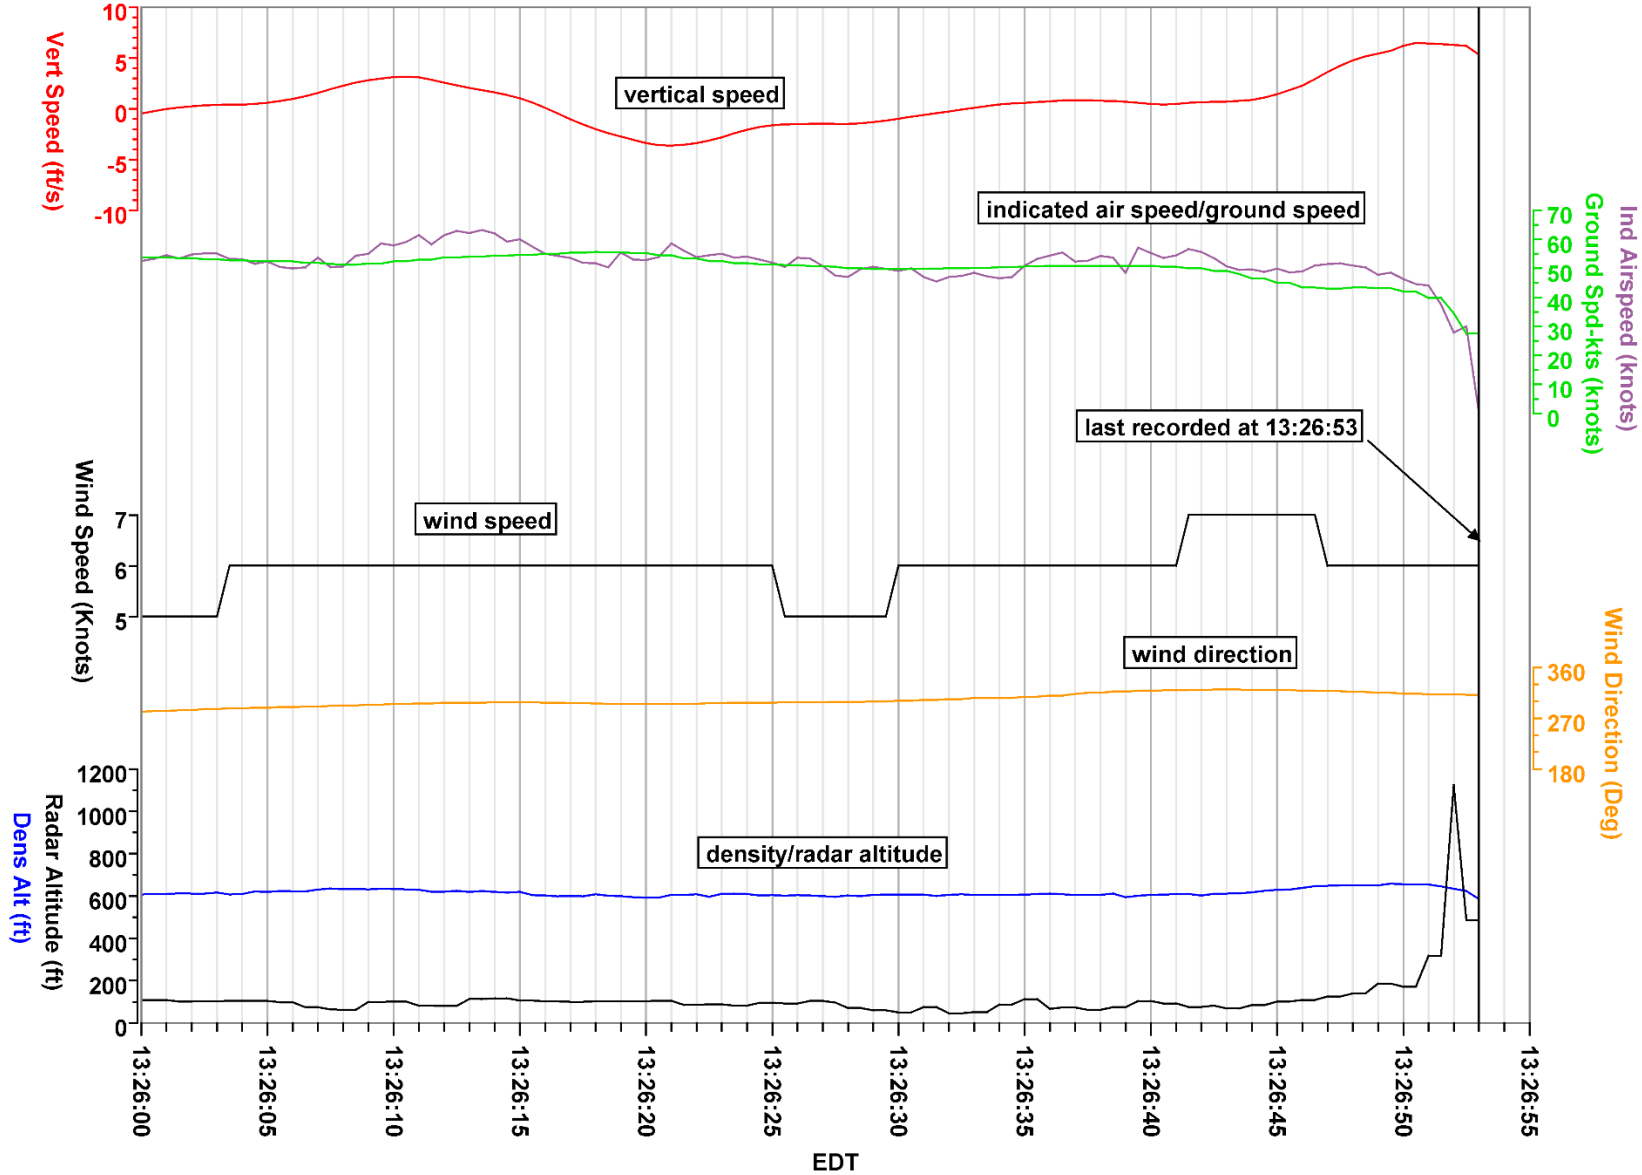
Figure 8: Plot of operational parameters for the last 1 minute portion of the accident flight.

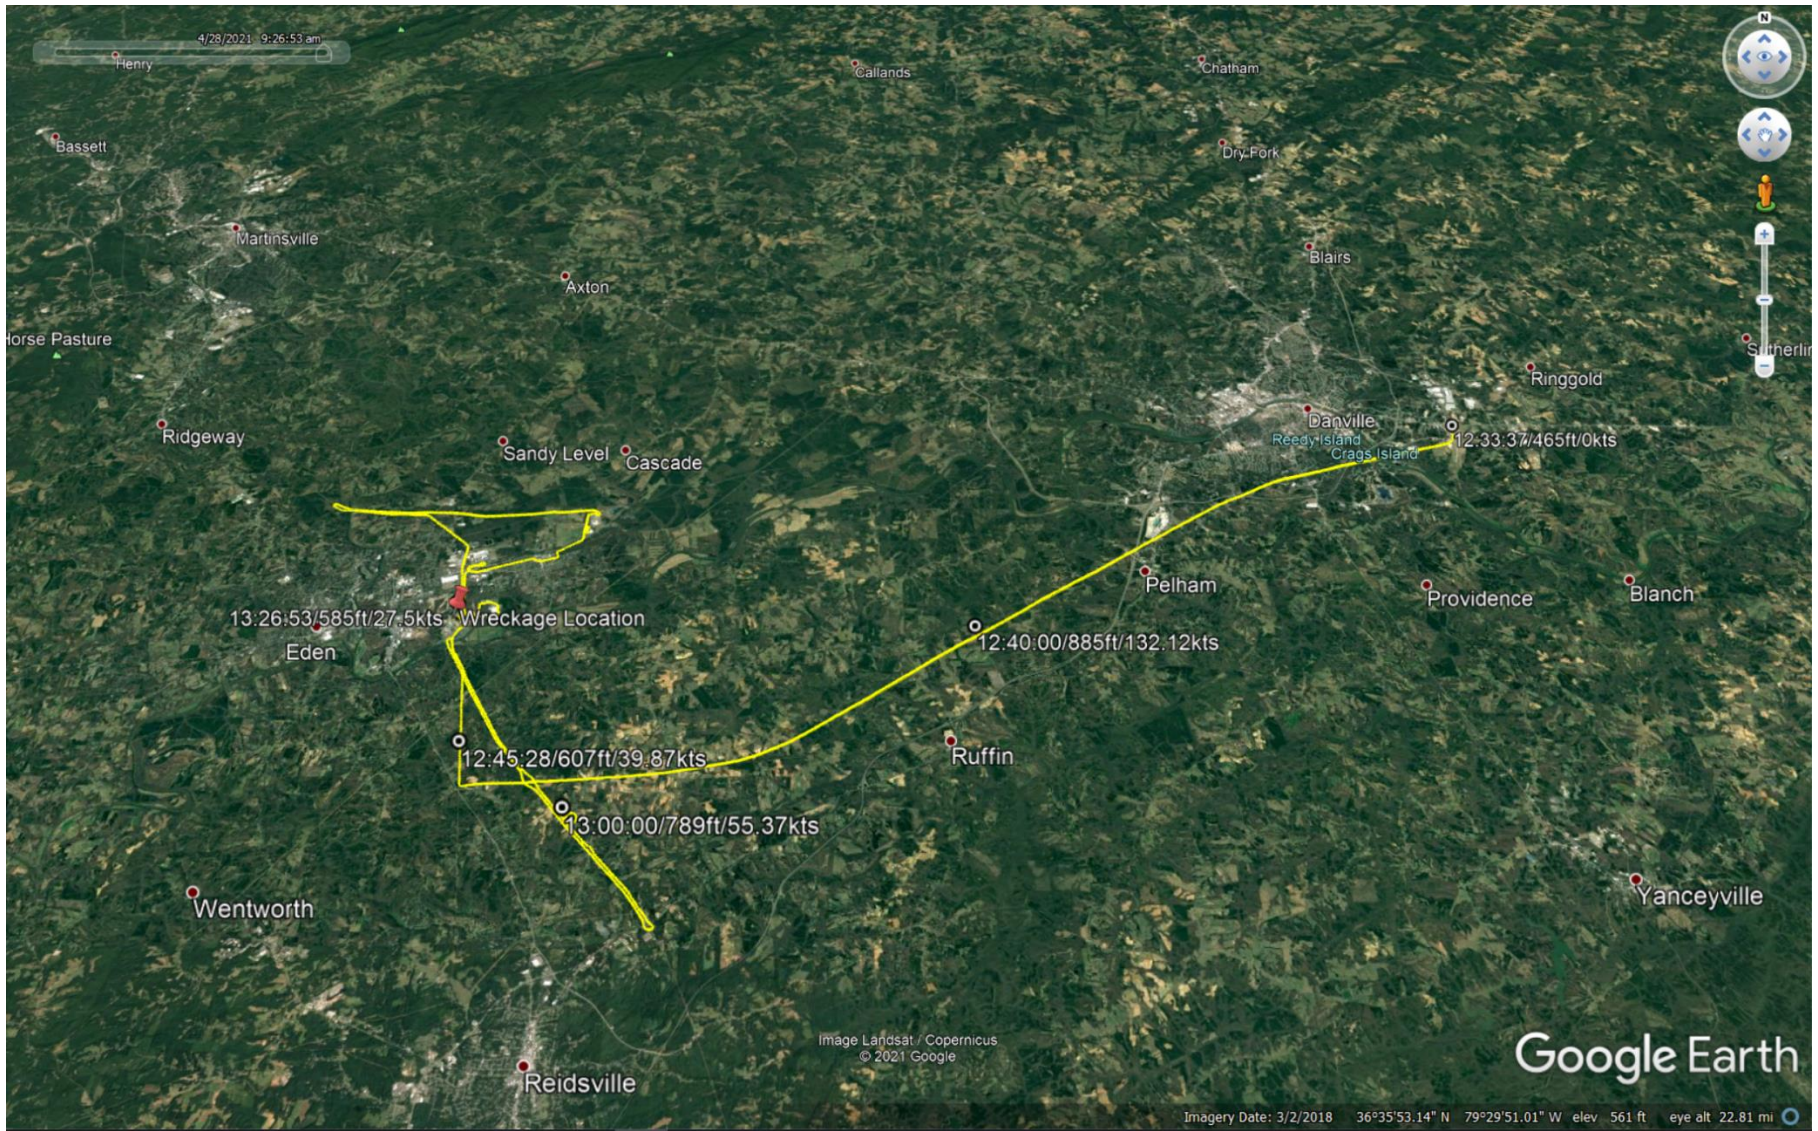
Figure 9 is a Google Earth overlay of the entire accident flight recorded on April 28, 2021. The weather and lighting conditions in Google Earth are not necessarily the weather and lighting conditions present at the time of the recording.

Figure 9: Google Earth overlay of the entire accident flight.

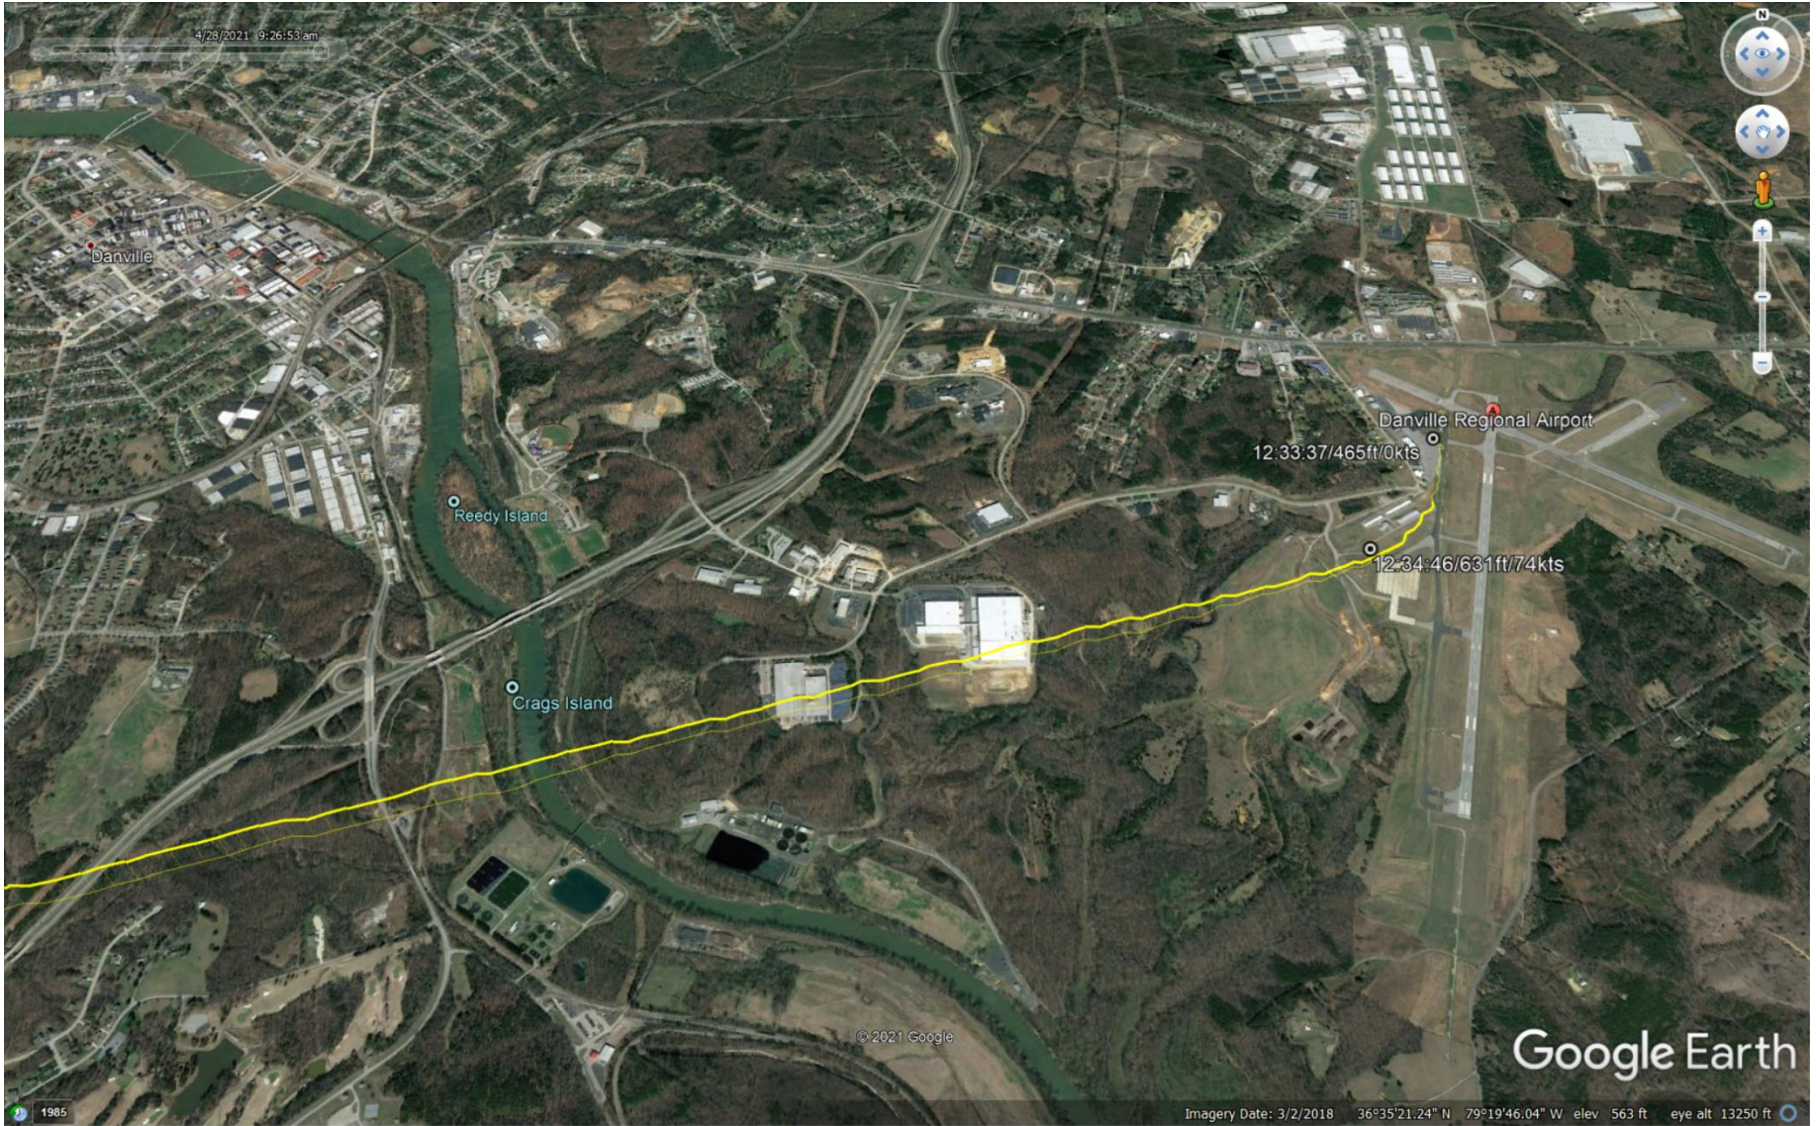
Figure 10 is a Google Earth overlay of the beginning of the accident flight. It shows the aircraft took off at Danville Regional Airport around 12:34:46 EDT, then headed west.

Figure 10: Google Earth overlay of the beginning of the accident flight.

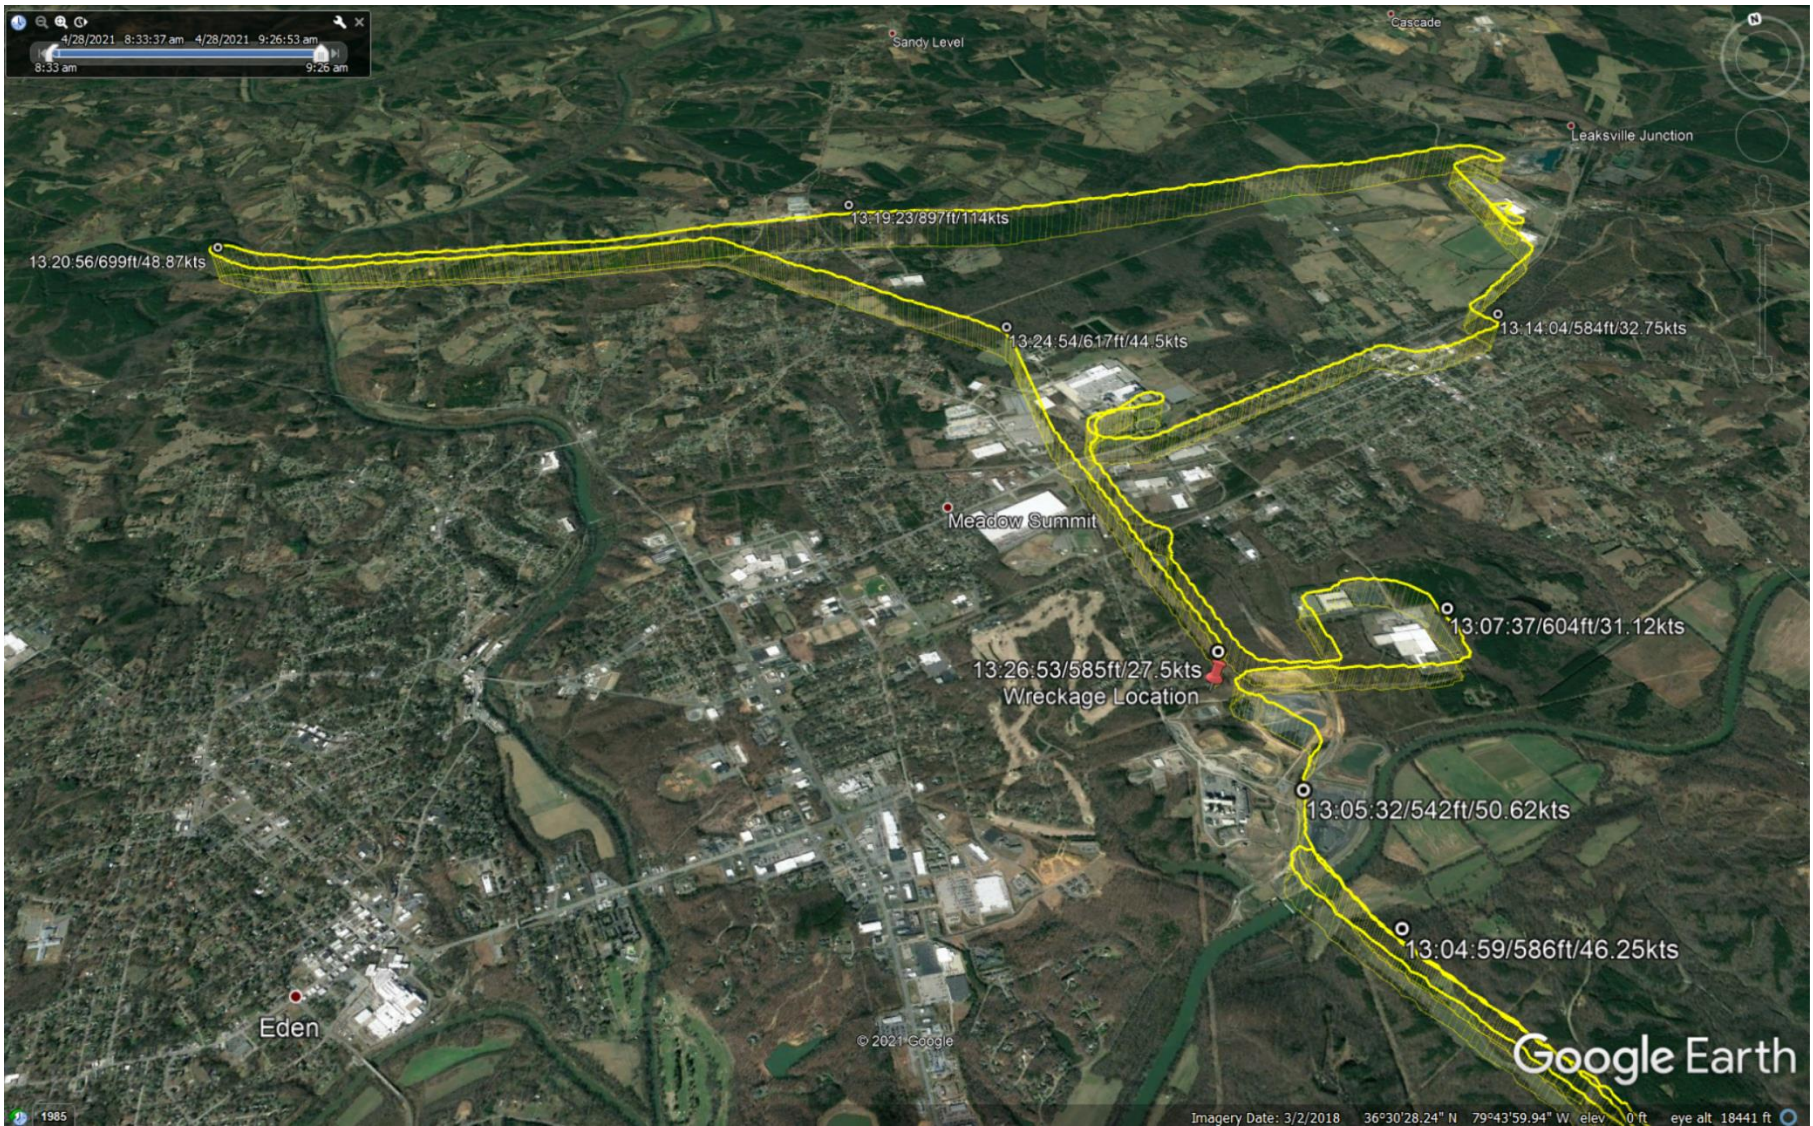
Figures 11 and 12 are Google Earth overlays of the final portion of the accident flight. The reported wreckage location is shown with a red pin.

Figure 11: Google Earth overlay of the final portion of the accident flight.

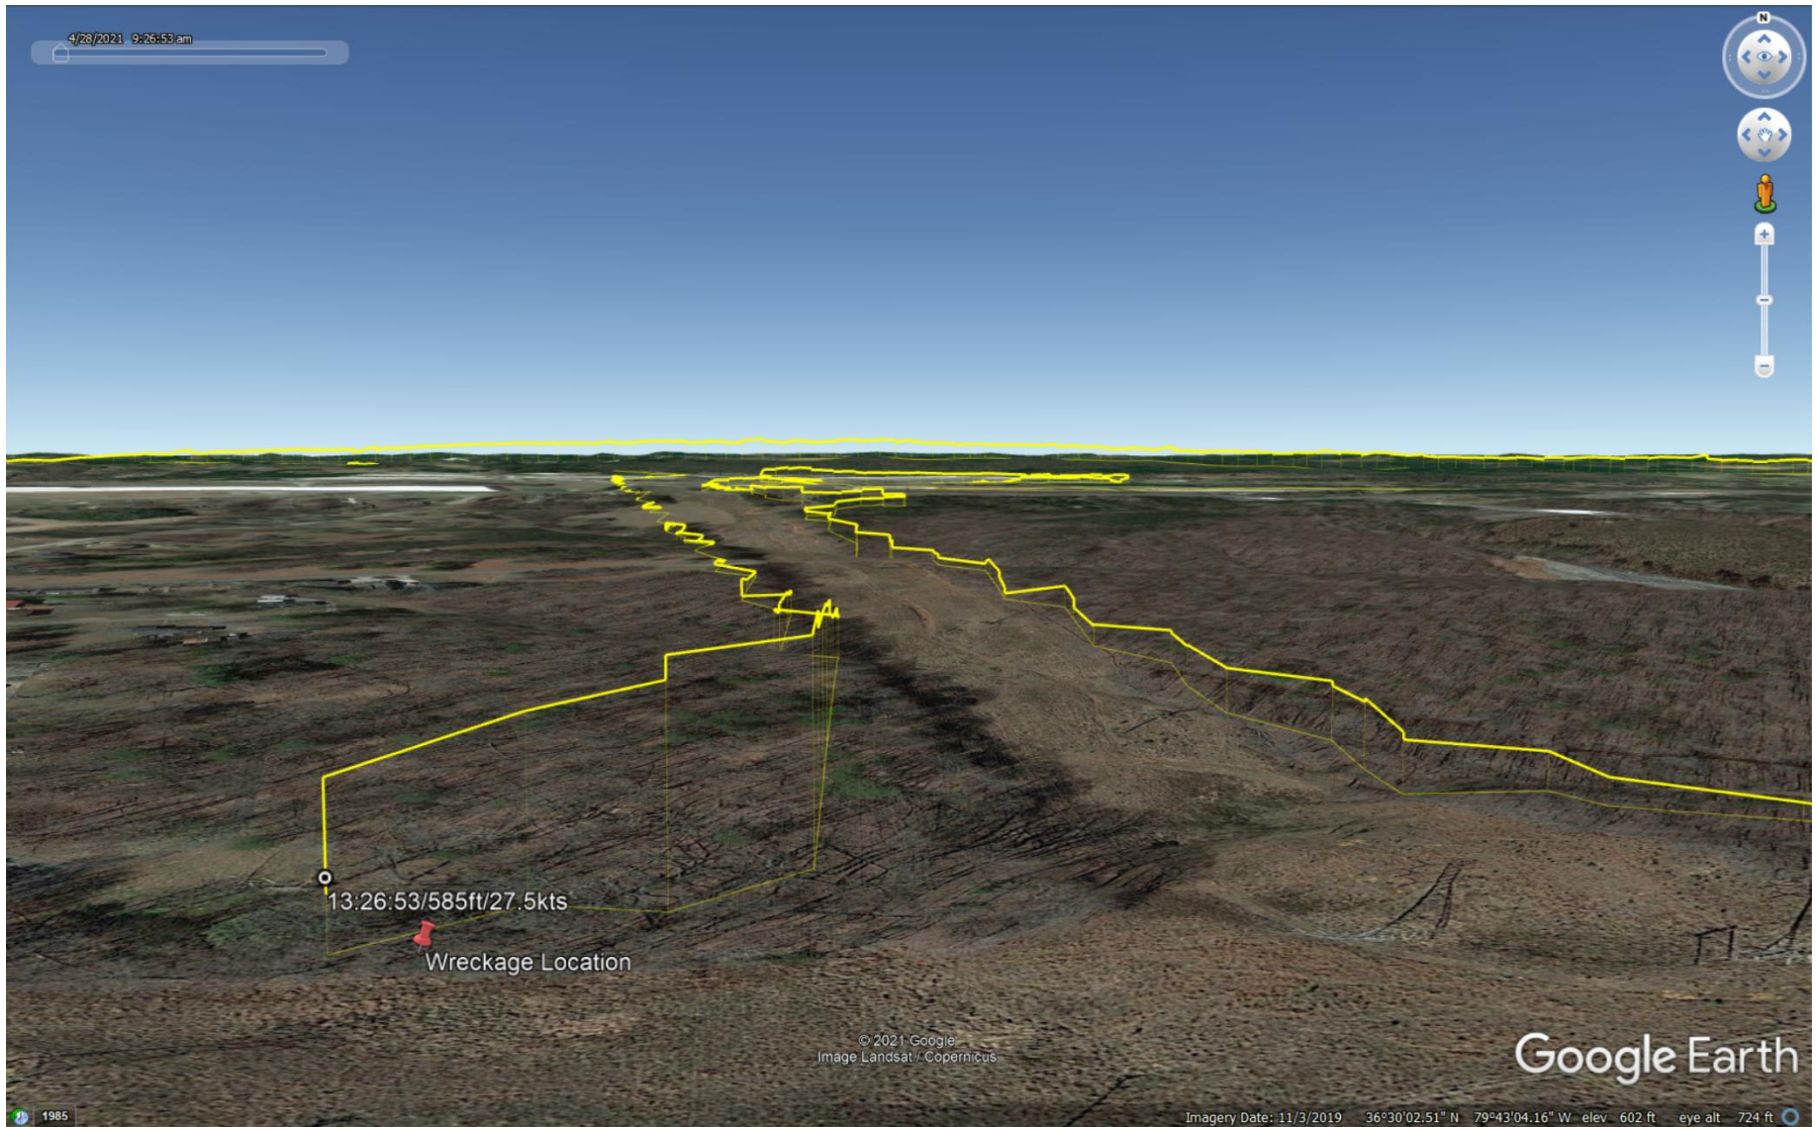
Figure 12: Google Earth overlay of the end of the accident flight with north up view.
