**Piper Aircraft, Inc.**  
2926 Piper Drive  
Vero Beach, FL, U.S.A. 32960

# SERVICE NO. 1375 BULLETIN

### PERIODIC REPLACEMENT OF MAIN LANDING GEAR ATTACHMENT HARDWARE

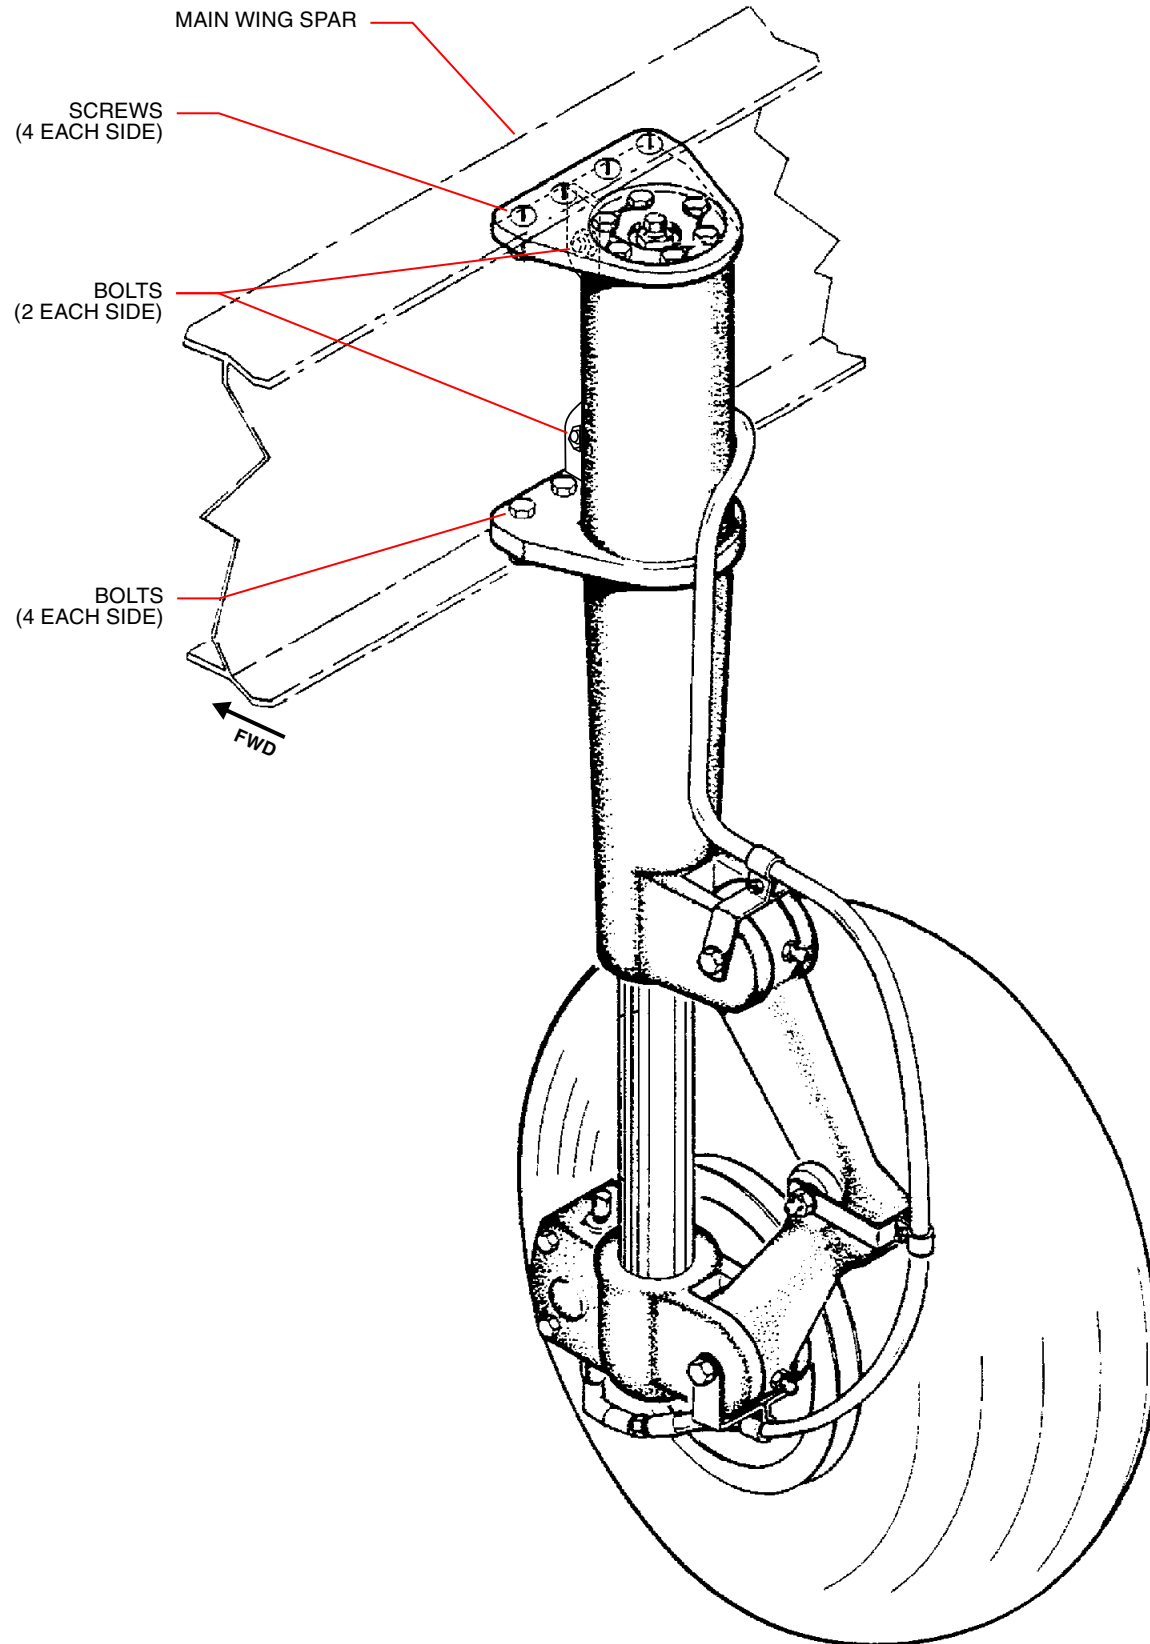
**Figure 1**  
Main Landing Gear – Mounting Hardware

A review of service history reveals that for the affected aircraft, the landing gear mounting hardware is subject to metal fatigue and corrosion. Failure of this hardware could result in a landing gear collapse.

The main landing gear (MLG) are attached to the aircraft with threaded fasteners that pass through mounting flanges on the strut cylinder and the upper and lower flanges of the main wing spar, as depicted in the illustration below. On some of the affected aircraft, additional threaded fasteners pass through the web of the main wing spar.

**MAIN LANDING GEAR (TYPICAL)**  
RIGHT SIDE SHOWN (LEFT SIDE OPPOSITE)

1. Place the aircraft on jacks.
2. Remove the fairing from around the cylinder housing and the access plate located on the bottom of the wing and to the rear of the housing by removing attaching screws.
3. Remove and discard all of the threaded fastener stack ups (which includes screws and bolts, as well as nuts and washers) that attach the MLG to the main wing spar. (See Figure 1.)
4. Inspect mounting holes and mating surfaces of MLG and main wing spar for damage, and repair or replace on condition.

5. Order and install new mounting hardware, as specified in the applicable Piper Airplane Parts Catalog (IPC).
6. Reinstall the access plate onto the bottom of the wing and the fairing that surrounds the cylinder housing.
7. Remove the airplane from jacks.
8. Make a logbook entry documenting compliance with this service bulletin.
