**MANDATORY**  
**SERVICE BULLETIN**

DATE: December 1, 1997 Service Bulletin No. 505B (Supersedes  
Service Bulletin No. 505A) Engineering  
Aspects are FAA Approved

SUBJECT: Inspection of Crankshaft I.D. for Corrosion

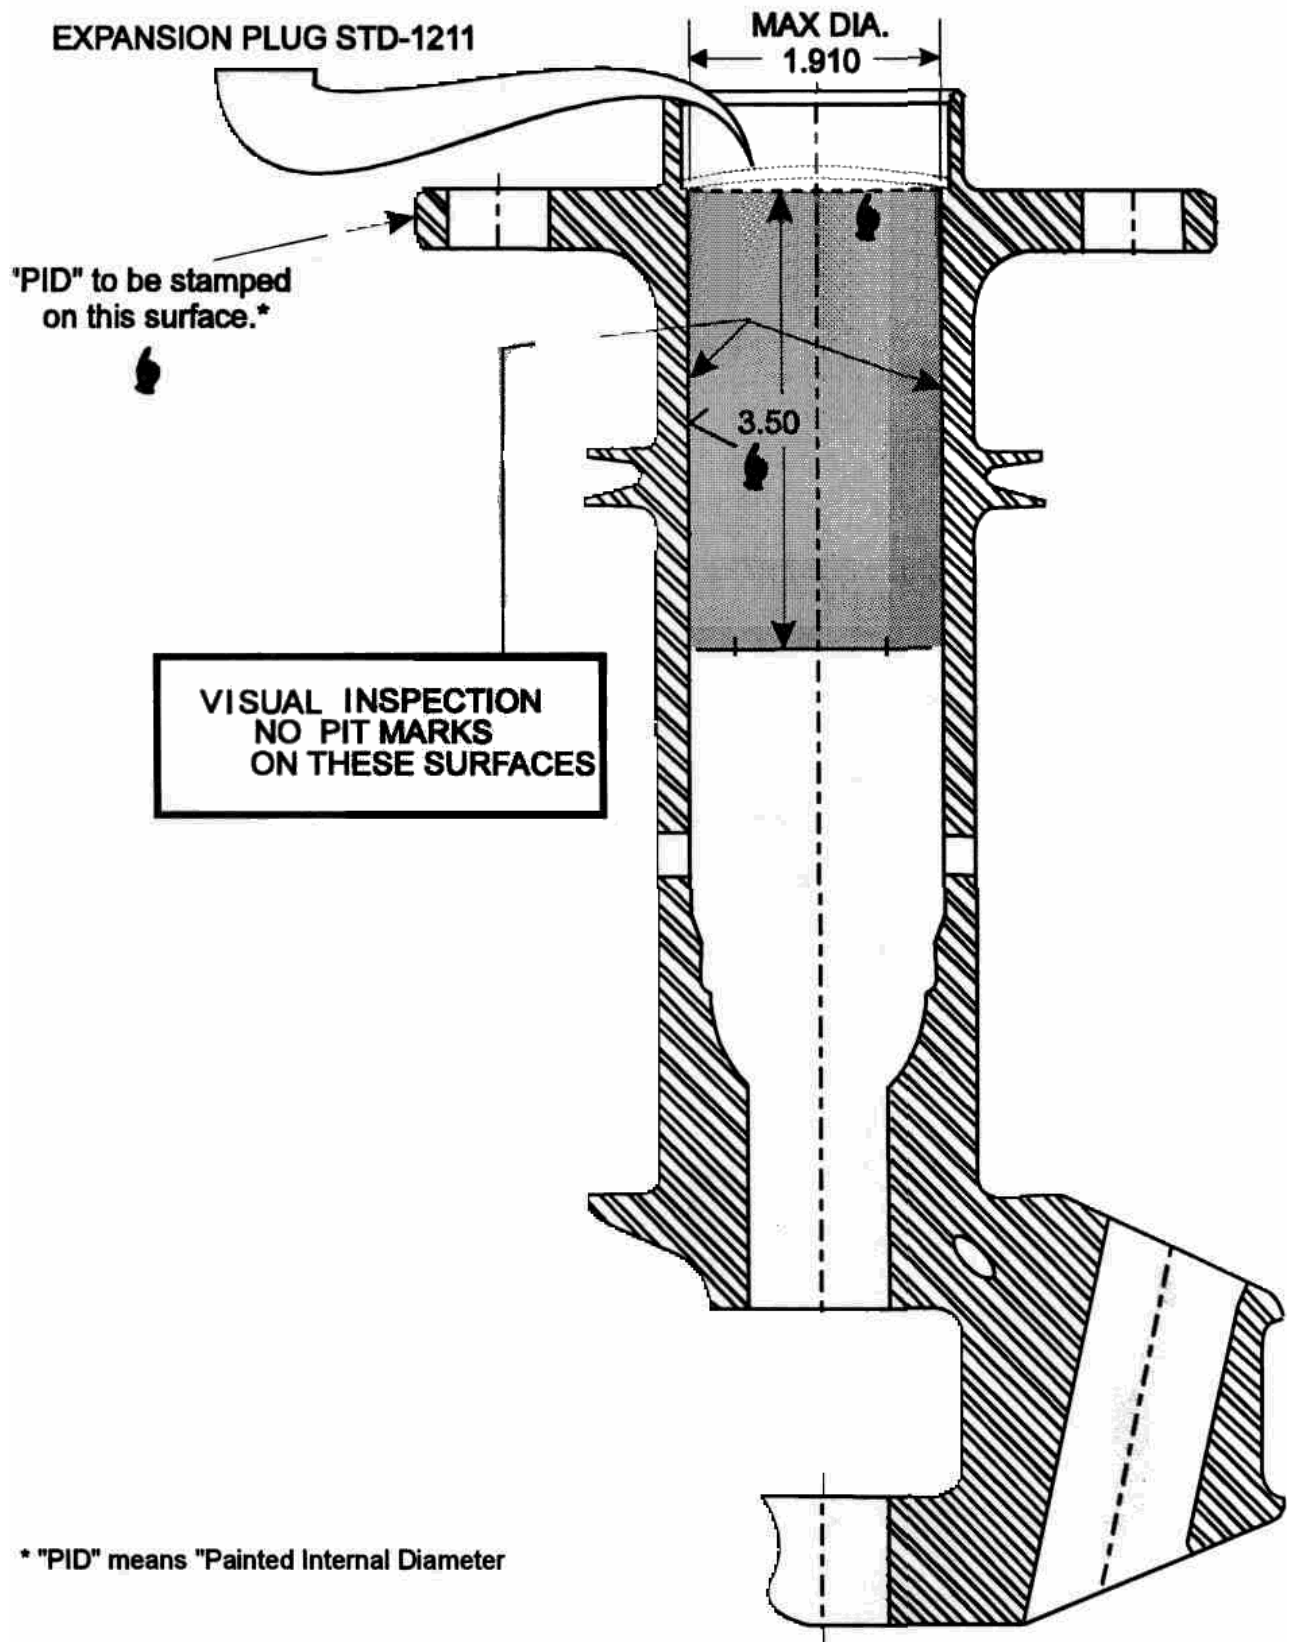
Figure 1. Area to be Inspected

TIME OF COMPLIANCE: **Uncoated Crankshafts (no "PID" stamped on flange OD, see Figure 1)**

- e. Make a visual inspection from the crankshaft flange inward using a flashlight and magnifying glass (power 4x). A small, right angle, dental examination mirror might be helpful. The above defined area should be clear of pit marks and corrosion.
- f. If during visual inspection any pitting resulting from corrosion is found, the crankshaft must be removed from service immediately or subjected to FPI according to Section II of this Service Bulletin on page 3. Removal of corrosion results in a clean surface that may have an irregular appearance indicated by slight waviness. This condition is deemed acceptable provided the maximum allowable diameter has not been exceeded. Pitting is characterized by holes or fissures of indeterminate depth and direction.
