**SURVIVAL FACTORS GROUP CHAIRMAN'S  
FACTUAL REPORT**

**Schoharie, NY**

**HWY19MH001**

**NATIONAL TRANSPORTATION SAFETY BOARD  
OFFICE OF HIGHWAY SAFETY  
WASHINGTON, D.C.**

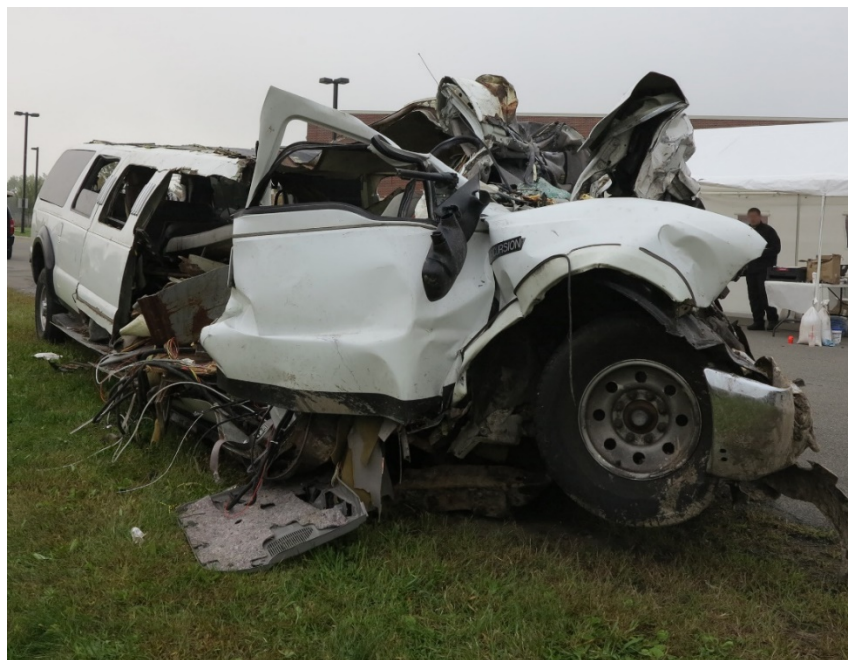
The limousine sustained severe impact damage at the front, with the passenger (right) side displaced towards to the left, as shown in Figure 5. The right front fender and door remained attached but with severe impact damage. The hood was crushed and resting above the engine, which had been displaced aft and into the front seating area, as shown in Figure 6. The driver (left) side fender and driver door were crushed and partially attached, hanging off the left side and above the front axle.

Figure 5: Passenger side view of the postcrash 2001 Ford Excursion limousine (source NTSB)

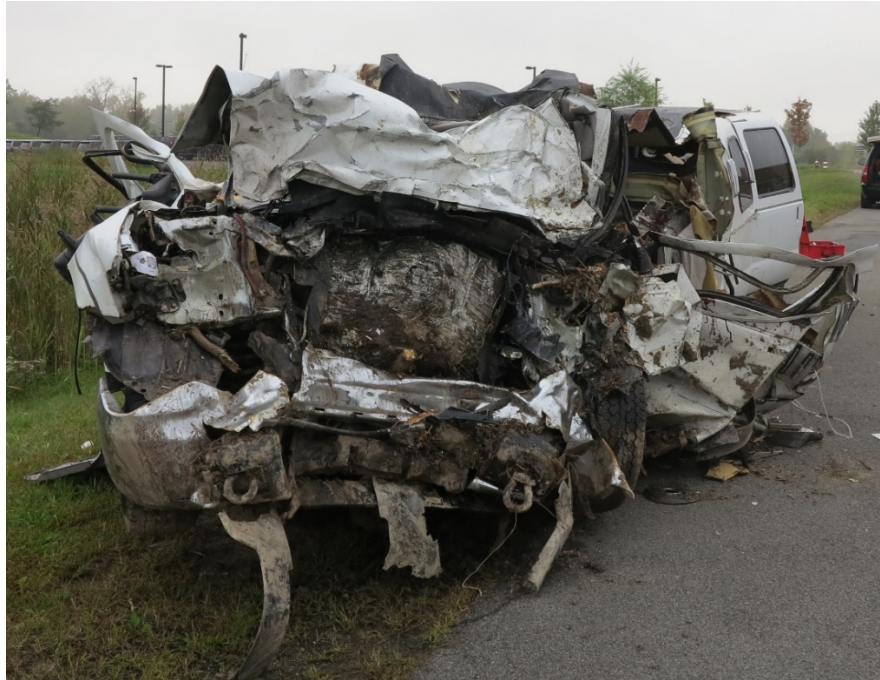
Figure 6: Front View of the postcrash 2001 Ford Excursion limousine (source NTSB)

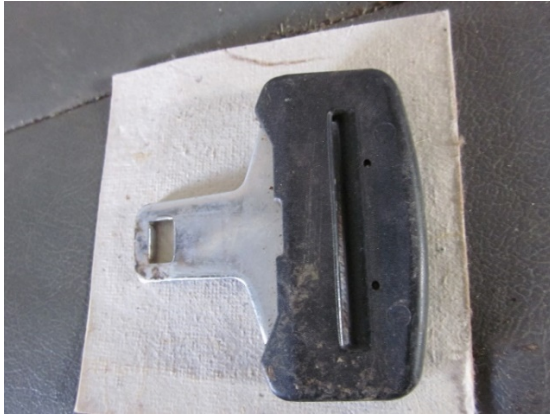
The driver seat pan was separated from the backrest upon examination, and it was reported that the emergency responders removed the driver seatback to gain access to the driver who was trapped between the seatback and the steering wheel. The seat pan was found partially attached to the floor, which was deformed to a nearly vertical angle and displaced aft into the front portion of the passenger cabin. The seatback was found in the passenger compartment of the limousine. The driver seat belt buckle assembly remained intact, and the seat belt connector was displaced. A seat belt connector from one of the front seats was found as shown in Figure 10, although it was unknown if it was from the driver or front passenger seat. The upper mounting bracket and attachment bolt of the seat belt was found near the driver seat pan, and the bolt threads did not exhibit signs of deformation. The section of belt attached to the upper bracket exhibited a tension failure pattern with the outer edges of the webbing longer than the middle. The inertia reel was mounted on the lower portion of the displaced B-pillar, the cover was missing, and the seat belt webbing was torn in an opposite pattern exhibited by the webbing attached to the upper bracket.

Figure 10: Front Seat Belt Connector

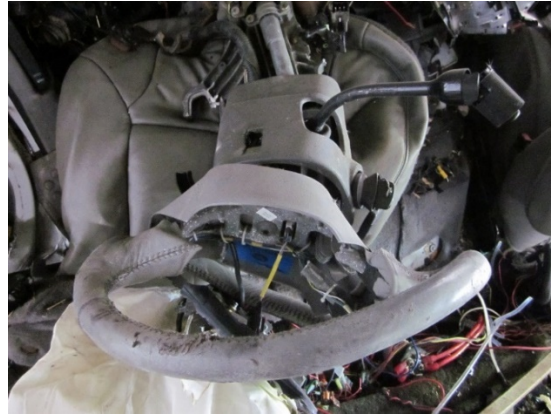
Figure 11: Steering Wheel

The dashboard was displaced aft and in contact with the underside of the driver seat pan. Portions of the deployed driver airbag were visible in the debris. The steering wheel is shown in Figure 11. Note that the steering wheel and other steering components were moved in order to access portions of the vehicle during the mechanical inspection. The driver airbag measured 21 inches in diameter and there was blood and biological material on the front surface.

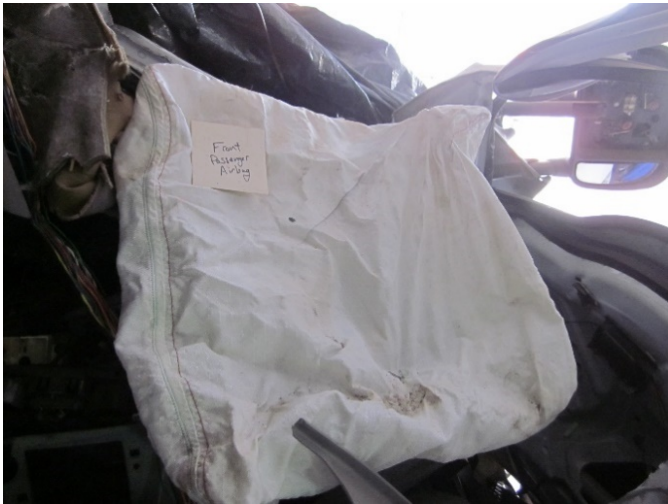
The deployed passenger airbag was visible on the deformed dashboard, as shown in Figure 12. The front passenger seatbelt was visibly attached to the inertial reel which remained attached to the lower B-pillar, and the trim panel was partially displaced as shown in Figure 13. The upper attachment of the front passenger seat belt was not located, and the upper half of the B-pillar was cut and displaced. The front passenger seat, airbag, and belt did not have evidence of being occupied at the time of the crash. The front passenger seat belt had damage consistent with responder cutting operations which occurred in this vicinity. The passenger side airbag measured 22 by 22 inches.

Figure 12: Passenger Airbag

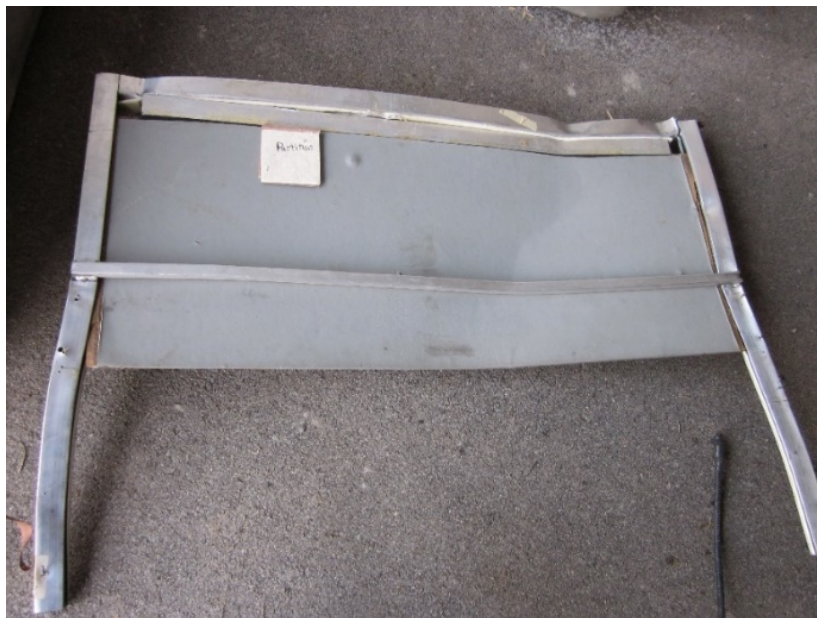
The privacy partition was displaced, a portion was found in the debris pile, and separated out by the NYSP, as shown in Figure 14. The partition measured 45.5 inches wide by 20.75 inches tall. It exhibited deformation on the upper portion, located 35 inches from the left (driver side) edge, and deformation at the center bar of partition 28 inches from the driver side edge.

Figure 14: Passenger privacy partition

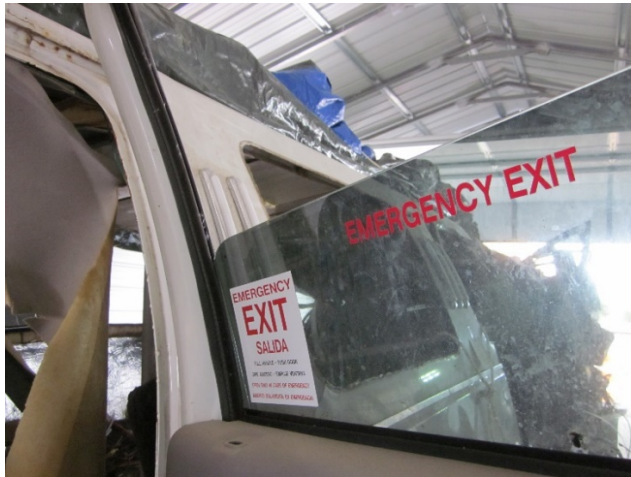
The left rear OEM doors were intact. The left rear door would not fully close due to damage at the forward surfaces. The right rear door was functional. Both doors were labeled as emergency exits, as shown in Figure 15. The rear doors had child locks (found unlatched) located near the door latches and included labels describing their use, as in Figure 16.

Figure 15: Right Rear Door

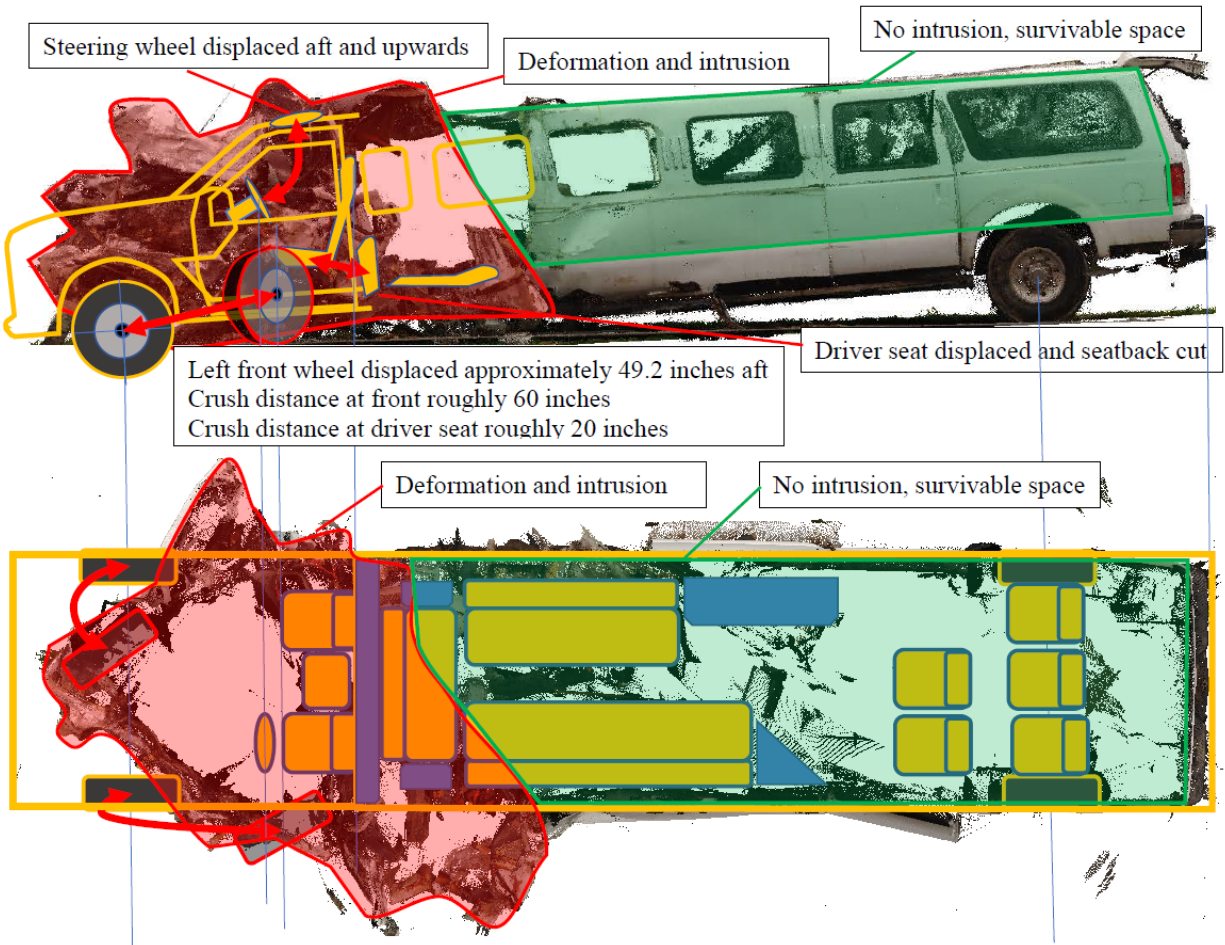
The limousine rear passenger compartment was inspected for evidence of intrusion, structural failure, or collapse. The left front portion of the compartment had an area of intrusion extending roughly 4 feet aft at the outer driver side (left sidewall). The intrusion was less further inboard and near the roof. Sections of the roof and both the driver and passenger sides were cut away. Aft of the intrusion zone, the roof, sidewalls and floor exhibited localized deformation, there was no evidence of major intrusion or collapse of the structure. The basic shape of roof line, sidewalls and floor were intact. The structure of the original passenger cabin interfaces with the stretched portion, and structure of the stretched portion and were intact. The aft, OEM portion of the limousine exhibited relatively minor deformations and was structurally intact.

The 3-D scan images previously shown were used to illustrate the post-crash condition of the limousine as compared to the estimated dimensions pre-crash. Figure 20 shows the driver side followed by an overhead view of the post-crash limousine, with line drawing overlays to show the approximate pre-crash outline and other features of the limousine. The pre-crash dimensions are based on the documentation and dimensional data for a 2001 Ford Excursion.<sup>38</sup>

Figure 20: Diagram of the passenger cabin with rear passenger cabin with approximate outlines of the precrash vehicle body shape and representations of the seats and furniture.

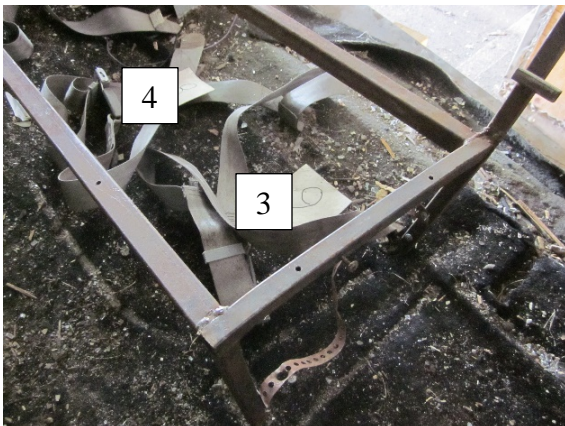
Steel frames from the non-OEM seats were found in the interior. The seat cushions were displaced. The non-OEM seat frames were constructed of welded square tubular steel. The seat pan frame tubes were 1 inch square, and the legs were 0.75 inch square. Typical dimensions for the depth of the seat pan frame was 14.5 inches and the height was 8.5 inches as measured from the floor. The seat pan frames had been mounted to the floor using metal straps and 2 individual screws through the metal strap and then through sheet metal floor pan as shown in Figures 22 and 23. Note that the seat placement number have been revised from the photo to reflect the numbering system used in this report (as opposed to the method used during on-scene inspection).

The metal straps appeared to be common mild steel pipe hanging strap. This type of strap in the 0.75 inch width, is made from 28 to 20 gauge (0.0375 inch) thick galvanized mild steel. The aft facing bench seat frame and the passenger side bench seat frame were attached at the fore and aft legs (no middle leg) through the straps. The driver side bench seat frame was attached at the fore and aft legs through the metal straps. There was also a center leg that rested on the floor, as apparent from floor impressions, but it was not screwed into the floor.

Figure 22: Right side bench seat frame

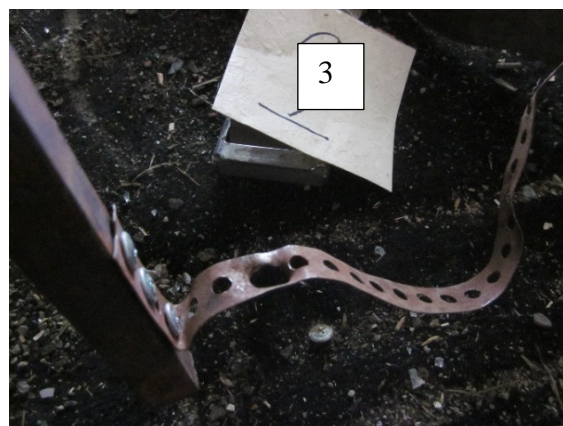
Figure 23: Right side bench seat detail
