SMART TRANSPORTATION DIVISION NATIONAL SAFETY TEAM

BEFORE THE NATIONAL TRANSPORTATION SAFETY BOARD
NTSB Case Number: RRD21MR017

Location: Joplin, Montana

Accident Overview, Contributing Factors, and Safety Recommendations in connection with the derailment and subsequent fatalities that were sustained on September 25, 2021, when Amtrak Train No. 7 derailed near Joplin, Montana

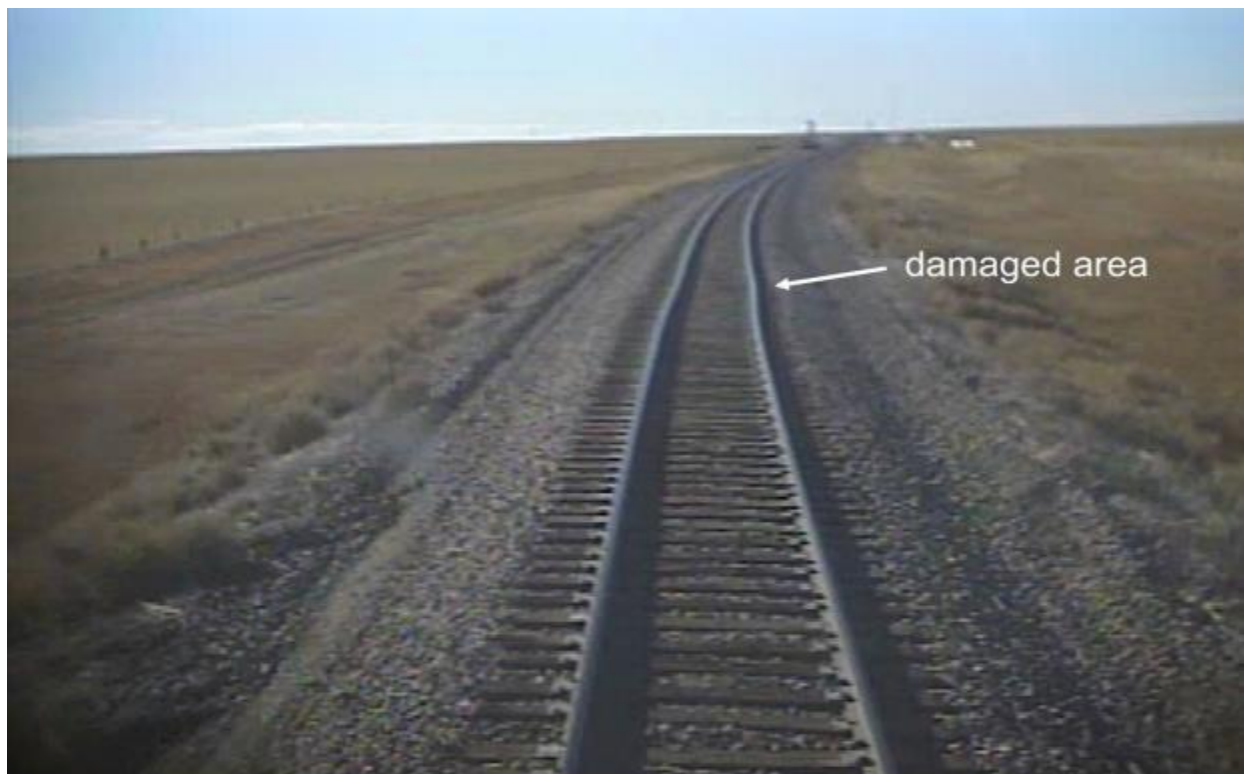
A camera mounted on the lead locomotive windshield recorded video that showed laterally displaced rails ahead of the train. Figure 1 shows one frame from that video. This and other frames from the video were used to estimate the maximum lateral displacement of the rails from their undamaged location. The video was recorded by a March Networks video system.⁸ It had 702 x 240 resolution that the March Networks DVR Player stretches vertically to generate 702 x 480 video for viewing and for video frame extraction. The video frame in Figure 1 is in the 702 x 480 format. The frame rate of the video was 15 frames/second.

Video captured by a locomotive camera was used to estimate the maximum lateral displacement of the right and the left rails and the length of the damaged track section at a location where rail cars derailed. It was estimated that the maximum lateral displacements of the rails were 2.9 ± 1.0 inches, the length of the track where the lateral rail displacements were significant was about 40 feet, and the total length of the damaged track section was about 60 feet.

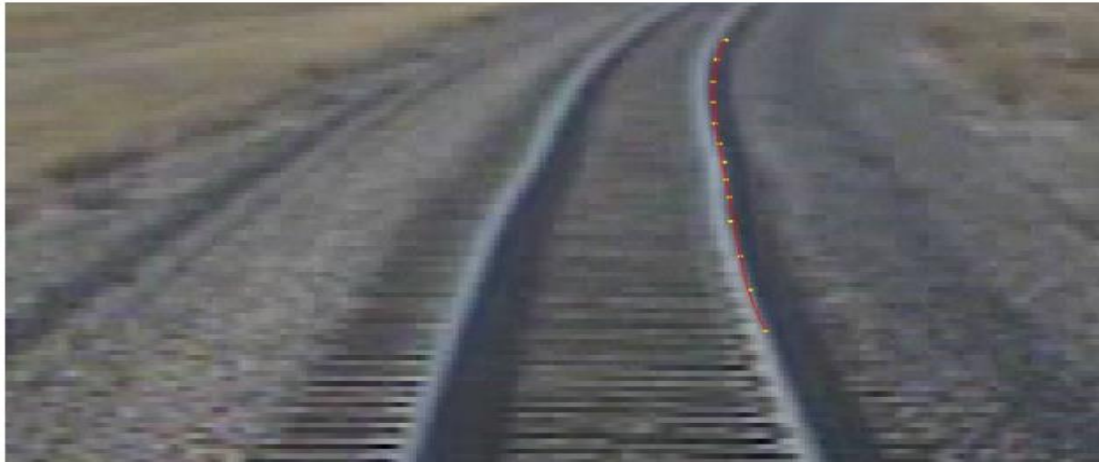
1. Video reviewed from Amtrak was used to determine the distance of shift in the track. In looking at the factual report from the NTSB, it becomes abundantly clear the camera resolution and the frames per second of the camera used on Amtrak Engine No. 7 are relatively low for still imaging. The camera used was March Networks video system. It had 702x240 resolution that the March Networks DVR Player stretches vertically to generate 702x480 video for viewing. The frame rate of the video was 15 frames/second. These specifications are barely usable for determining any useful information in a still picture (See Image 2 on page 11.). This is the second incident this investigator has been involved in where the outward-facing video was crucial in determining what happened during an incident. The train was traveling roughly 78 mph, which equals approximately 115 feet per second divided by 15 frames per second equals 7.5 feet per frame. A

frame-by-frame review shows Amtrak Train No. 7 approaching the track deviation the next frame it is on top of it and no longer visible. Video systems with much higher resolution and more frames per second are readily available and would allow for a more detailed analysis, resulting in a smaller error rate.

Image #2 from Amtrak Train No. 7 depicting track deviation. The lack of resolution is evident.

1. The outward-facing video recorders in their fleet should be upgraded to a modern system with higher resolution and clarity.
2. Passenger cars and locomotives should be equipped with emergency ladders.
3. Emergency lighting needs to be tested and repaired.
4. First aid kits should be audited and supplemented with extra gloves.
5. Additional training should be provided to crew members on how to handle catastrophic incidents.
