# Spirit Of Boston

ON 954835

Explanation of shorted and melted wire in the Machinery Alarm Junction Box or as labeled by the builder as "Alarm Panel" Located in the Engine Room.

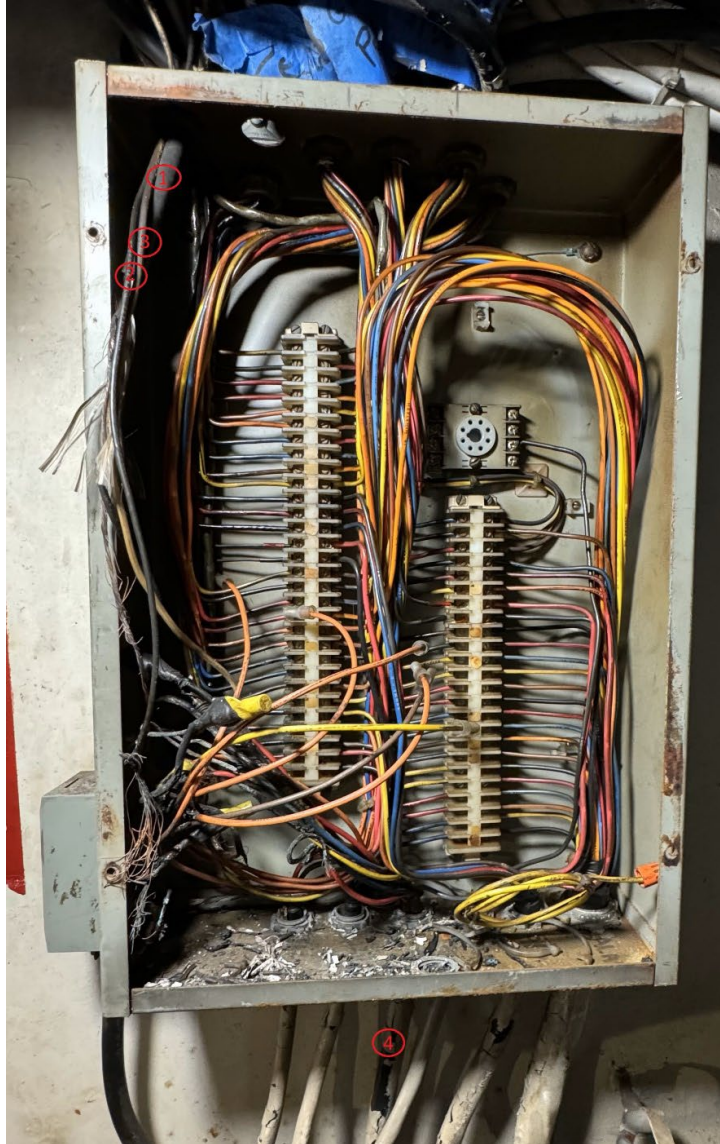
Photo 1- “Alarm Panel” located in the engine room Port side, mounted on the forward-facing side of Tonnage frame 60.

- Photo 1, Wire 1- This is the suspect wire that was found to be melted by means of a short circuit. It was found to have melted inside and outside of the “Alarm Panel”. This wire was reported by the shipyard crew to have been routed from the “Alarm Panel” to the Port Main Engine starting batteries where it was connected to the batteries and was not fitted with circuit protection and showed signs of melting throughout its length. Photo 2 shows the remains of Wire 1 that was found in the battery box. This wire was then connected to the multiconductor Wire 4 inside the “Alarm Panel”.
- Photo 1, Wire 2- This wire was also found to be melted inside and outside the “Alarm Panel” This wire was reported by the shipyard crew to have been routed from the “Alarm

Panel” to the Port Main Engine starting batteries where it was connected to the batteries and was not fitted with circuit protection and showed signs of melting throughout its length. This wire was then connected to the multiconductor Wire 4 inside the “Alarm Panel”.

- Photo 1, Wire 3- This wire was for an intercom system and was still intact and was routed to the Engine room entrance trunk where it dead ended and not connected to anything. We have reason to believe that there was an intercom device mounted in this area at some point. This wire is connected to multiconductor Wire 4 in the “Alarm Panel”. This wire’s significance is that it proves the identity of the multiconductor Wire 4 in the pilot House.

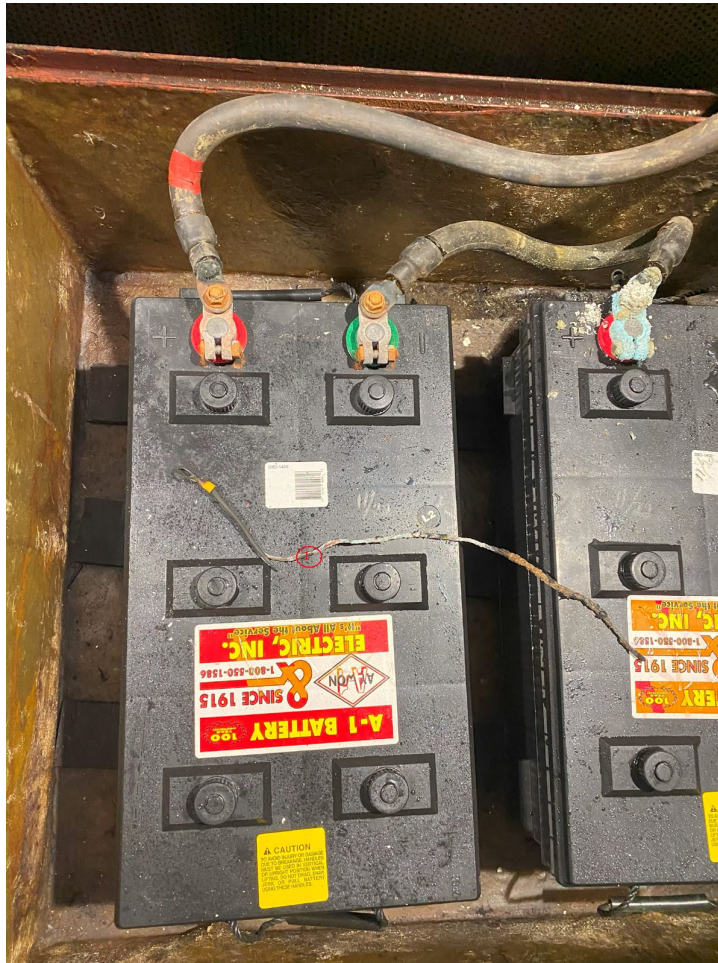
Photo 2- Port Main Engine starting batteries and the remains of Wire 1 Located just off centerline port between BH66 and FR64

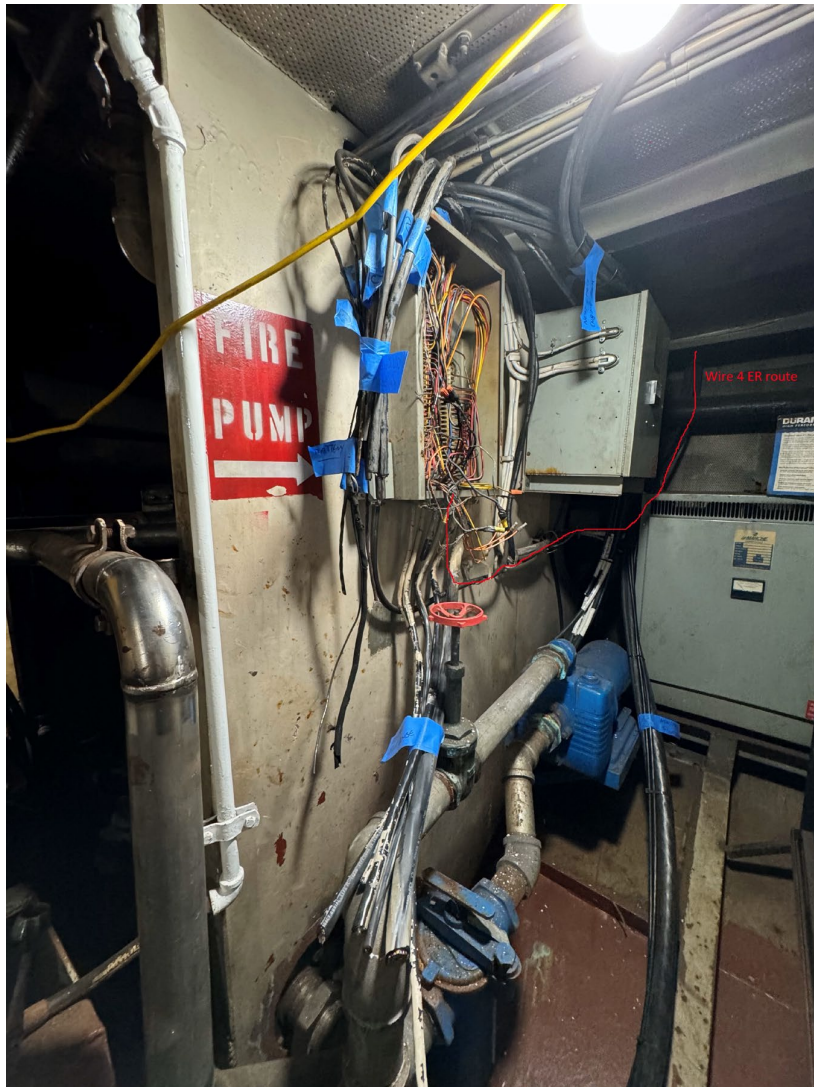
Photo 3- Showing the “Alarm Panel” and route of Wire 4

- Photo 3 shows where Wire 4 leaves the “Alarm Panel” in the engine room on it way up to the pilothouse.
- Photo 4 shows where Wire 4 penetrates the engine room deck head and enters the main deck space.

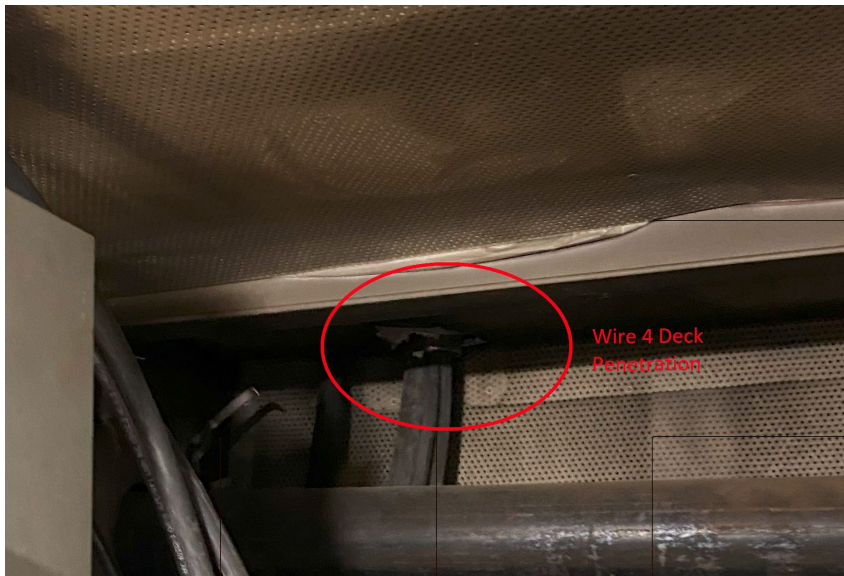
Photo 4- Zoomed version of photo 3 showing the deck penetration of Wire 4

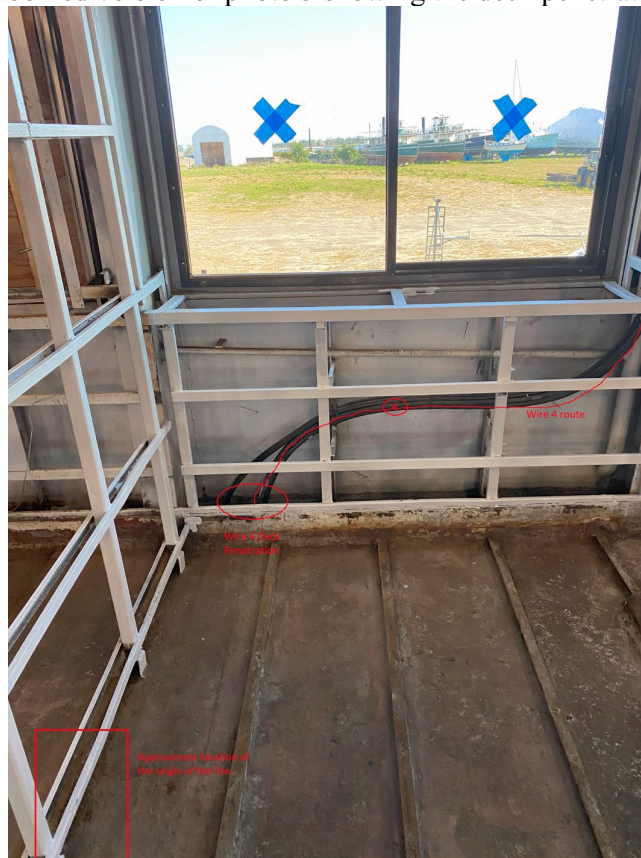
Photo 5- Showing the route of Wire 4 and the origin of the fire. Port side Outboard between FR57-60

- Photo 5 shows where Wire 4 comes into the main deck space entering through the deck inside of the port side outer superstructure bulkhead between FR's 57-60, then leads forward and up through the column dividing the windows to reach the overhead.

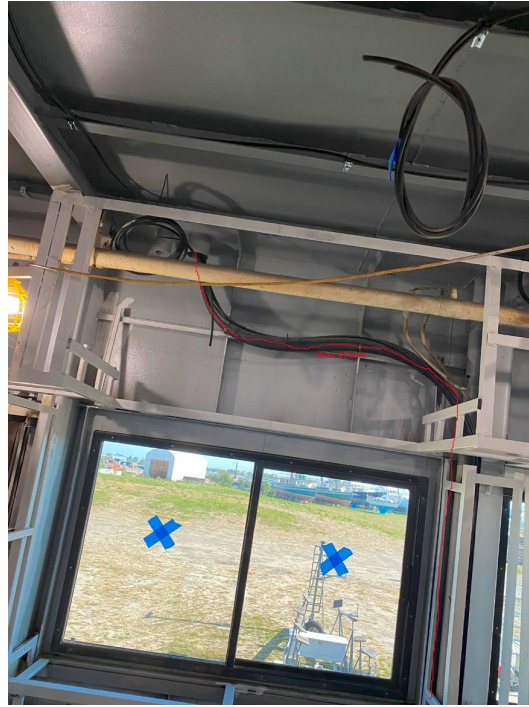
Photo 6- Showing the route of Wire 4 in the overhead of the main deck  
Connecting to Photo 5.

- Photo 6 is an extension of photo 5 showing where Wire 4 continues through the exterior portside superstructure bulkhead into the overhead and through a deck penetration to the second deck leaving the space on its way to the pilothouse.

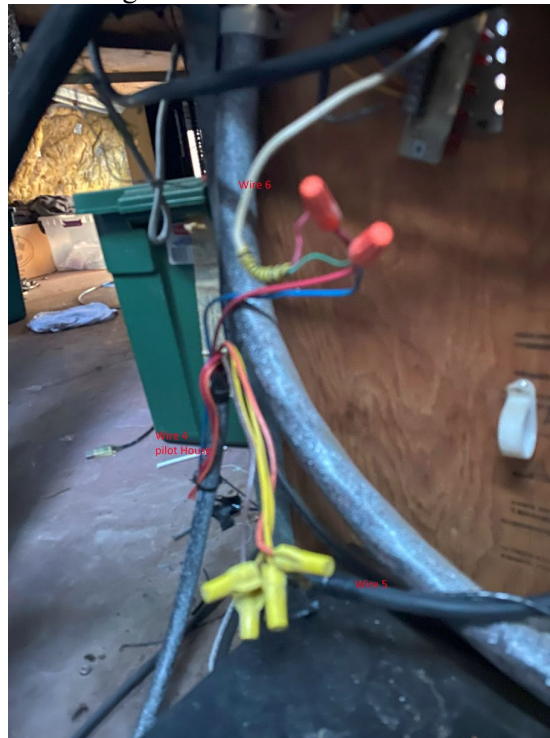
Photo 7- Showing Wire 4 where it terminates under the console in  
The pilothouse.

- Photo 7 shows where wire 4 terminates in the pilot house and feeds wire 5 which continues over to the windshield wiper panel photo 8 where it is providing power to the windshield wiper system from the port main engine starting batteries. You can also see wire 6, which is an intercom wire.

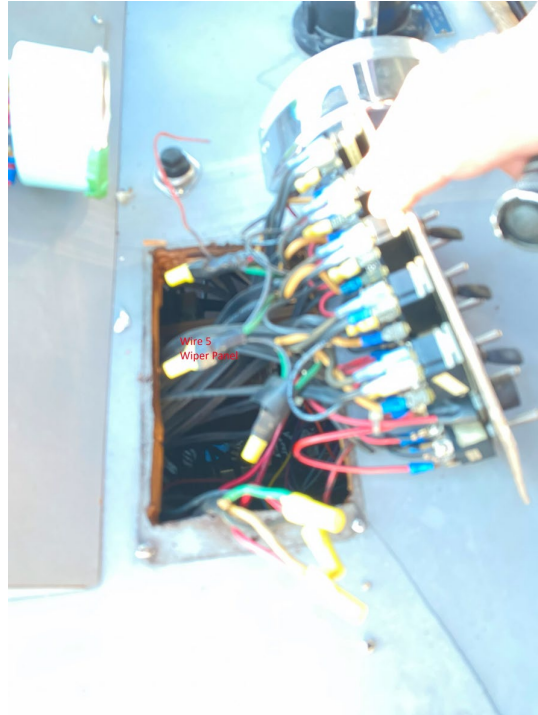
Photo 8- Showing Wire 5 terminating at the windshield wiper Control panel.

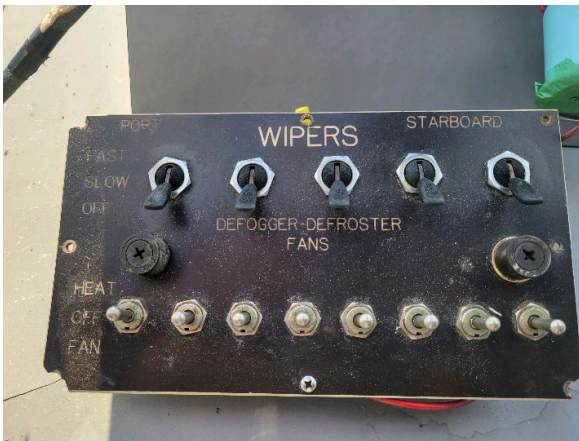
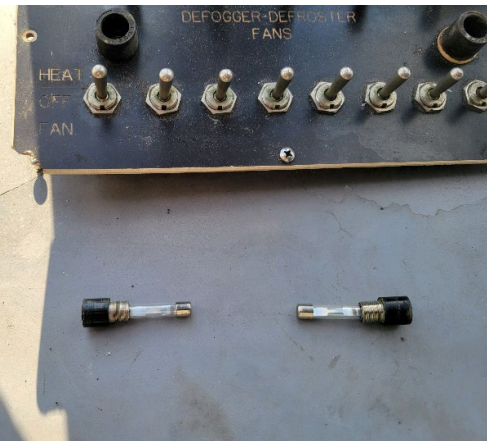
Photo 9 Wiper Panel

Photo 10 Wiper Panel with Fuses

- Photos 9 and 10 show the wiper panel and fuses. The fuses were not blown show that the short must have been downstream prior to the panel and not after the panel. The crew of the vessel would have to be questioned about whether or not the system was functioning prior to the casualty.
