# National Transportation Safety Board

ANC23FA008

## **SEARCH AND RECOVERY**

Group Chair's Factual Report  
Attachment 1 - Points of Interest

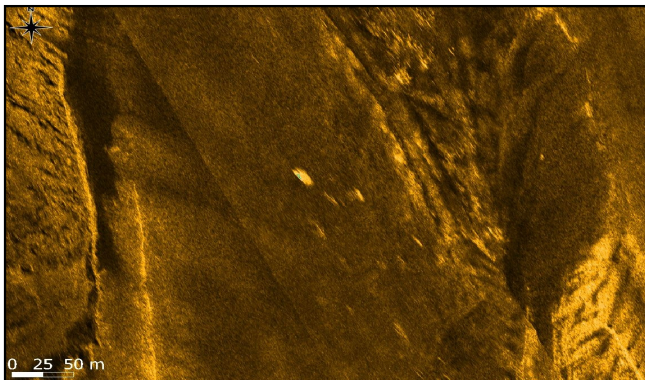
FIGURE 1: Wreckage echo on SSS (75KHz)

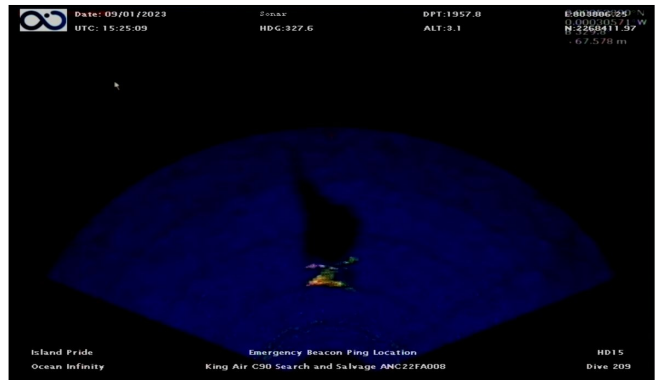
FIGURE 2: Wreckage echo on ROV forward looking sonar

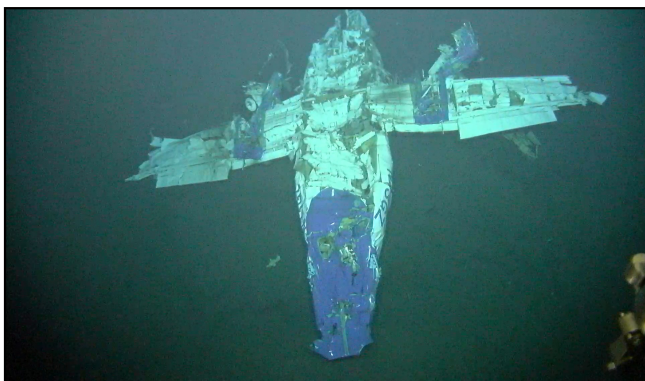
FIGURE 3: POI\_01 Overview of wreck

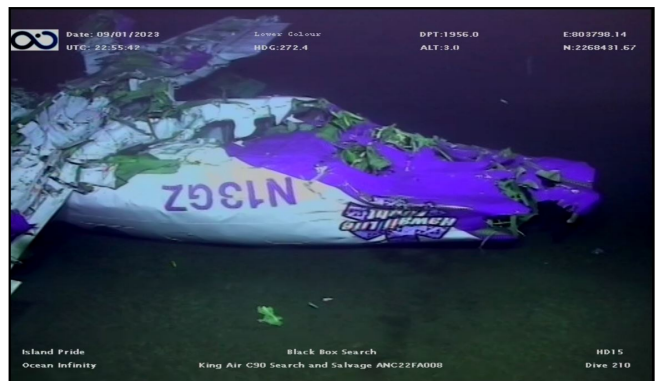
FIGURE 4: Aircraft tail

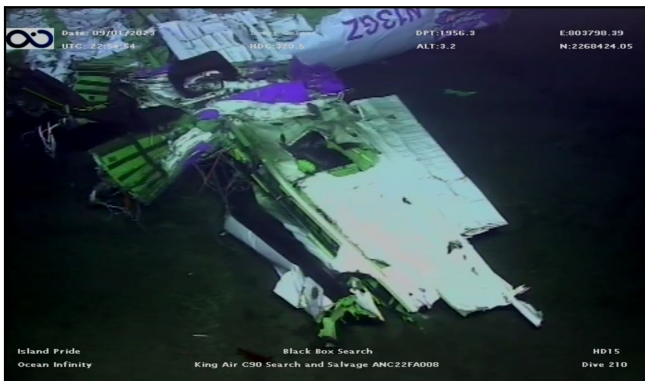
FIGURE 5: Starboard wing

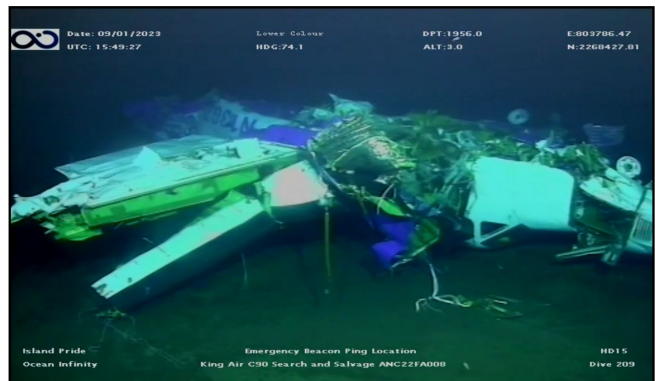
FIGURE 6: Port wing

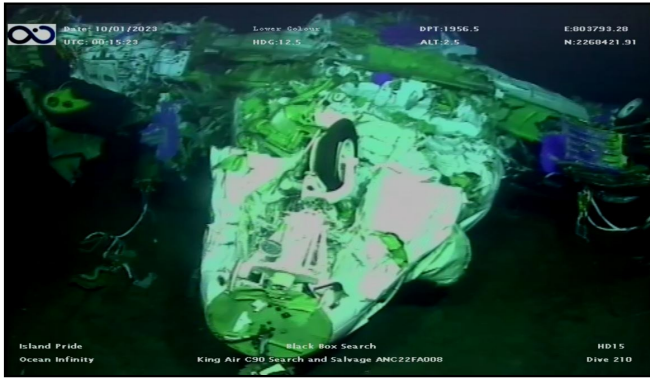
FIGURE 7: Aircraft nose

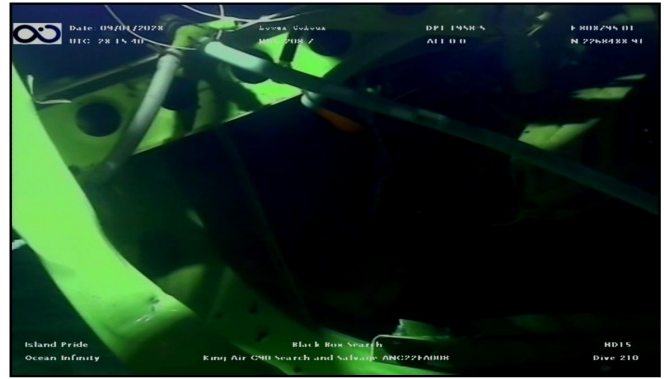
FIGURE 8: Black box identification in tail section

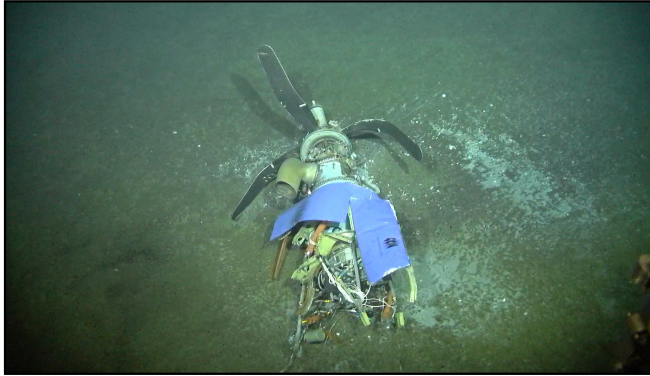
FIGURE 9: POI\_06 Propeller found 114m southeast of wreck

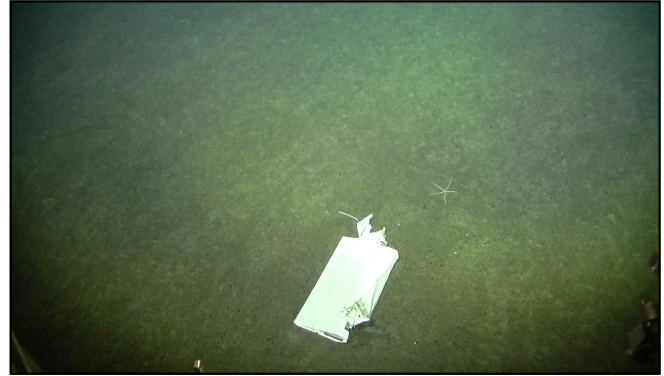
FIGURE 10: POI\_07 Wing Flap found 114m southeast of wreck

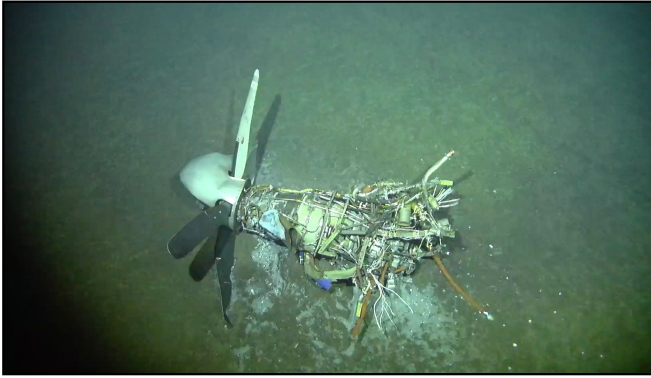
FIGURE 15: POI\_16 Propeller found at 180m North east of the wreck
