SUMMARY OF FINDINGS

Eric M. Gutierrez
Air Safety Investigator
Western Pacific Region

Date: June 29, 2022
Person Contacted: Sergeant Brandon Littrell
NTSB Accident Number: WPR22LA238

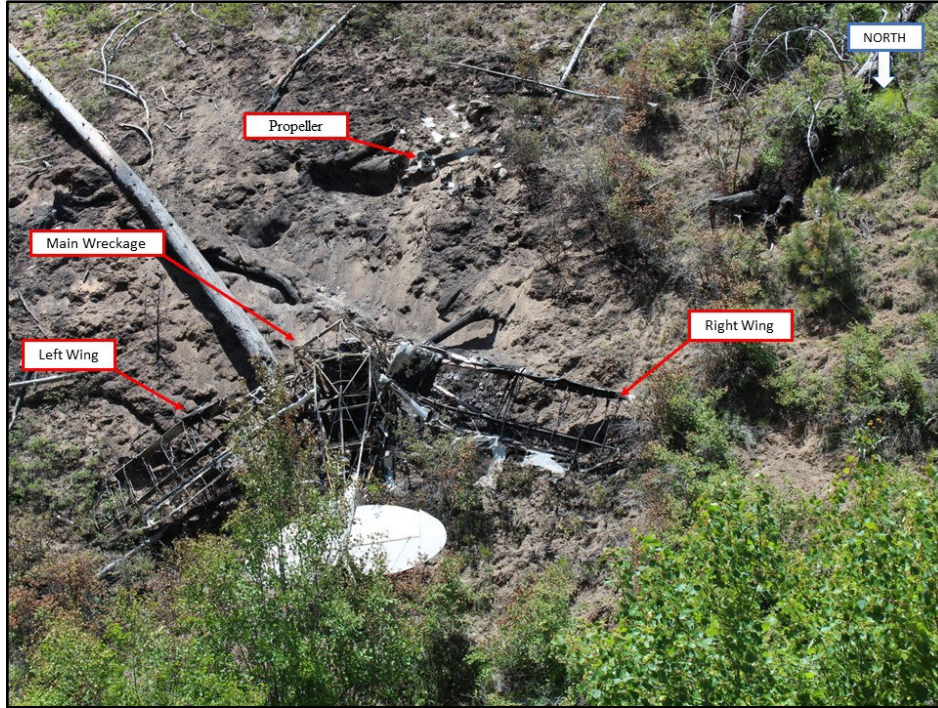
Examination of the accident site revealed that the airplane impacted steep rising mountainous terrain at an elevation of about 6,240 ft mean sea level (msl), in an approximate southern heading. The main wreckage came to rest upright about 30 ft below the initial impact point and was mostly consumed by fire. All major structural components of the airplane were observed at the accident site.

Figure 2: View of accident airplane (photo courtesy of local law enforcement)

The forward section of the fuselage was heavily impact and thermal damaged. The cabin area was heavily impact and thermal damaged. The instrument panel had various instruments separated, impact and thermal damaged. The engine mount had several fractures, consistent with impact damage. The aft section of the fuselage exhibited thermal damage throughout.

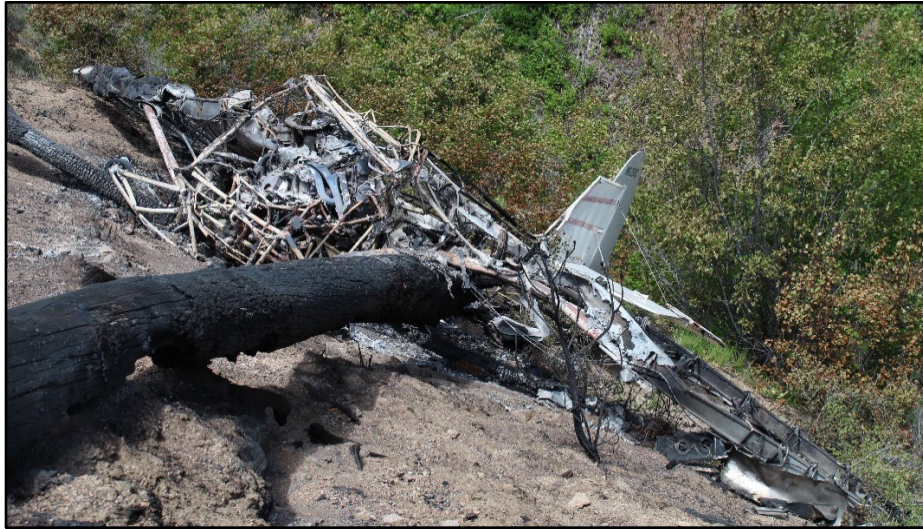
The left wing remained attached to the fuselage. Crushing, bending and thermal damage was observed throughout the wing. The left aileron remained attached via their mounts and thermal damaged.

Figure 3: View of left wing. (photo courtesy of local law enforcement)

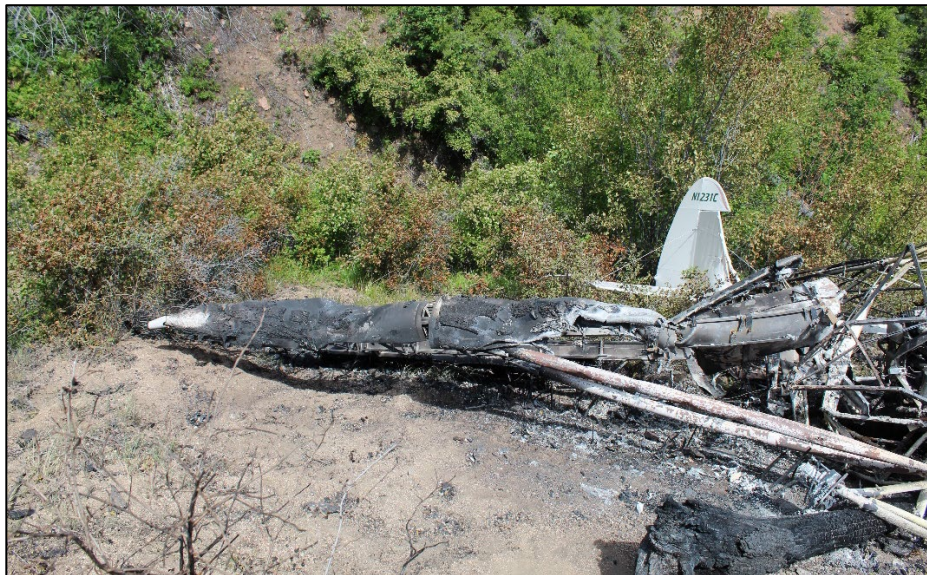
The right wing remained attached to the fuselage. Crushing, bending and thermal damage was observed throughout the wing. The right aileron remained attached via their mounts and thermal damaged.

Figure 4: View of right wing. (photo courtesy of local law enforcement)

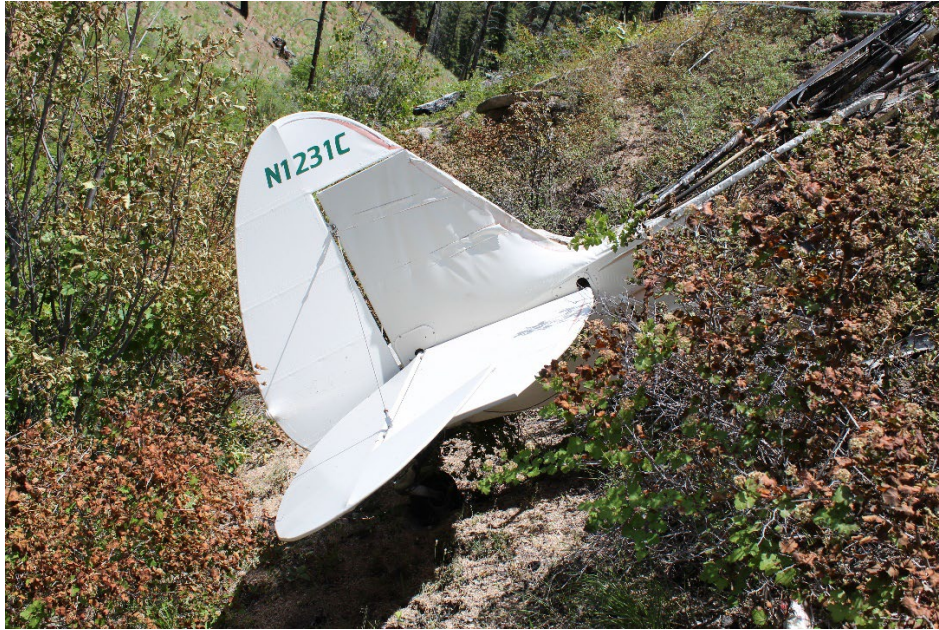
The vertical stabilizer, rudder, horizontal stabilizer, and elevator remained attached and secure to their respective mounts.

Figure 5: View of empennage. (photo courtesy of local law enforcement)

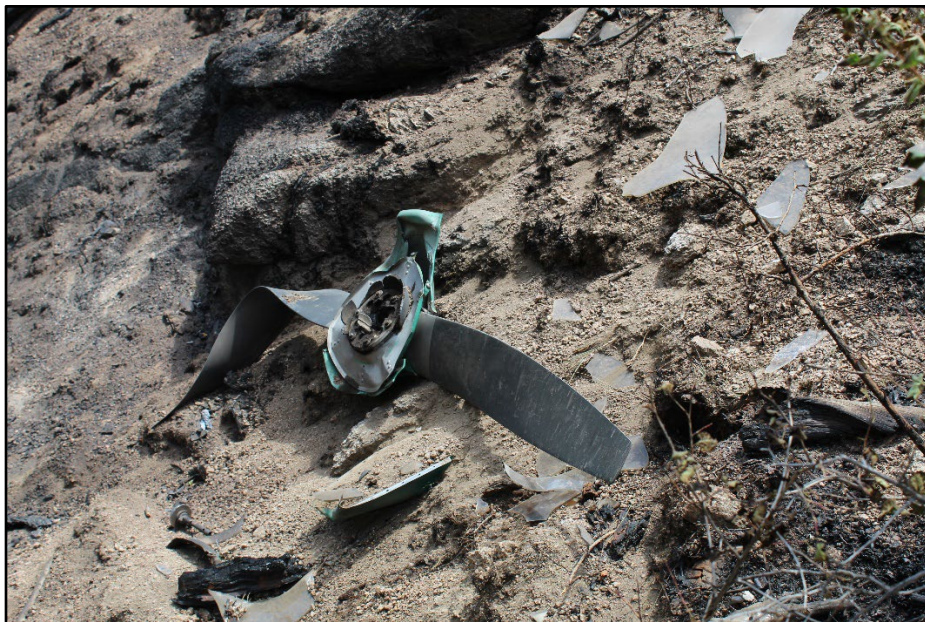
The airplane was equipped with a two blade propeller. The propeller and attached crankshaft flange separated from the engine at the crankshaft. Both blades remained attached to the propeller hub. Propeller blade A exhibited polishing along the leading edge, along with unidirectional striations on the cambered side of the blade. Propeller blade B exhibited S bending mid span, with unidirectional striations on the cambered side of the blade.

Figure 6: View of propeller. (photo courtesy of local law enforcement)
