National Transportation Safety Board

Collision of Revenue Light Rail Train 9 with Maintenance Light Rail Vehicle 310

Mechanical Group Factual

NTSB Accident Number: RRD19FR011
Date of Accident: August 22, 2019
Time of Accident: 9:38 p.m. (WDT¹)
Type of Trains: LRV
Railroad Owner: SACRT
Train Operator: SACRT
Fatalities: 0
Injuries: 27
Location of Accident: Sacramento, CA

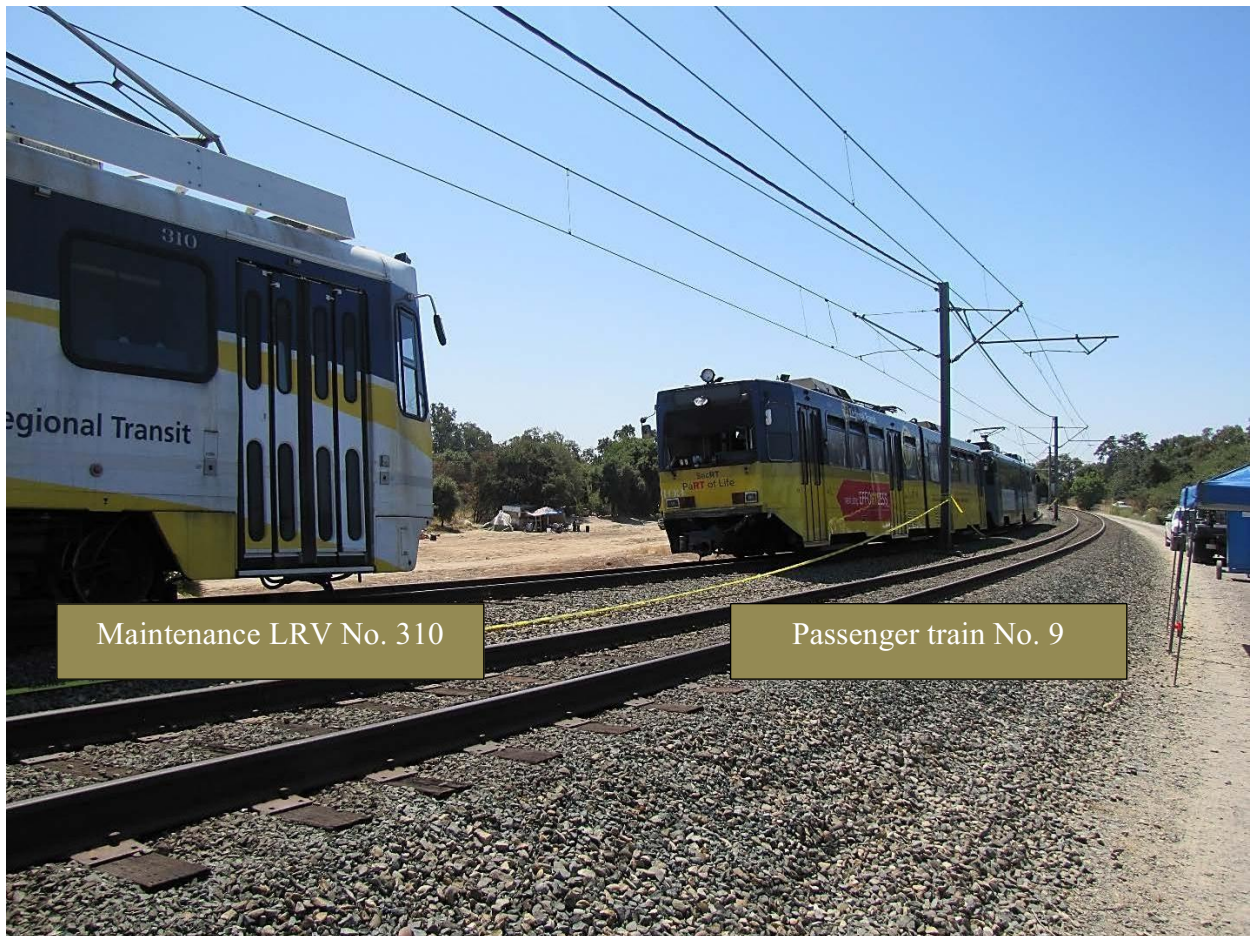
Figure 1. Photograph of train No. 9 and maintenance LRV No. 301 at the point of rest after the collision.

using emergency brakes and one second later was struck by train No. 9. Collision speed is estimated at 32.5 mph.

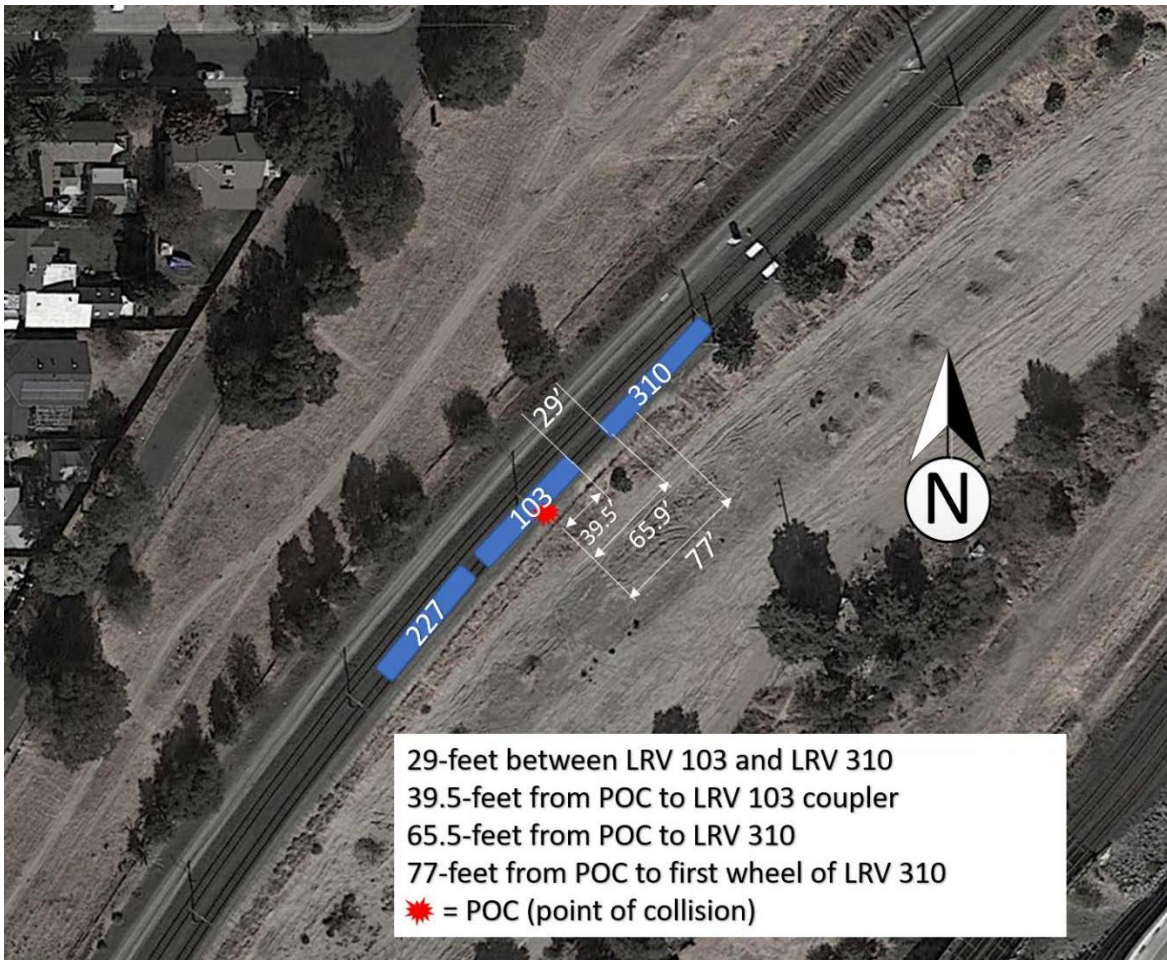
Investigators completed examinations, collected measurements and visual assessments of the damage to the LRVs involved in the collision while the streetcars were still on-scene. When the LRV collided, train No. 9 struck the stopped maintenance LRV 310. The resulting collision shoved LRV 310 north about 65-feet. See accident diagram in figure 2.

Figure 2. Accident diagram.

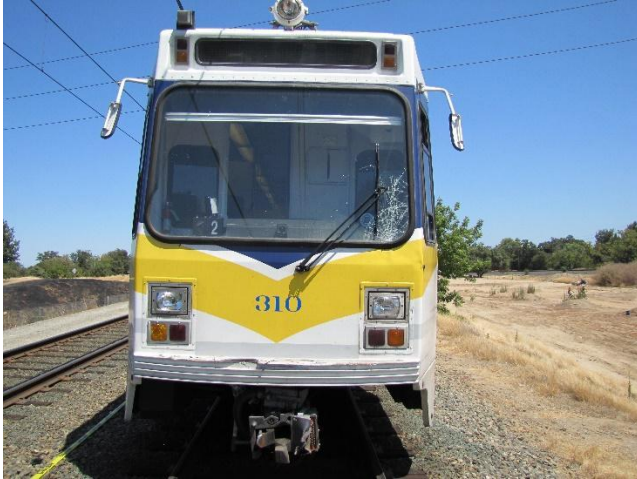
- LRV 310, visible damage visible at the A end. The damage consists of a cracked windshield on both right and left side, coupler and minor damage to the anti-climber in addition to body damage on the front-end structural post on the driver's side.

Figure 3. Leading end of LRV 310.

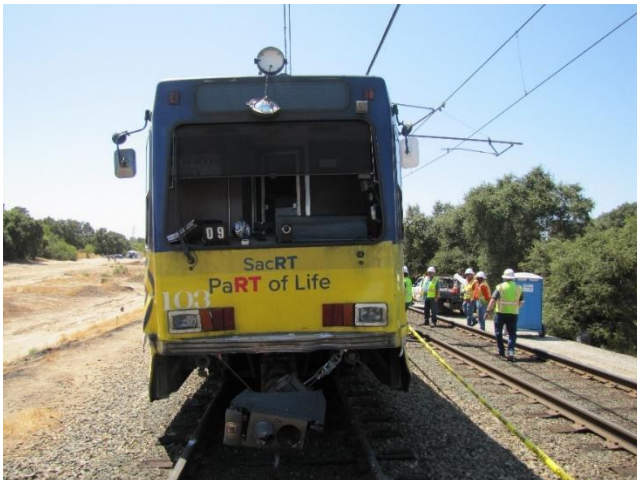
- LRV 103, this LRV sustained major damage. Major damage was sustained to the anti-climber mechanical coupler, front lights and the following right-side components:
 - Underframe
 - Side sill (structural member)
 - Sidewall
 - Windshield

Figure 4. Leading end of LRV 103.
