National Transportation Safety Board

RRD23LR006

SAFETY PERFORMANCE OF WHEELSETS

Specialist's Factual Report
September 21, 2023

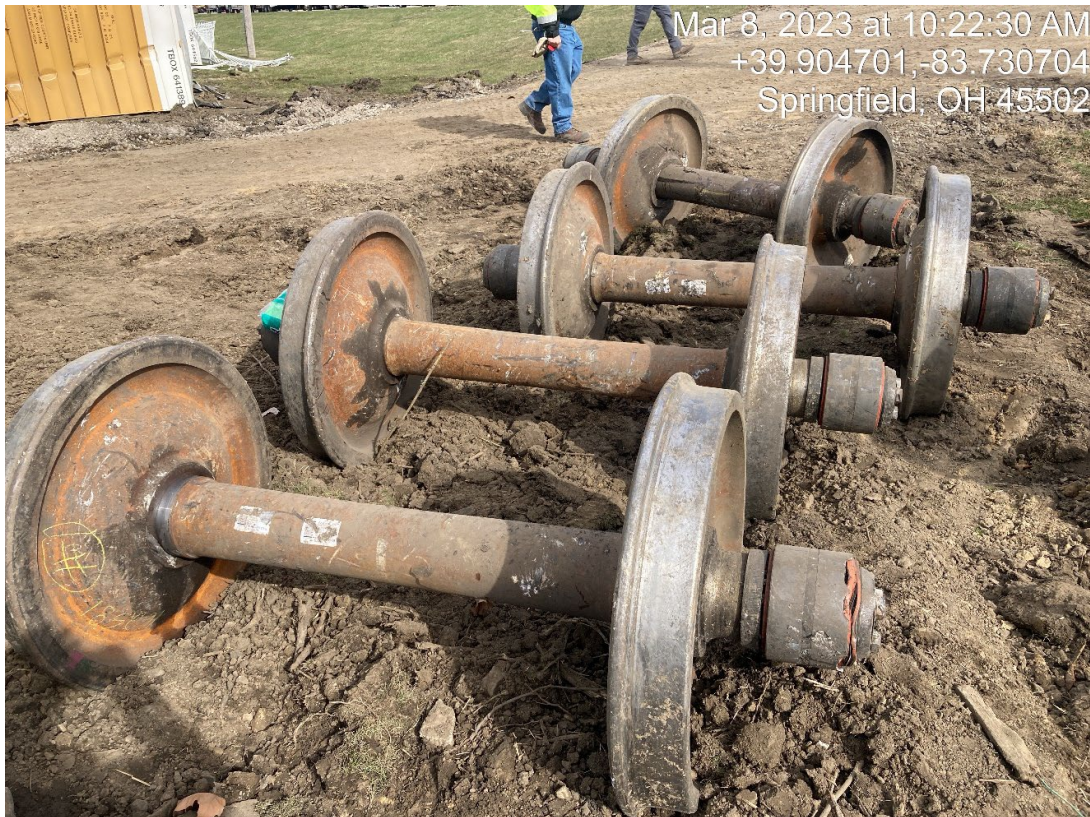
NTSB placed an investigative hold on twelve wheelsets from three cars of the derailed train. The wheels on three of the wheelsets had moved from their seats on their axles during the derailment. Each wheelset held by NTSB was mounted by National Steel Car around the same time as those exhibiting movement on their axles in the derailment.

Figure 1. Wheelsets from car NS 162581 held by NTSB for investigation at the derailment scene.

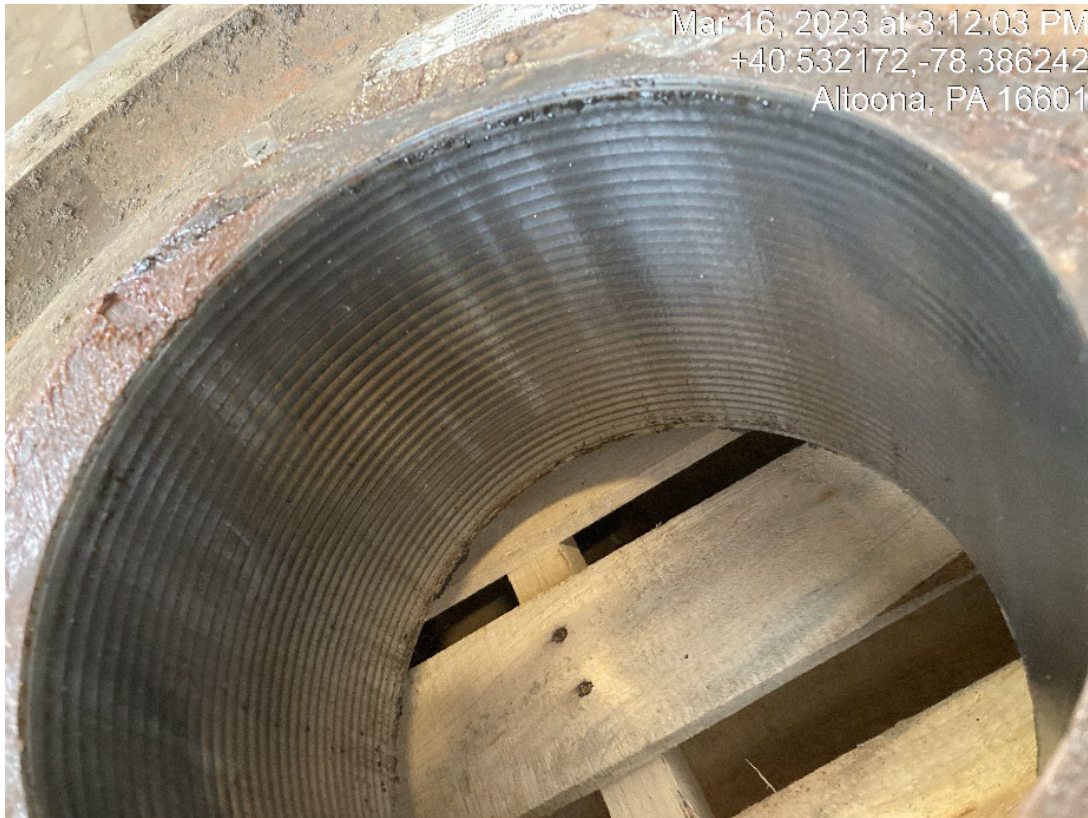
The axle containing wheel 05544 that was completely dislodged in the derailment was cut to remove the dislodged wheel. The mate wheel to wheel 05544 (wheel 05508) was pressed from the axle, and the wheel bore and axle seat of each wheel from that axle were visually examined for evidence of movement on the axle, along with conditions that could lead to such movement, such as fretting. No evidence of movement on the axle prior to the derailment was identified. The wheel bores for wheels with serial numbers 05523, 05987, 07084, 07340, and 05508 from cars NS 162581 and NS 162582 each contained between 31 and 32 machining grooves per bore.

Figure 2. Wheel bore of wheel 05508 from car NS 162581 after being pressed from its axle.

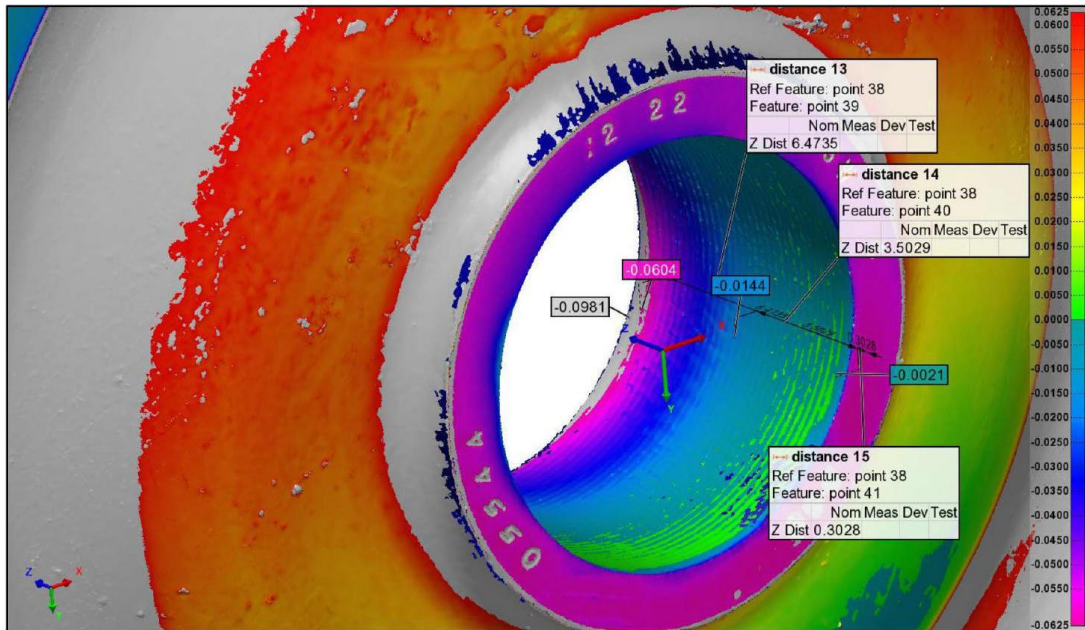
Wheel 05544, which moved off its seat in the derailment, showed asymmetric distortion of the wheel bore on the front side (outboard) and a smaller localized area of distortion on the inside (inboard), directly opposite. A similar pattern of distortion, though of a lesser magnitude than that present on wheel 05544, was present on the outboard front side of wheel 07340, which dislodged in the derailment.

Damage was noted on the rim of wheel 05544, opposite of the area of distortion in the wheel bore. Additionally, damage was present on the bearing end cap on the opposite end of the axle of dislodged wheel 05544.

Figure 3. Image generated during 3D scan of wheel 05544 showing the overall variation in the shape of the wheel bore compared to a 3D model of a nominal wheel. A large amount of distortion on the outboard side is evident. View from inboard side of wheel.
