In the frame of the investigation on the accident of the EC130T2 helicopter, registered N11VQ, that occurred on January 17th, 2016 in Hawaii, Safran Helicopter Engines (formerly known as Turbomeca) produced the following documents:

INVESTIGATION REPORT	Preliminary <input type="checkbox"/> Final <input checked="" type="checkbox"/>
-----------------------------	---

N11VQ ACCIDENT INVESTIGATION

N11VQ – Ruptured Pipe : Additional Examinations & Analyses at SafranHE

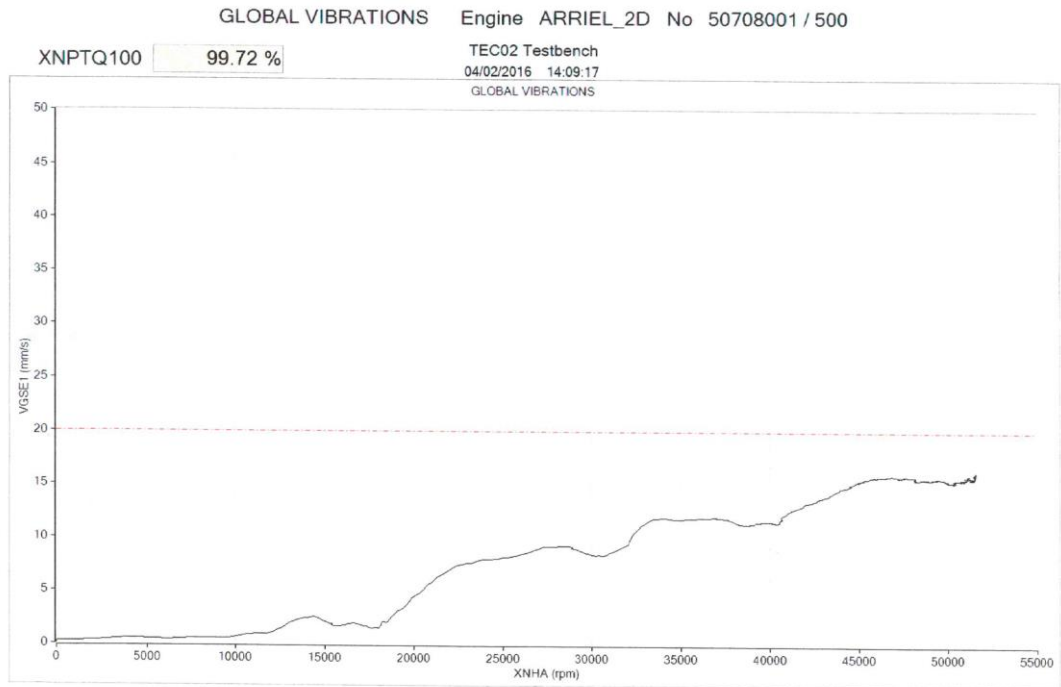
524-03) ACCIDENT STARTER

Global vibration results with accident starter installed.

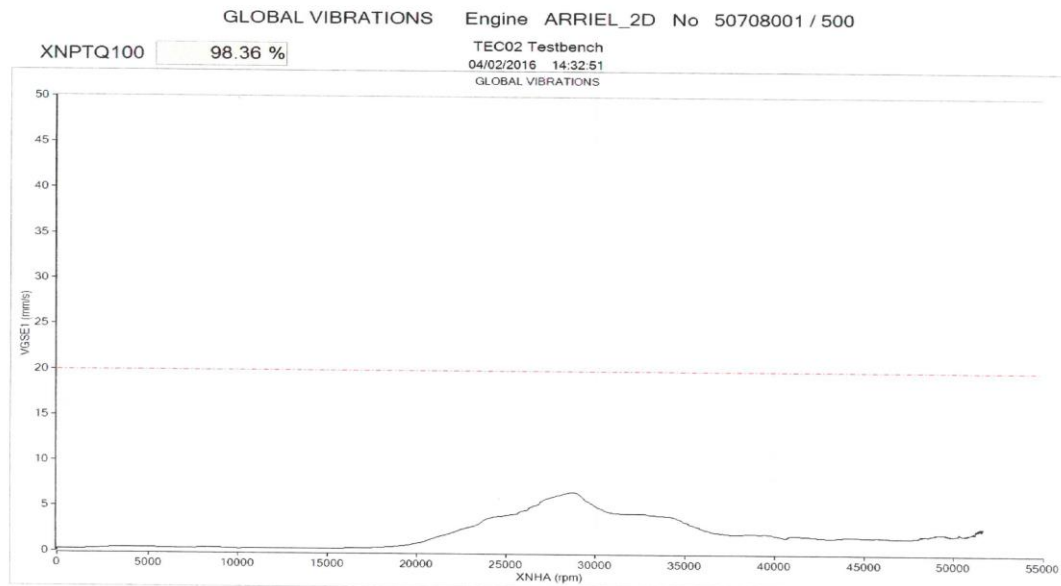
524-03) TEST CELL STARTER

Global vibration results with shuttle starter installed.

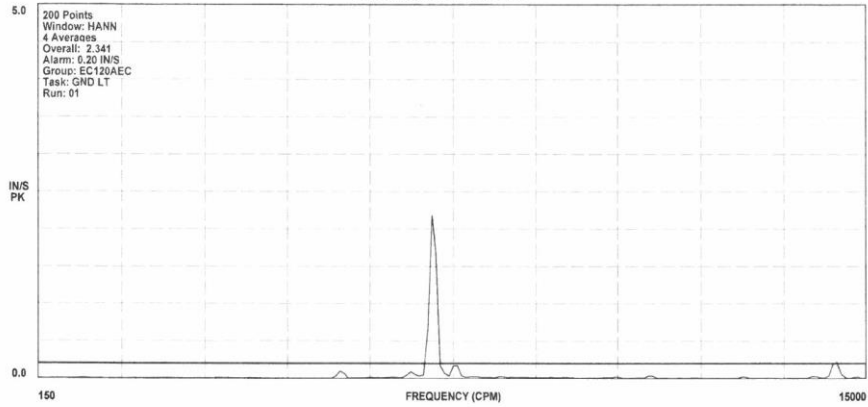
FREQ (CPM)	MAG (IN/S)	ALARM	STATUS	DESCRIPTION	FREQ (CPM)	MAG (IN/S)	ALARM	STATUS	DESCRIPTION
5584.9	0.099	0.200	OK	---	8833.7	0.092	0.200	OK	---
7222.8	2.315	0.200	-WARN-	---	7614.1	0.201	0.200	-WARN-	---
7915.8	0.027	0.200	OK	---	8426.1	0.028	0.200	OK	---
10526.1	0.022	0.200	OK	---	11135.9	0.041	0.200	OK	---
14956.0	0.034	0.200	OK	---	14447.3	0.239	0.200	-WARN-	---

5. Accident starter @ starter mount with 0292737310 pipe ground idle

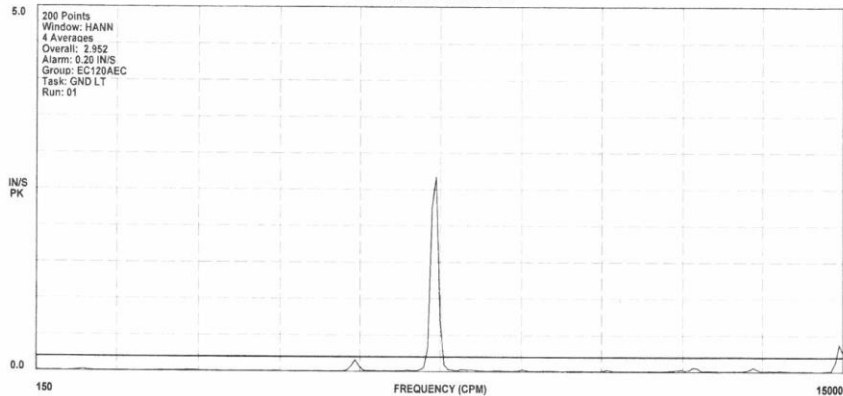
FREQ (CPM)	MAG (IN/S)	ALARM	STATUS	DESCRIPTION	FREQ (CPM)	MAG (IN/S)	ALARM	STATUS	DESCRIPTION
5998.5	0.157	0.200	OK	---	7472.2	2.924	0.200	-WARN-	---
7981.0	0.031	0.200	OK	---	8175.0	0.020	0.200	OK	---
9082.4	0.027	0.200	OK	---	10659.9	0.026	0.200	OK	---
11981.8	0.027	0.200	OK	---	12252.8	0.064	0.200	OK	---
13352.9	0.059	0.200	OK	---	14925.0	0.374	0.200	-WARN-	---

6. Accident starter @ starter mount with 0292737310 pipe flight idle

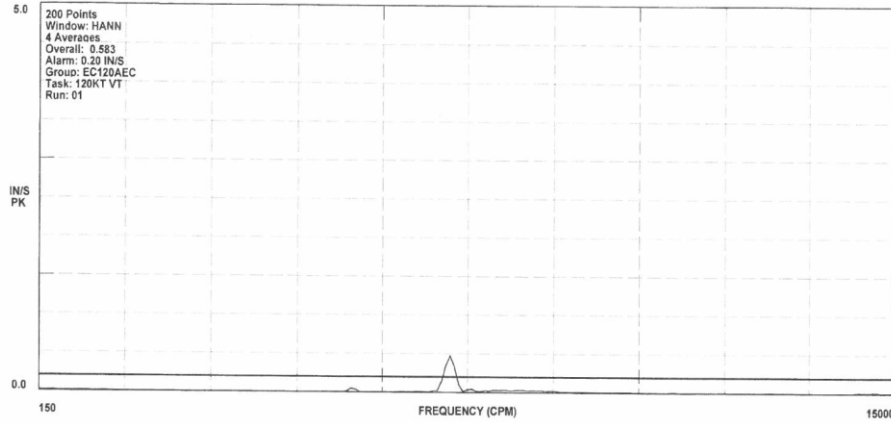
FREQ (CPM)	MAG (IN/S)	ALARM	STATUS	DESCRIPTION	FREQ (CPM)	MAG (IN/S)	ALARM	STATUS	DESCRIPTION
5574.0	0.050	0.200	OK	---	7253.9	0.496	0.200	-WARN-	---
7618.5	0.047	0.200	OK	---	7575.0	0.024	0.200	OK	---
8025.0	0.029	0.200	OK	---	8211.0	0.035	0.200	OK	---
8439.0	0.036	0.200	OK	---	8700.0	0.028	0.200	OK	---
8850.0	0.023	0.200	OK	---	9000.0	0.021	0.200	OK	---

7. Accident starter @ injection union mount with 0292737310 pipe ground idle

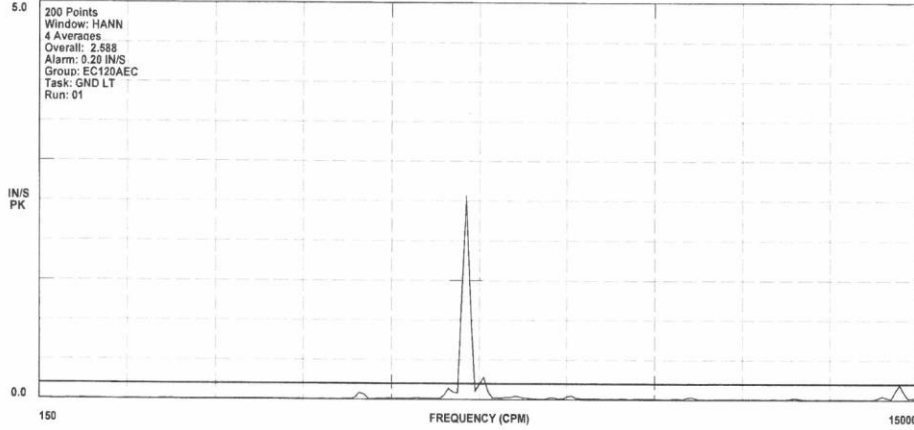
FREQ (CPM)	MAG (IN/S)	ALARM	STATUS	DESCRIPTION	FREQ (CPM)	MAG (IN/S)	ALARM	STATUS	DESCRIPTION
5571.6	0.089	0.200	OK	---	7065.4	0.144	0.200	OK	---
7348.1	2.588	0.200	-WARN-	---	7630.0	0.291	0.200	-WARN-	---
8025.0	0.029	0.200	OK	---	8201.3	0.050	0.200	OK	---
9122.1	0.053	0.200	OK	---	11148.7	0.035	0.200	OK	---
14410.8	0.045	0.200	OK	---	14692.2	0.193	0.200	OK	---

9. Accident starter @ starter mount with 0292730350 pipe ground idle

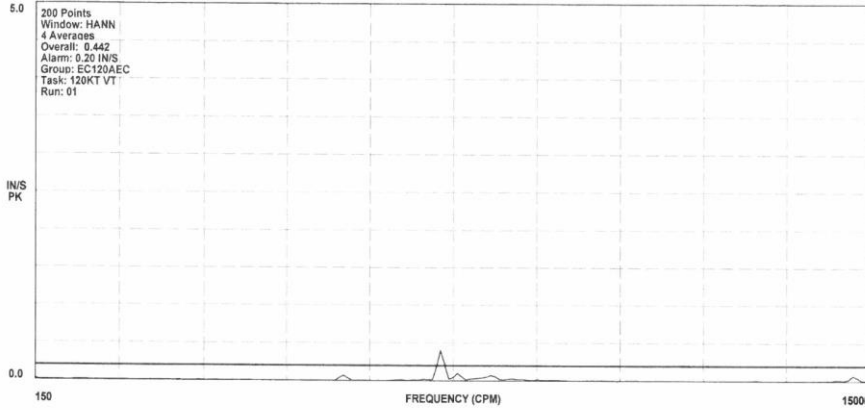
FREQ (CPM)	MAG (IN/S)	ALARM	STATUS	DESCRIPTION	FREQ (CPM)	MAG (IN/S)	ALARM	STATUS	DESCRIPTION
5620.4	0.067	0.200	OK	---	7063.9	0.021	0.200	OK	---
7355.9	0.401	0.200	-WARN-	---	7635.9	0.098	0.200	OK	---
8270.7	0.078	0.200	OK	---	8601.5	0.031	0.200	OK	---
9097.1	0.018	0.200	OK	---	9340.3	0.015	0.200	OK	---
14426.2	0.017	0.200	OK	---	14716.6	0.073	0.200	OK	---

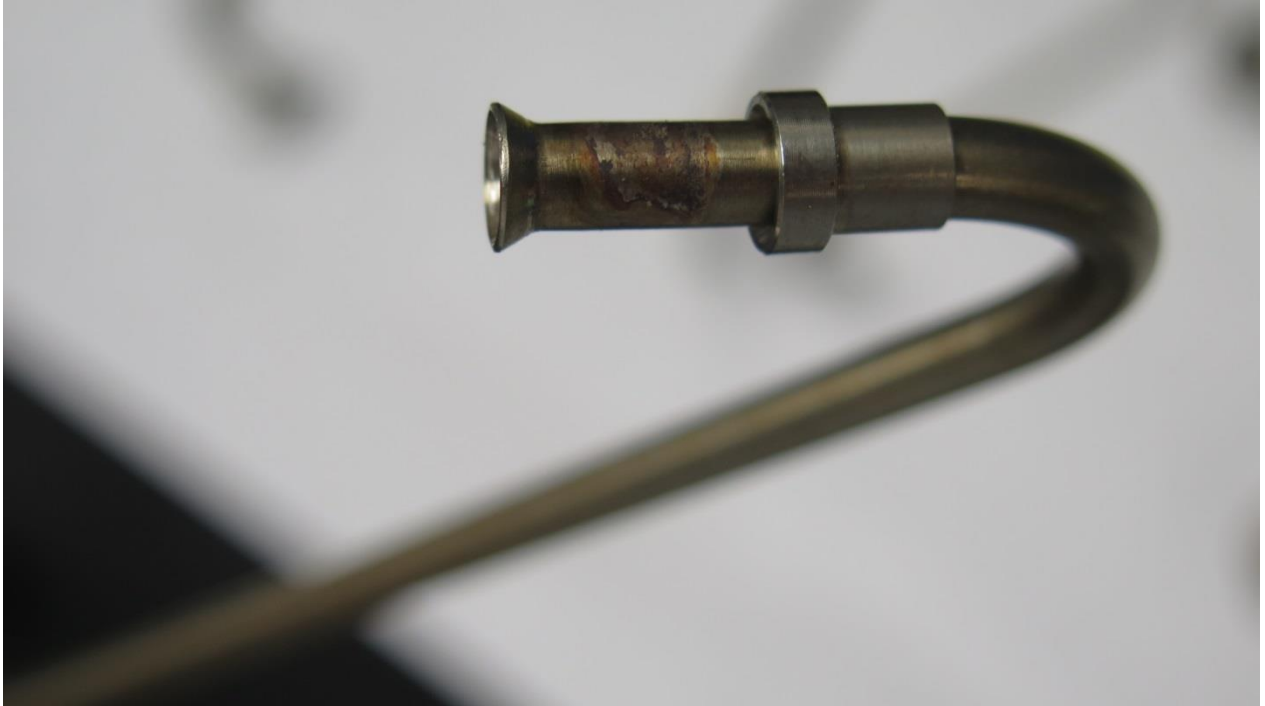
Example of corrosion found on engine equipment (start injector pipe)

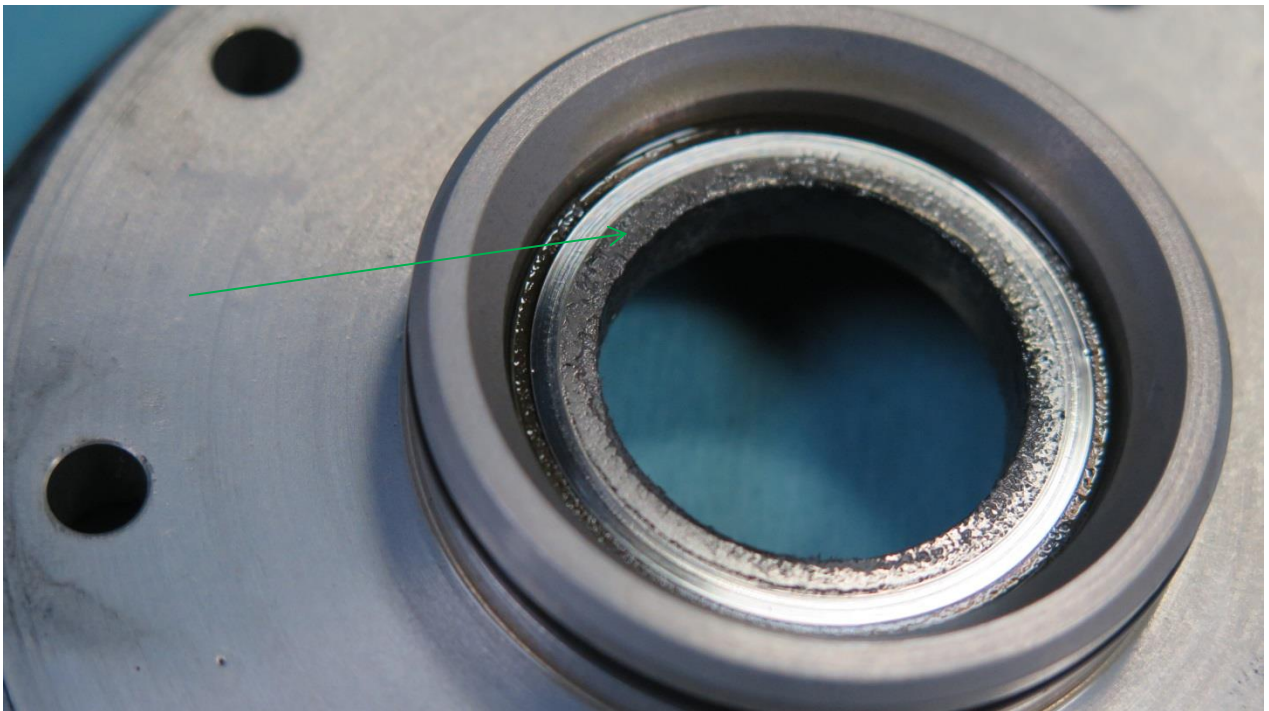
- The starter generator was removed revealing a large amount of black greasy liquid. The operator indicated that this was unusual to what they normally see.

Sludge found on starter magnetic seal

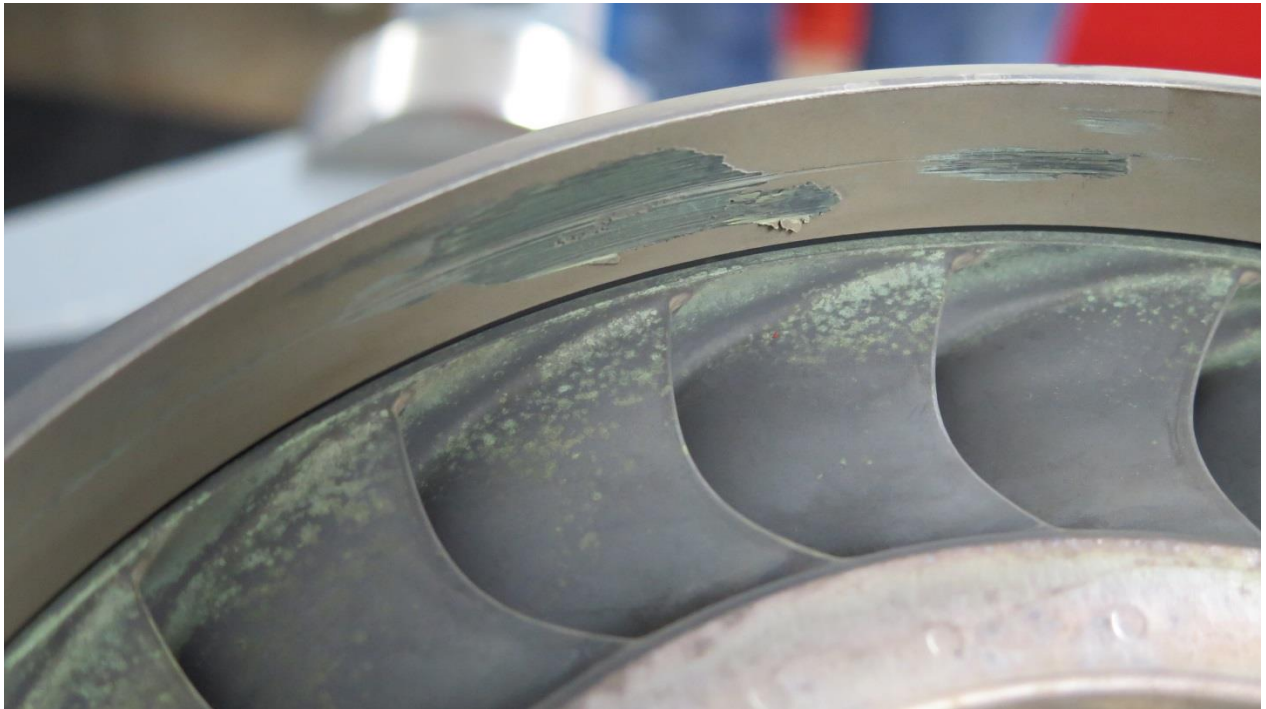
Free turbine shroud rub.

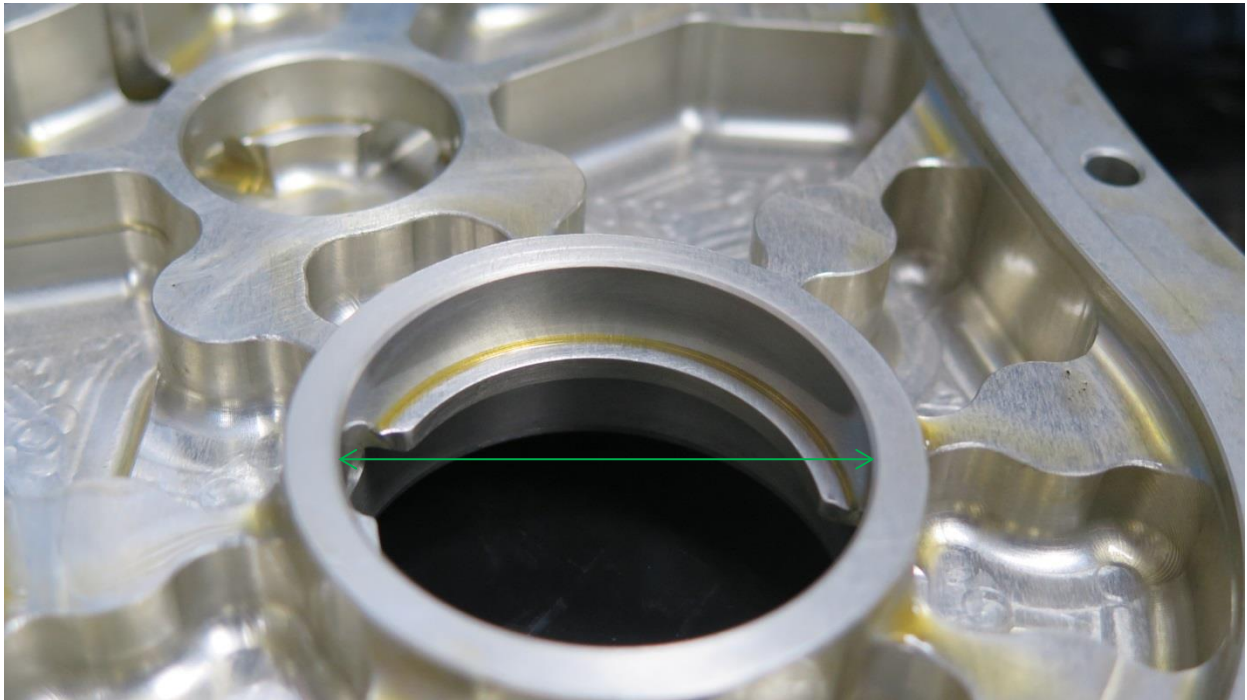
Starter gear bearing race diameter (limits 41.994 - 42.010 mm) (actual 42.005 mm)

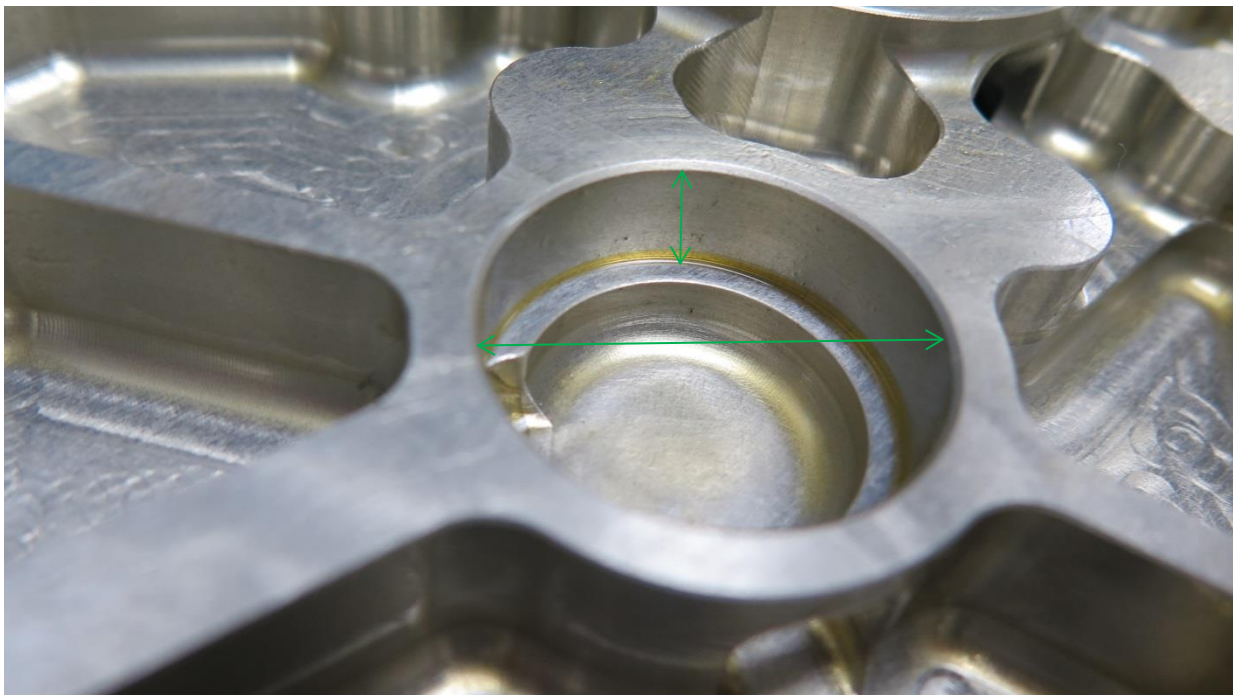
Bevel gear bearing race (limits 27.995 – 28.008 mm) (actual 28.005 mm)
Bevel gear seat depth (limits 13.450 – 13.650 mm) (actual 13.570 mm)

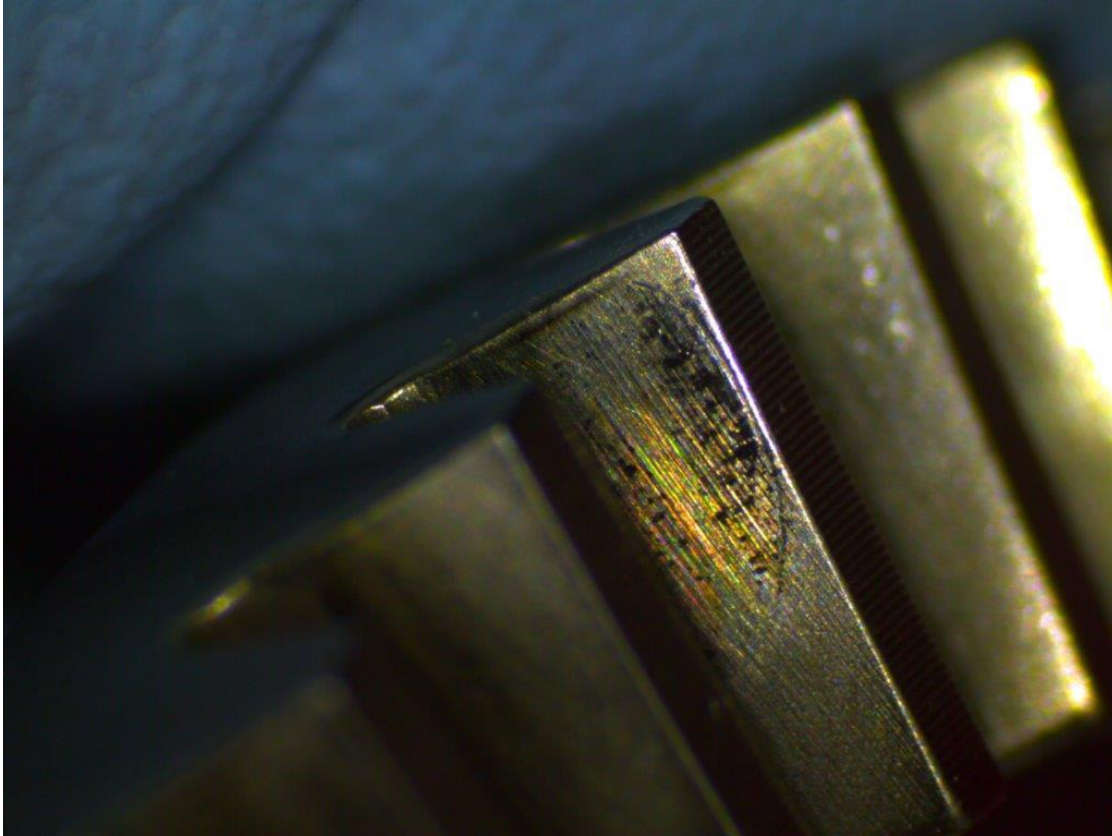
Contact marks on bevel gear. Corresponds to the area where the two gears come in contact.

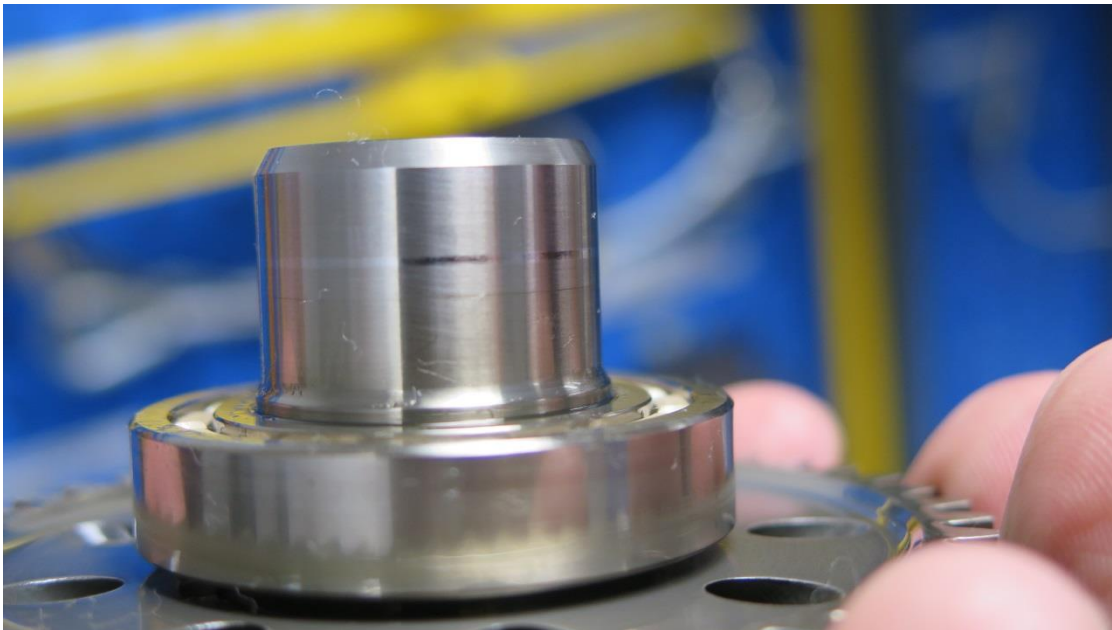
Shiny line on starter gear outer diameter

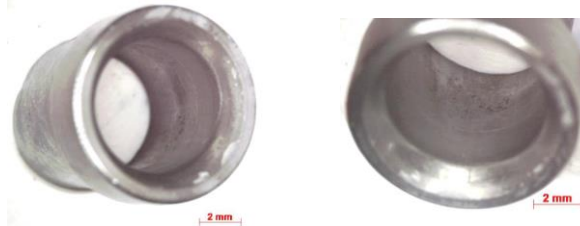
- Fracture surface : only one half of the fracture surface was available (the one on the flared end). The examination by SafranHE matched the analysis by NTSB.
- Close examination of the flare showed that the sleeve's contact area was in the conical area as normal.
- The close examination of the sleeve showed light fretting marks which are in line with experience.

- Metal composition : the material was identified as Z10CNT18-11 which corresponds to the defined metal
- Hardness was measured at 165 HV5 which corresponds to a yield strength of 530 MPa which is within the specified 500 – 700 MPa range.

→ **Other controls did not reveal any significant discrepancy**

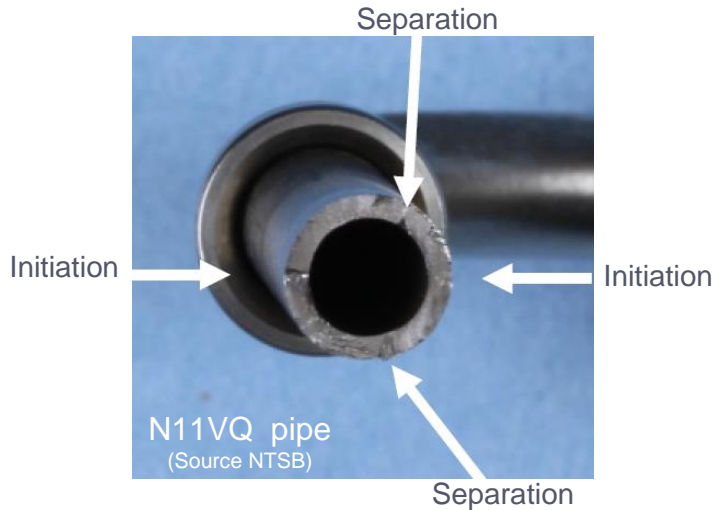
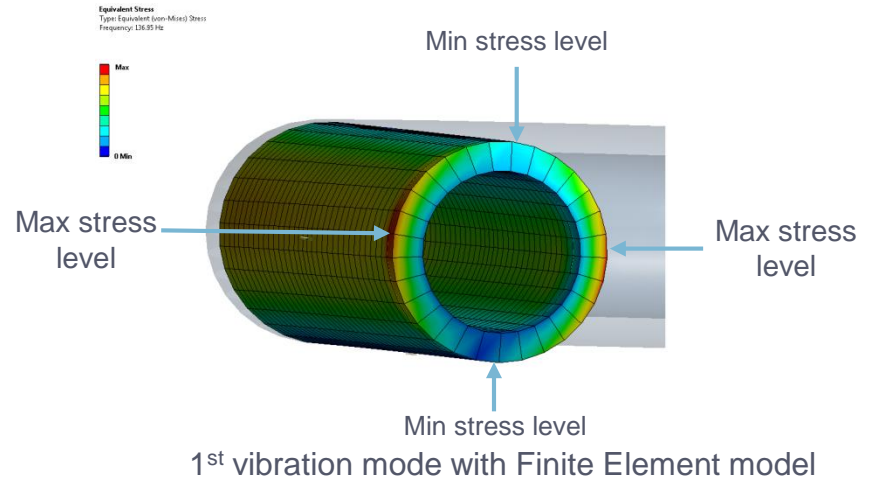
→ Crack initiation locations match maximum stress areas on the pipe's 1st vibration Mode

- Controls on a jig revealed a gap at pipe's end whose origin could not be determined. Analyses showed that a misalignment prior to the event was unlikely.
- Other dimensional controls were unremarkable
- Other controls (material, hardness, sleeve) were unremarkable
- Finite Element Analysis of pipe showed that Crack initiation locations match maximum stress areas on the pipe's 1st vibration Mode
- Fracture surface examination by SafranHE in line with NTSB's examination i.e. reverse bending fatigue fracture

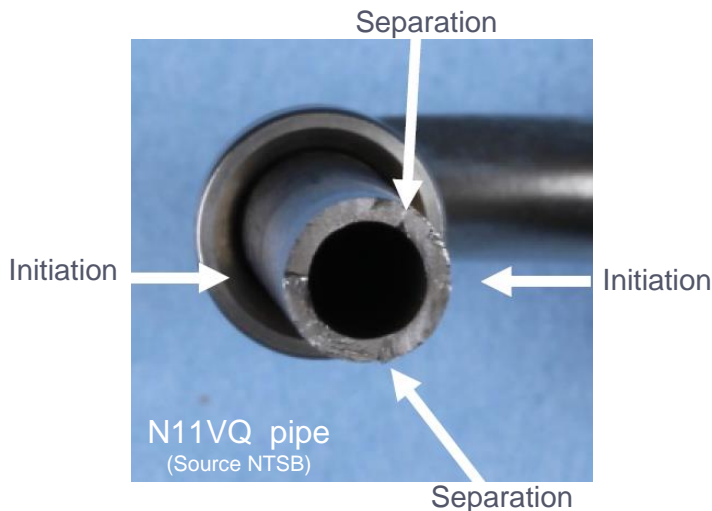
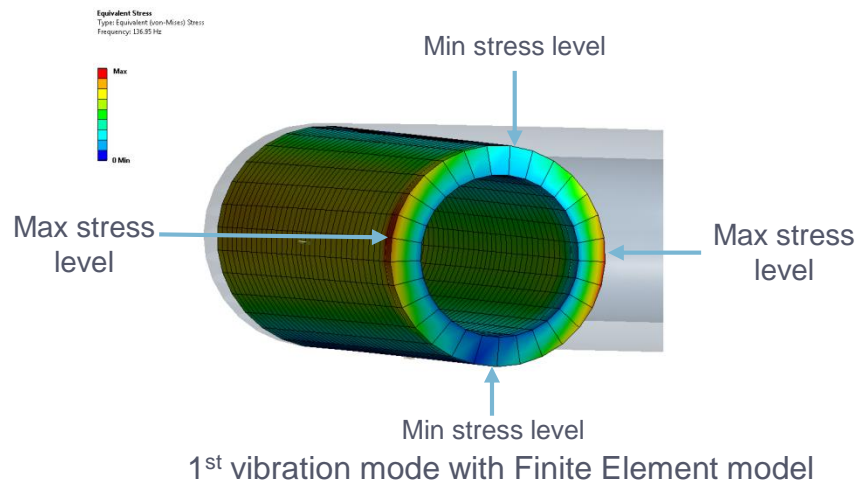
→ Crack initiation locations match maximum stress areas on the pipe's 1st vibration Mode

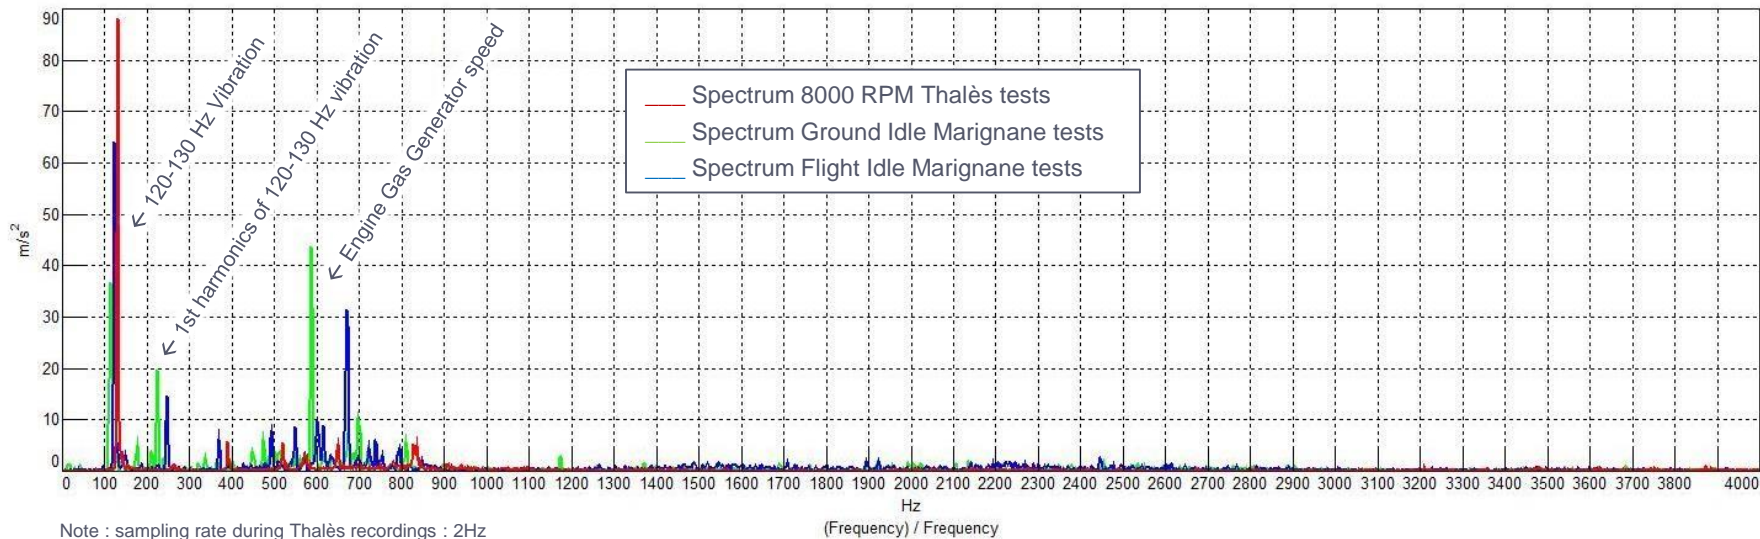
Comparison of vibration spectrums of S/G of N11VQ alone and on engine installed on helicopter = no significant difference

→ Engine is not a source of vibration on the Starter/Generator (other than the Gas Generator speed)
