**NATIONAL TRANSPORTATION SAFETY BOARD**  
Office of Railroad, Pipeline, and Hazardous Materials Investigations  
Washington, D.C. 20594

### Group Chairman's Factual Report of the Investigation<sup>1</sup>

– Crashworthiness and Fire Department Response<sup>2</sup> –

NTSB Accident Number:	RRD22MR007
Location (accident reference):	San Bruno, CA (San Mateo County)
Date / Approx. Time of Accident:	March 10, 2022 / 10:34 a.m. PST <sup>3</sup>
Brief Synopsis:	commuter train collision with railroad construction project equipment
Railroad (Property Owner):	Caltrain
Accident Site (Location):	Caltrain Main Line, Track #2, at milepost 11.7 (approximately), which was about <sup>8</sup> / <sub>10</sub> of a mile south of the San Bruno (commuter train) station

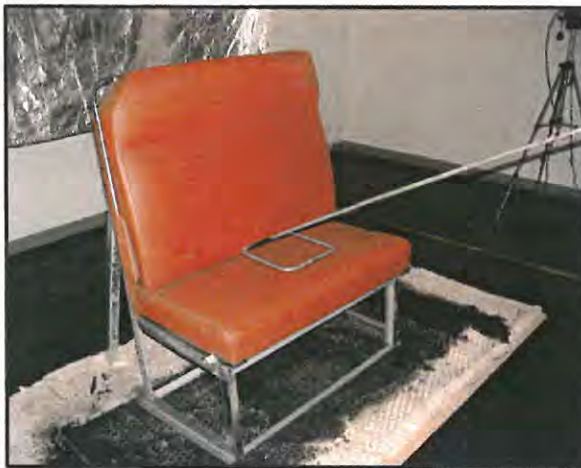
Figure 20: VRE seat before fire test, WH photo

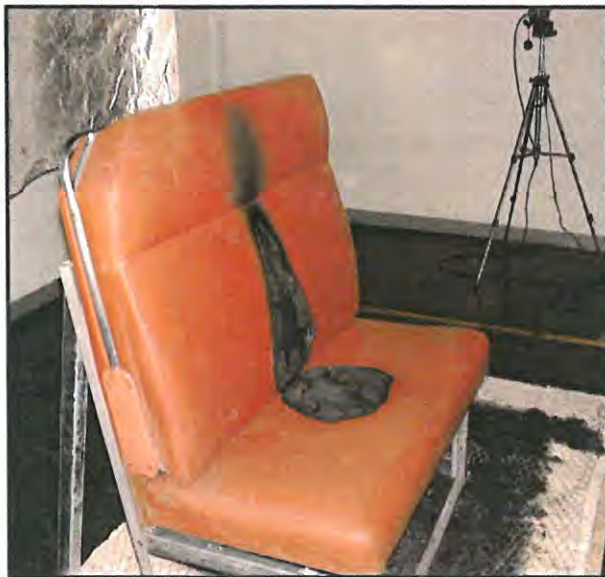
Figure 21: VRE seat after fire test. WH photo

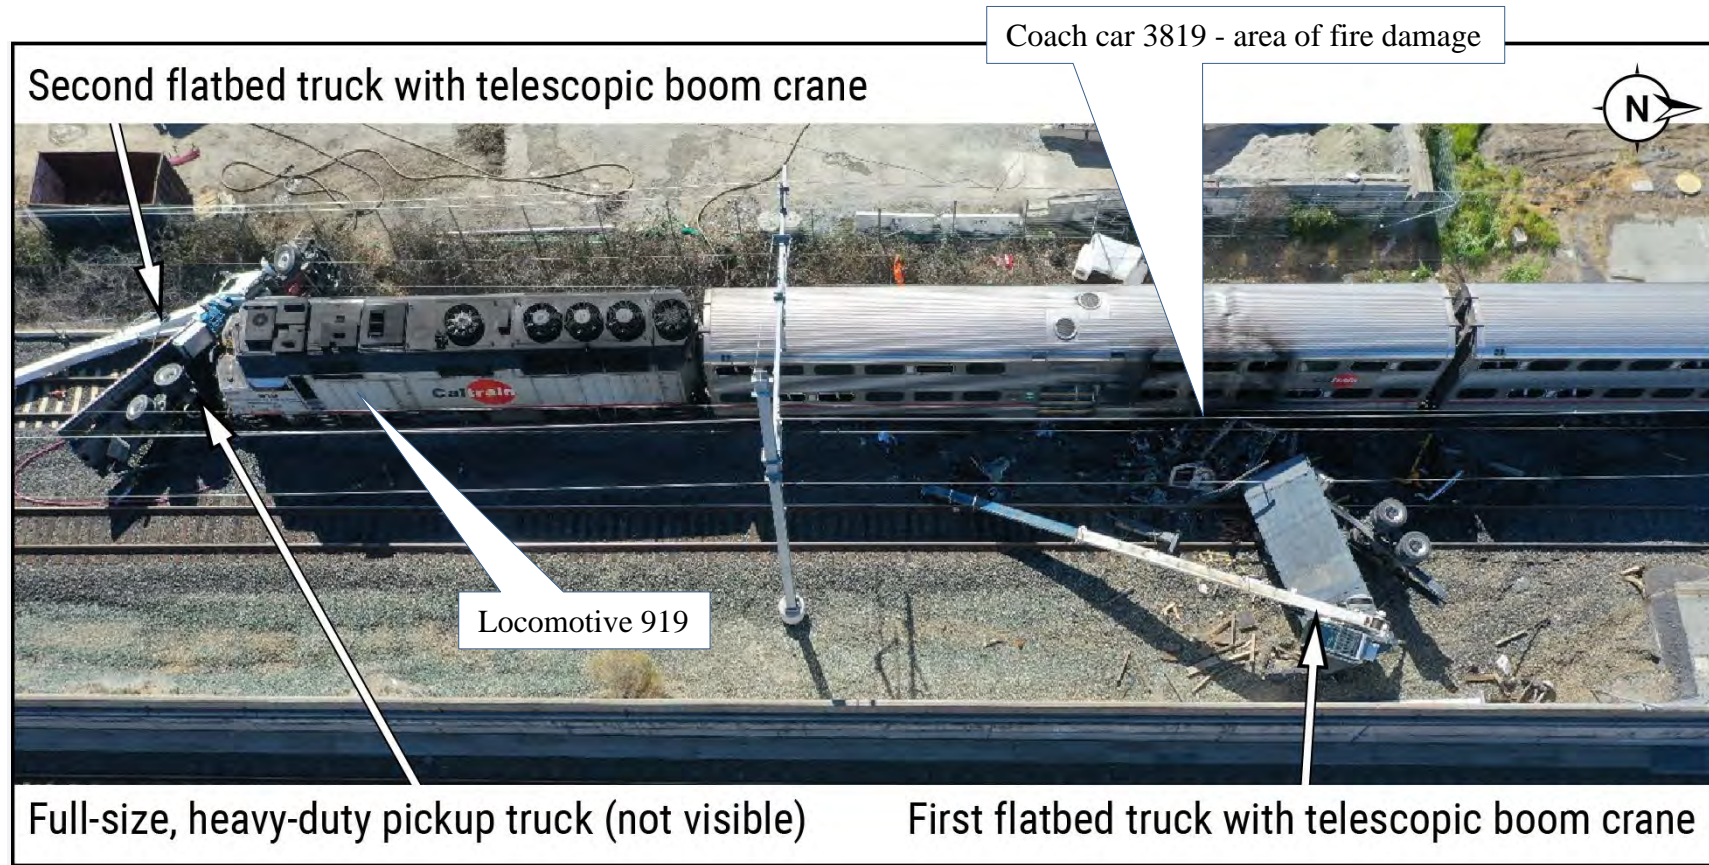
Exhibit 5. Wreckage Distribution / Aerial Imagery Map - Annotated<sup>1, 2</sup>

- the wreckage of this vehicle came to rest lodged between the front of locomotive 919 and wreckage of the Road / Rail ‘Boom Truck’ Vehicle # 3,
- this vehicle sustained severe collision impact damage and severe fire damage, to which the identity of this vehicle (i.e., the make and model designation) was visibly indiscernible.

- the wreckage of this vehicle came to rest in a somewhat upright orientation, on the Number 1 track of the Main Line trackage, situated to the immediate east of where coach 3819 came to rest, in which it was located proximate to an area aft of the mid-point segment of that railcar,
- the cab of this vehicle sustained severe collision impact damage and severe fire damage, in which the cab of this vehicle came to rest immediately adjacent to the exterior sidewall of coach 3819,
- the cab of this vehicle wreckage came to rest approximately 229 feet to the south of the approximate point of collision.

- the wreckage of this vehicle came to rest on its left side, at approximately a 45-degree orientation to the track centerline, and was essentially wedged against the front of locomotive 919,
- a segment of the wreckage of the Pilot vehicle came to rest lodged between the front of locomotive 919 and the wreckage of this vehicle,
- the cab of this vehicle sustained severe collision impact damage and severe fire damage.

The train and maintenance vehicles after the collision. (Photograph courtesy of the San Bruno Fire Department.)
