RRD22LR007 Caltrain collision with on track equipment and derailment March 10, 2022 San Bruno, California

National Transportation Safety Board

Operations Factual Report

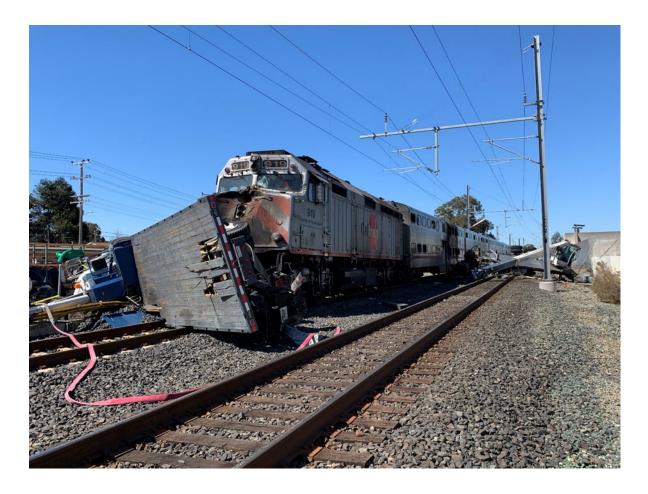
Figure 1: Photograph of accident scene taken on 3/11/22.

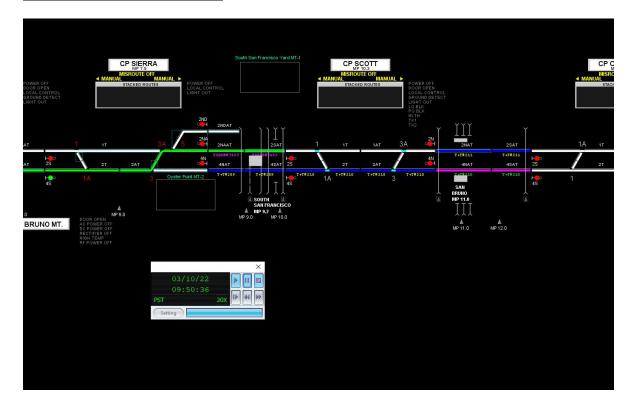
Figure 2: Screenshot from the train dispatchers CAD system when T&T Authority 209, 210, and 211 are all active. The blue line indicates the location of the T&T

authority. The magenta line is a shunt occurring in the field in a block that is protected by T&T authority.

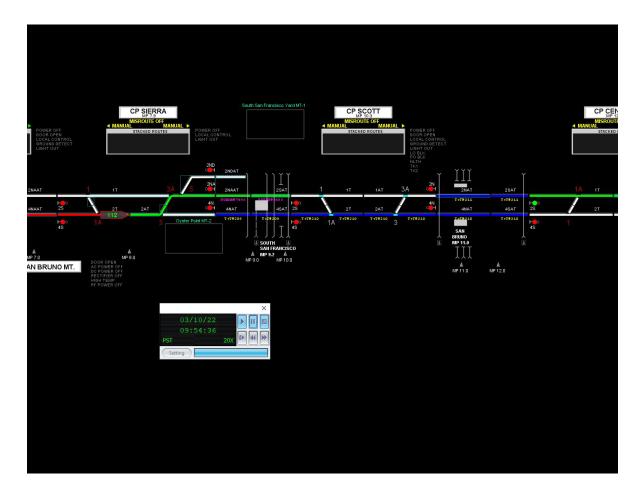
Figure 3: Screenshot from the train dispatchers CAD system when T&T Authority 209, 210, and 211 are all active. The 112 Icon is SB Caltrain #112. The red line indicates the block occupied by train #112. The green line is the set route for train #112.

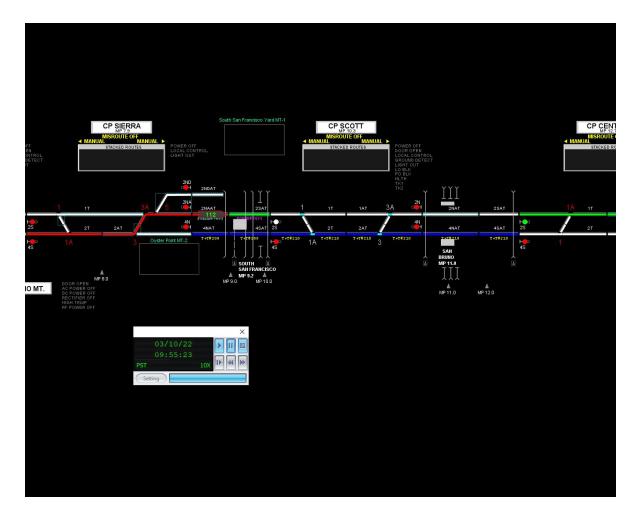
Figure 4: Screenshot from the train dispatchers CAD system when T&T Authority 209 and 210 are active. T&T authority 211 was released at this time. The 112 Icon is SB Caltrain #112. The red line indicates the block occupied by train #112. The green line is the set route for train #112.

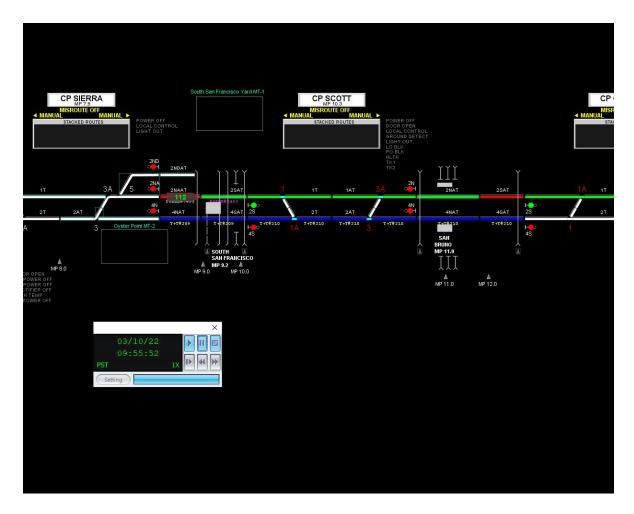
Figure 5: Screenshot from the train dispatchers CAD system when T&T Authority 209 and 210 are active. The 112 Icon is SB Caltrain #112. The red line indicates the block occupied by train #112. The green line is the set route for train #112.

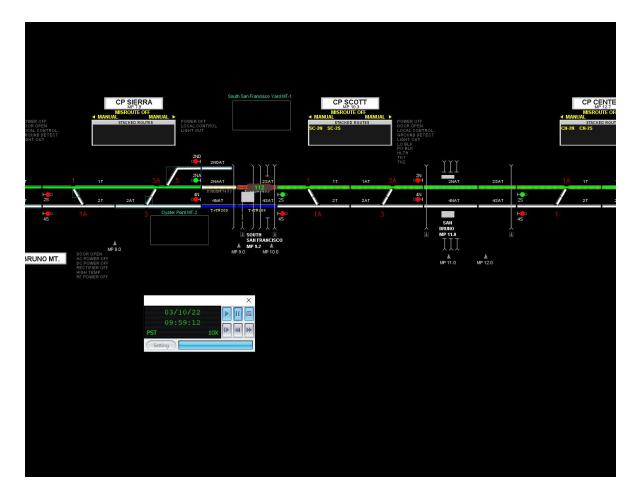
- When RWIC MW 200 released track and time # 210 at 0958 PST, it left the on-track equipment unprotected on main track # 2 between CP Scott and CP Center. The train dispatcher stated that Caltrain train # 112 was leaving South San Francisco and he decided against crossing the train from main track #1 to main track # 2 the "normal" southbound track. In hindsight the train dispatcher felt if he would have crossed train #112 back to the "normal" southbound track the train would of stopped at San Bruno Station and would of departed "delayed in block" to the next intermediate signal which was just north of the work group that was struck by train # 506. If train # 112 had been operating delayed in block the train dispatcher conveyed in our interview that the crew might have been able to stop short of the on-track equipment when they became aware they were on the track. His thought process of keeping train 112 on MT-1 was due to passenger signs were already displayed and if he changed the arrival track the passengers would have been on the wrong side.

- The train dispatcher said after the RWIC MW 200 released track and time #210 he never saw any track indications on his dispatcher board which might have alerted him of the on-track equipment still on main track # 2.

Figure 6: Screenshot from the train dispatchers CAD system when T&T Authority 209 is active. T&T authority 210 has been released at this time. The 112 Icon is SB Caltrain #112. The green line is the set route for train #112.

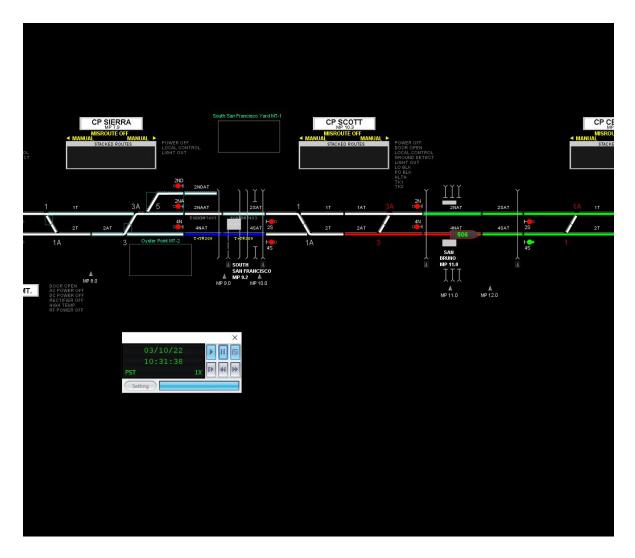
- Instead, the train passed the work group on the adjacent track, the following southbound train # 506 was crossed over from main track #1 to main track # 2 at CP Center into the on-track equipment located at MP 11.7.

Figure 7: Screenshot from the train dispatchers CAD system when T&T Authority 209 is active. The 506 Icon is SB Caltrain #506. The green line is the set route for train #506. The red line indicates the block that occupied by train #506. In this image, train #506 is in the block where the collision occurred.
