N7522U Fuel Selector Test

Objective

To evaluate the functionality and reliability of the fuel selector valve to supply adequate fuel to operate the engine.

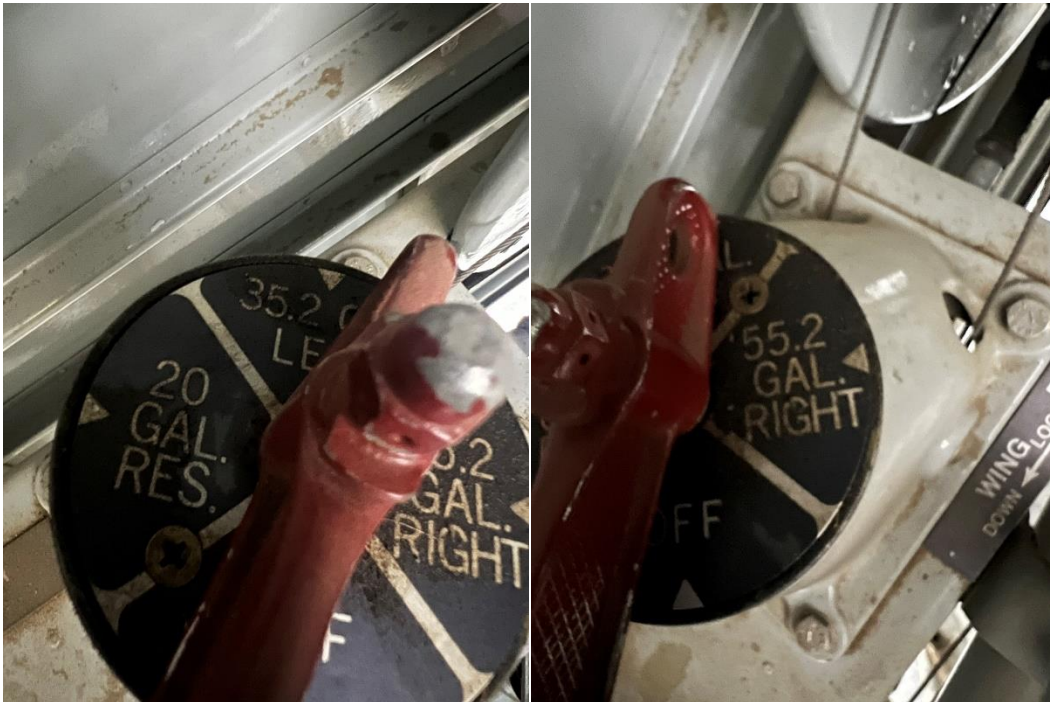
Detail view of the front seat fuel selector handle and placard

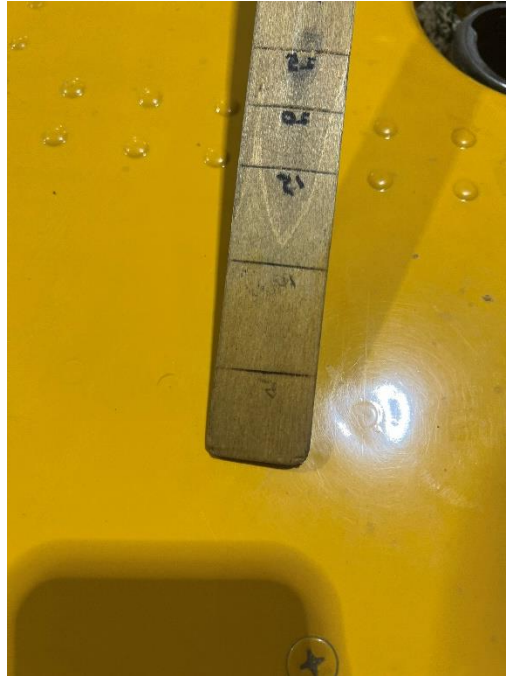
Upon arrival in Lone, the recovery team indicated that they drained an unknown quantity of fuel from one or both tanks prior to transporting the aircraft to its storage location in Lone, CA. After the airplane was unloaded in Lone, the pilot’s calibrated fuel stick was retrieved and used to examine the remaining fuel quantity in the fuel tanks, with the wing approximately in the cruise attitude. The right tank indicated nearly empty, and the left tank indicated slightly under 10 gallons of fuel.

Detail view of the calibrated dip stick reading of the left tank upon arrival in lone

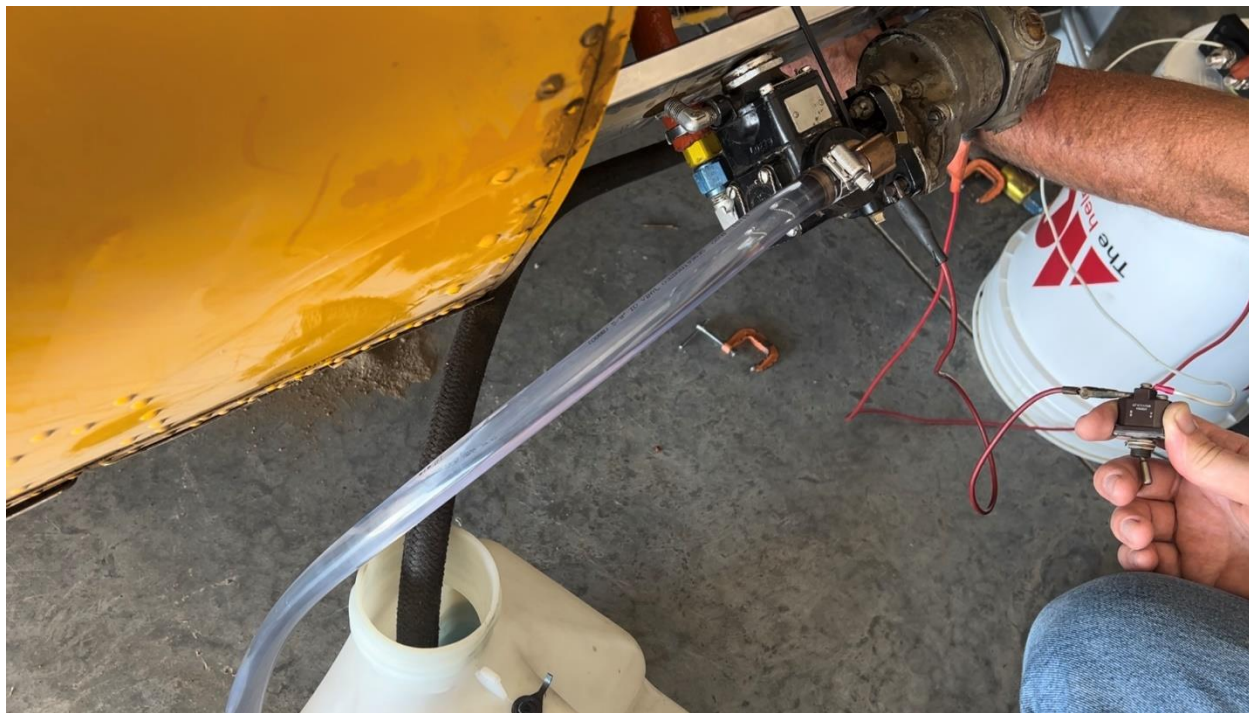
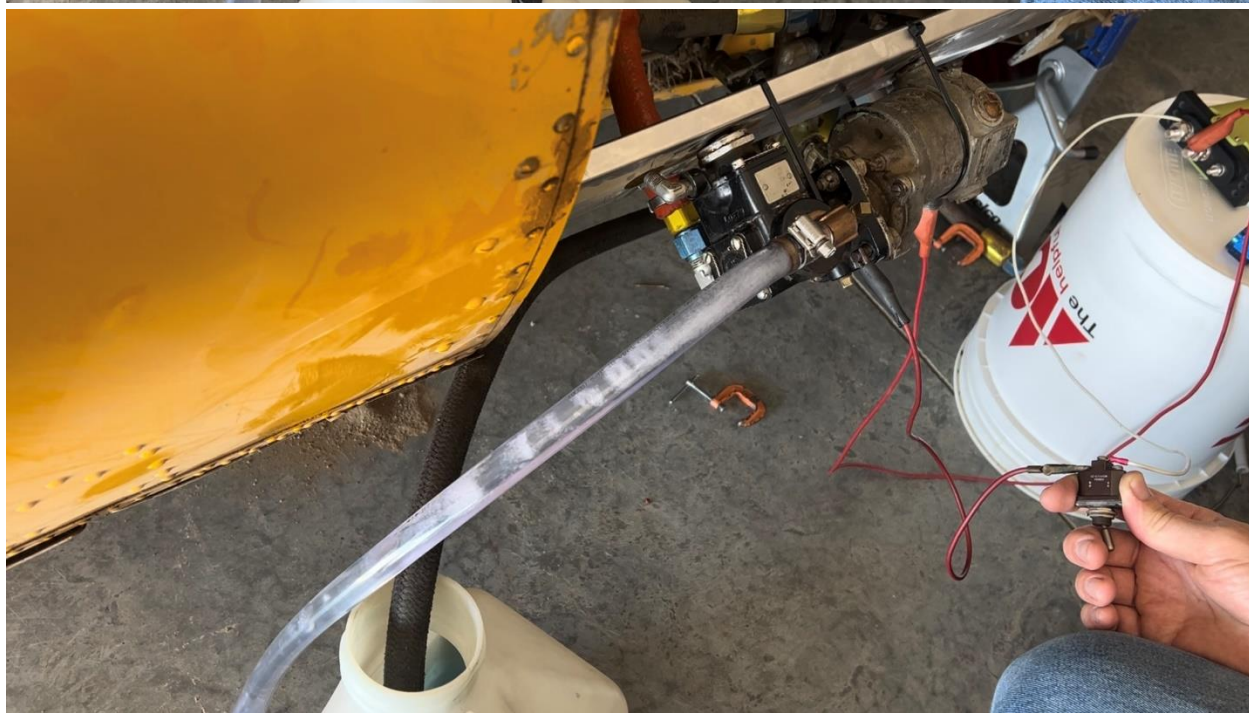
“RESERVE” Position Test

There was no observable damage to any of the components of the fuel system, however the hose connecting the outlet side of the fuel selector to the wobble pump was removed to allow separation of the fuselage from the wing to enable transportation of the aircraft. To begin the test, the fuel selector was set to the “RESERVE” position with the fuel supply plumbed to it. The supply ports to each of the other two positions (“LEFT” and “RIGHT”) were left open to ambient air. To begin the test, both unselected positions were temporarily sealed to prevent the suction of air. The pump was energized, and fuel began flowing through the clear tubing and was observed to be a steady and uninterrupted flow of fuel at approximately the correct rate. With the pump running, the temporary seals were removed from the unselected ports and the fuel observed in the clear tubing immediately became severely aerated and the flow rate of fuel decreased substantially. After observing the large air bubbles, the seals were reinstalled on the unselected ports of the fuel selector and the fuel resumed flowing steadily and uninterrupted.

Photos retrieved from video captured with fuel pump on, note steady and constant fuel flow when unselected ports are sealed (Top); and severe aeration of fuel when unselected ports of fuel selector are open to air (Bottom)

The fuel selector proved to be leaking consistently between ports which resulted in significant aeration of the fuel.

The fuel selector failed to provide sufficient fuel flow to support operation of the engine due to cross-port leaking. The original fuel selector valve utilizes cork to seal the unselected ports to stop the draw of fluid from those tanks. The cork seal of this fuel selector failed and therefore the engine driven fuel pump drew simultaneously from all three ports, regardless of fuel selector position. If any one of these ports were subject to air, the output of the engine driven fuel pump would be so severely aerated that the engine could cease to run.

There is a reasonable expectation that the fuel selector will continue to provide fuel to the engine so long as the selected tank still has usable fuel in it. The fuel selector failed in this “RESERVE” position which still had some quantity of usable fuel as was observed by the Sanders Aeronautics team. The engine likely ceased to run due to the severe aeration of the fuel which was delivered by a faulty fuel selector. The site of the landing was close enough to the Modesto airport (to which the pilot immediately deviated after experiencing the first indications of engine roughness) that the remaining usable fuel would have been sufficient to approach and land.

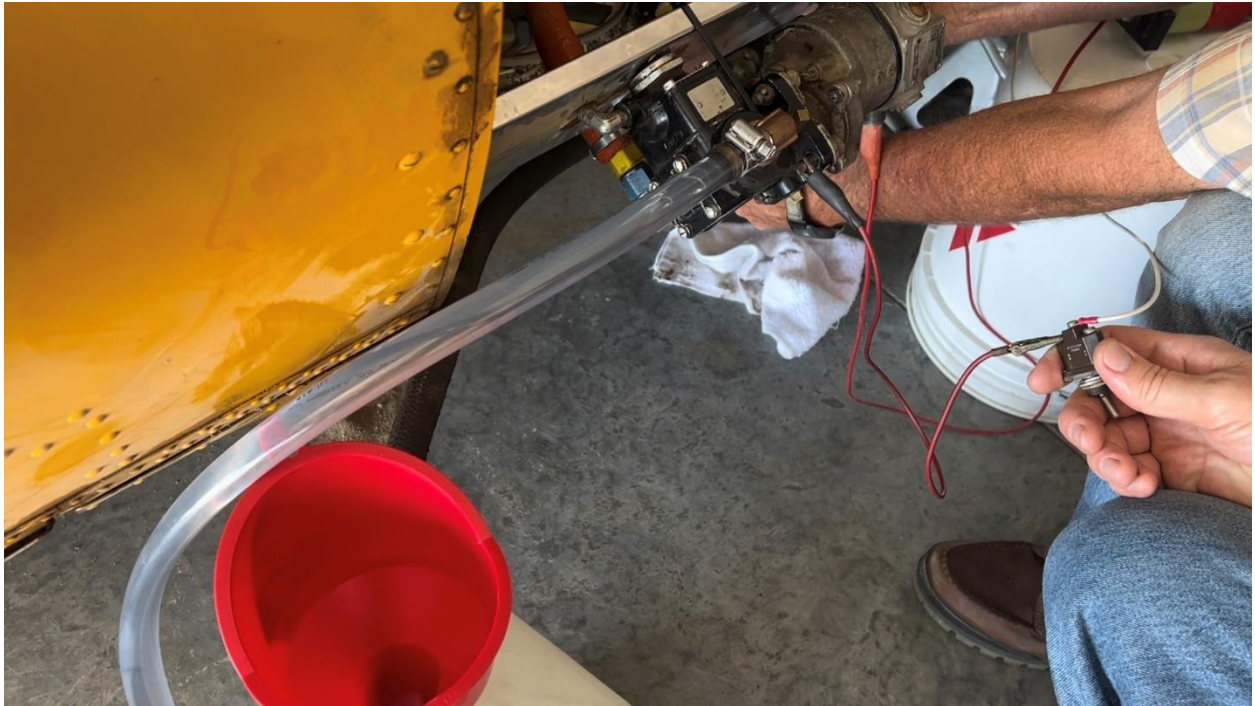
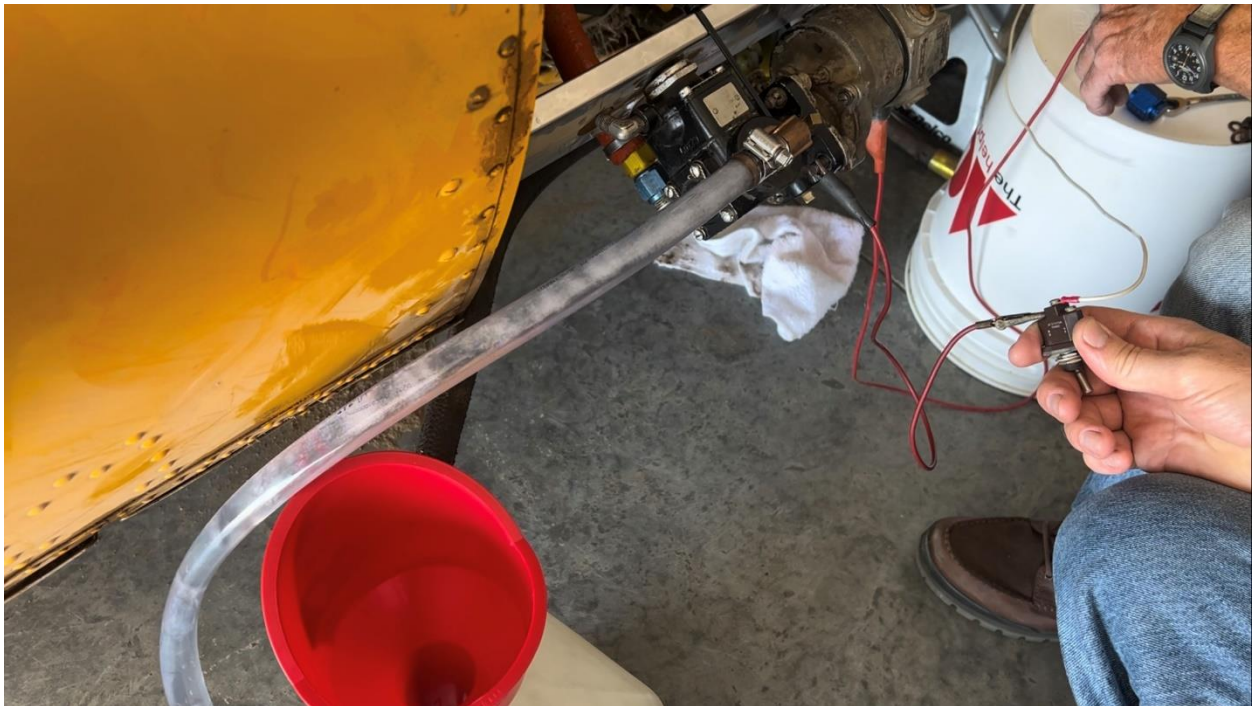
“LEFT” Position Test

Photos retrieved from video captured with fuel pump on, results are very similar to those of the “RESERVE” position test; unselected ports sealed (Top) and unsealed (Bottom)

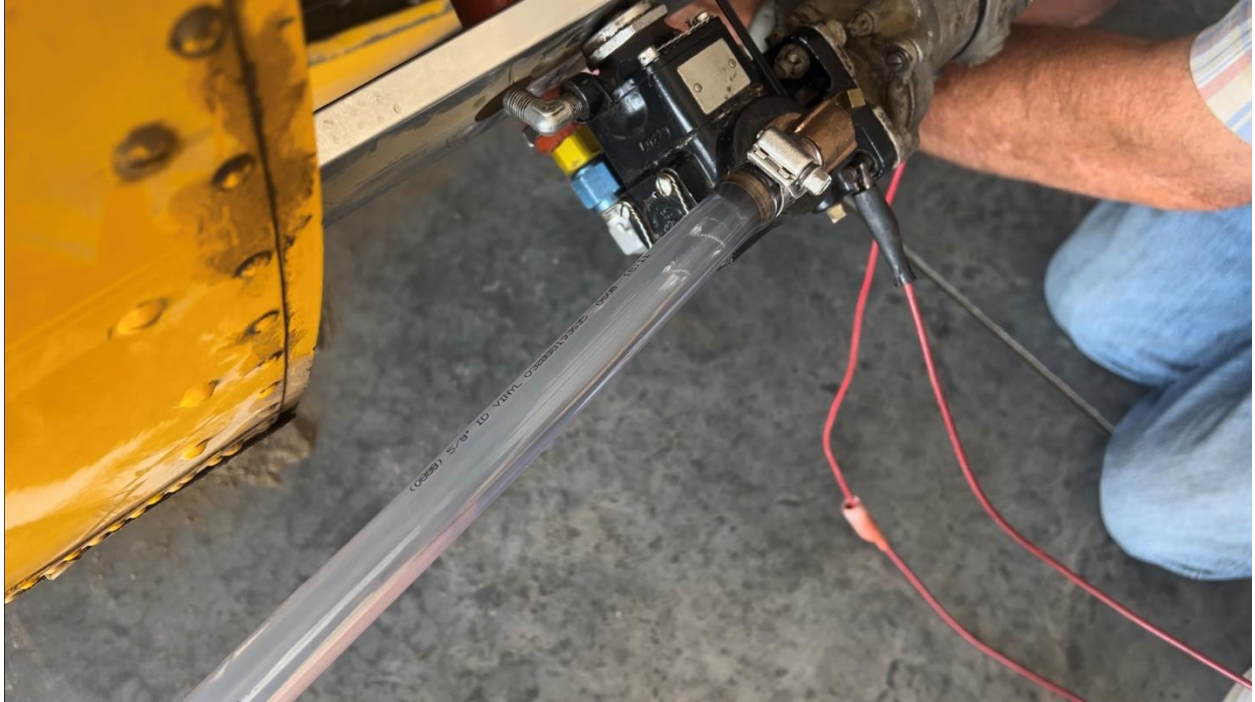
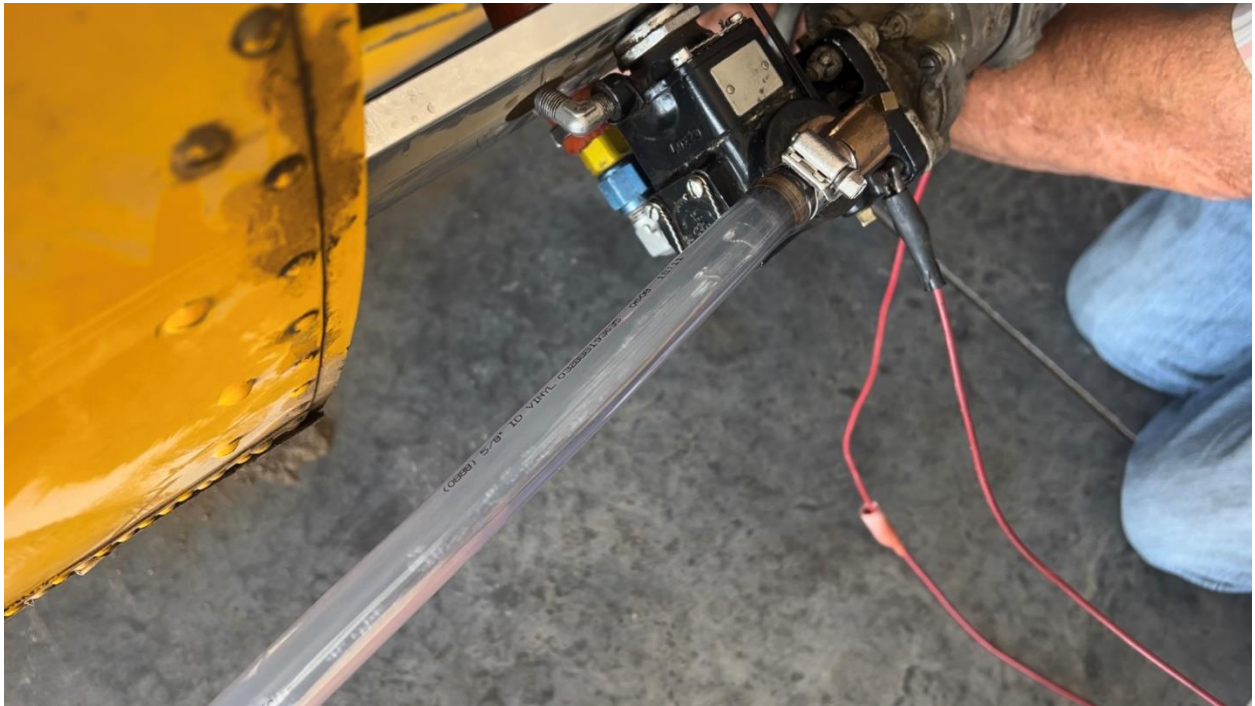
“RIGHT” Position Test

and similar results were observed. When the fuel selector was set to the “Right” position the fuel flow was less aerated though certainly not as steady and uninterrupted as when the unselected ports were sealed.

Photos retrieved from video captured with fuel pump on the aeration of the fuel while the selector was in the “RIGHT” position was less severe than in the other positions but present nonetheless when unselected ports were open to air (Bottom)
