**NATIONAL TRANSPORTATION SAFETY BOARD
OFFICE OF HIGHWAY SAFETY
WASHINGTON, D.C.**

**VEHICLE FACTORS GROUP CHAIRMAN'S
FACTUAL REPORT**

Vehicle 1: 2001 Ford Excursion "Stretch" Limousine

NTSB #: **HWY19MH001**

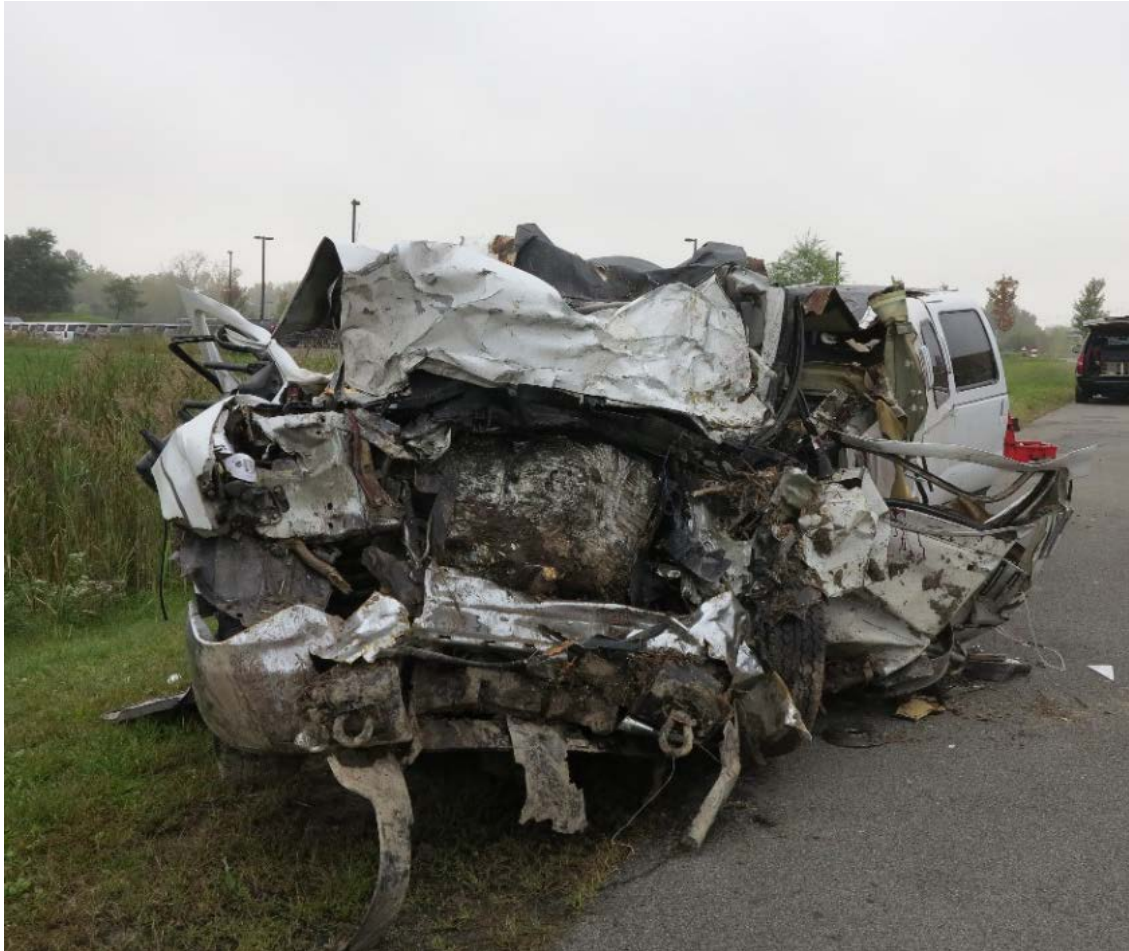
There was contact damage to the entire front end, with more rearward displacement on the left side than the right.¹⁶ The left side of the radiator was displaced rearward to axle 1. The rear portion of the engine was in what would have been the driver’s footwell area of the vehicle. The steering wheel was displaced upward and was at the roofline of the vehicle. The bottom portion of the driver’s seat was displaced upward approximately 90 degrees and compressed into the seatback. The right front passenger seat was deformed in a similar manner.

The left fender was twisted, distorted and displaced. The driver’s door was distorted and mostly torn away from the frame. The “A” pillar on the left side was folded in half.¹⁷ The “B” pillar on the left side was missing, having been cut by emergency responders for post-crash access. The windshield was displaced and the glass from the driver’s door and the window to the rear of the driver was missing. The three additional windows on the left side were intact. **Figure 1** shows the vehicle damage as seen from the left front corner.

Figure 1: Left Front View 2001 Ford Excursion Limousine

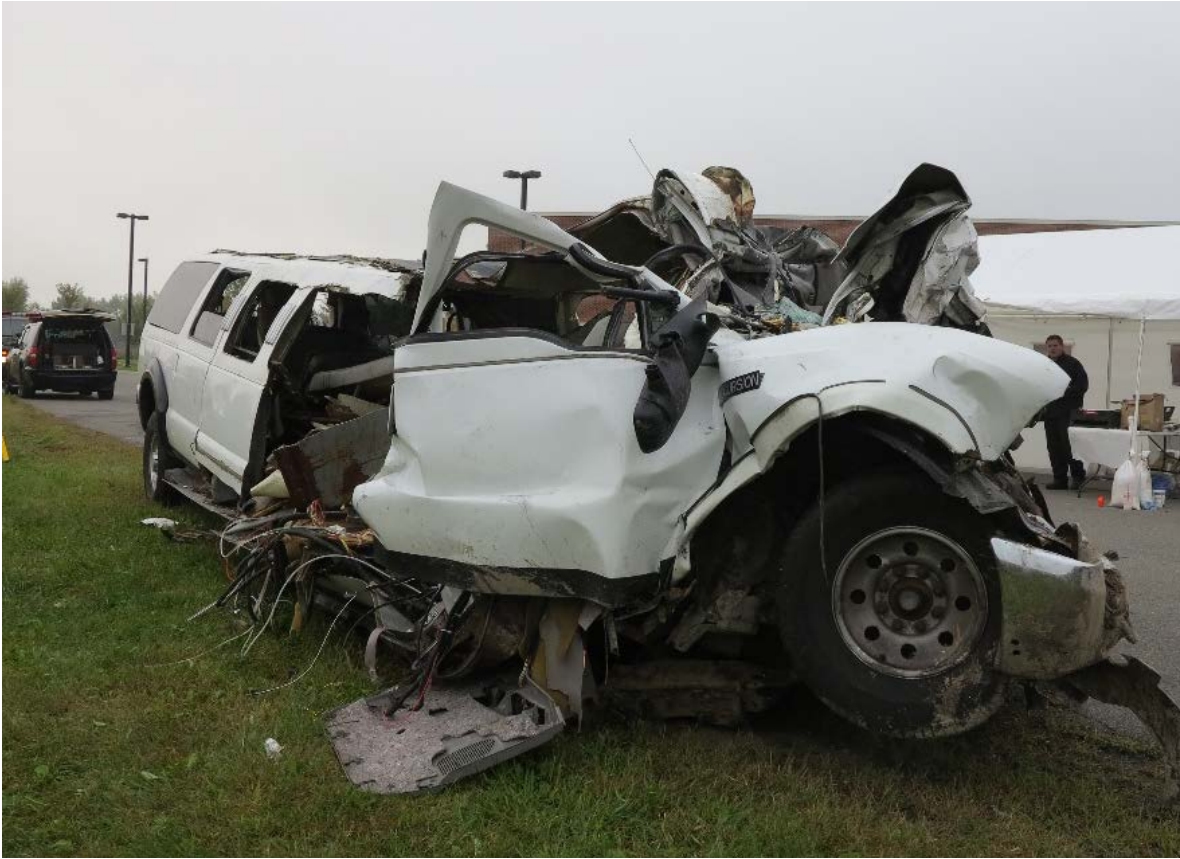
The right fender was damaged but in place. The front passenger door was still attached at the “A” pillar, but the top of the pillar and the top of the door were displaced rearward and to the right. The door was folded almost in half. The “B” pillar on the right side had been cut approximately halfway between the floorboard and the roof. The “C” and “D” pillars had been removed during the extrication process. The rear two windows on the right side were intact, but the front two windows were missing. The rear window was missing. **Figure 2** shows the damage as seen from the right front corner of the vehicle.

Figure 2: Right Front View 2001 Ford Excursion Limousine

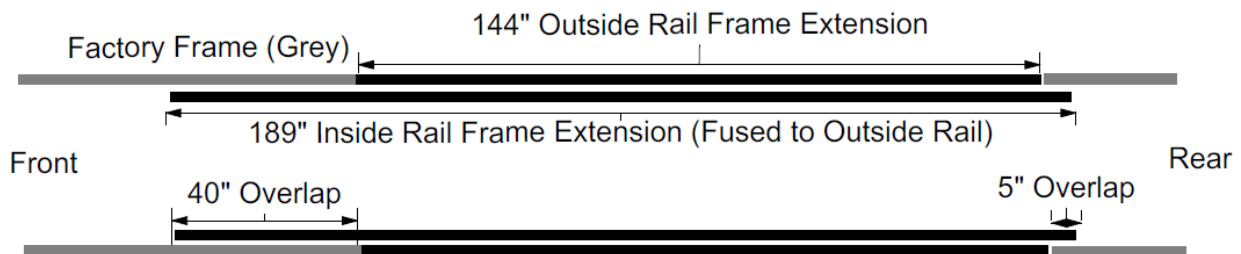
To stretch the Excursion, the alterer had fused two C-section frame rails together and installed them on the vehicle after cutting the original frame aft of the “B” pillar. One of the rails was 144-inches long and the other was 189-inches long. These new rails were then placed between the two halves of the Excursion with the shorter rail to the outside. The longer rail on the inside overlapped the original frame by 40-inches at the front of the vehicle and 5-inches at the rear. Ford QVM guidance does not require two new fused rails in the frame extension but does call for a 10-inch minimum overlap between the new rail and the factory frame on each end. **Figure 3** illustrates how the two new rails were fused and installed on the factory frame of the Excursion.

Figure 3: Frame Extension

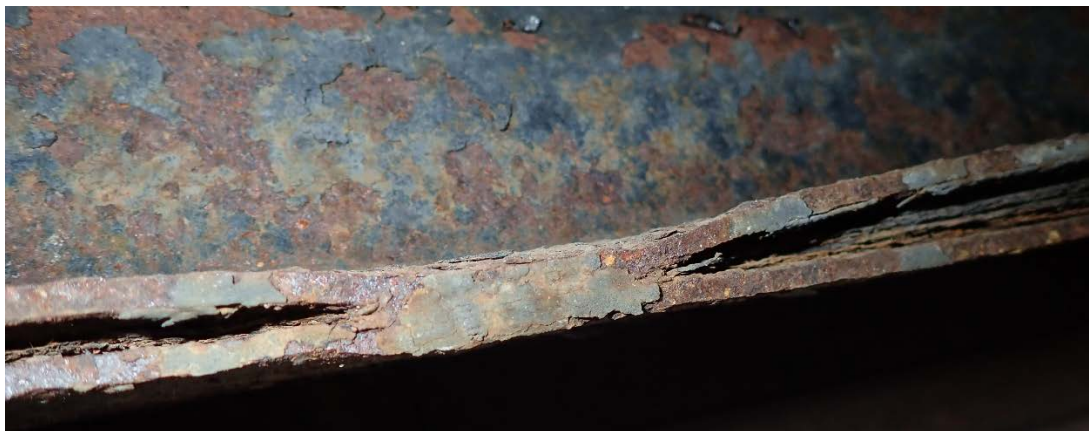
The two rails were continuously welded together at the ends but were just spot welded every 13-inches along the remaining length. This left an open gap between the rails where they were not welded. These gaps showed evidence of corrosion between the two rails. **Figure 4** shows one of the spot welds and the corrosion between the two rails.

Figure 4: Spot Weld Joining Two Rails

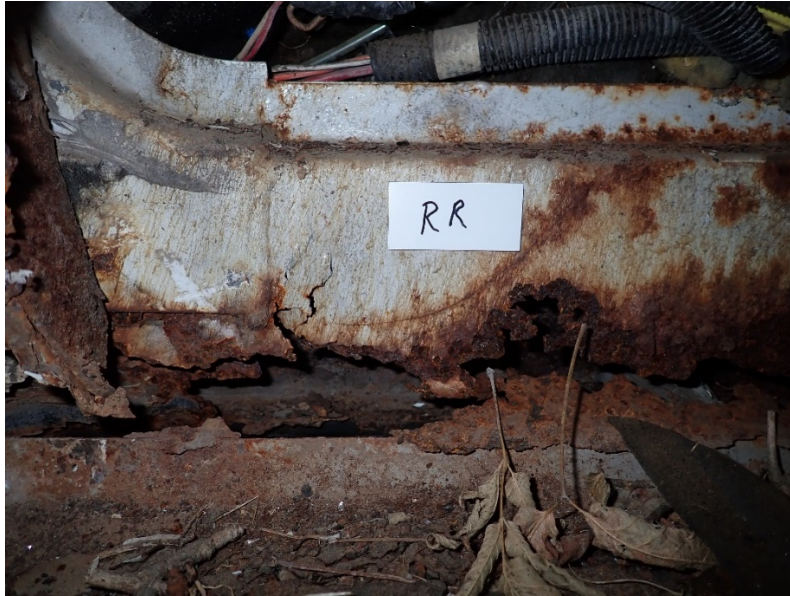
The frame and chassis were inspected for corrosion and possible failure. Frame welds and underbody structural supports were inspected. All welds were intact and undamaged. There was substantial corrosion present on the underbody supports and the where the chassis support gussets connected to the frame. **Figure 5** shows chassis corrosion near a gusset on the right rear of the limousine.

Figure 5: Corrosion to Right Rear Chassis

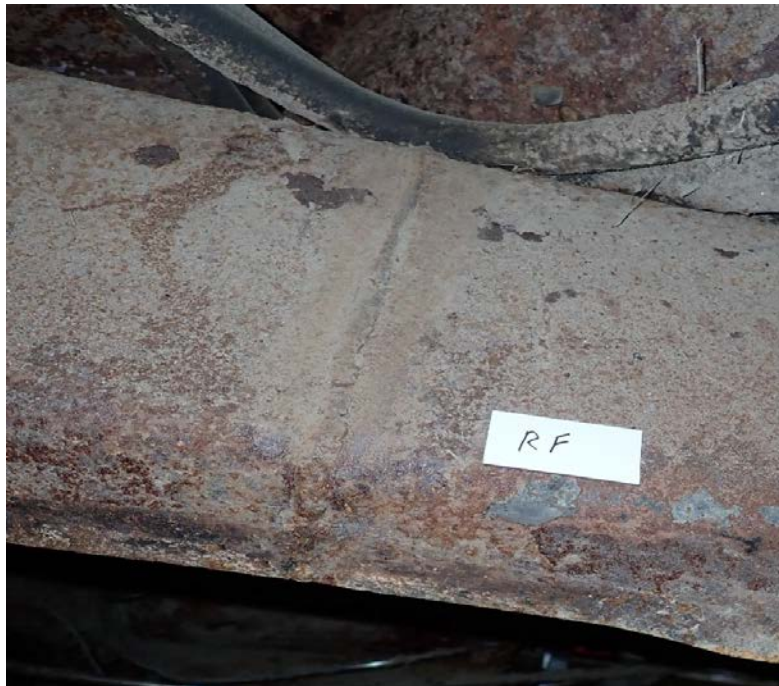
The frame rail itself was straight and appeared structurally sound rearward of the area of contact damage from the crash. **Figure 6** shows the weld on the right front frame rail.

Figure 6: Right Front Frame Weld

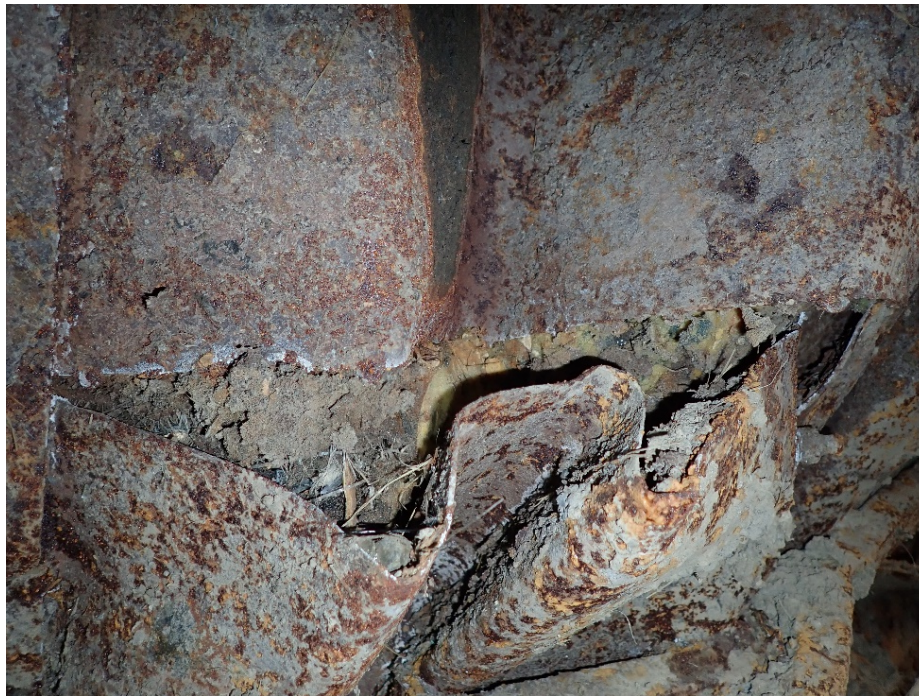
The floorboard of the vehicle showed severe deterioration and was rusted through in locations, leaving openings exposing the interior carpeting. **Figure 7** shows one such opening in the floorboard as viewed from beneath the vehicle.

Figure 7: Opening in Floorboard

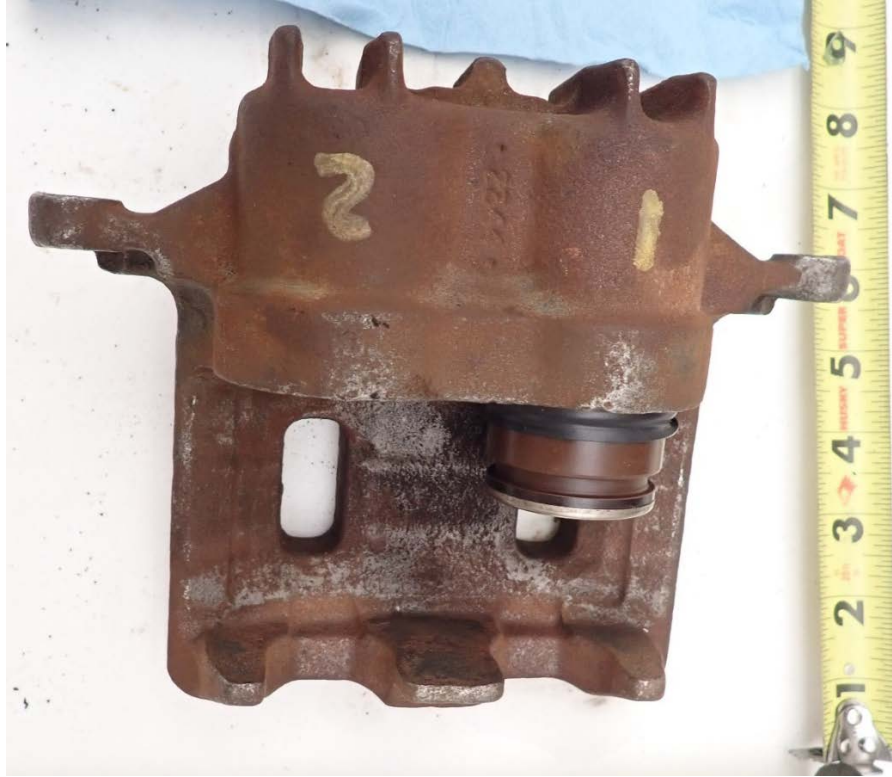
The left rear caliper showed minor oxidation across its surface. There were two phenolic pistons in the caliper.²³ One of the two pistons was missing from the piston bore but was located in the same evidence package. The other piston was extruding from the piston bore and appeared to be seized in place. Superficial striations were noted on the metal disc flange surface of the pistons. **Figure 8** shows the condition of the caliper and pistons at the time of inspection.

Figure 8: The Left Rear Brake Caliper of the Limousine

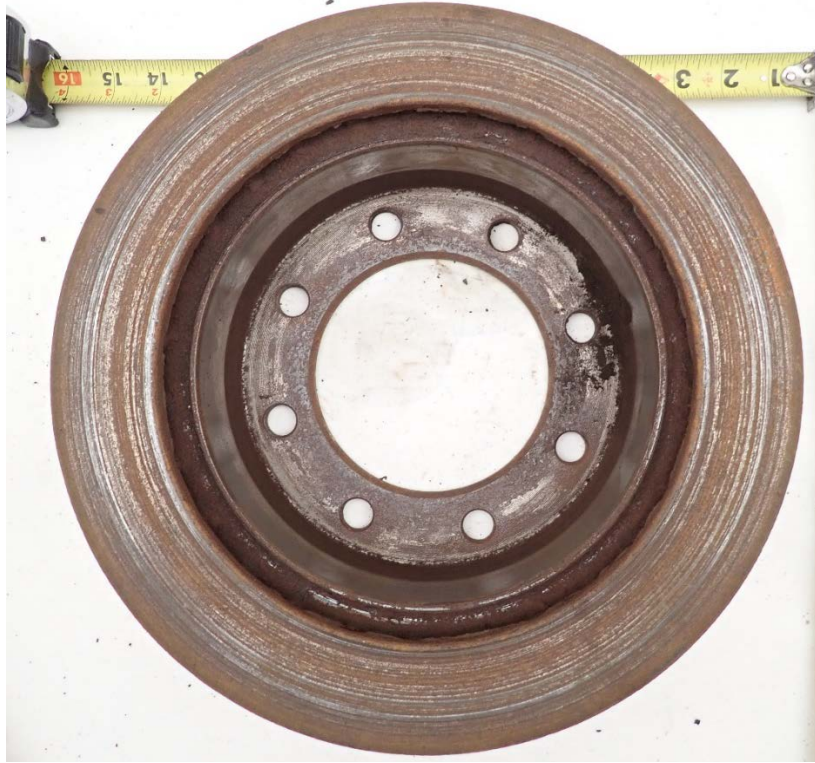
The left rear disc brake rotor was 12.83-inches in diameter with 8 stud holes and was a vented design. Corrosion and significant scoring observed on both the inner and outer swept areas.²⁴ There was heavy corrosion located in the cooling vent vanes between the two swept surfaces. **Figure 9** shows the corrosion and scoring on the swept area of the left rear disc brake rotor.

Figure 9: Left Rear Brake Rotor of the Limousine

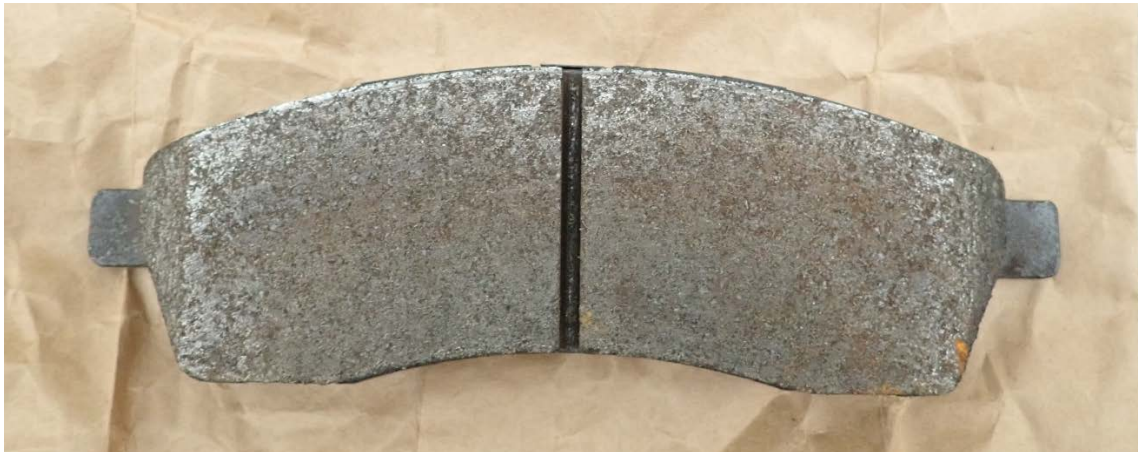
The left rear disc brake pads, both inner and outer, were in good condition with little to no wear evident. Part markings were evident on both. **Figure 10** shows the friction surface of the inner brake pad. **Figure 11** is the metal backing plate of the same pad.

Figure 10: Friction Surface of Left Rear Brake Pad

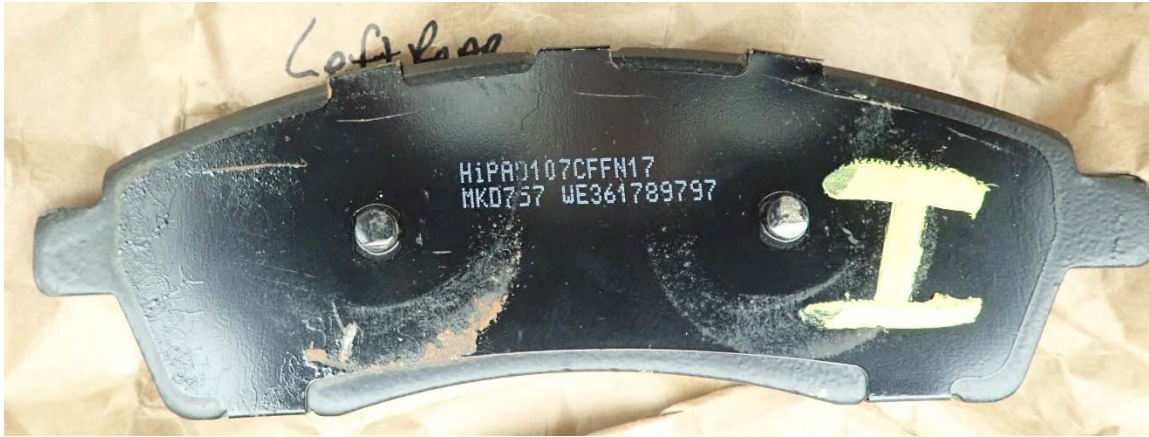
Figure 11: Backing Plate of Left Rear Brake Pad

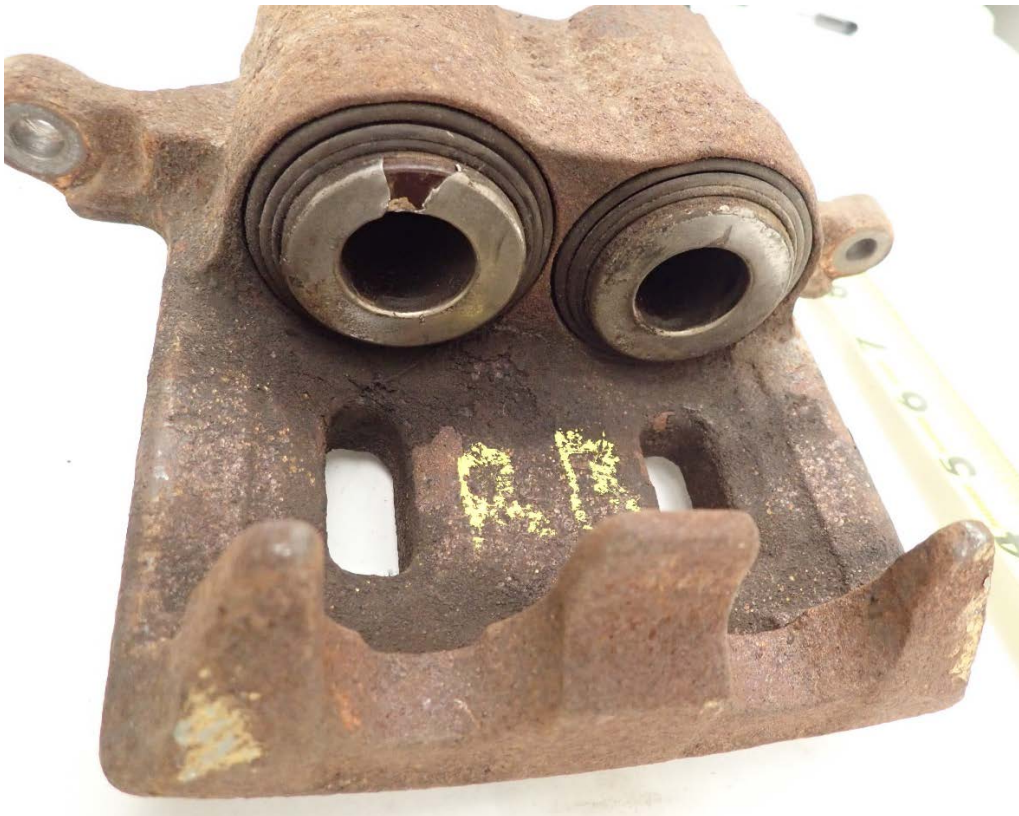
The right rear disc brake caliper showed heavy oxidation across all surfaces. Both pistons were still seated within their respective bores. Light manual manipulation of these pistons resulted in no movement. The metal disc flange surface of both pistons also showed oxidation with one missing a small fragment of the metal. **Figure 12** shows the caliper with the pistons still seated in their respective bores and the missing metal fragment.

Figure 12: Right Rear Disc Brake Caliper

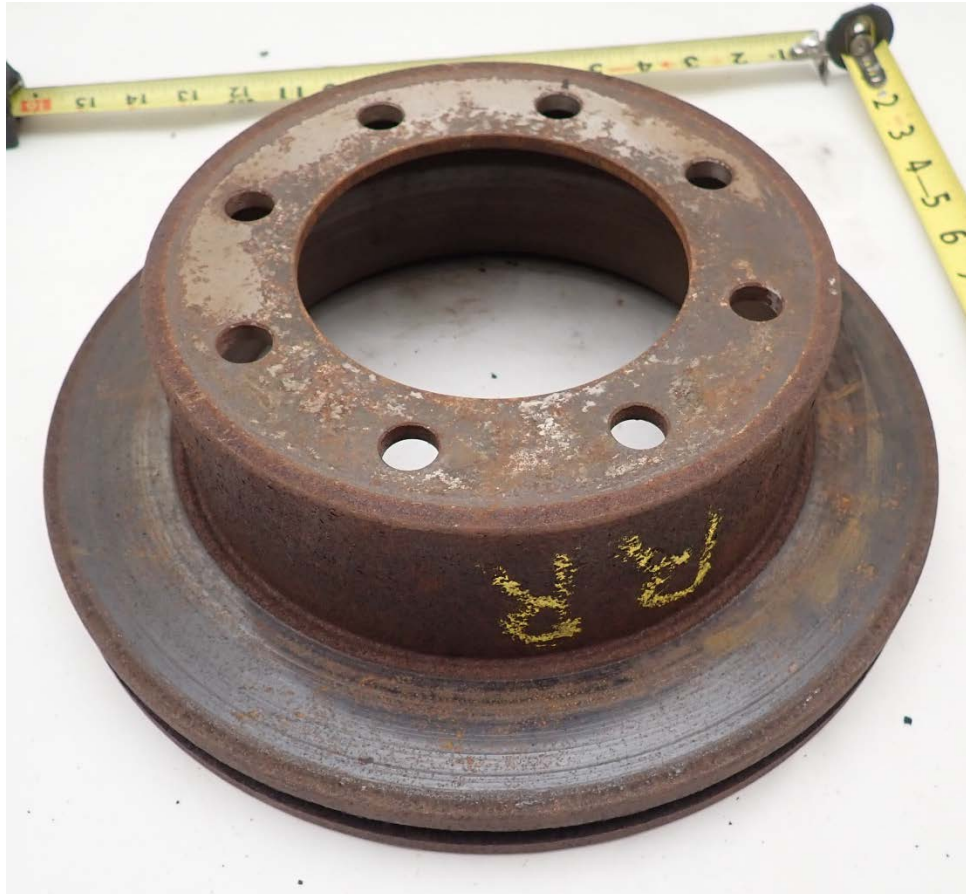
The right rear disc brake rotor was similar in manufacture to the left rear. Both inner and outer swept areas showed corrosion and scoring. There was corrosion in the cooling vent vanes between the two swept surfaces and all other portions of the rotor. **Figure 13** shows the condition of the brake rotor at the time of the NTSB inspection.

Figure 13: Right Rear Brake Rotor of the Limousine

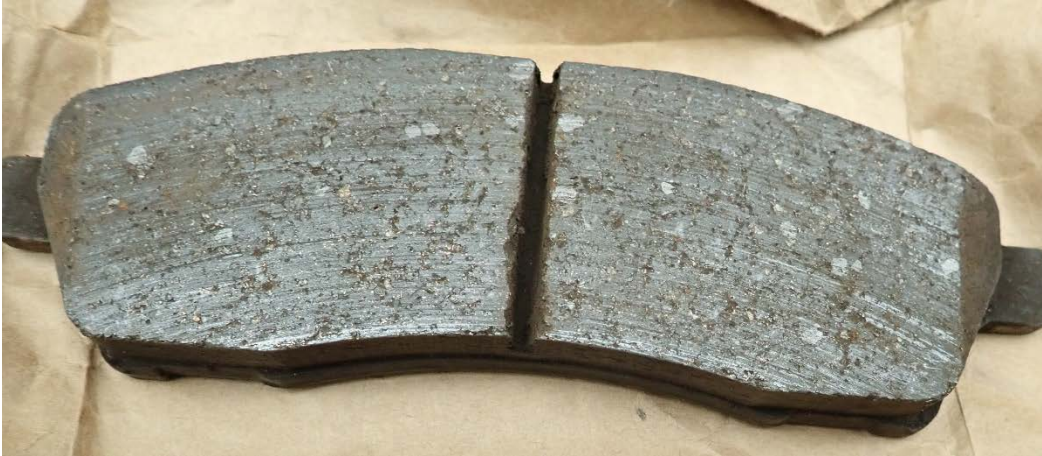
The right rear brake pads were heavily corroded on all metal surfaces and the friction material showed uneven wear. **Figure 14** shows the friction surface of the outer brake pad. **Figure 15** shows the metal backing plate of the same pad.

Figure 14: Right Rear Brake Pad Friction Surface

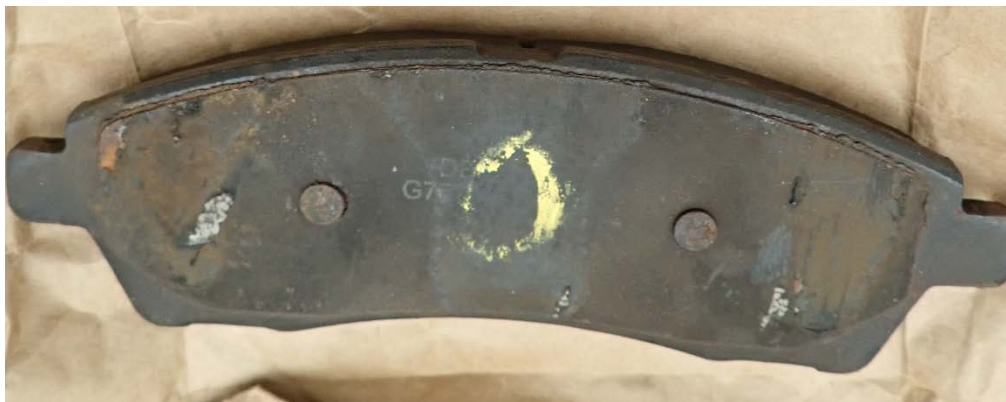
Figure 15: Metal Backing Plate of Right Rear Brake Pad

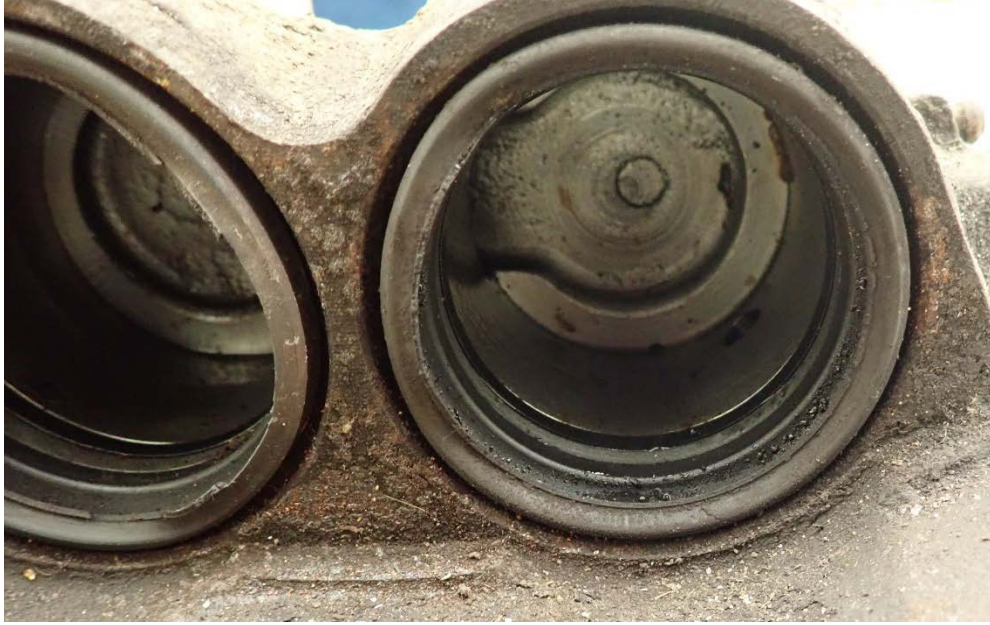
The left front disc brake caliper showed minor oxidation across all metal surfaces. The brake hose fitting was sheared at the housing. The phenolic caliper pistons were not located in the caliper bores and were packaged in individual plastic bags within the same evidence box. Both pistons had slight scoring and the metal disc flange surface showed oxidation. The piston bores had what appeared to be brake fluid and particles contaminating them. There was a burnt odor present when examining the caliper. **Figure 16** shows the interior of one of the caliper piston bores.

Figure 16: Interior of the Left Front Caliper Piston Bores

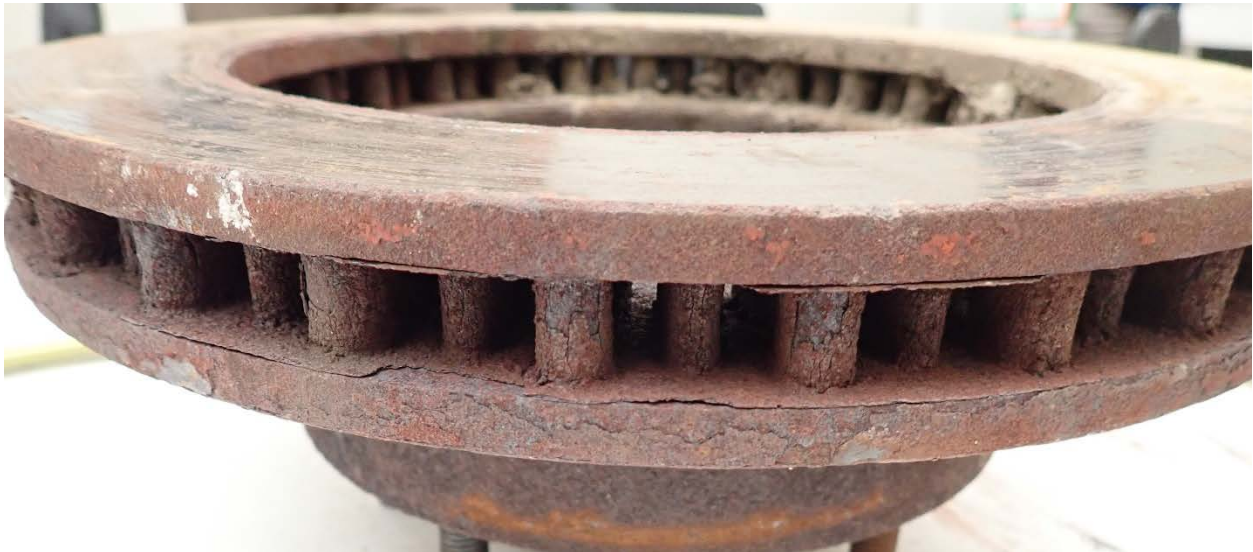
The left front disc brake rotor was 13-inches in diameter with 8 stud holes and was a vented design. There was heavy corrosion in the cooling vent vanes and all areas of the rotor except for the two swept surfaces. There was minor pitting and corrosion present on the swept surfaces and what appeared to be embedded friction material. **Figure 17** shows the corroded vent vanes on the rotor.

Figure 17: Left Front Brake Rotor Vent Vanes

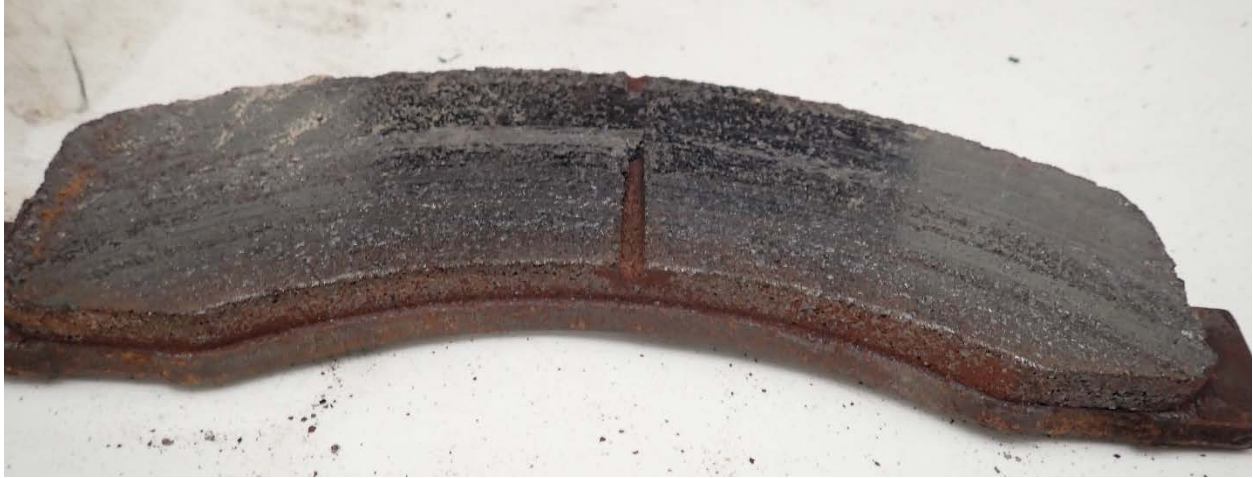
All metal parts of the left front disc brake pads were severely corroded. The pads showed glazing and evidence of deterioration on the friction surface, which was beginning to delaminate from the metal mounting plate. There were uneven wear patterns on both pads. **Figure 18** shows

Figure 18: Friction Surface of Left Front Brake Pad

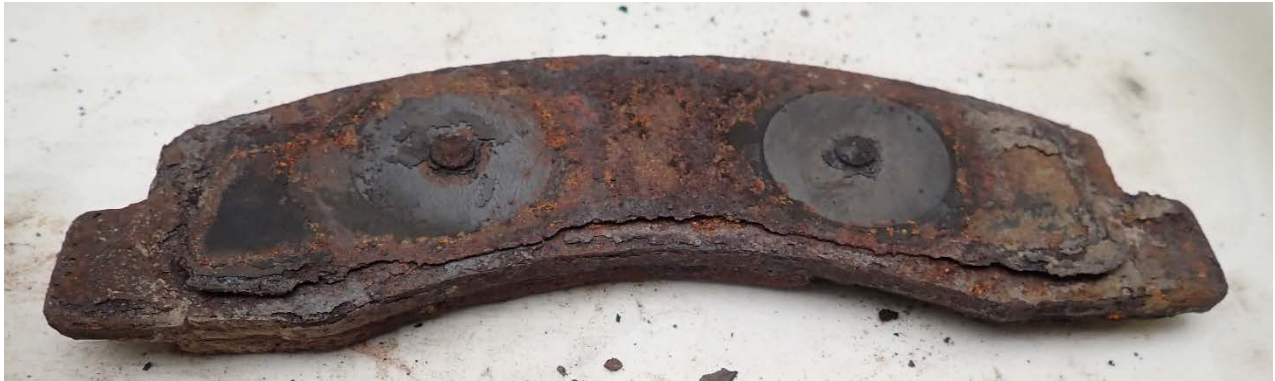
the friction surface of the inner brake pad. **Figure 19** shows the metal backing plate of the same brake pad and the heavy corrosion present.

Figure 19: Metal Backing Plate of Left Front Brake Pad

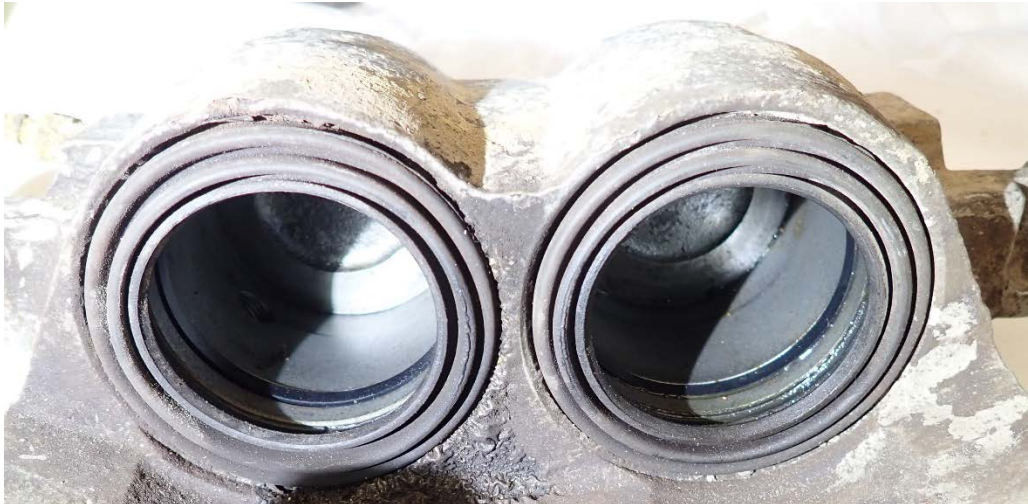
The right front disc brake caliper showed minor oxidation across all metal surfaces. The brake hose fitting was sheared at the housing. The phenolic caliper pistons were not located in the caliper and were packaged in individual plastic bags within the same evidence box. Both pistons had slight scoring and the metal disc flange surface showed heavy oxidation. The piston bores had what appeared to be brake fluid and particles contaminating them. There was a burnt odor present when examining the caliper. **Figure 20** shows the interior of the right front caliper piston bores. **Figure 21** displays the corrosion present on the metal flange of one of the pistons.

Figure 20: Interior of Right Front Caliper Piston Bore

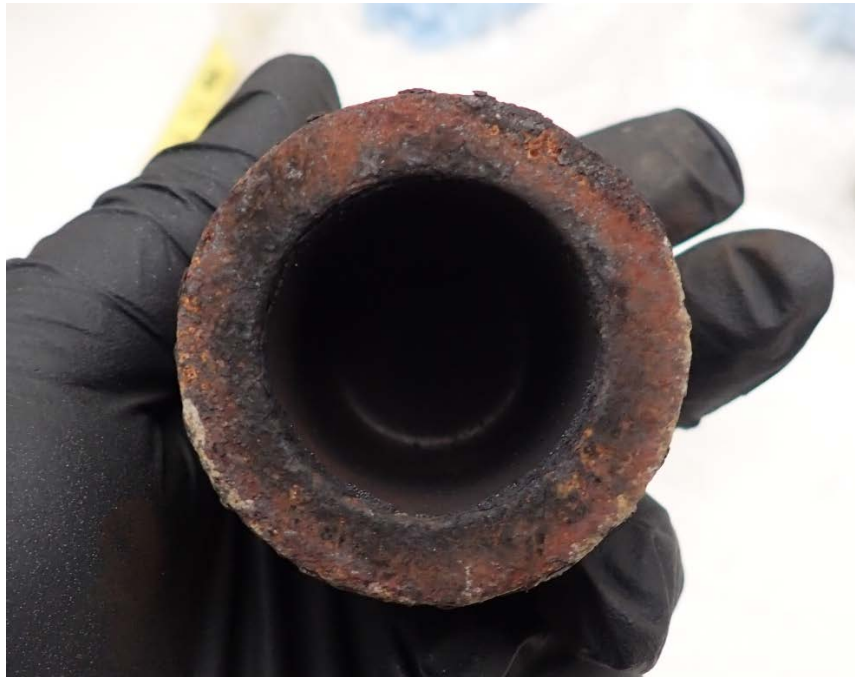
Figure 21: Corroded Right Front Caliper Piston

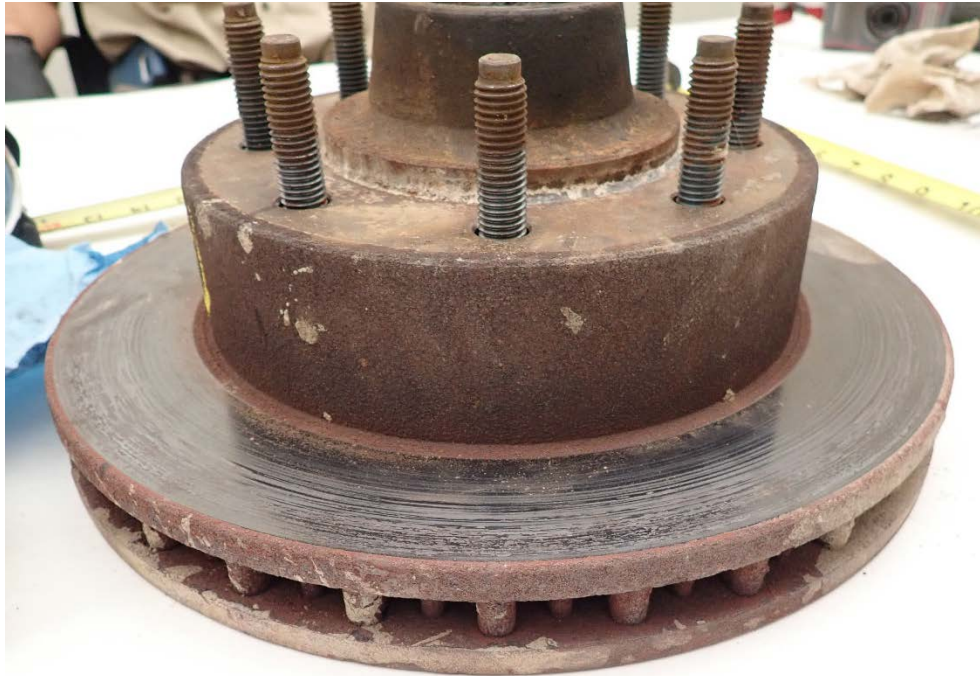
The right front disc brake rotor was similar in manufacture to the left front and was a vented design. There was heavy corrosion in the cooling vent vanes and all areas of the rotor except for the two swept surfaces. There was minor pitting and corrosion present on the swept surfaces and what appeared to be embedded friction material. **Figure 22** is the right front rotor showing the corrosion present in the vent vanes and on the swept surface.

Figure 22: Right Front Disc Brake Rotor

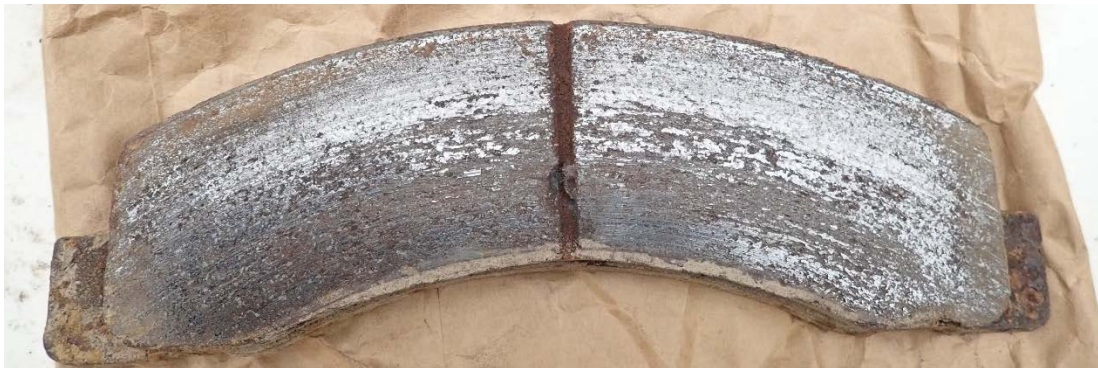
All metal parts of the right front disc brake pads were severely corroded. The pads showed glazing and evidence of deterioration on the friction surface, which was beginning to delaminate from the metal mounting plate. There were uneven wear patterns on both pads. **Figure 23** shows the friction surface of the inner brake pad. **Figure 24** is the metal backing plate of the same pad.

Figure 23: Inner Pad Friction Surface from Right Front Brake

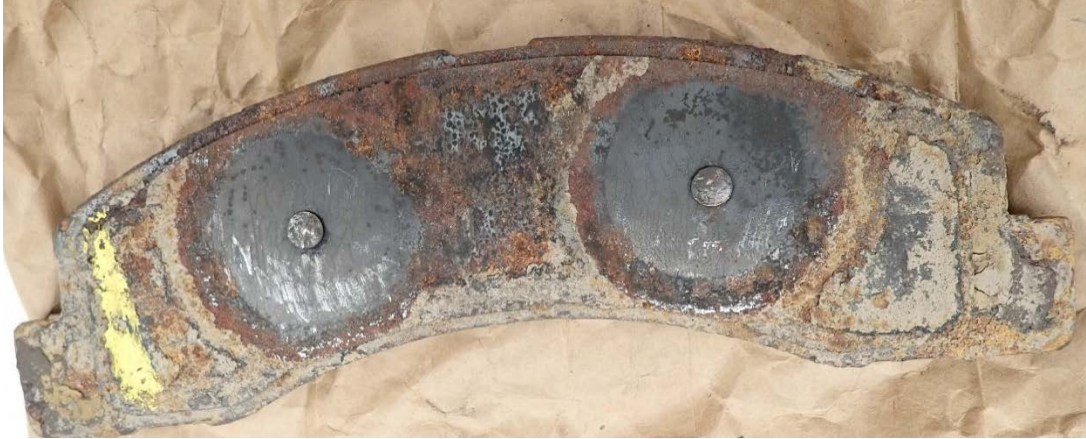
Figure 24: Metal Pad Backing Plate from Right Front Brake

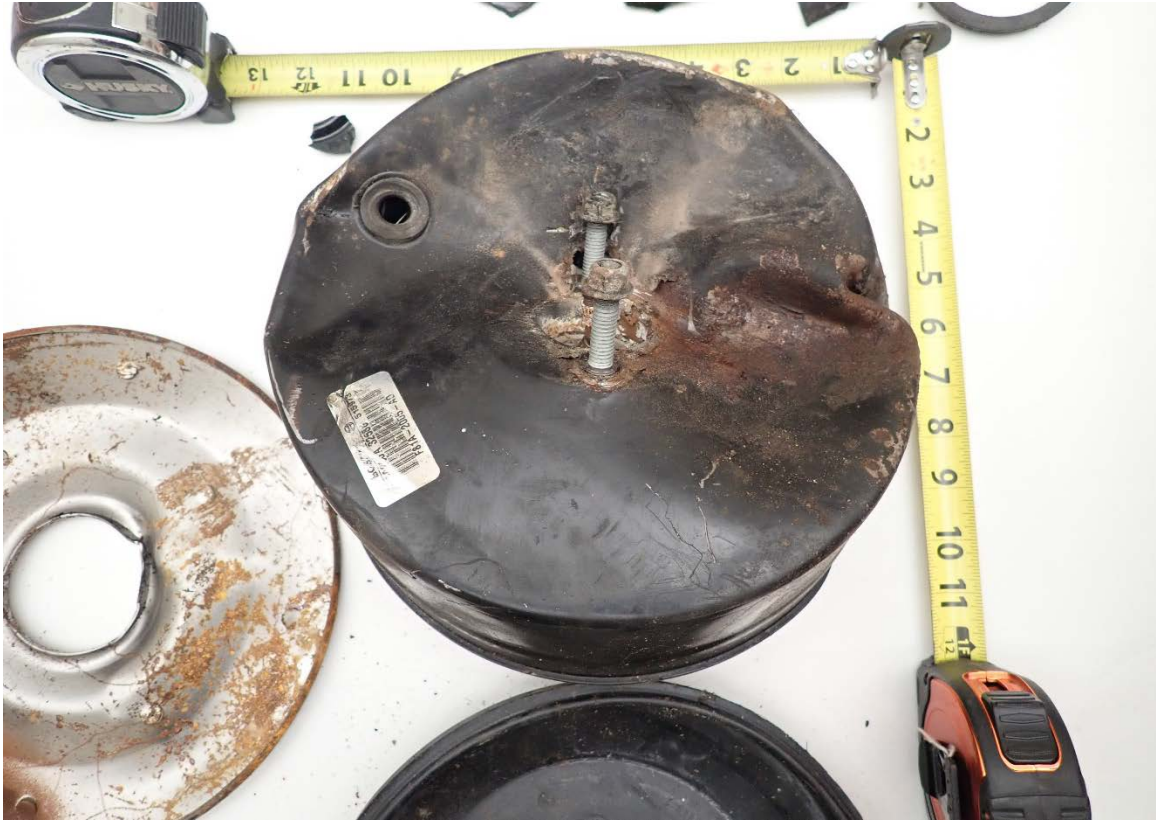
The limousine was equipped with a split service, tandem master cylinder assisted by a power brake vacuum booster.²⁵ The brake system master cylinder and the power brake vacuum booster were damaged in the crash. The brake fluid reservoir was separated from the master cylinder and had a small puncture in the side. The vacuum booster housing was deformed. **Figure 25** shows the damaged vacuum booster. **Figure 26** is the brake fluid reservoir showing the puncture to the side.

Figure 25: Damaged Brake Vacuum Booster

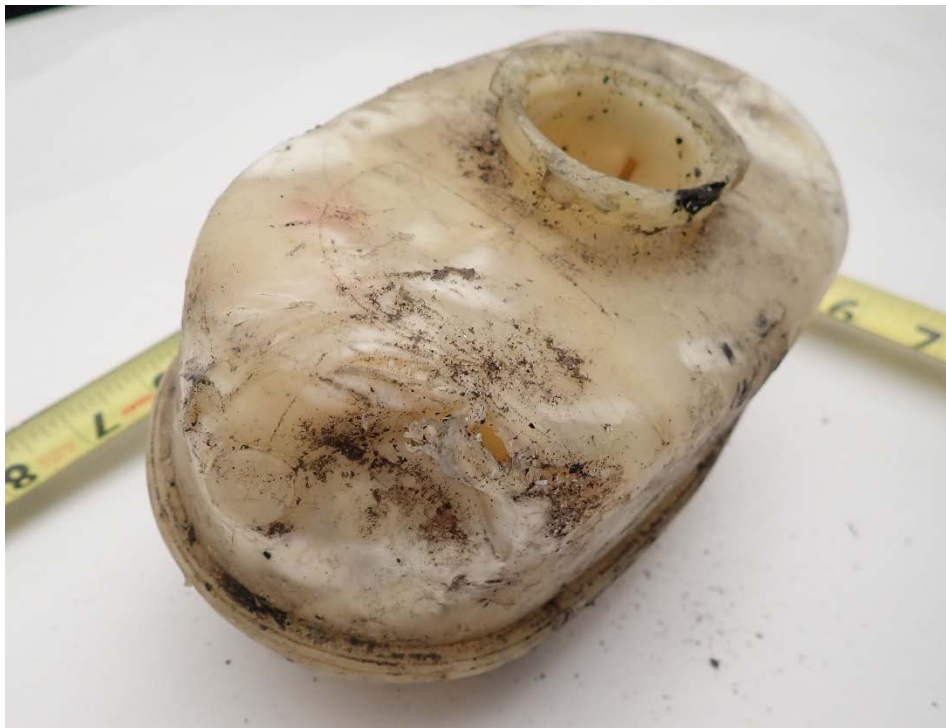
Figure 26: Limousine's Brake Fluid Reservoir

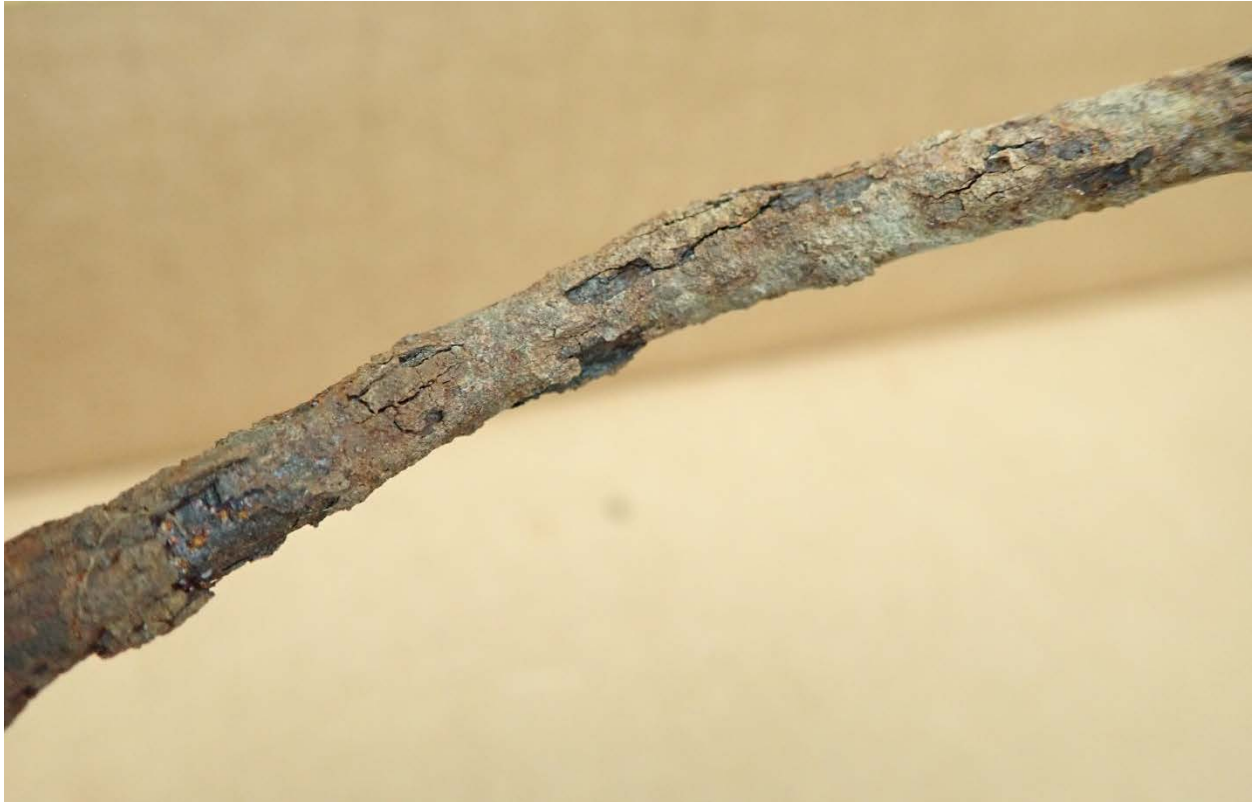
The steel brake tubing crossing over the rear differential was severely corroded with a crimp in the tubing near the connection with the right rear flexible brake hose. One portion of the tubing appeared to still be coated with brake fluid at the time of the inspection. **Figure 27** shows the corrosion present on the tubing at the time of the inspection. **Figure 28** is the brake tubing with arrows pointing to the crimp. A coating of brake fluid is evident on the tubing. **Figure 29** is another view of the corrosion with brake fluid coating the tubing.

Figure 27: Corroded Steel Tubing Removed from Rear Brakes of Limousine

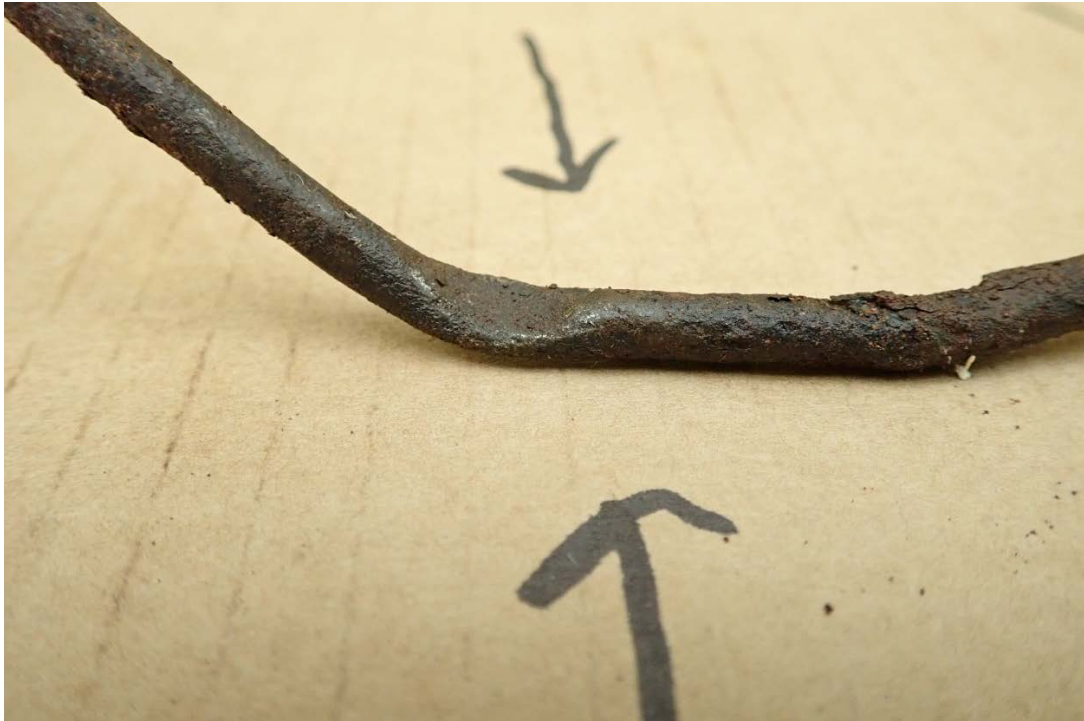
Figure 28: Crimped and Corroded Steel Tubing from Limousine Brake System

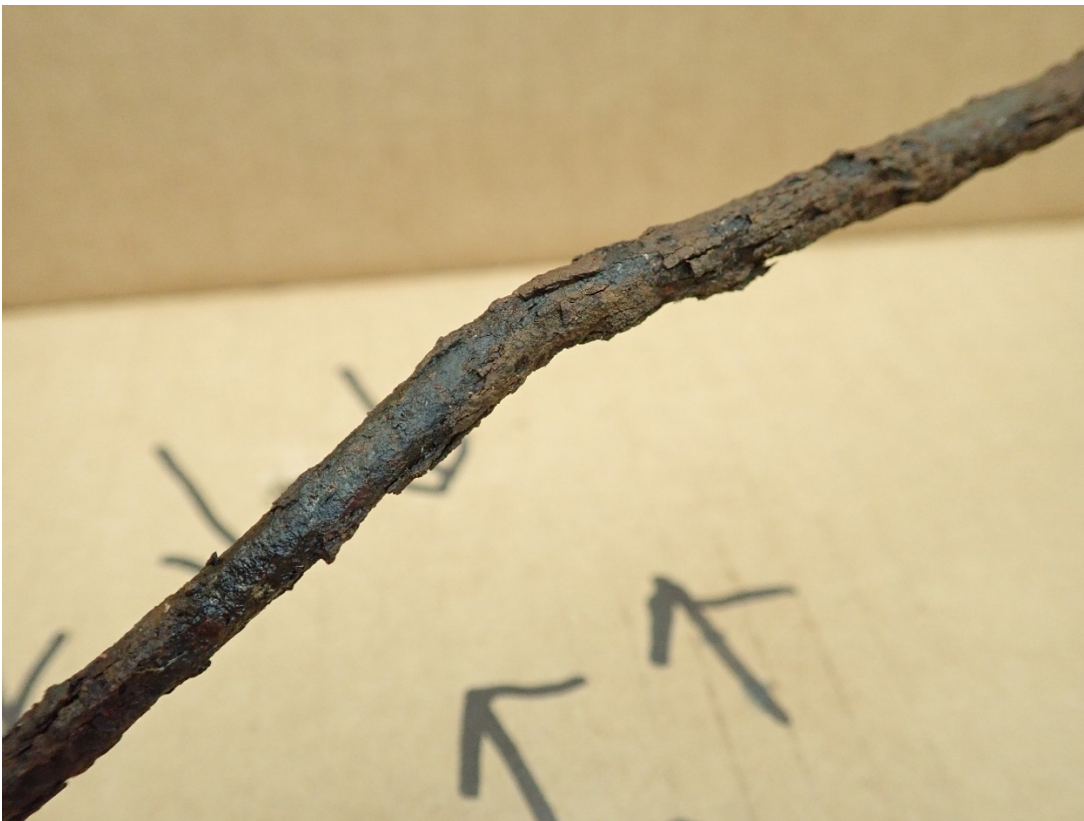
Figure 29: Corroded Steel Tubing with Brake Fluid Coating

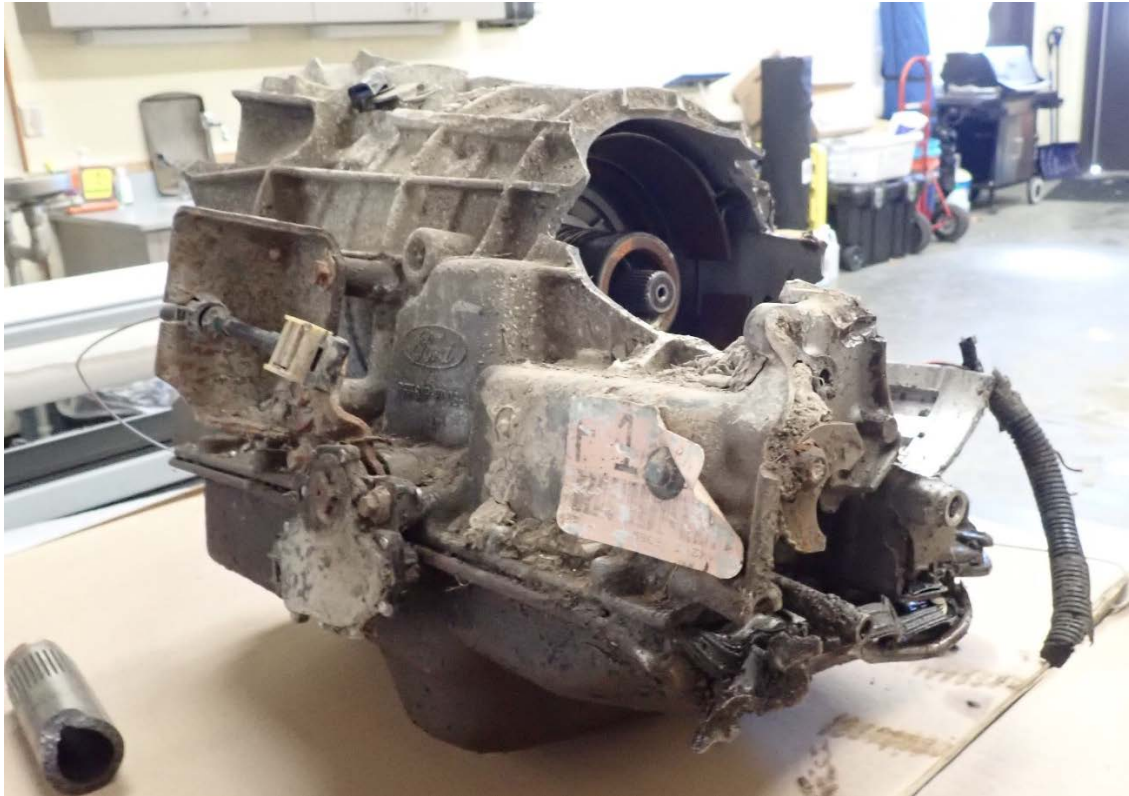
The automatic transmission was damaged, fractured into several pieces, and found under the vehicle. The transmission main case and extension housing were separated. There was severe wear to the transmission bushings and the forward clutch friction disc showed very little friction material remaining. This was taken into evidence by the NYSP and an analysis was performed by their expert. **Figure 30** shows the fractured transmission main case. **Figure 31** is the transmission output shaft photographed near the vehicle on October 8, 2019.

Figure 30: Fractured Transmission Main Case of Limousine
