**NATIONAL TRANSPORTATION SAFETY BOARD
OFFICE OF HIGHWAY SAFETY
WASHINGTON, D.C.**

**VEHICLE FACTORS GROUP CHAIRMAN'S
FACTUAL REPORT**

Vehicle 1: 2001 Ford Excursion "Stretch" Limousine

NTSB #: **HWY19MH001**

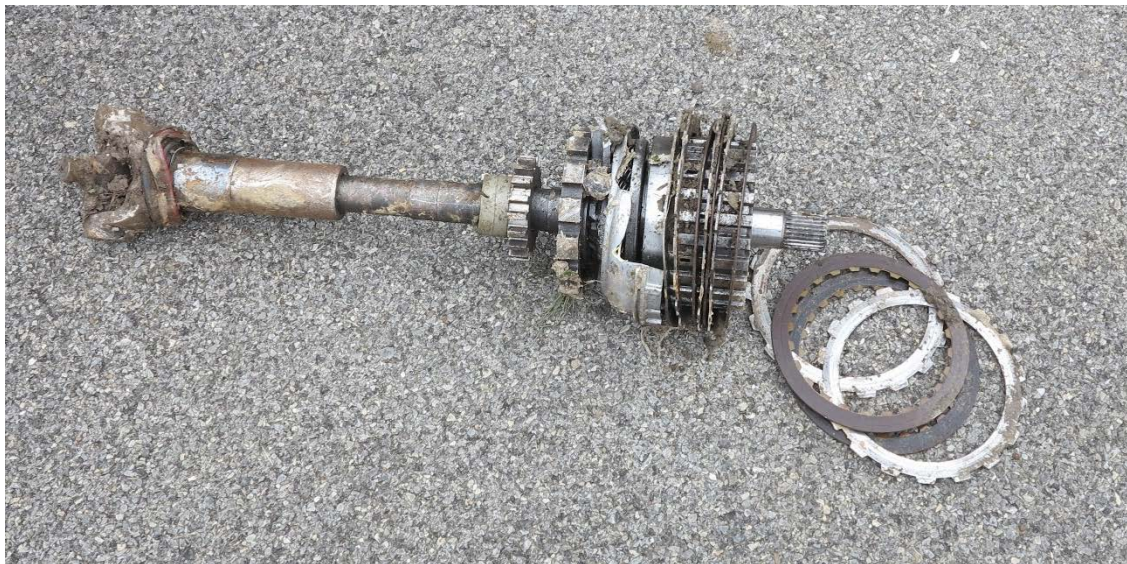
Figure 31: Transmission Output Shaft

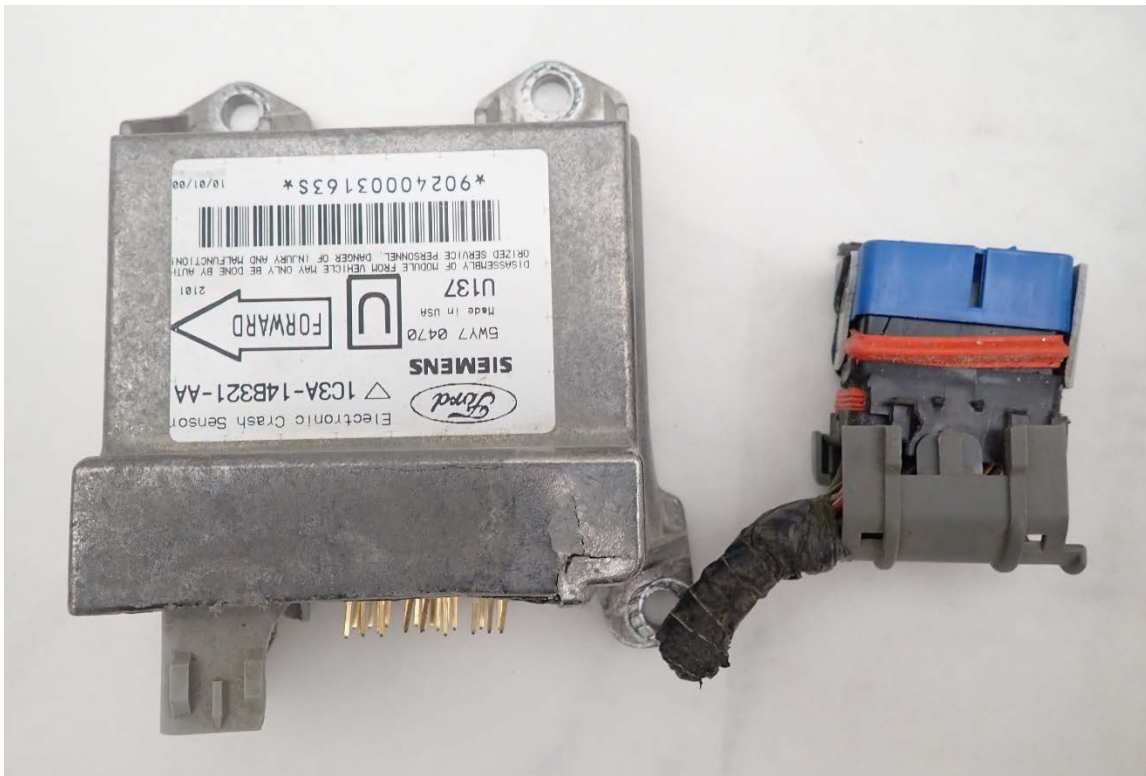
Figure 32: Damaged ACM from Ford Limousine

The data from the limousine ACM was limited in nature due to the age of the vehicle. The recorded event included 106 milliseconds of longitudinal acceleration and a cumulative change in velocity (delta-V) of 29.36 miles per hour.

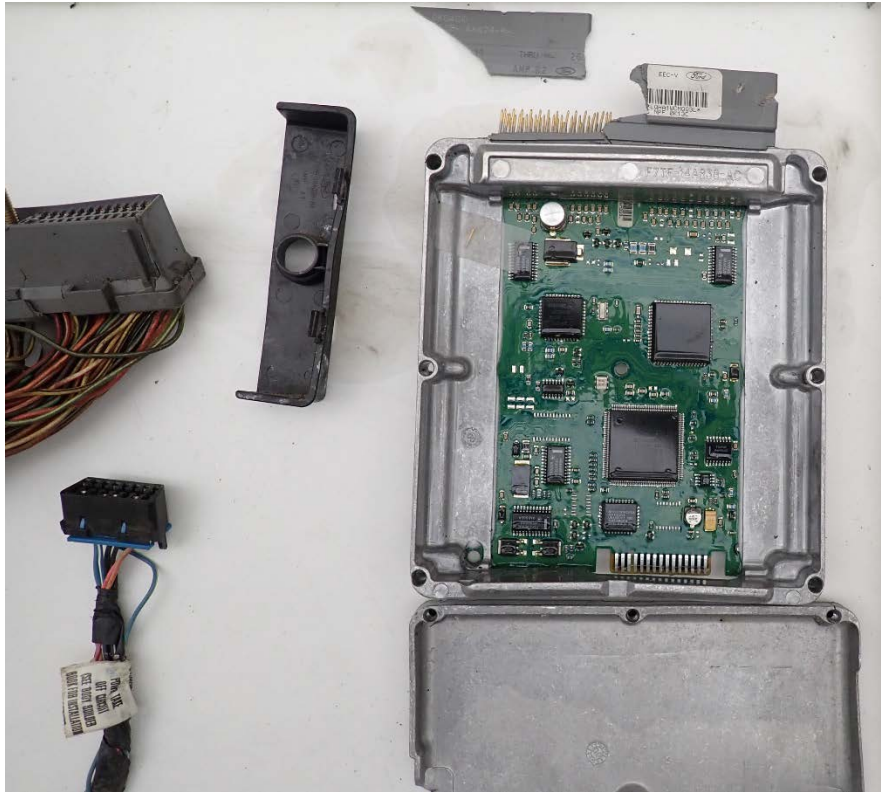
The damaged engine powertrain control module (PCM) was also removed by the NYSP who attempted to access any data it may contain. No information was recovered from the module. **Figure 33** is the Ford PCM from the limousine.

Figure 33: Ford PCM Obtained from Limousine

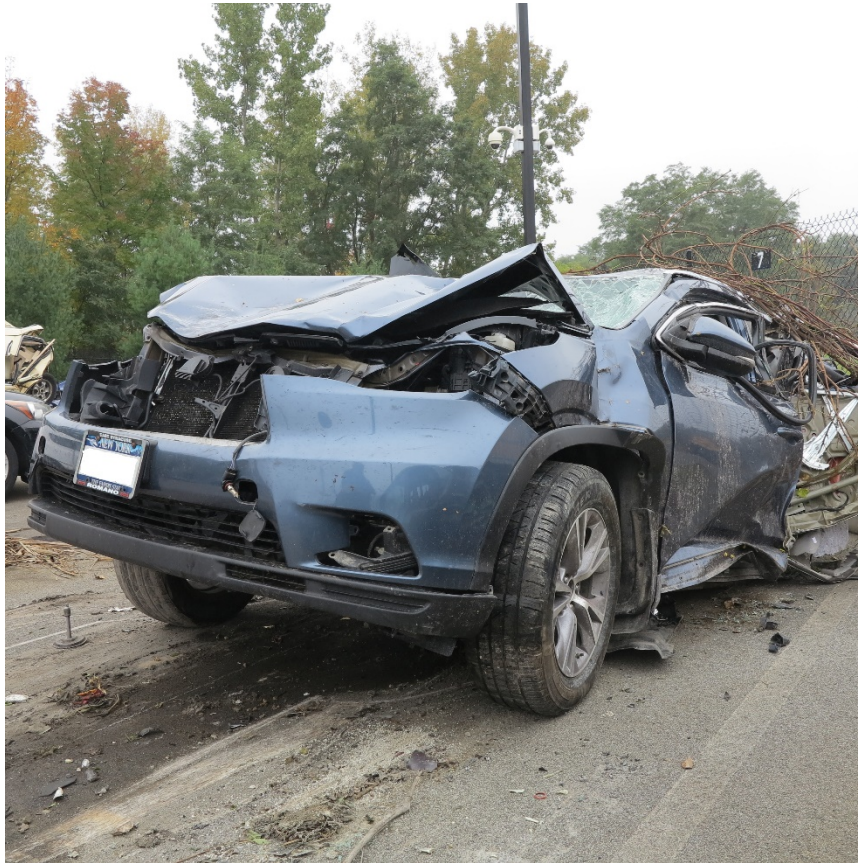
There was contact damage to both the front and rear of the Toyota. The radiator and hood were displaced rearward, and the hood folded upward. The front bumper was damaged, but intact and in place. The windshield was shattered, but in place. The driver's door was jammed in a partially open position and there was damage and distortion to the bottom portion of the door. The door window was missing. The left rear passenger door sheet metal was torn away from the vehicle. **Figure 33** shows the damage as seen from the left front corner of the Toyota.

Figure 34: Left Front View 2015 Toyota Highlander

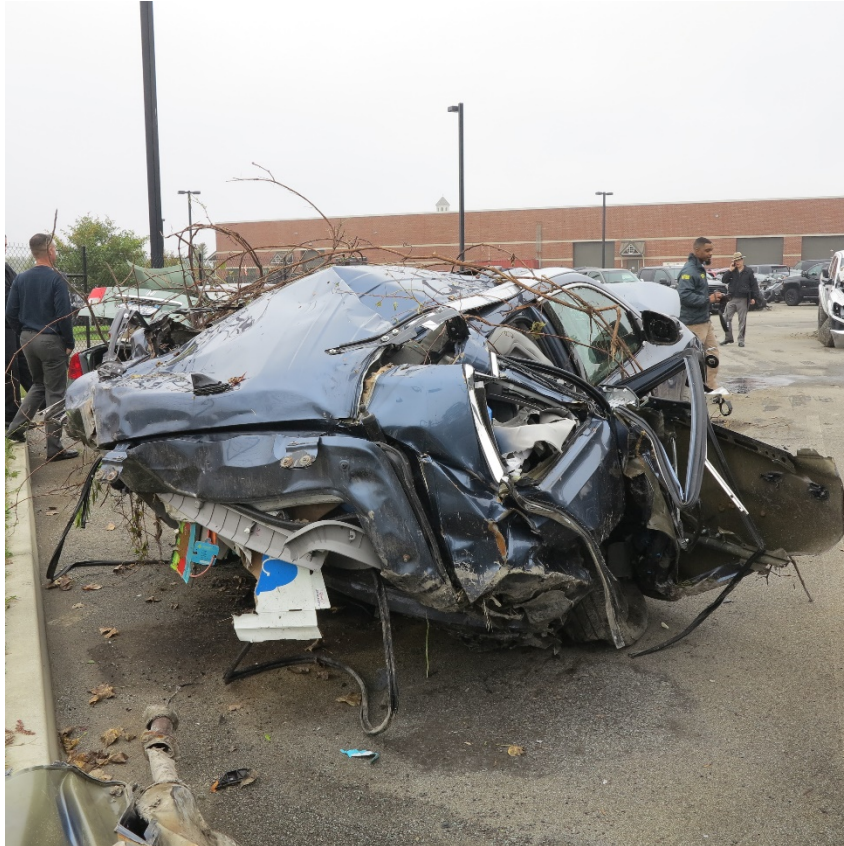
The rear of the Toyota was displaced forward, and the rear axle was under the “B” pillar of the vehicle. The top of the rear hatch was displaced forward to the “C” pillar. The right rear passenger door was crushed and distorted forward. The right front passenger door was jammed in place, but with minor damage and the glass was intact. The roof was folded forward and the sunroof frame was distorted, and the glass was missing. **Figure 34** shows the damage as seen from the right rear corner of the Toyota.

Figure 35: Right Rear View 2015 Toyota Highlander
