NTSB Vehicle Photos

Schoharie, New York HWY19MH001

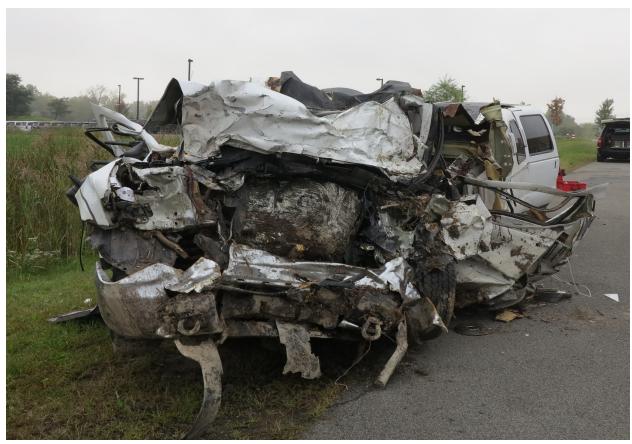
Vehicle Photograph: 1- 2001 Ford Excursion Limousine – Overall damage view facing left front corner.

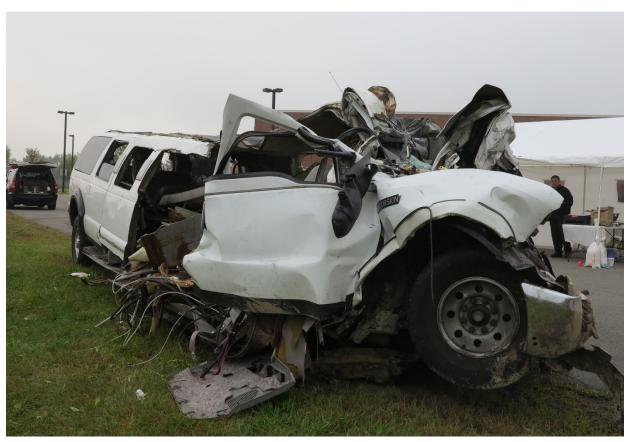
Vehicle Photograph: 2 - 2001 Ford Excursion Limousine – Overall damage view facing right front corner.

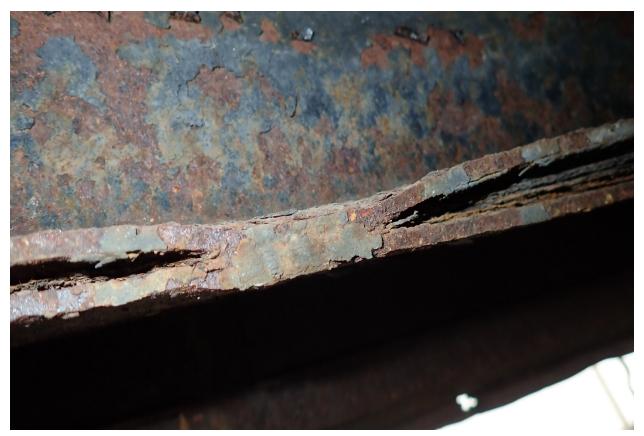
Vehicle Photograph: 3 - 2001 Ford Excursion Limousine – Image shows a spot weld joining the two frame rails.

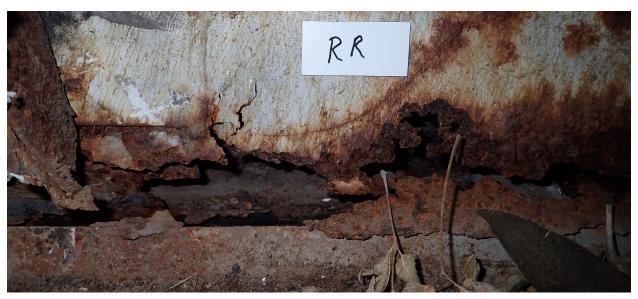
Vehicle Photograph: 4 - 2001 Ford Excursion Limousine – Image documents the severe corrosion present on the right rear of the vehicle chassis.

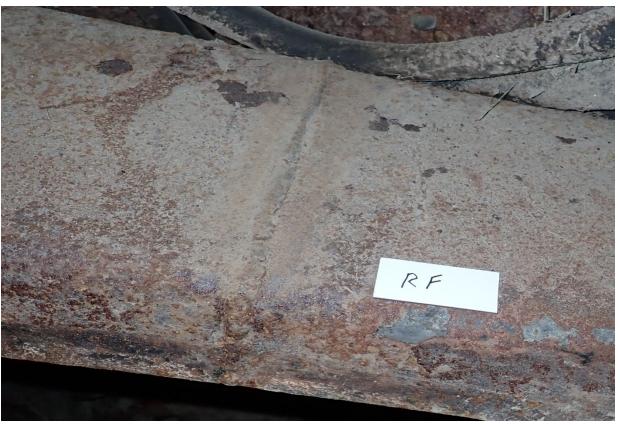
Vehicle Photograph: 5 - 2001 Ford Excursion Limousine – Image shows the weld joining the extension frame rail to the original frame rail at the right front of the vehicle.

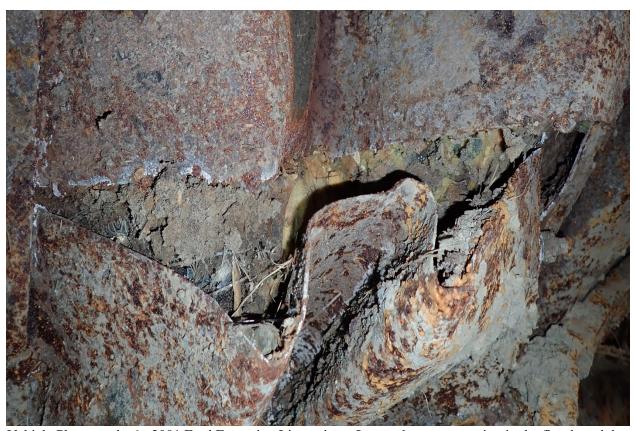
Vehicle Photograph: 6 - 2001 Ford Excursion Limousine – Image shows an opening in the floorboard due to corrosion. Interior carpet can be seen through the hole.

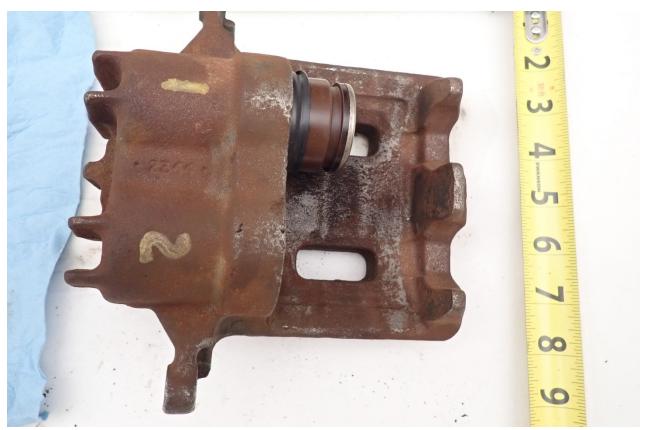
Vehicle Photograph: 7 - 2001 Ford Excursion Limousine – Left rear brake caliper showing one piston partially extruding from the piston bore.

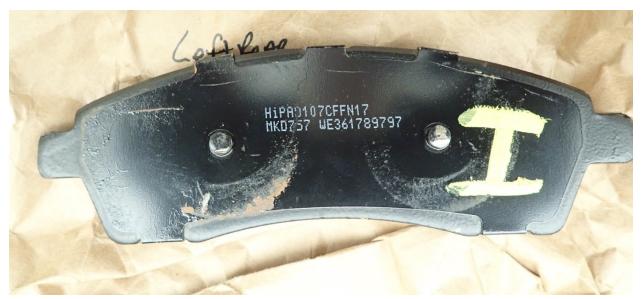
Vehicle Photograph: 10 - 2001 Ford Excursion Limousine – Image shows the backing plate of the left rear brake pad. It is in good condition and identifying markings are present.

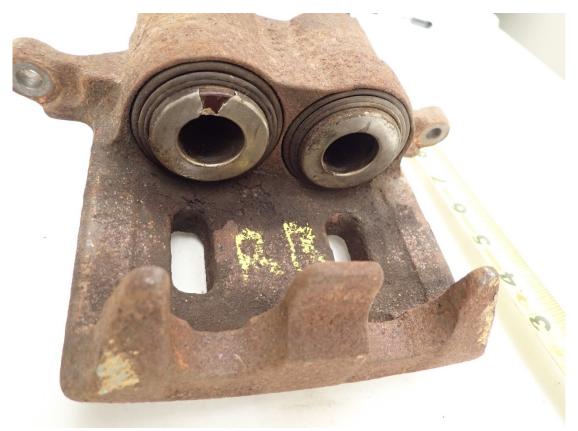
Vehicle Photograph: 11- 2001 Ford Excursion Limousine – Image shows the right rear disc brake caliper and damage to one of the pistons.

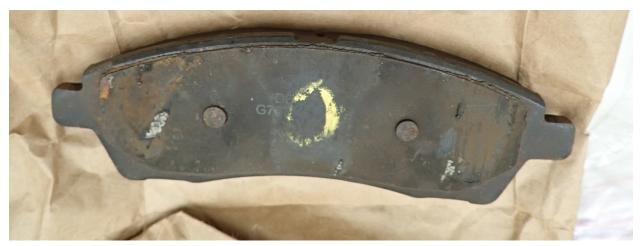
Vehicle Photograph: 14 - 2001 Ford Excursion Limousine: - Image shows the worn condition of the right rear brake pad backing plate.

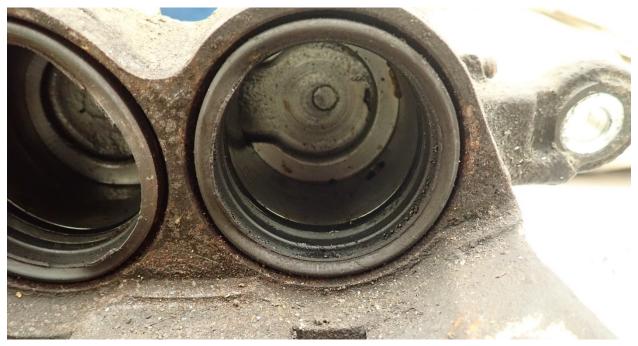
Vehicle Photograph: 15 - 2001 Ford Excursion Limousine – Image shows debris in the interior of the left front caliper piston bores.

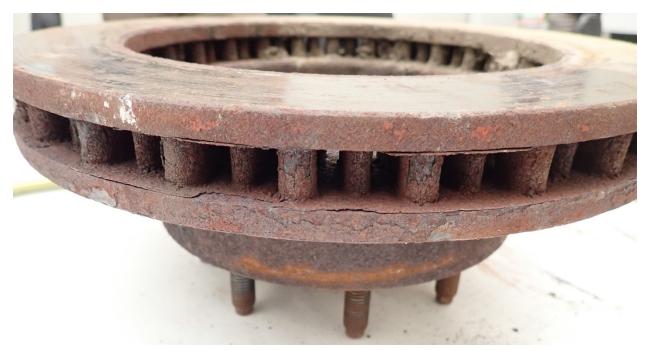
Vehicle Photograph: 16 - 2001 Ford Excursion Limousine – Image shows the corrosion present on the left front brake rotor vent vanes.

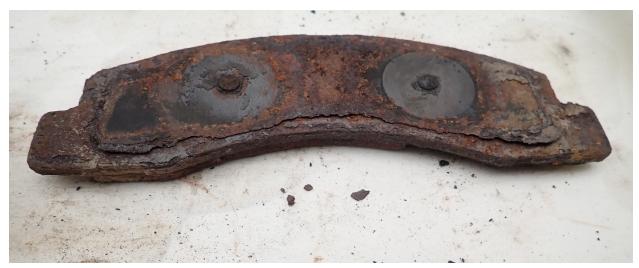
Vehicle Photograph: 18 - 2001 Ford Excursion Limousine – Image shows the severely deteriorated metal backing plate of the left front brake pad.

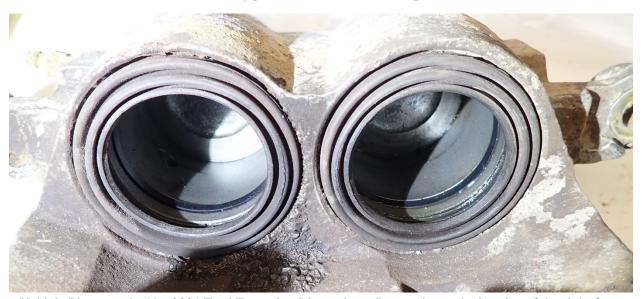
Vehicle Photograph: 19 - 2001 Ford Excursion Limousine – Image shows the interior of the right front caliper piston bore.

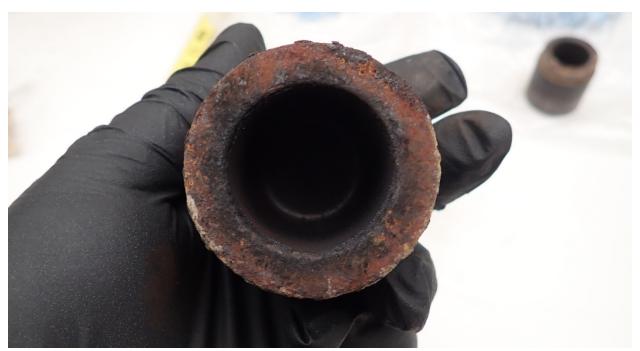
Vehicle Photograph: 20 - 2001 Ford Excursion Limousine – Image shows the severely corroded right front caliper piston shield.

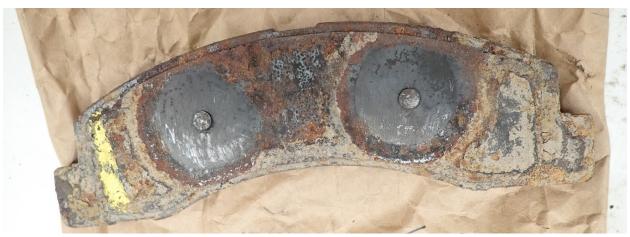
Vehicle Photograph: 23- 2001 Ford Excursion Limousine - Image shows the severely deteriorated metal backing plate of the right front brake pad.

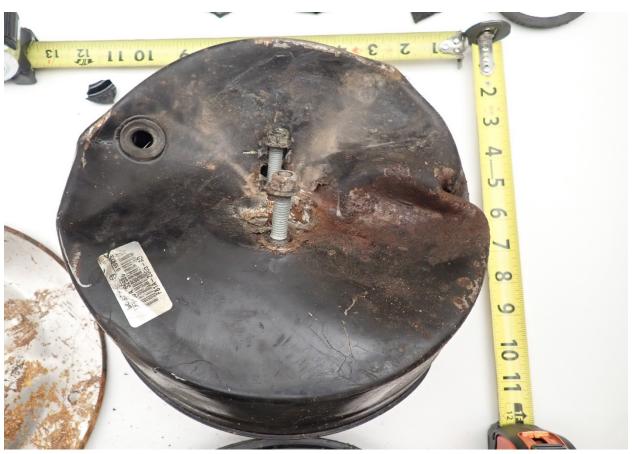
Vehicle Photograph: 24 - 2001 Ford Excursion Limousine - Damaged brake vacuum booster.

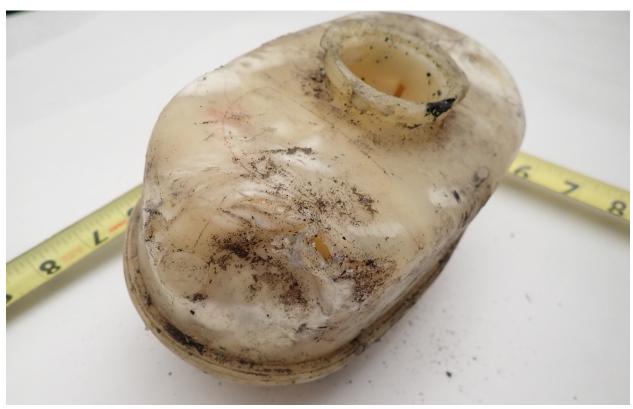
Vehicle Photograph: 25 - 2001 Ford Excursion Limousine – Damaged brake fluid reservoir.

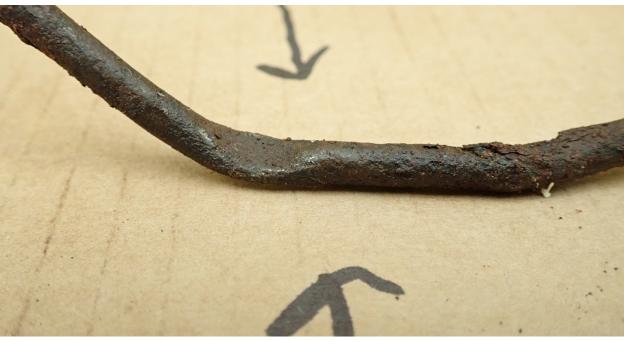
Vehicle Photograph: 27 - 2001 Ford Excursion Limousine – Image shows a crimp in the rear hydraulic brake tubing with corrosion present.

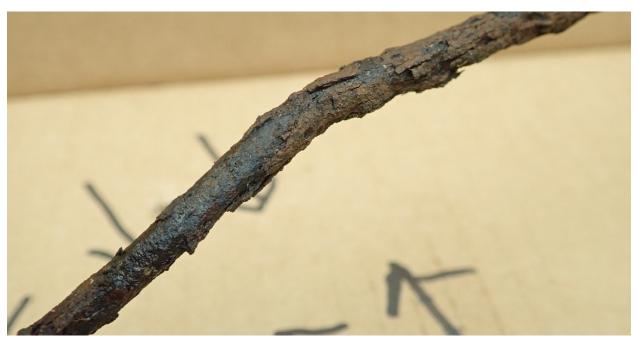
Vehicle Photograph: 28 - 2001 Ford Excursion Limousine – Image shows a portion of the corroded steel brake tubing with a coating of brake fluid.

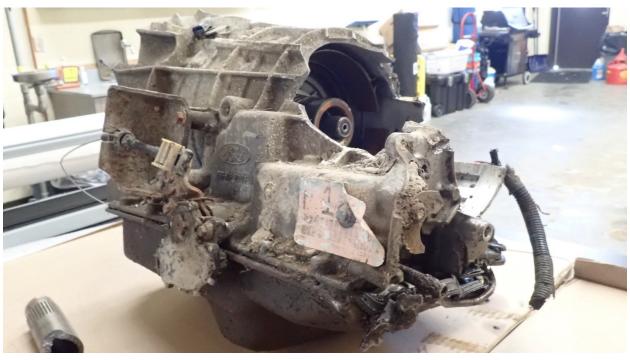
Vehicle Photograph: 29 - 2001 Ford Excursion Limousine - Fractured transmission main case.

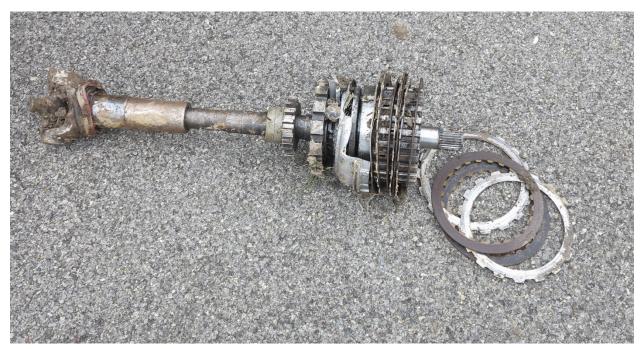
Vehicle Photograph: 30 - 2001 Ford Excursion Limousine – Image shows the damaged transmission output shaft which was displaced from the vehicle during the crash.

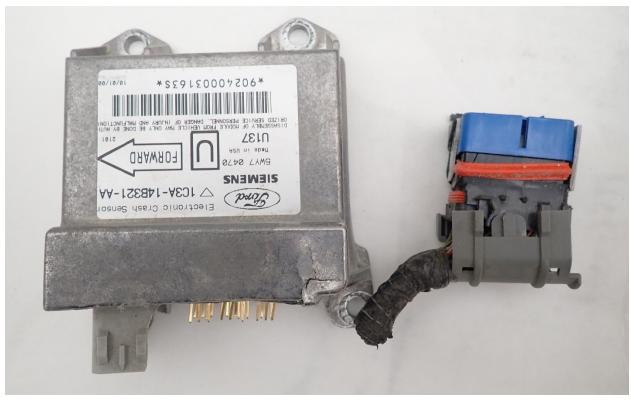
Vehicle Photograph: 31- 2001 Ford Excursion Limousine – Damaged Ford airbag control module.

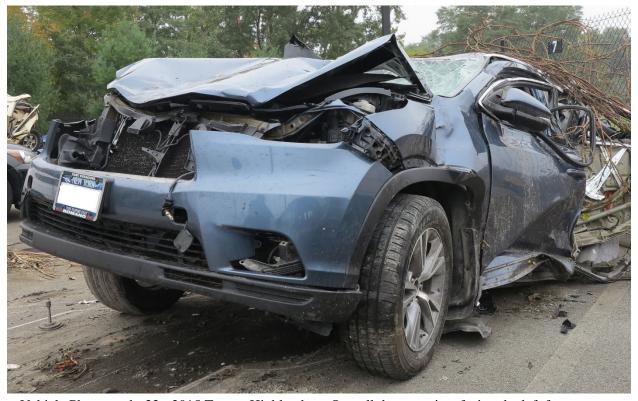
Vehicle Photograph: 33 - 2015 Toyota Highlander – Overall damage view facing the left front corner.

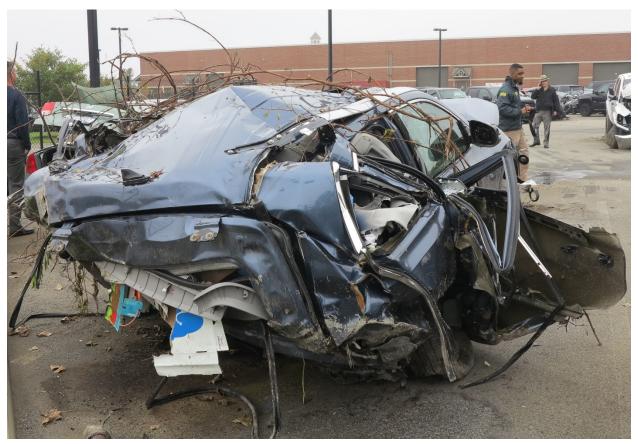
Vehicle Photograph: 34 - 2015 Toyota Highlander – Overall damage view facing the right rear corner.
