National Transportation Safety Board

RRD23FR001

SECURITY CAMERA

Specialist's Factual Report

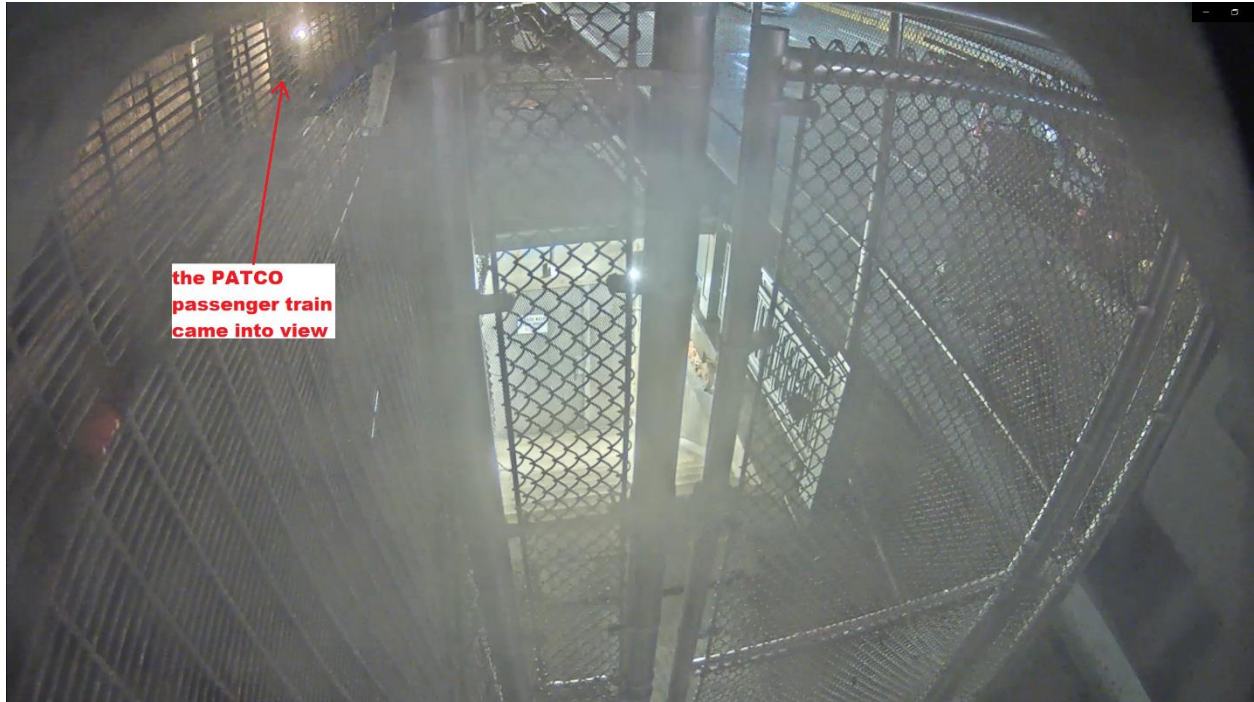
Figure 1. A screenshot of the field-of-view of the camera of the security video file #1 at 21:21:19.

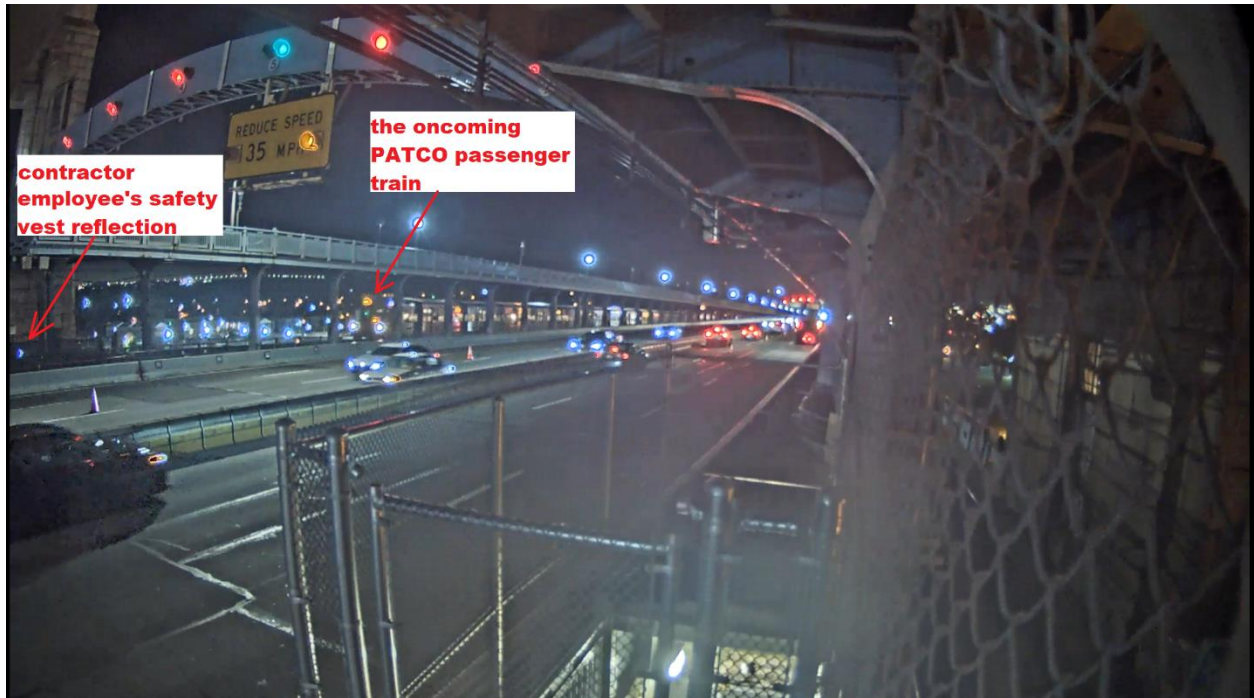
Figure 2. A screenshot of the field-of-view of the camera of the security video file #2 at 21:21:20.
