Accident Site Diagram  
CEN19FA104  
N4MH WW24, Sundance Airport (KHSD) Yukon, OK  
18 March, 2019

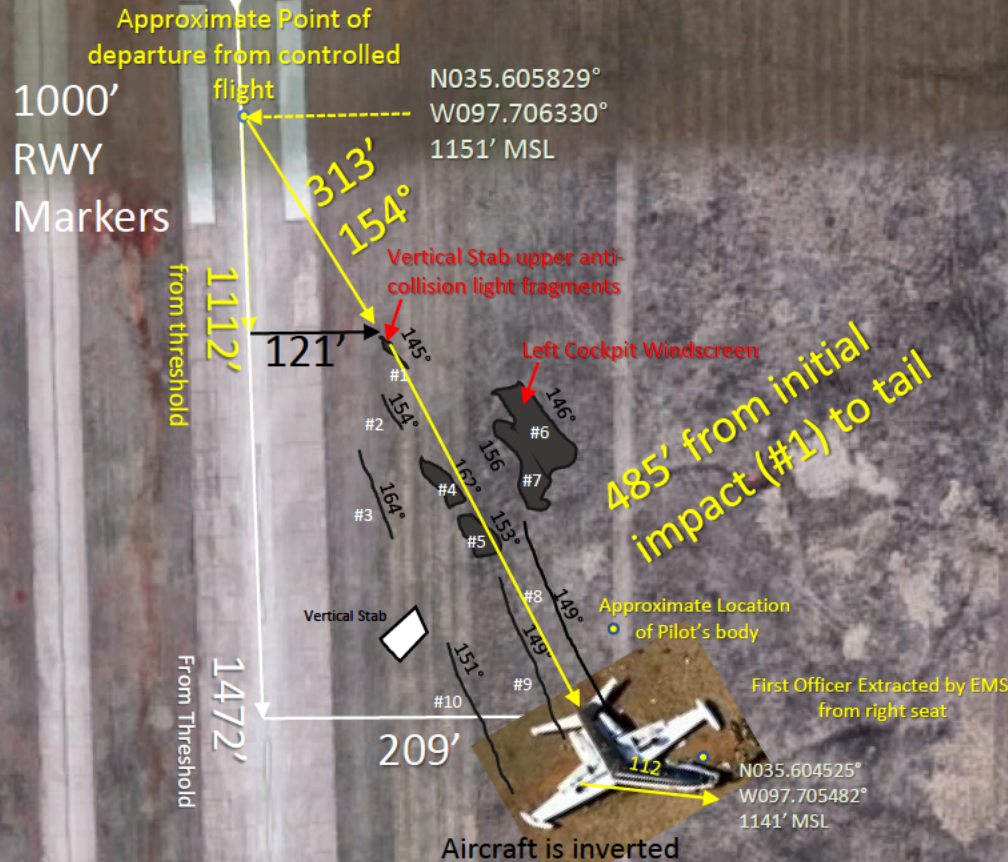
- GPS locations = ●
- All degrees Magnetic
- All depicted impact marks and drawn locations are approximate
