National Transportation Safety Board

WPR22FA361

ACCIDENT SITE SURVEY

Location:Sahuarita, ArizonaDate:September 28, 2022Time:0900 mountain standard timeAirplane:Grumman American AVN AA5B

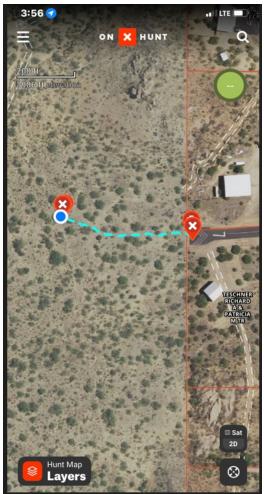
Figure 1. Image provided by the volunteer investigator in charge. The airplane's resting locating is indicated by a blue dot.

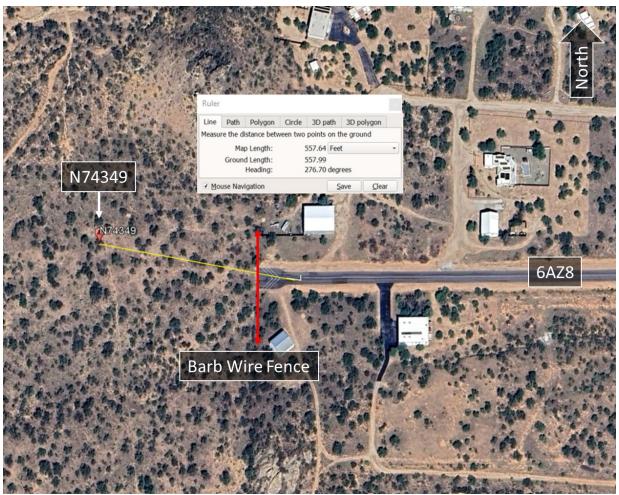
Figure 2. Goggle Earth view of the accident site, 6AZ8, and the barbed wire fence.

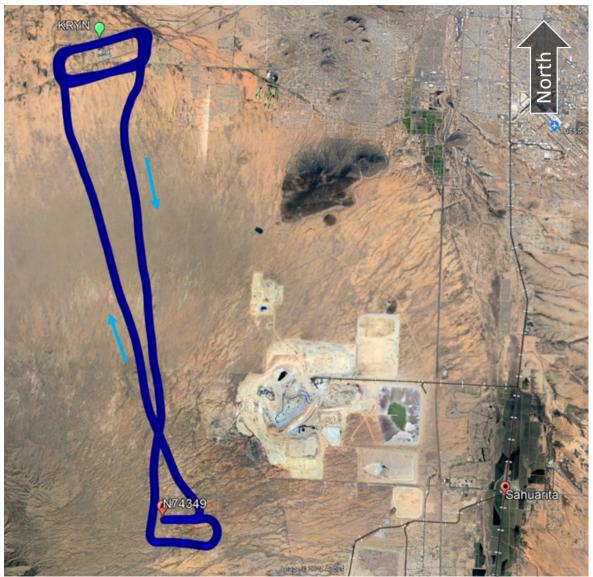
Figure 3. ADS-B overlay. The direction of travel is indicated with blue arrows.

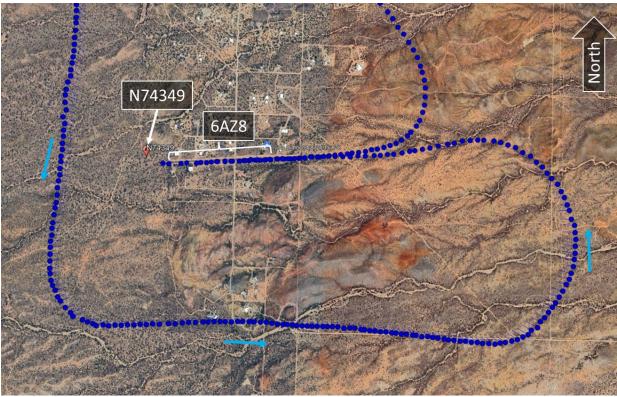
Figure 4. Close up view of the ADS-B track, showing the shape of the traffic pattern.

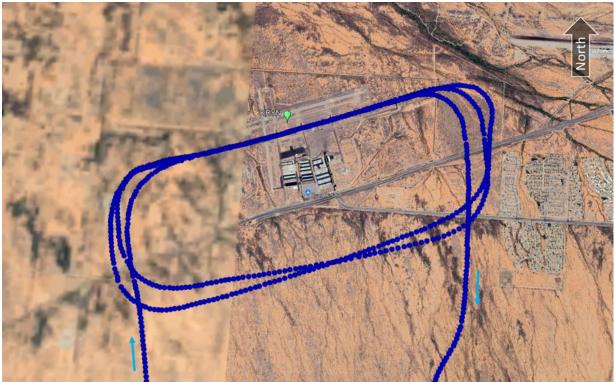
Figure 5. ADS-B overlay showing the traffic patterns at Ryan Field Airport, (RYN) Tucson, Arizona.

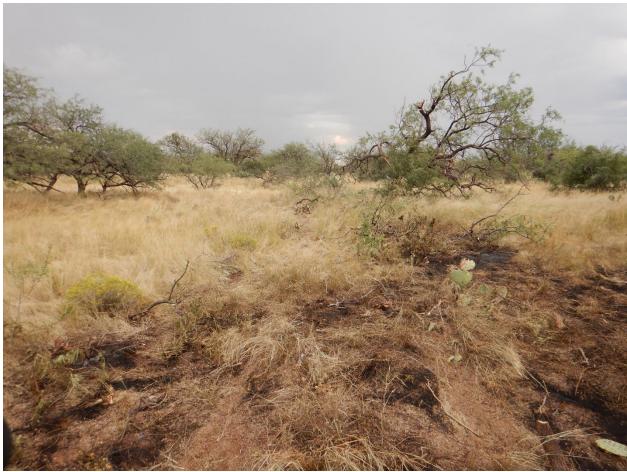
Figure 6. Image showing broken tree branches along the accident path.
