# National Transportation Safety Board

WPR24FA002

## **ACCIDENT SITE SURVEY**

Location: Moab, Utah  
Date: October 1, 2023  
Time: 2022 MDT  
Airplane: Piper PA28-140 / N7153R

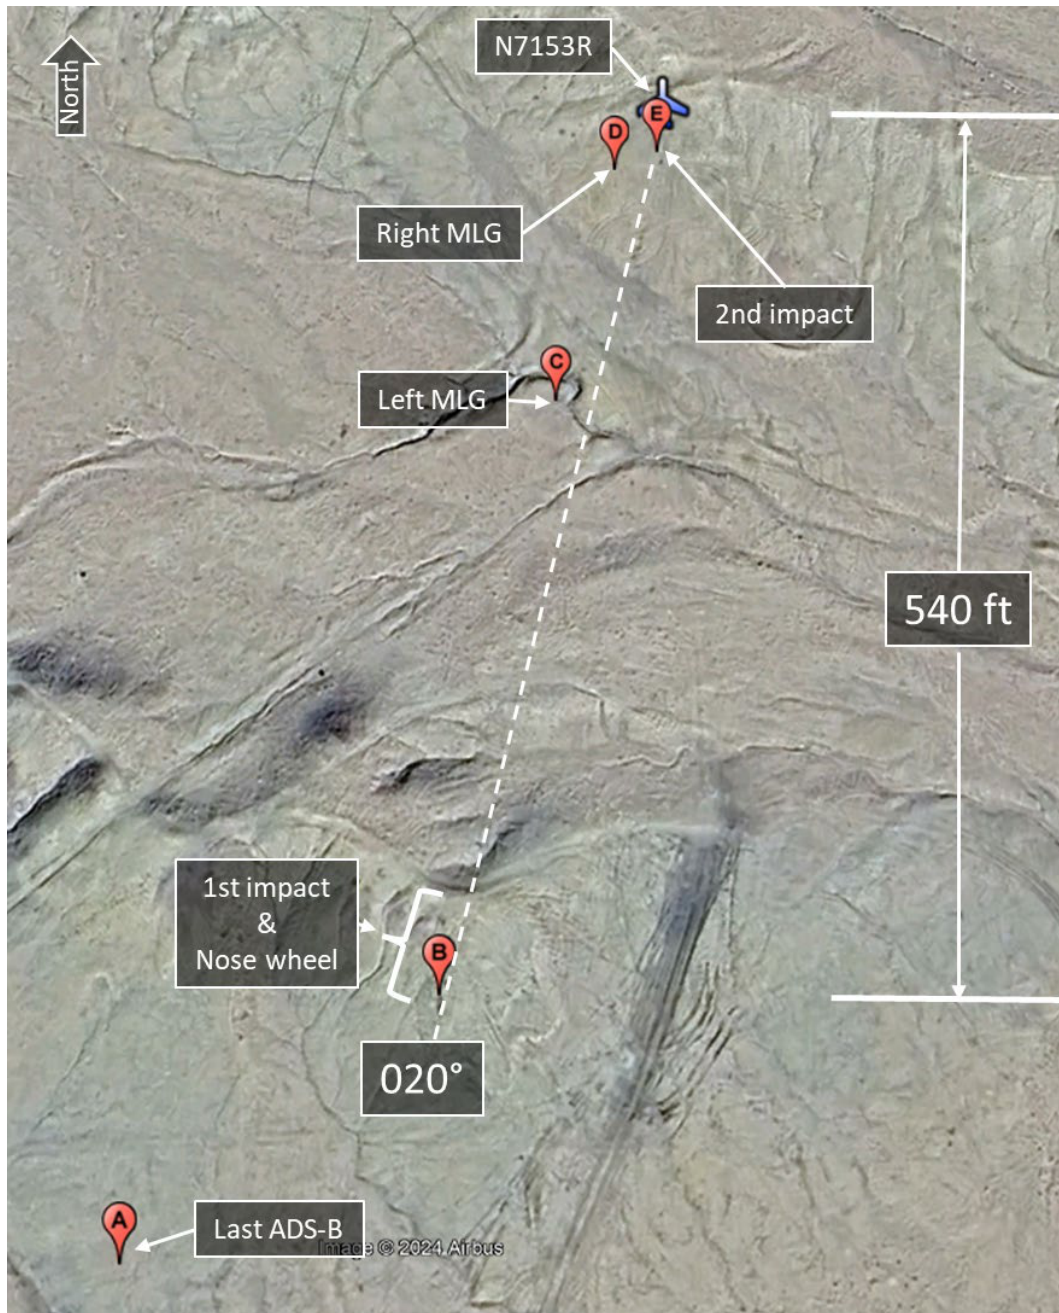
The accident scene consisted of a first point of probable impact (FPPI) where the nose wheel was deposited, a second point of probable impact (SPPI) and the location of the airplane. The left main landing gear separated from the fuselage and was deposited at N38° 45' 04.6" W109° 46' 12.9". The right main landing gear separated from the fuselage and was deposited at N38° 45' 06.0" W109° 46' 12.2." Figure 4 is a Google Earth closeup of the location of the landing gear. A line drawn from the FPPI to the center of the wreckage resulted in a heading of about 020° magnetic.

Figure 4. Google Earth of the accident scene.

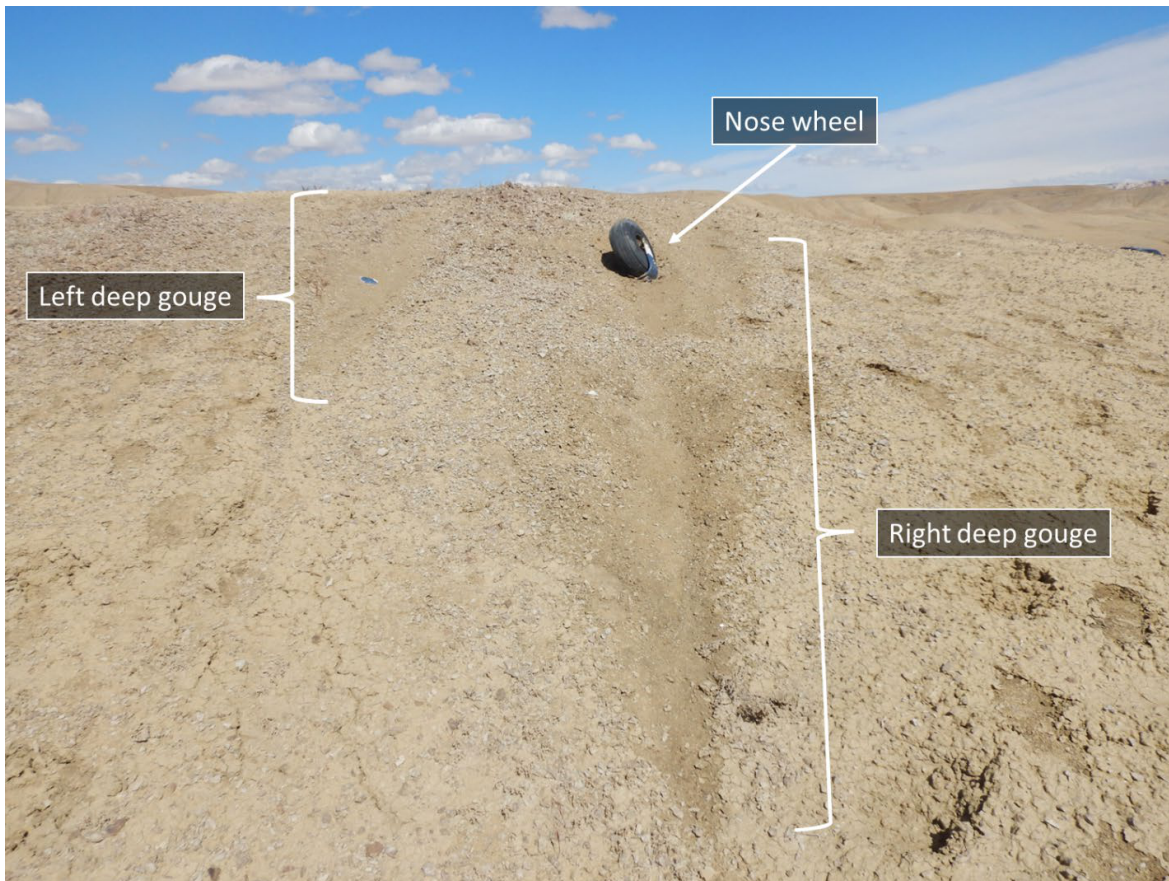
The first point of probable impact (FPPI) was located at N38° 45' 01.3" W 109° 46' 14.3". The FPPI consisted of a line of three gouges rising uphill into the soft dirt of a hill. An initial gouge of about 12' X 24" of disturbed soil, consistent with the nose wheel making contact, a small gouge, consistent with the nose wheel bouncing into the dirt, then about 50 ft northeast and uphill, a third gouge consistent with the left and right main landing gear (figure 5). The nose wheel was deposited in this location.

Figure 5 The first point of probable impact, showing the location of the nose wheel and the left and right MLG gouges.

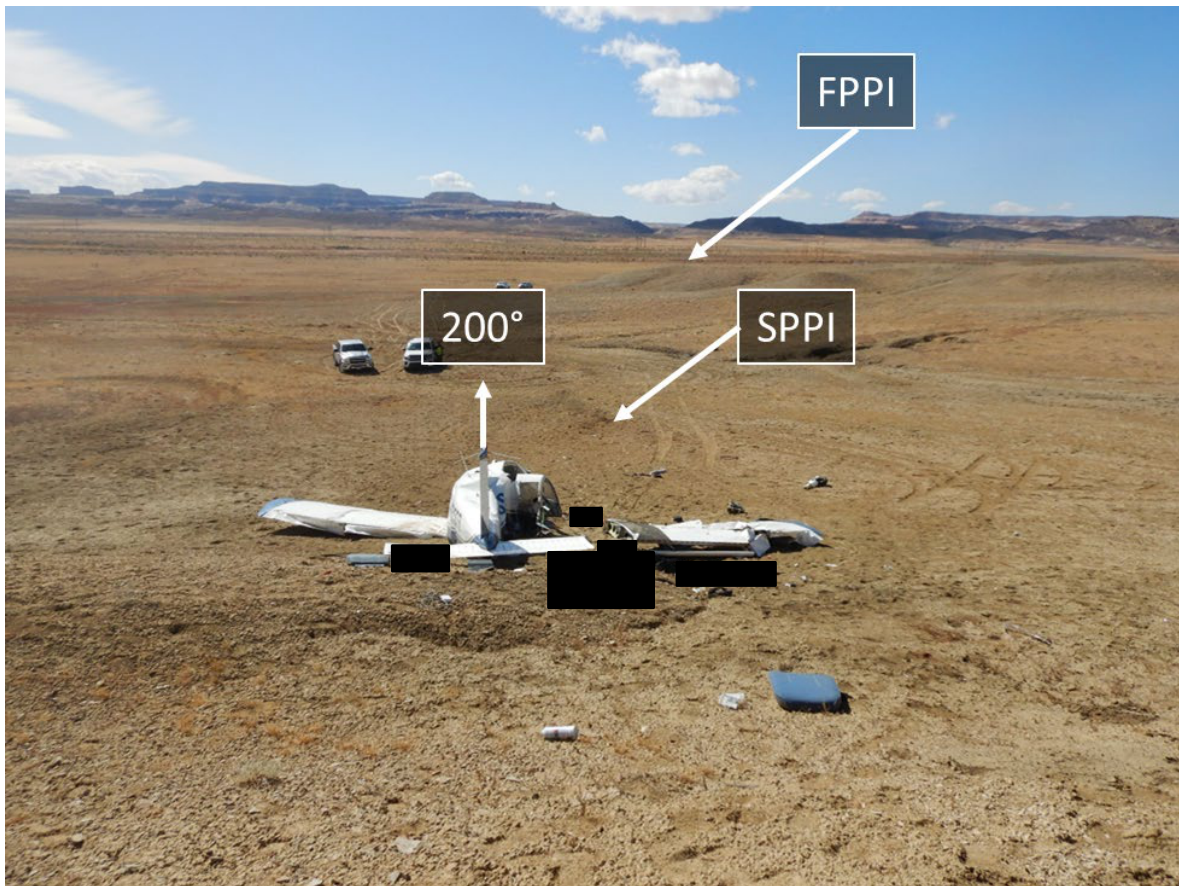
A second point of probable impact (SPPI) was located about 500 ft northeast of the FPPI on a heading of 020° magnetic. A section of a seat track was removed from this impact point. The airplane came to rest on a second hill, about 540 ft northeast of the FPPI, at N38° 45' 06.2" W109° 46' 11.8". The airplane rotated about the vertical axis 180° before coming to rest on a 200° magnetic heading. The engine was partially attached to the damaged engine mounts and was oriented downward.

Figure 6. Accident site, looking southwest, showing the three points of probable impact.
