Surveillance Video Screenshots Hartford Airport

NTSB # ERA23LA121

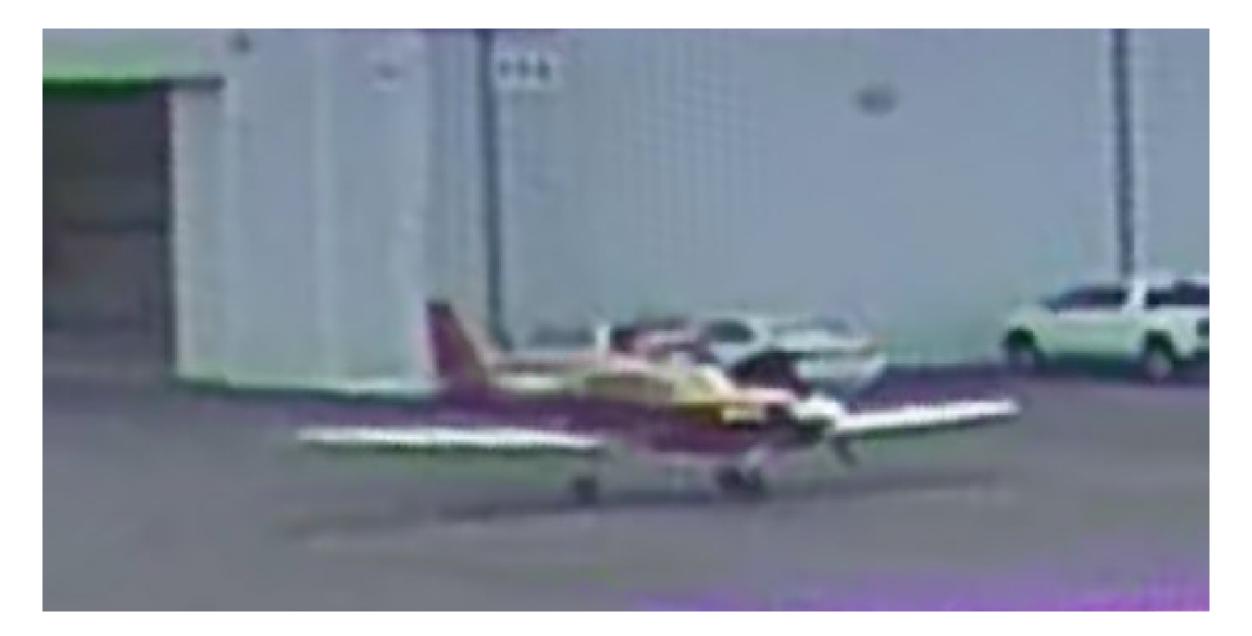
Airplane on ramp, prior to engine start

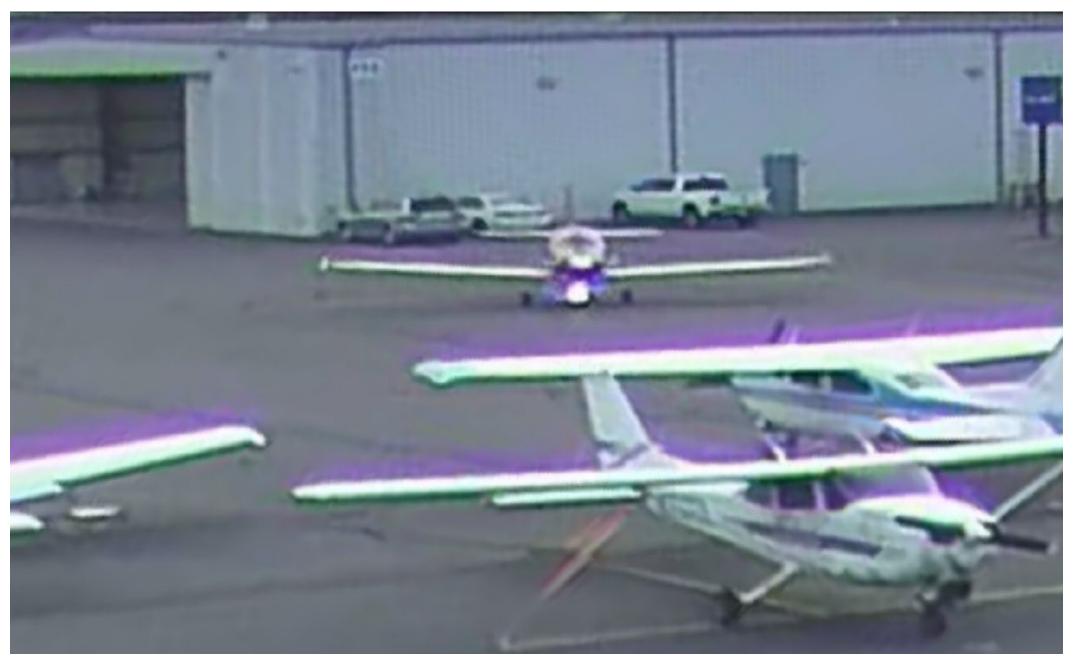
Taxi commences

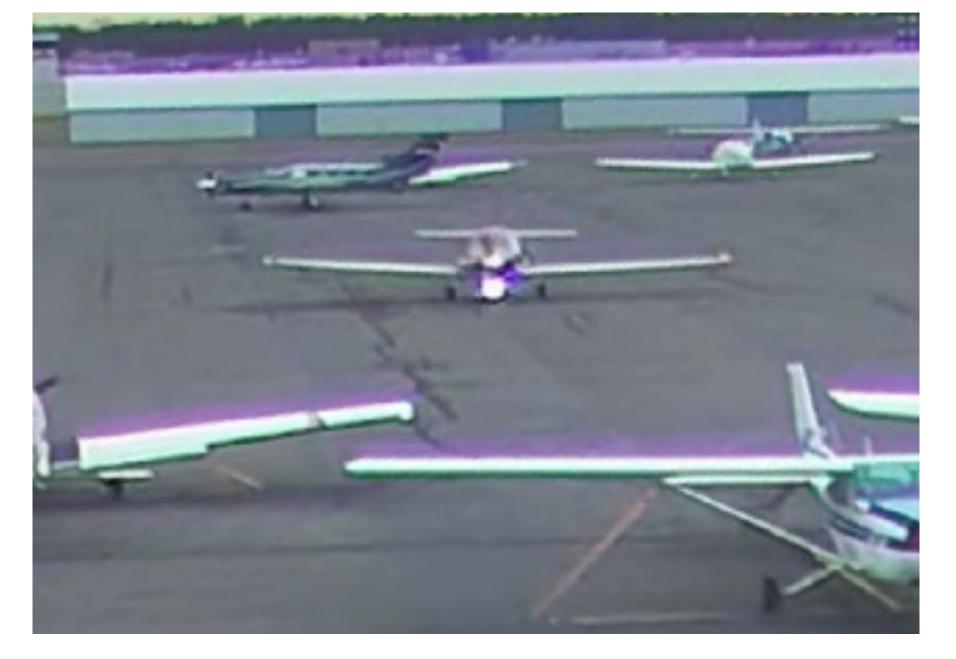
Airplane returned from runway to ramp after aborted takeoff. Completes a 360° right turn circle maneuver on the ramp.

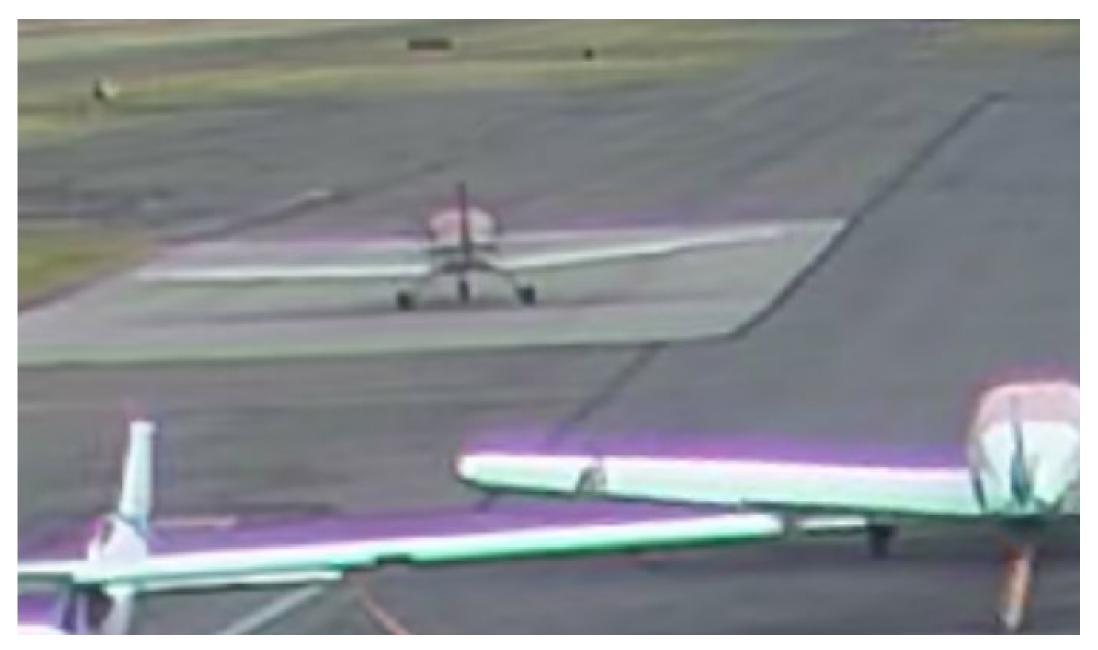
View of airplane circling on ramp.

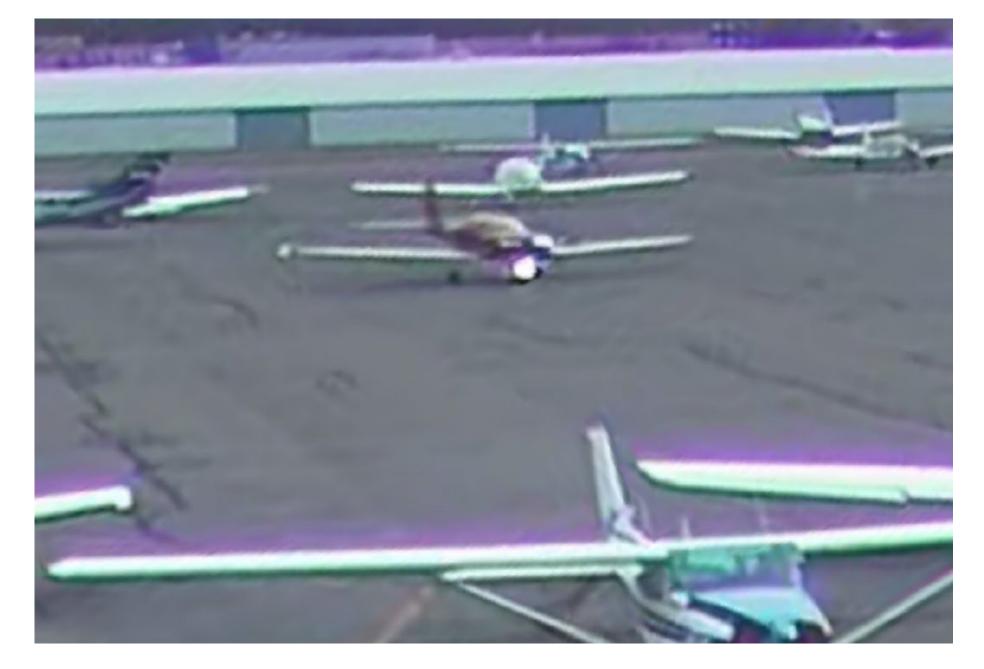
View of airplane completing 360° right turn on the ramp.

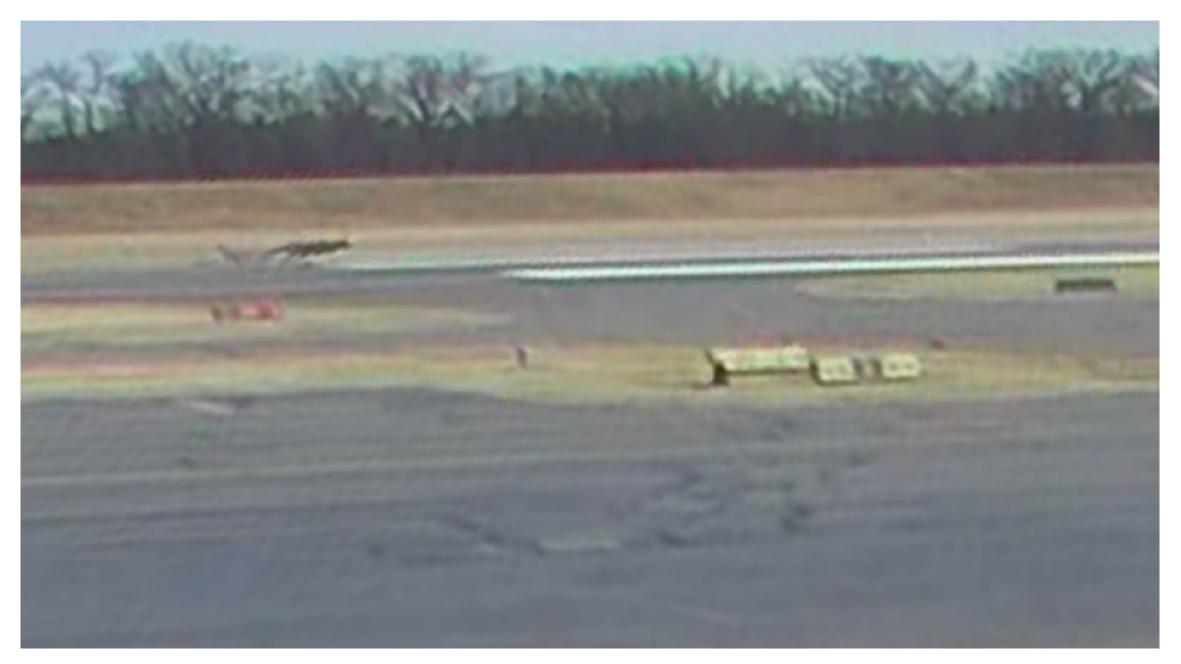
Accident Takeoff. Rotation - first sign nose coming off runway. (Approaching 1,000 ft markers)

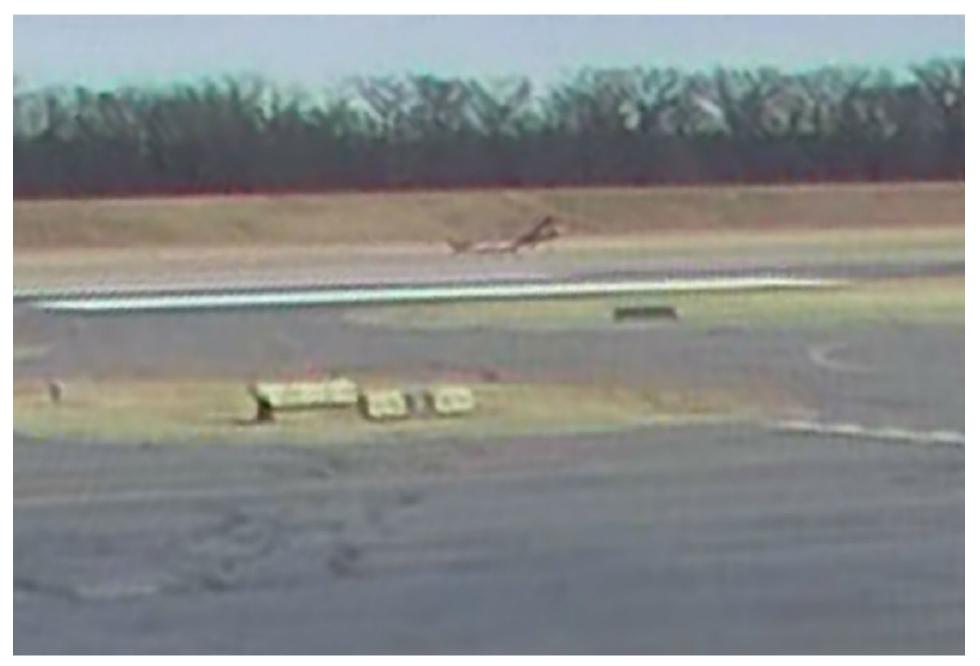
Accident Takeoff. Rotation - immediate left bank observed.

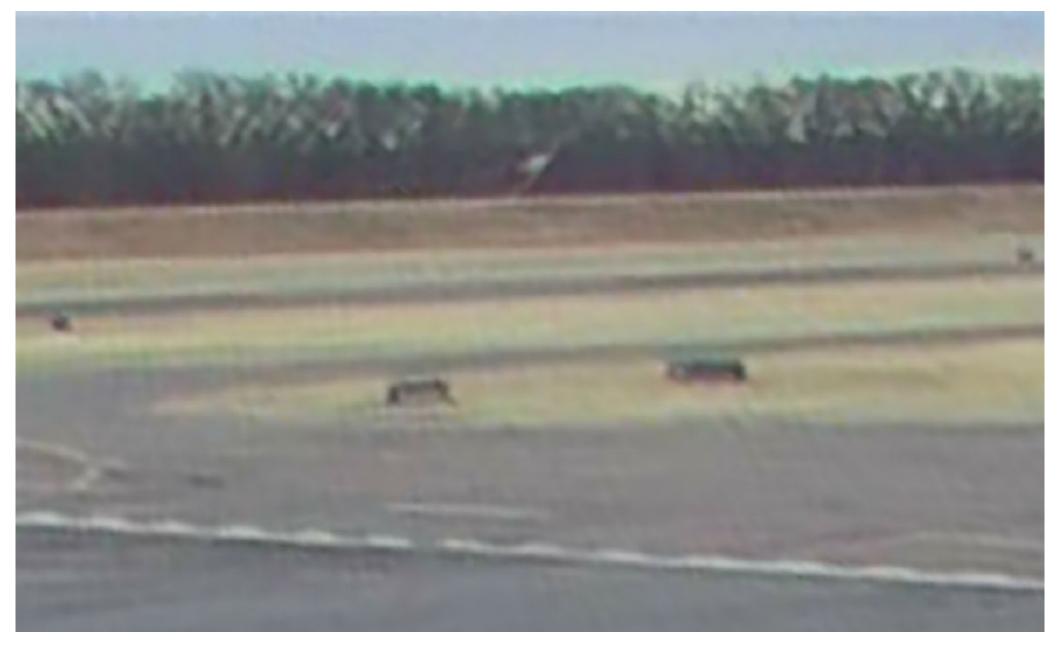
Few seconds after rotation, left roll and turn observed.

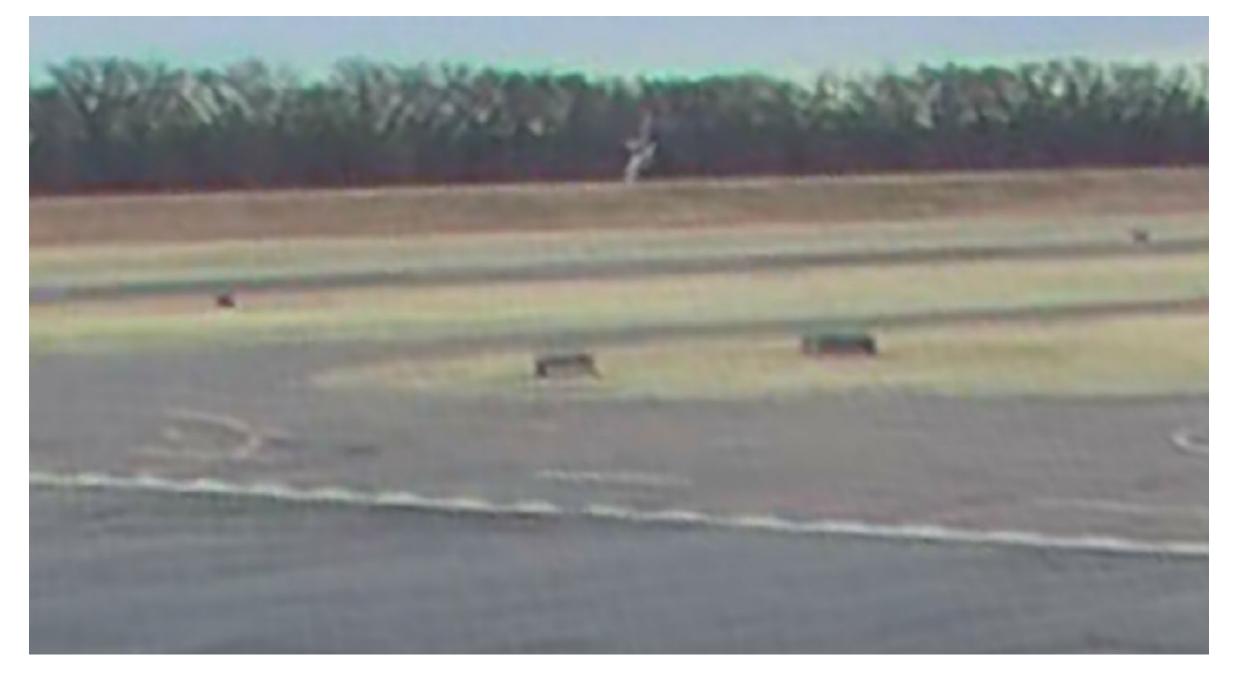
Left roll increases, nearly 90° knife edge bank. Left turn continues.

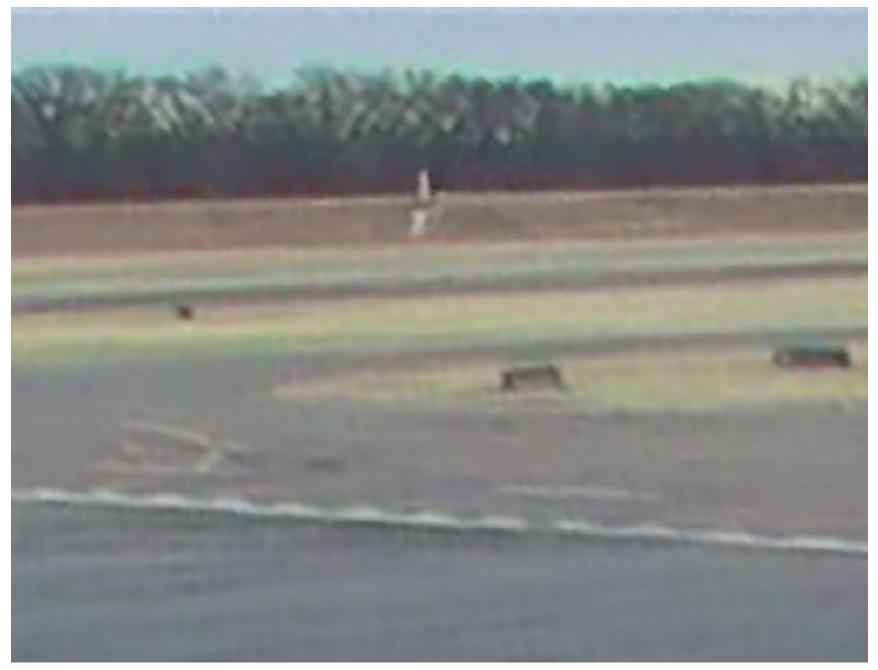
Left wing roll and turn continues, altitude loss observed.

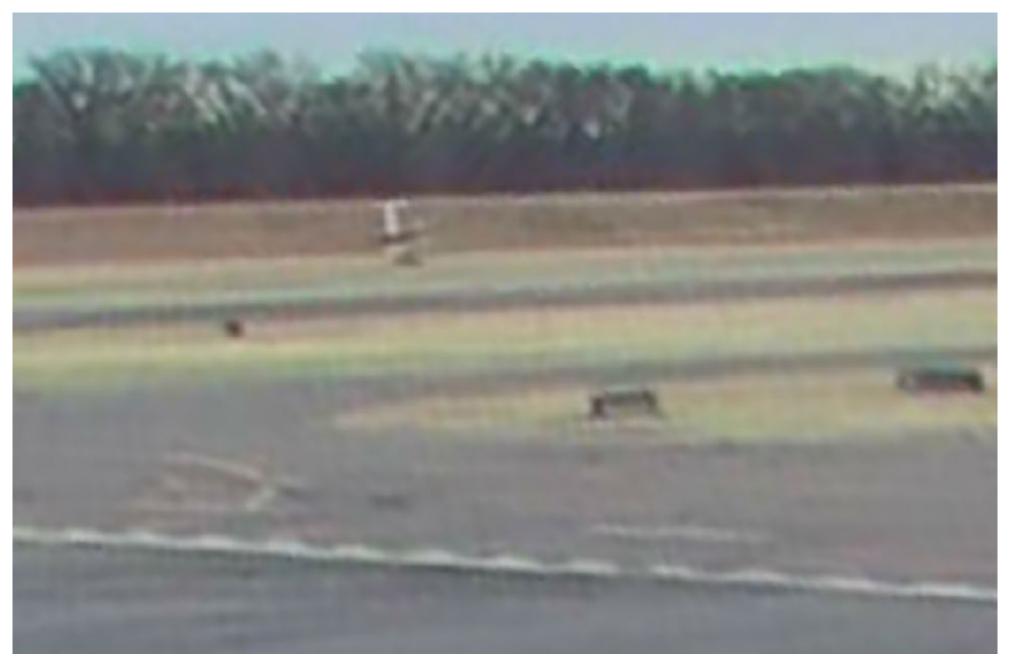
Left wing impacts terrain first.

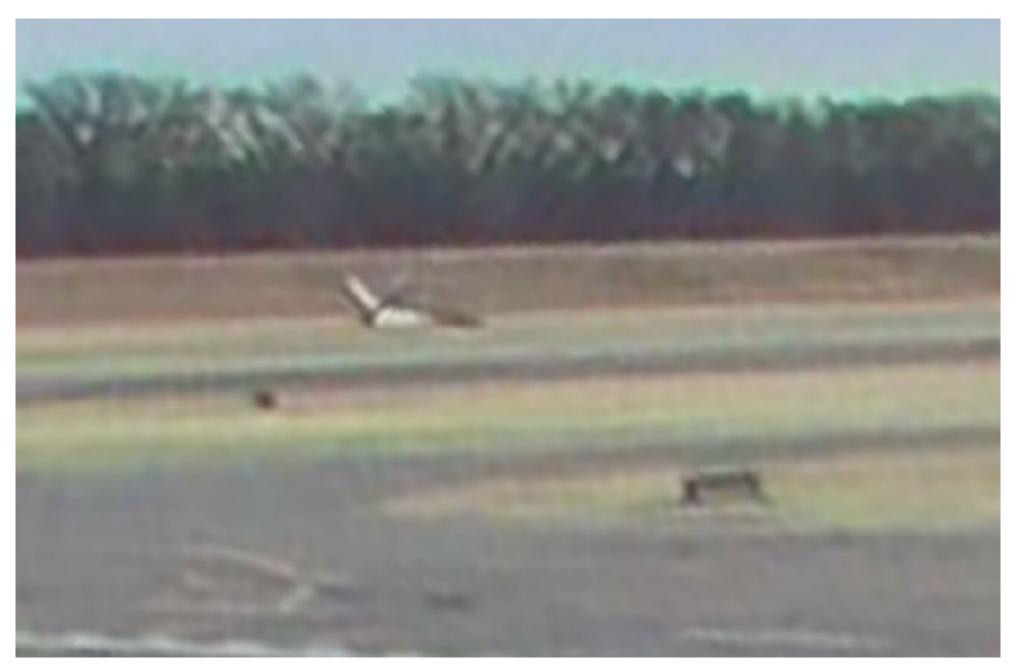
Left wing drags through the terrain, pulling nose downward into terrain.

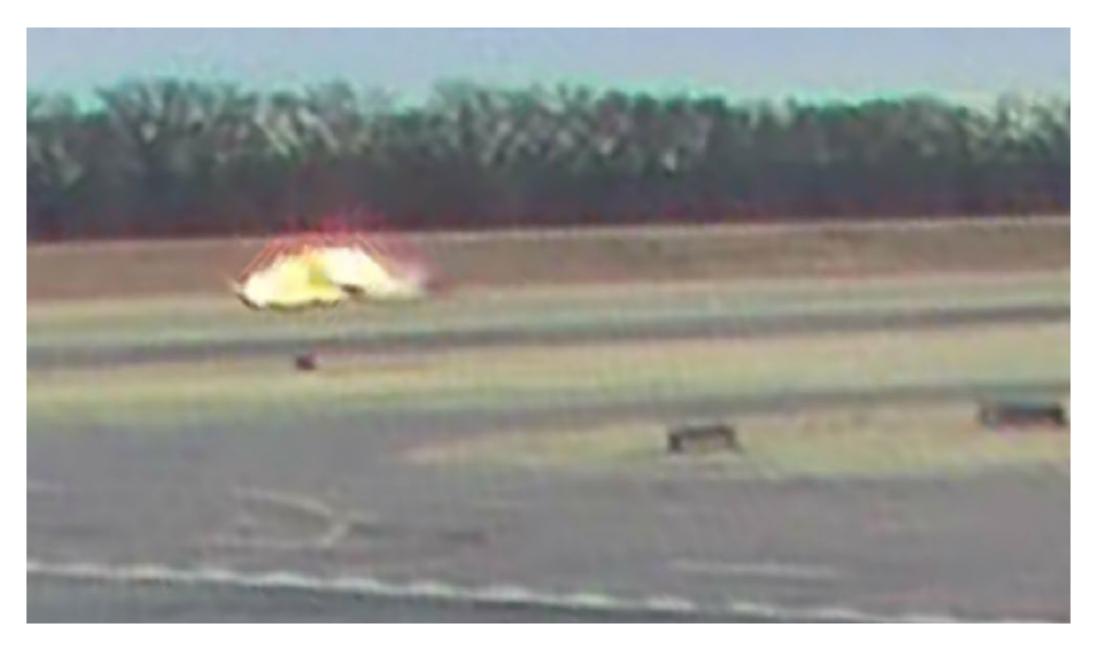
Explosion observed.
