Parker Hannifin Corporation
Hose Products Division
30240 Lakeland Boulevard
Wickliffe, OH 44092
Phone: [REDACTED]
Fax: [REDACTED]

TECHNICAL SERVICE PRODUCT ANALYSIS REPORT

Distributor/OEM: Strato Inc.
Attn:
Address: 100 New England Ave
Piscataway, NJ 08854

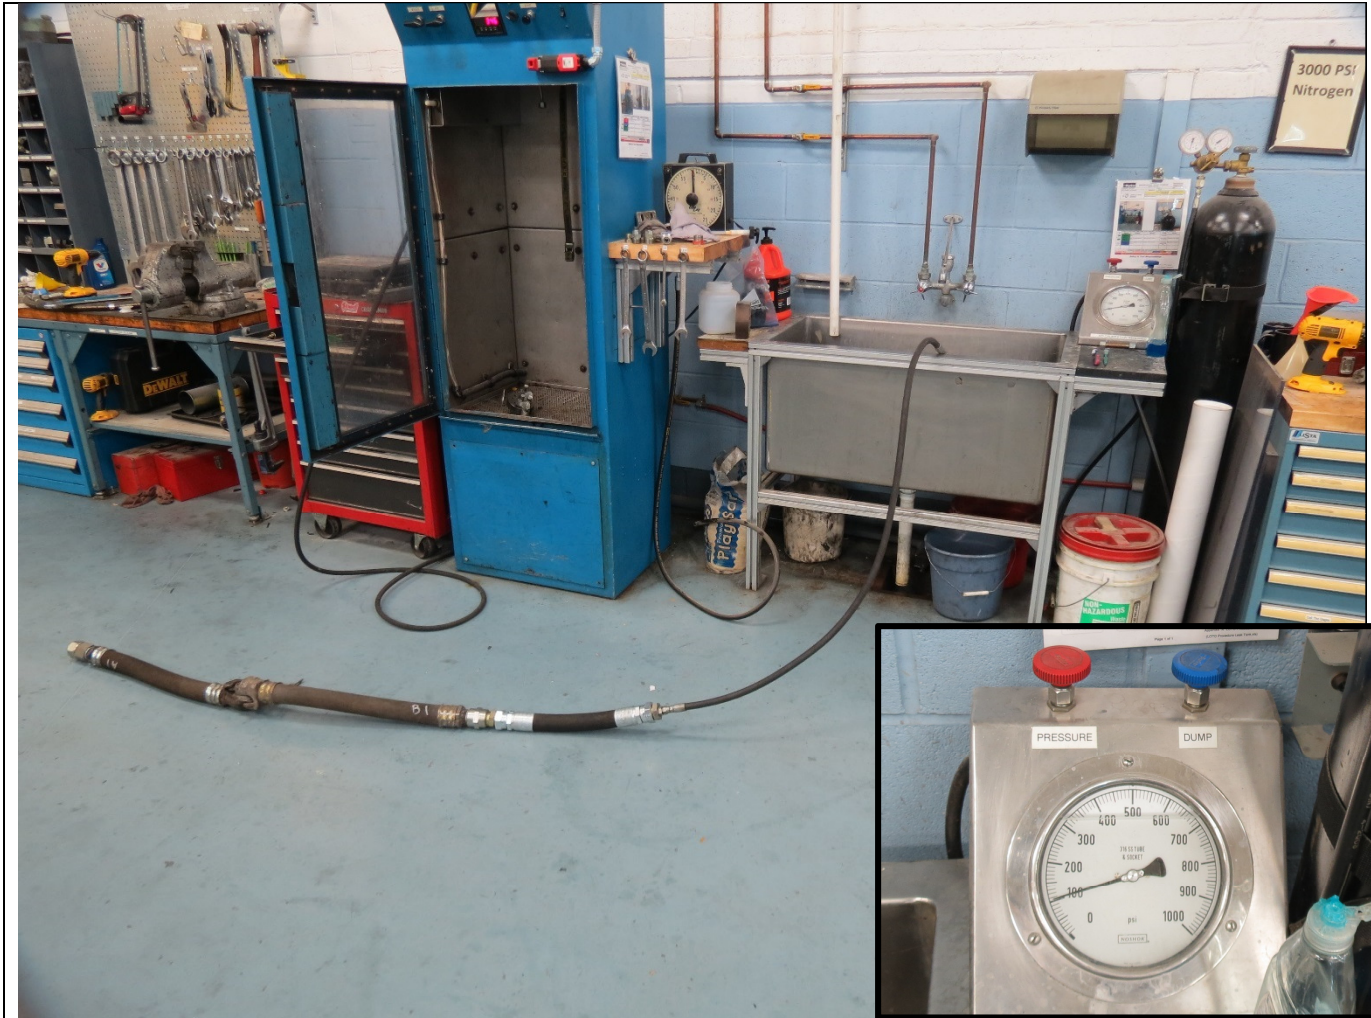
Figure 3: Pressure testing assemblies A1 and B1 with nitrogen at 100 psi. This set up was used to test all the assemblies.

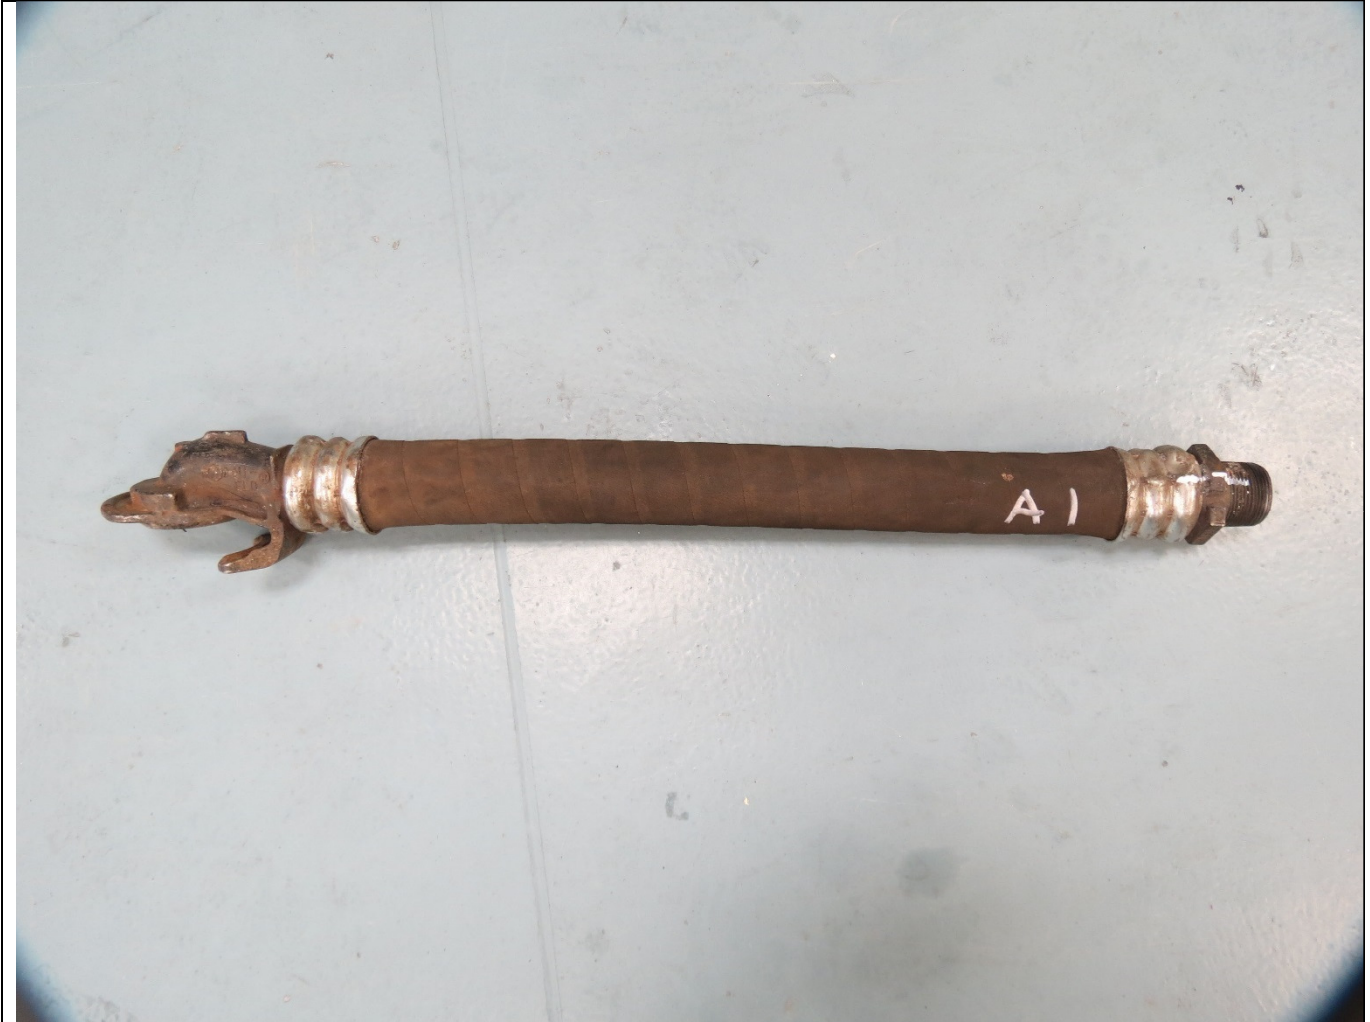
Figure 4: Assembly A1. No external damage. No issues with the ID of the assembly.

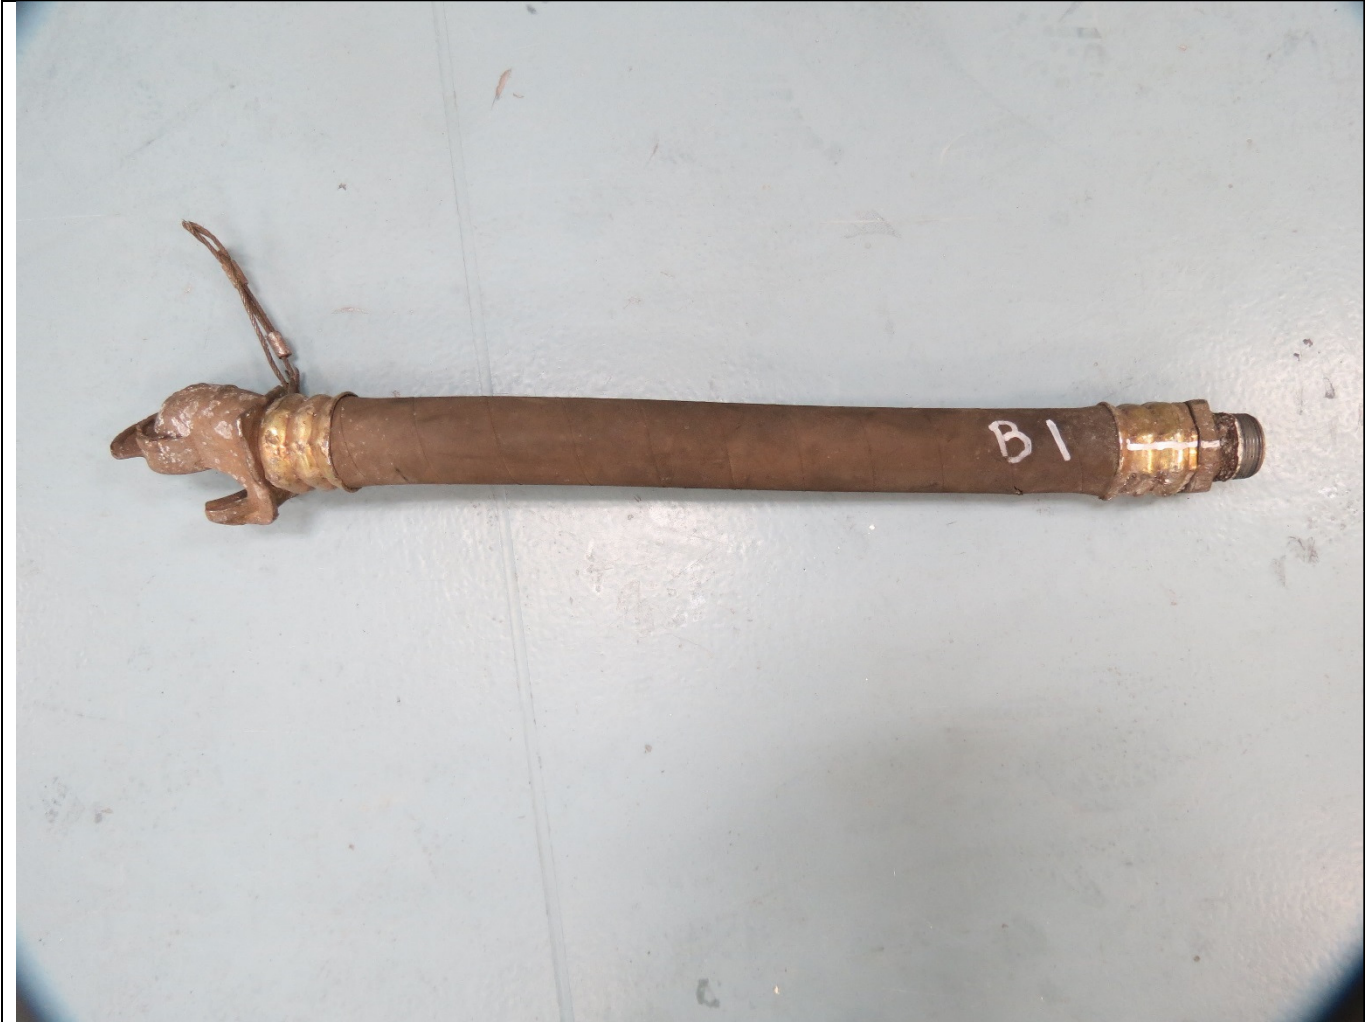
Figure 5: Assembly B1. Some cover damage at the end marked B1. No damage to the ID

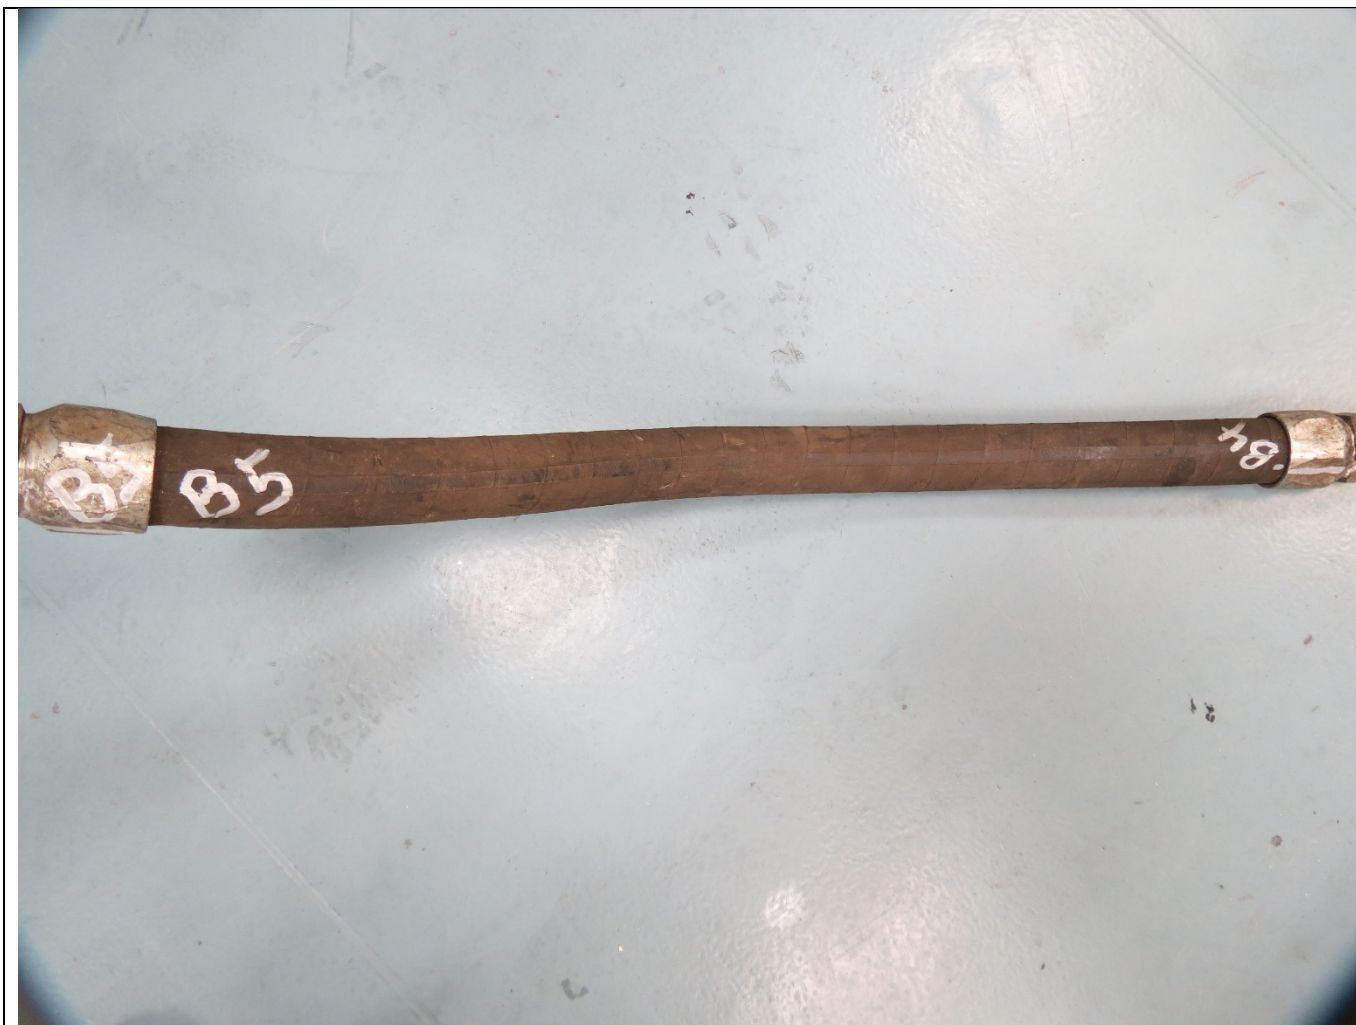
Figure 6: Assembly B4-B5. No external damage to the outside of the hose. No issues with the hose ID.

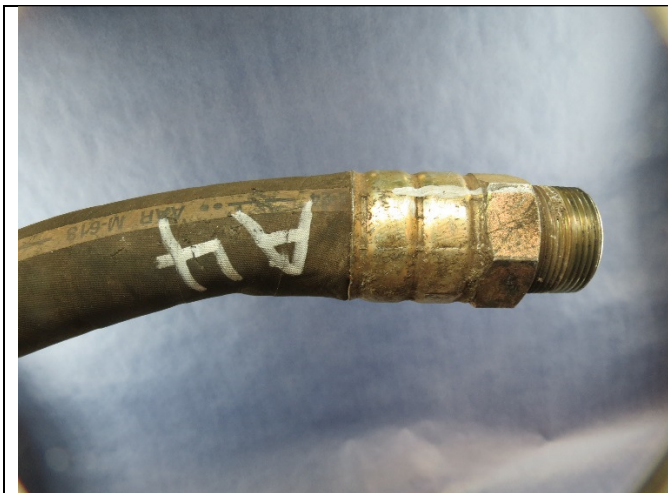
Figure 7A: Slight kink at one end.

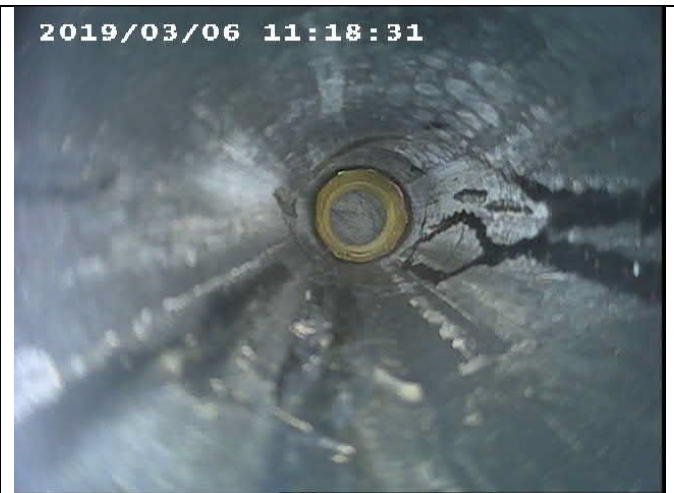
Figure 7B: View down the ID at the location of the kink.

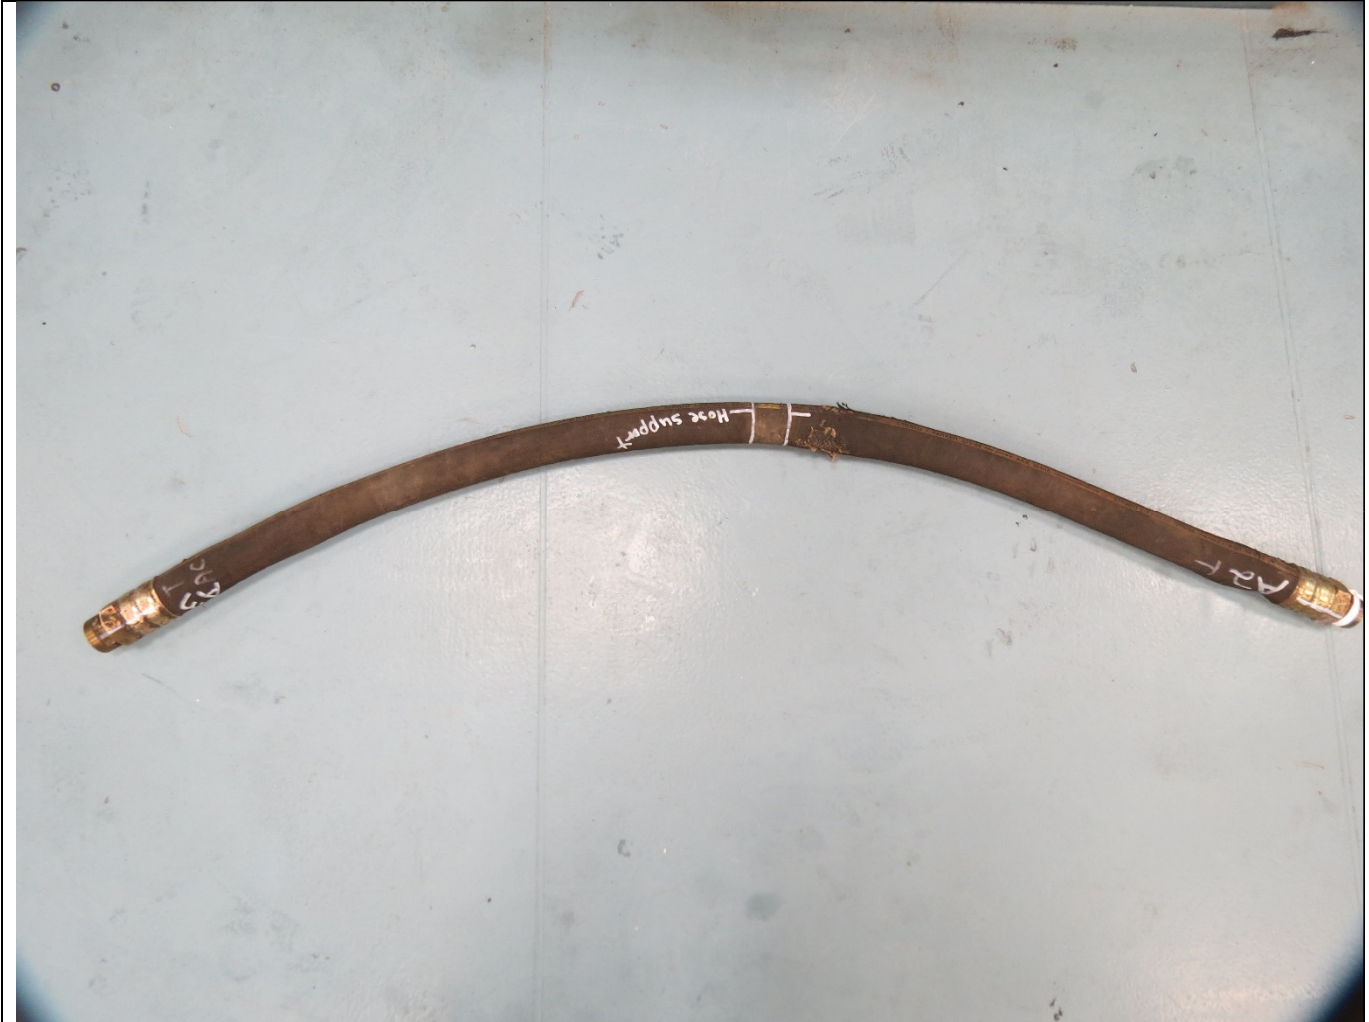
Figure 8: Assembly A2-A3. Has severe kink at end marked A2. Slight indentation at the opposite end fitting. No leaks during pressure testing.

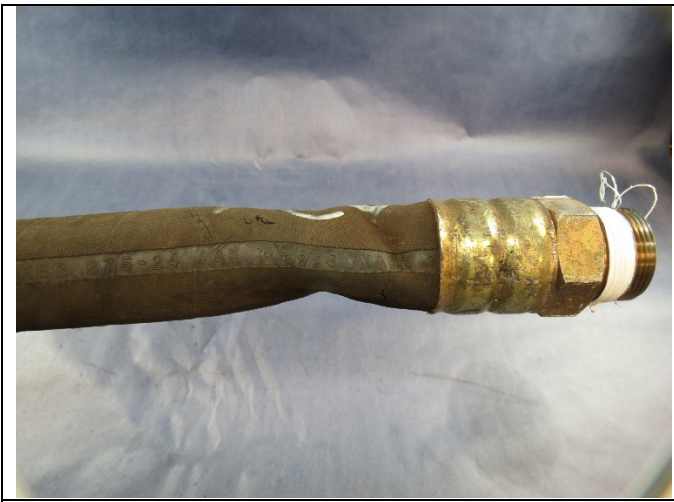
Figure 8A: Hose kinked at end marked A2

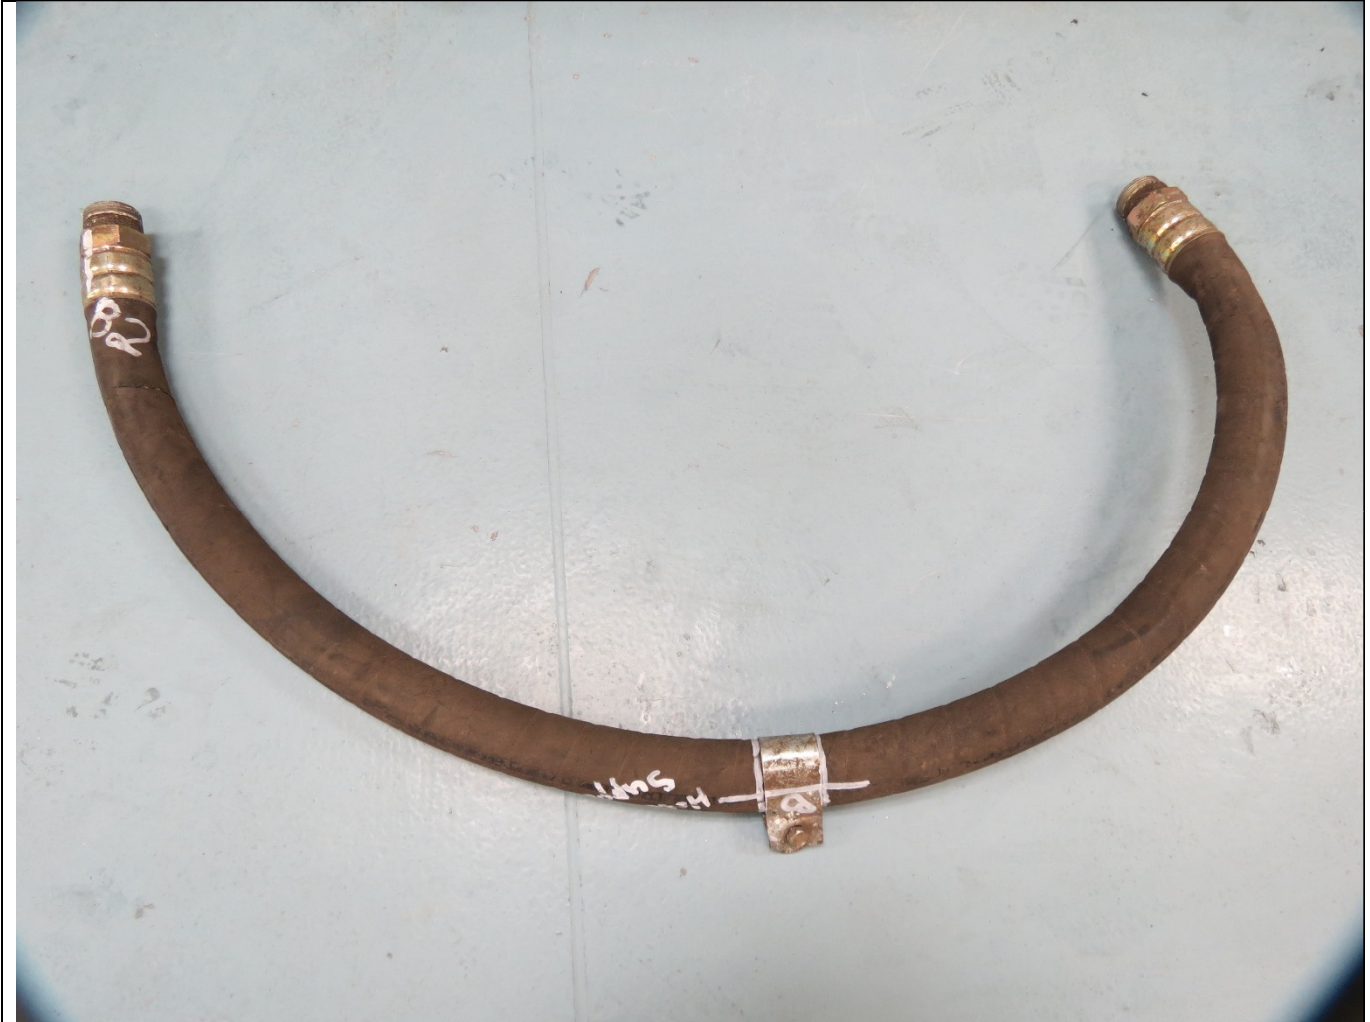
Figure 9: Assembly B2-B3. Severe damage at end mark B3. Also, some flattening at the support clamp.

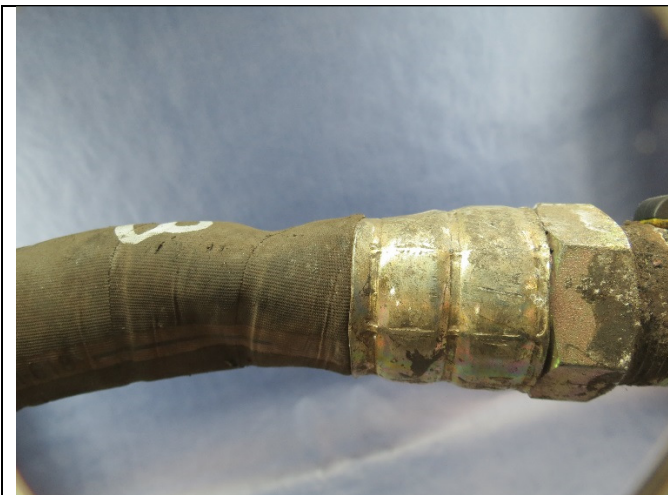
Figure 9A: Damage at end marked B3
