Parker Hannifin Corporation  
Hose Products Division  
30240 Lakeland Boulevard  
Wickliffe, OH 44092  
Phone: [REDACTED]  
Fax: [REDACTED]

### TECHNICAL SERVICE PRODUCT ANALYSIS REPORT

**Distributor/OEM:** Strato Inc.  
**Attn:**  
**Address:** 100 New England Ave  
Piscataway, NJ 08854

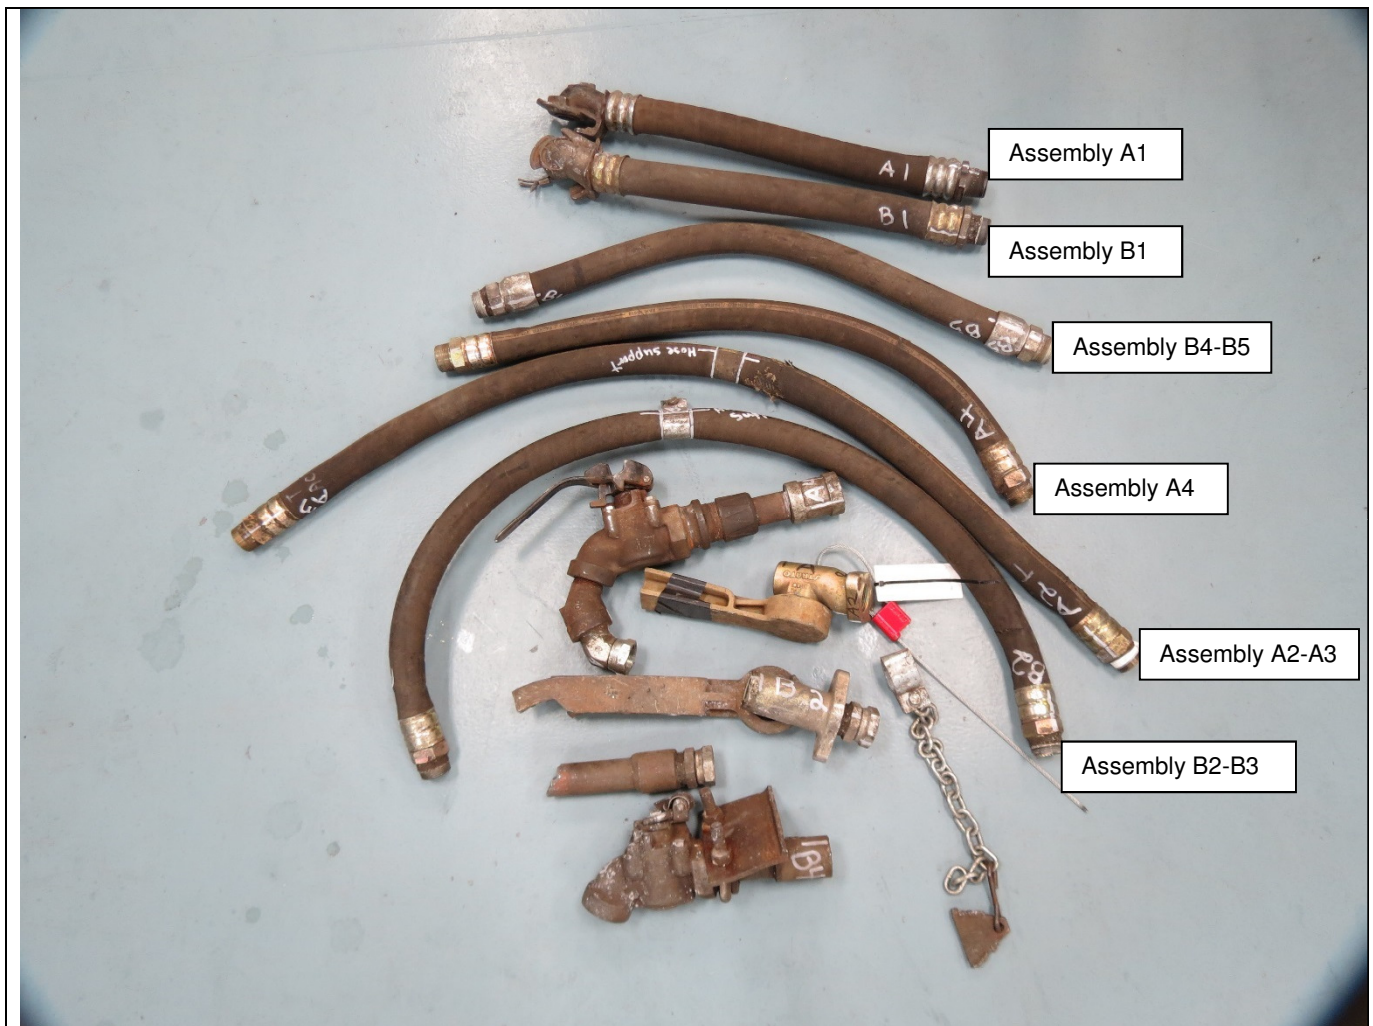
Figure 1: Received assemblies and components. The assemblies will be referred to throughout the report as labeled in the Figure above.

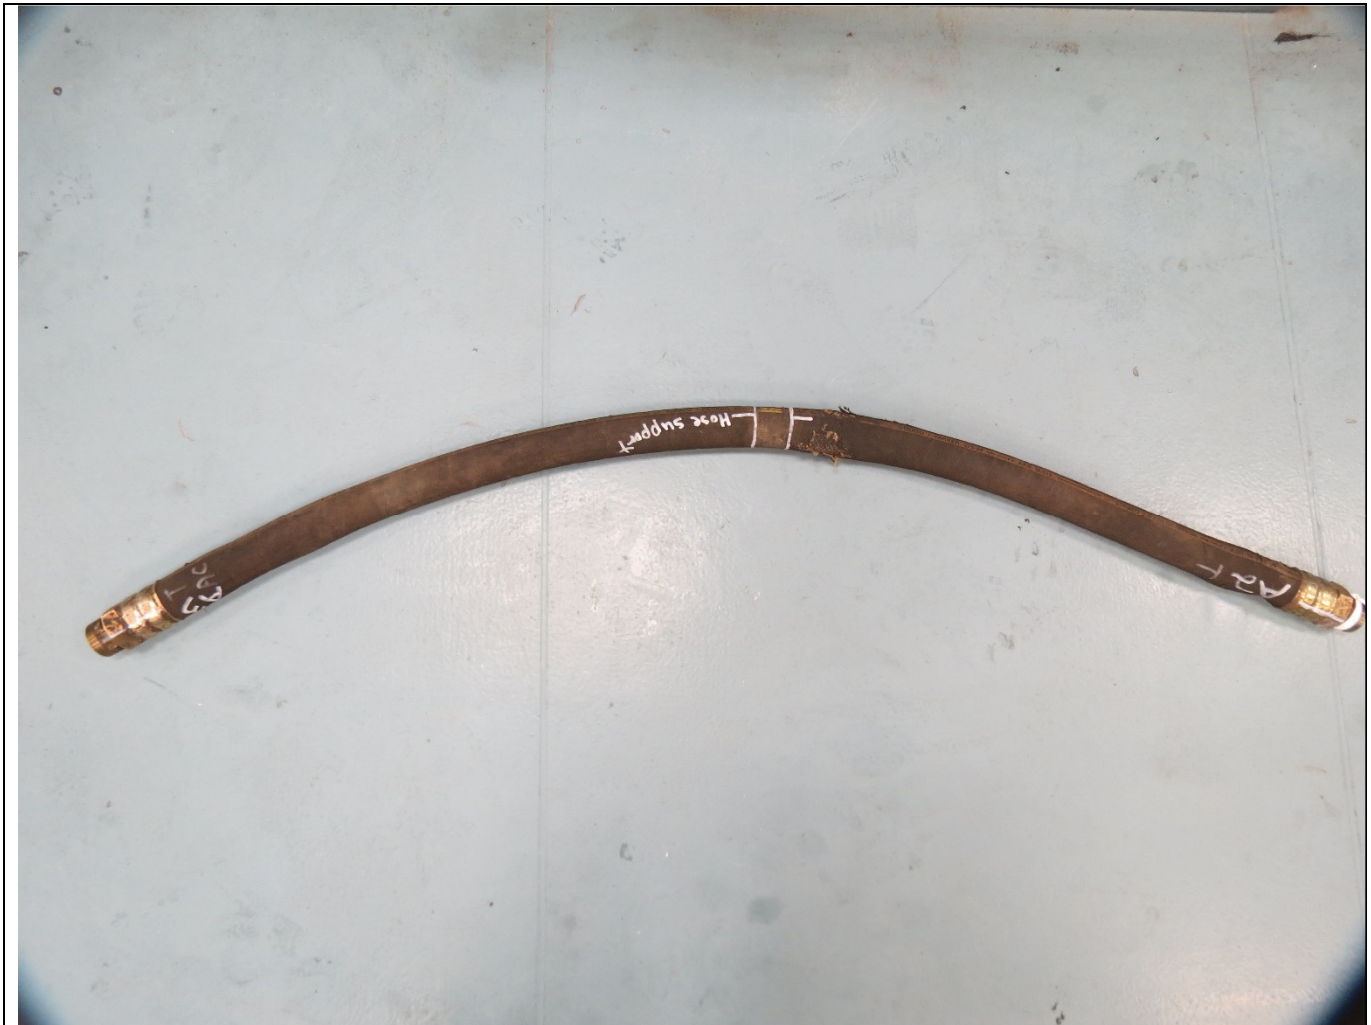
Figure 2: Assembly A2-A3. Has severe kink at end marked A2. Slight indentation at the opposite end fitting. Worn cover and some frayed wires at the hose support location. No leaks during pressure testing.

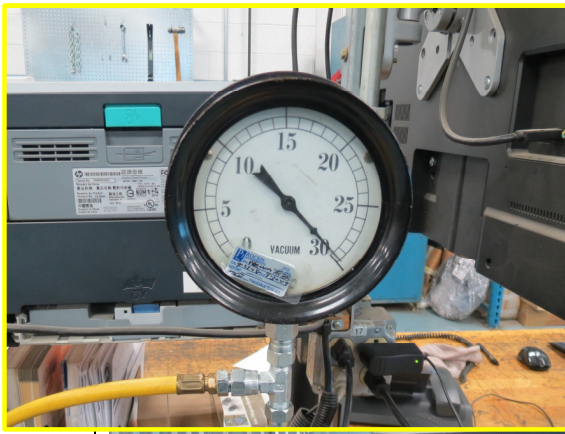
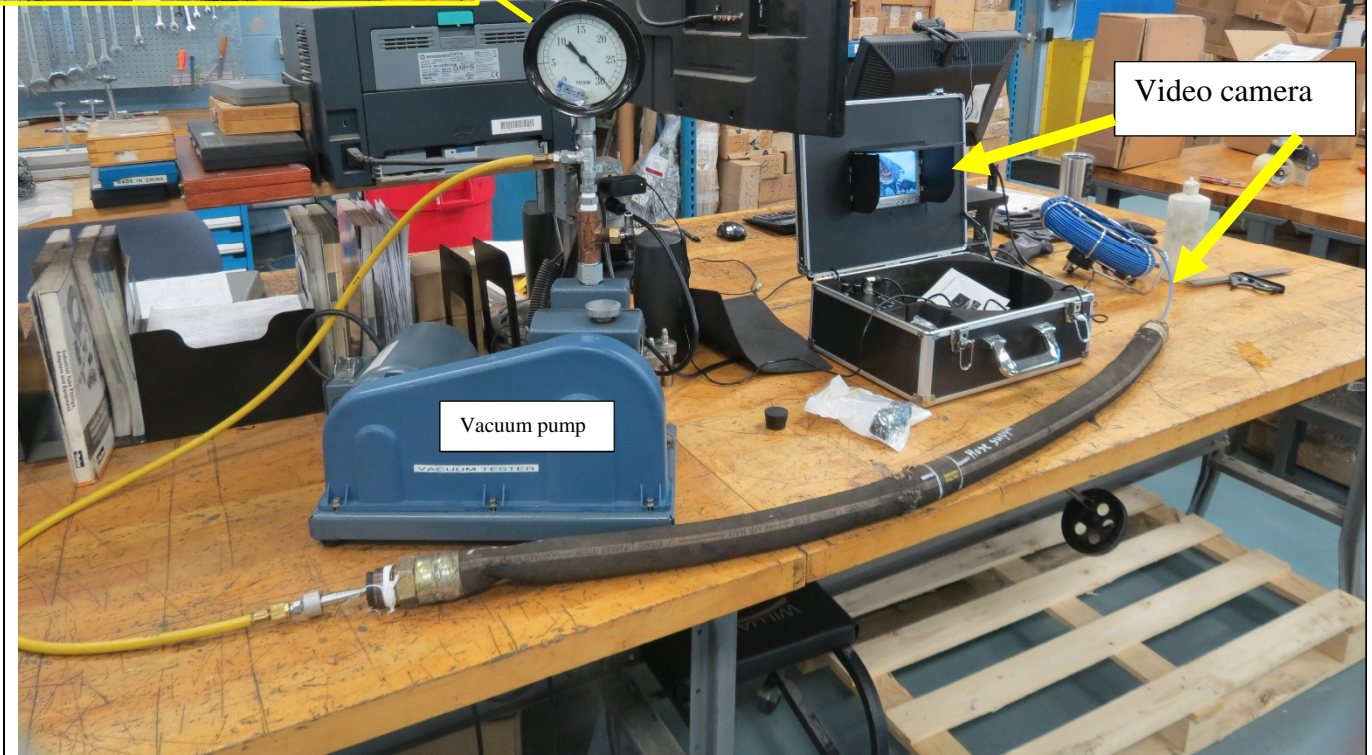
- Assembly A2-A3 was vacuum tested.
- Inspection was conducted from end to end using a video camera while maintaining full vacuum in the hose.
- No collapsing of the hose or inner tube was observed.
- See figures below for set up.
- Video also available.

Figure 3: Vacuum test set up.

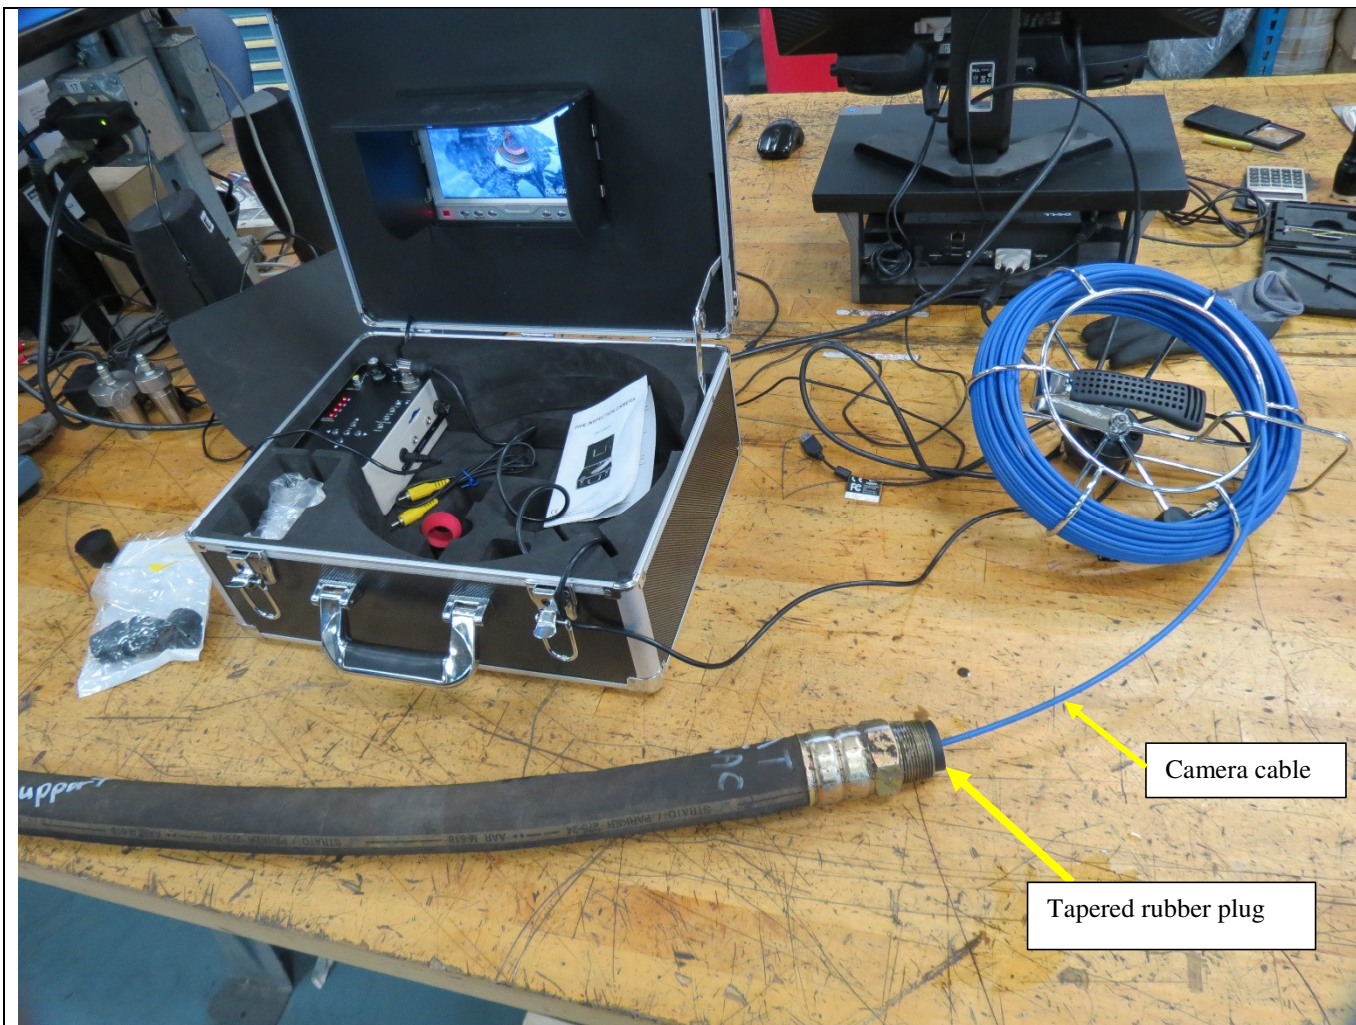
Figure 4: A tapered rubber plug was inserted in one end of the fitting with the camera cable running through a hole in the center of the plug. While maintaining full vacuum, the camera cable was fed through the entire length of the hose.

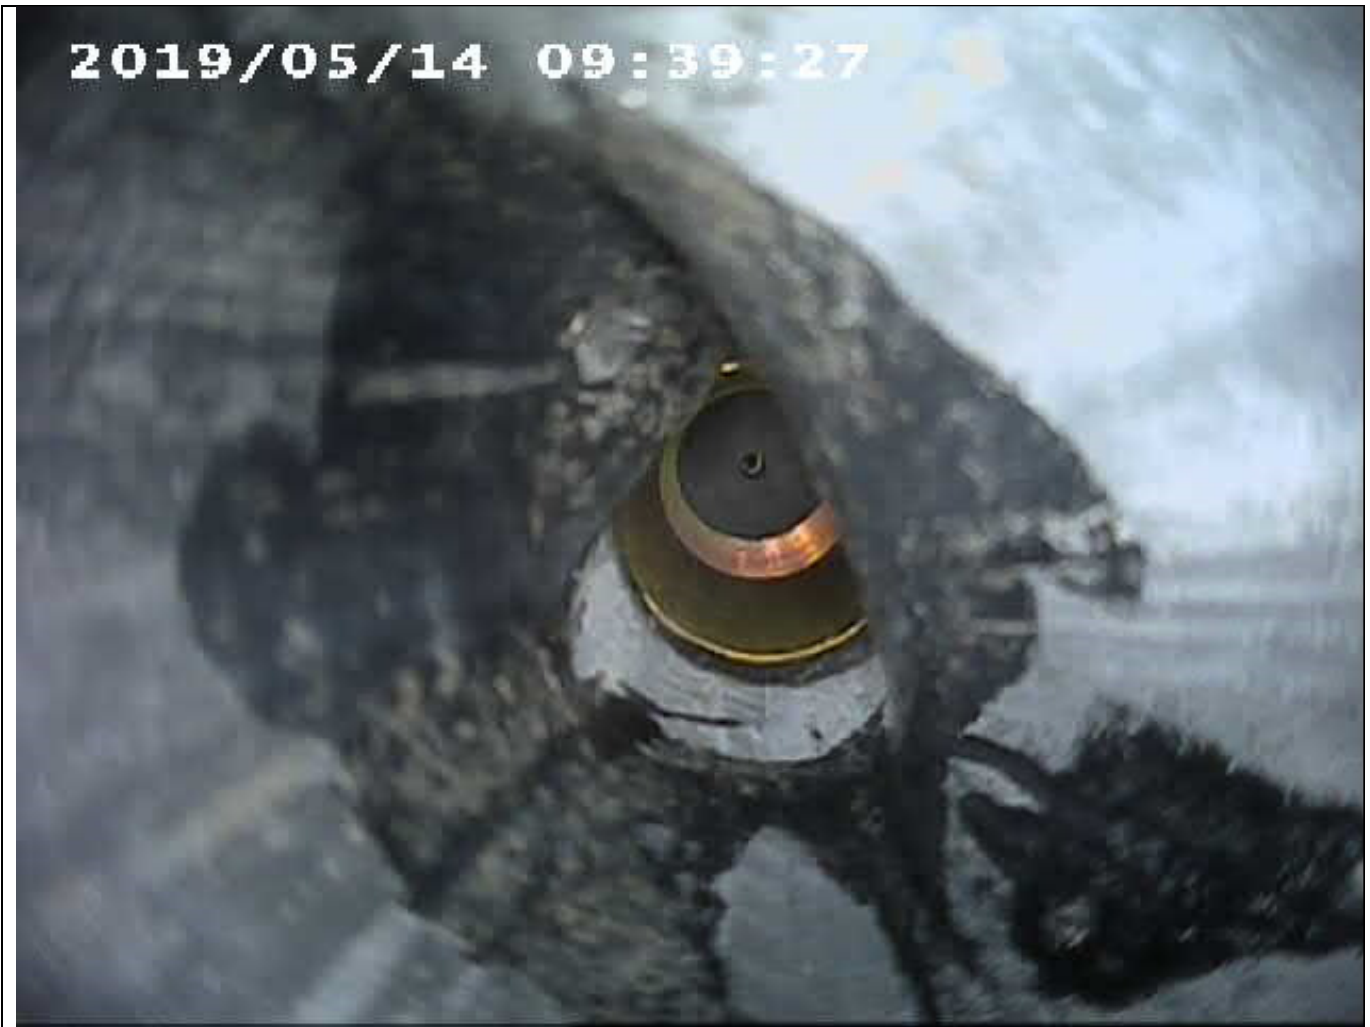
Figure 5: Kinked end under full vacuum.

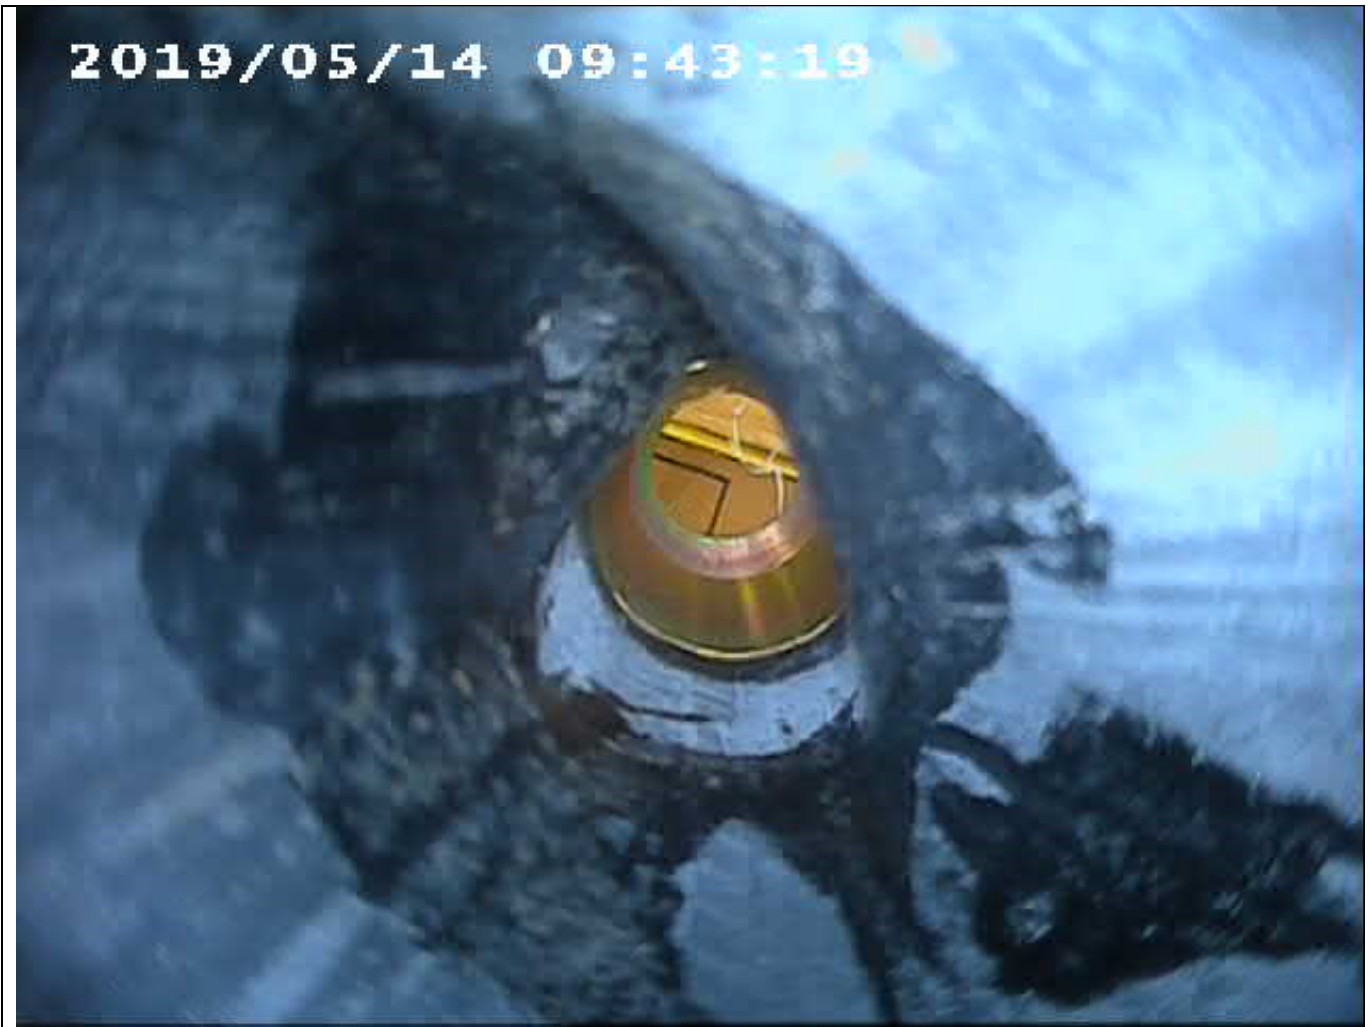
Figure 6: Kinked end under no vacuum,
