# NATIONAL TRANSPORTATION SAFETY BOARD

## STRUCTURES GROUP CHAIRMAN'S FACTUAL REPORT

### A. ACCIDENT      **DCA05MA004**

**Location:** Kirksville Regional Airport (IRK), Kirksville, Missouri  
**Date:** October 19, 2004  
**Time:** 1945 Central Daylight Time (CDT)  
**Aircraft:** American Connection 5966, BAe Systems Jetstream 3201, N875JX

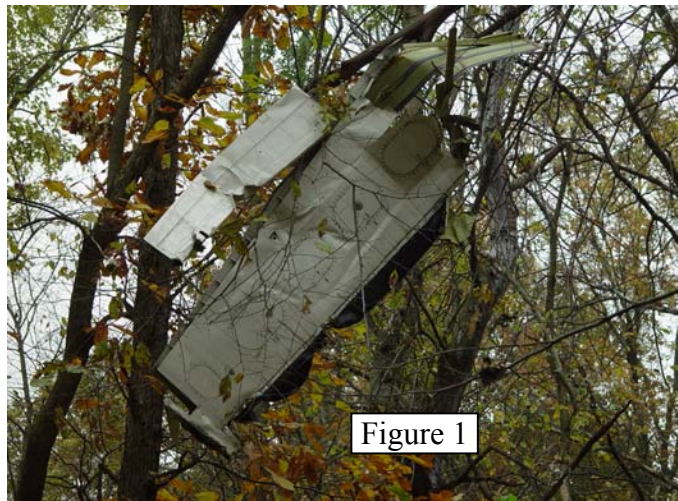
Figure 1

initial tree strike, a section of the outboard left wing was stuck about 15 feet up in a tree (Figure 1). About 45 feet prior to the wing and 90 feet to the right of the flight path was a 6-inch long tip section from one of the propeller blades. About 80 feet forward of the wing section a large oak tree was struck and one of the two large (18 inch diameter) branches that make up the upper portion of the tree was separated and found about 50 feet forward of the trunk in a pile of branches and tree debris. A section of the left wing and left outboard flap were found in this pile of branches with significant fire damage. A section of the left aileron was found about 15 feet prior to this pile and the left nose landing gear door was found about 5 feet forward of the pile. The left nose landing gear door hinges were pulled away from the actuator attachment fitting. The trees along the flight path from the wing section to the edge of the wooded area were cut at an angle of about 60° to horizontal as viewed looking back along the flight path from the main wreckage site (Figure 2). About 100 feet prior to the main

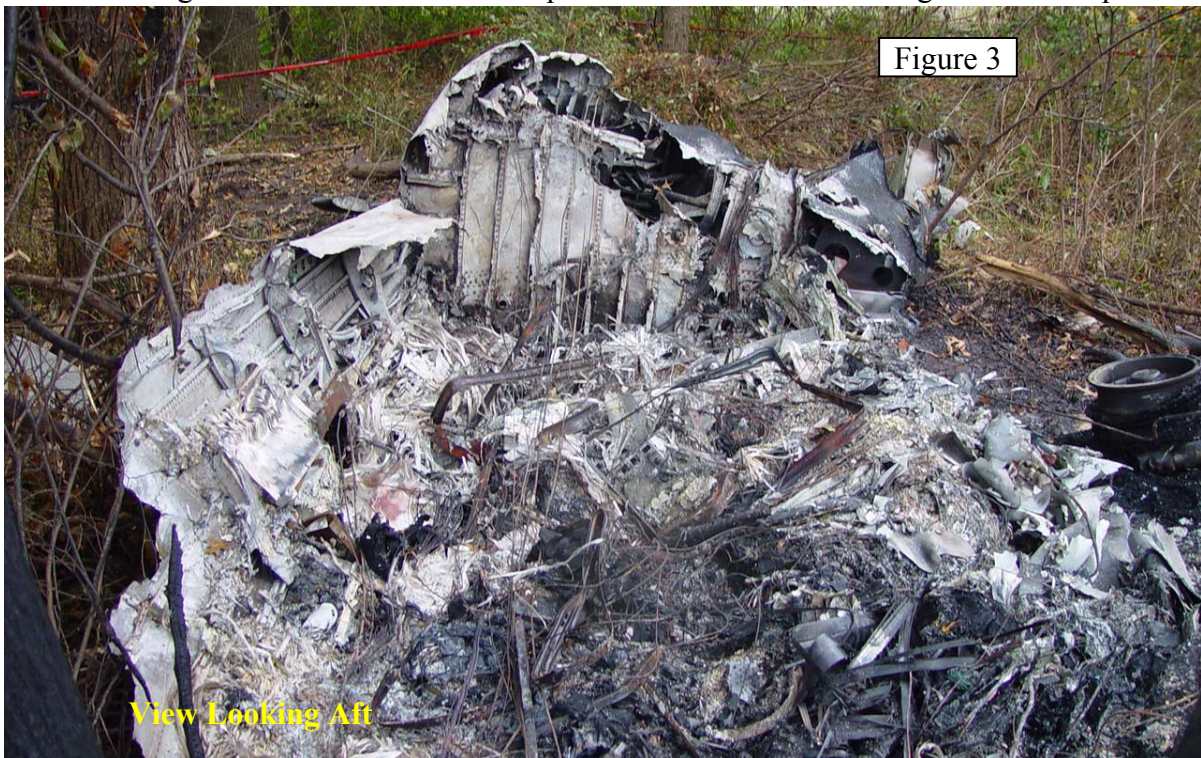
The aft fuselage from STA 315 to the aft bulkhead at STA 463 and from stringer 7°-right on the top to stringer 170°-left on the bottom was relatively intact and laying on its left side (Figure 3). The remainder had been consumed by fire. The aft portion of the fuselage was oriented on a 240° magnetic heading. The passenger entry door located in the aft, left fuselage was mostly intact with fire damage to the interior and was found in the closed and latched position. About 50% of the aft pressure bulkhead (APB) remained in the aft fuselage with significant fire damage. The Flight Data Recorder mounting rack was still attached to the aft fuselage structure while the Cockpit Voice Recorder mounting rack was separated.

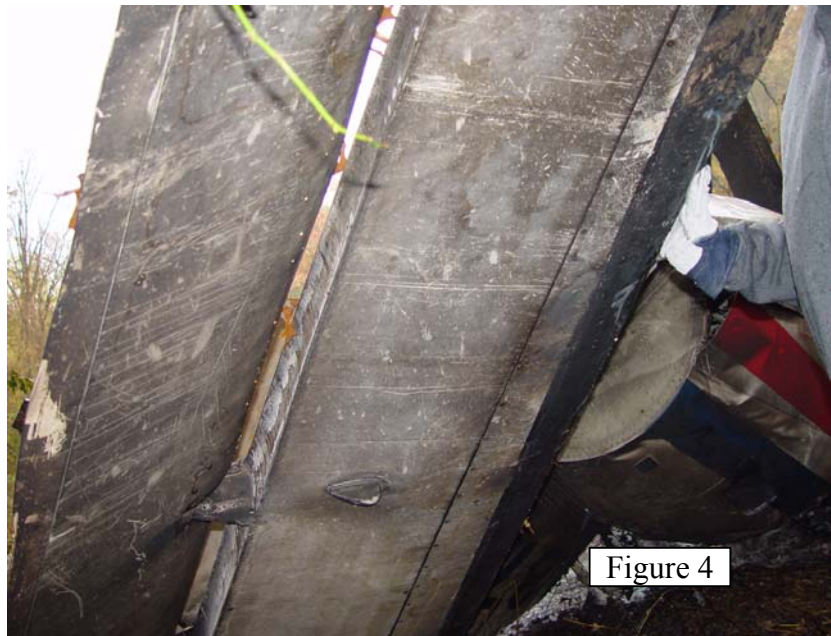
Figure 4

The inboard 52 inches of the lower surface of the horizontal stabilizer and elevator exhibited moderate sooting with light sooting on the remainder. The upper surface of the stabilizer and elevator were moderately sooted across the entire span even though they were recovered facing the ground (Figure 4). The sooting on both the upper and lower surfaces exhibited streaks where the soot had been rubbed away revealing the underlying white paint. Samples of the sooting on the upper and lower surfaces were retained for further analysis.

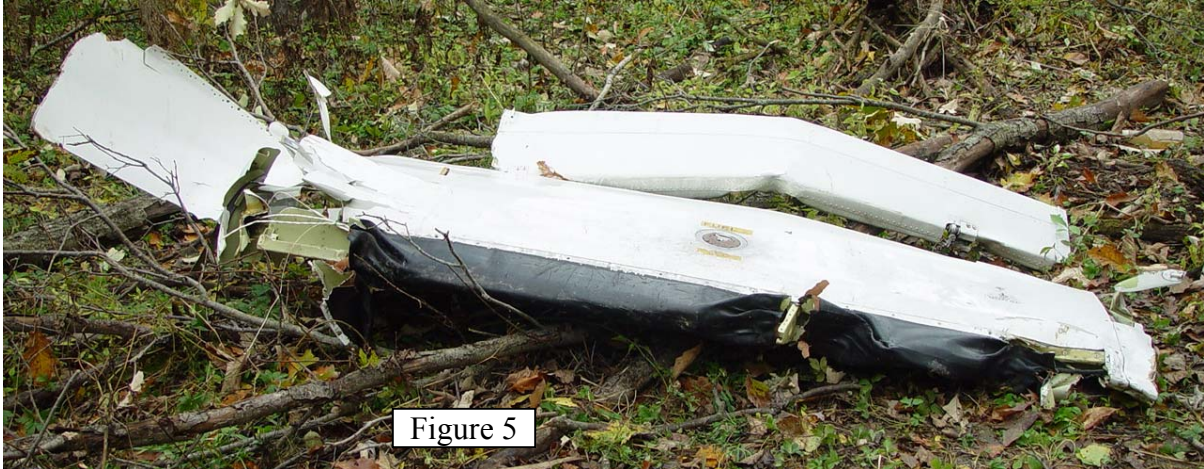
The inboard section of the left wing was found at the main wreckage site in an orientation consistent with the fuselage wreckage. The upper skin, leading edge and forward spar outboard of the nacelle were consumed by fire. The forward spar inboard of the nacelle, rear spar and the lower skin remained with heavy fire damage. The left, inboard flap assembly was intact and remained attached to the rear spar with heavy fire damage. The left wing, aft attach clevis remained attached to the rear spar with a fracture in the aft tang of the clevis. A portion of the fuselage lug remained in the clevis. The left main landing gear (LMLG) was attached to the bottom of the wing with the actuator in the extended position. Both LMLG tires were consumed by fire. The left exhaust remained attached to the upper portion of the wing although the left engine was separated. Outboard of the nacelle, there was a section of rear spar that extended to STN 155. Attached to the lower side of the spar were several pieces of deformed lower skin. These all exhibited moderate fire damage. A section of the upper wing skin was found unburned just forward of the main wreckage site. The left leading edge access panel normally located outboard of the nacelle was also found at the main wreckage site. The middle portion of the left wing extended from STN 155 to STN 187 at the trailing edge and to STN 210 at the leading edge. This section was found in the pile of branches and tree debris as described earlier with extensive fire damage. The forward spar was deformed rearward about 90° at STN 155. The upper skin was totally consumed by fire leaving the spars and lower skin with extensive fire damage. The outboard flap remained attached also with extensive fire damage. The inboard aileron hinge fitting was still attached to the rear spar with the aileron attach bolts still installed. The outboard wing section extended from STN 187 at the trailing edge and STN 210 at the leading edge to the wing tip. This section was found stuck in a tree as described earlier with no evidence of fire. The leading edge exhibited 4 distinct impact marks (Figure 5). At STN 215 there was a semi-circular impression about 12 inches wide and 18 inches deep that fractured the forward spar. At STN 232 there was a semi-circular impression about 13 inches wide and 10 inches deep. At STN 277 there were two semi-circular impressions adjacent to each other with a leading edge rib between them. The damage area was about 18 inches wide and 8 inches deep. At STN 300 there was a semi-circular impression about 17 inches wide and 8 inches deep. The wingtip fairing had damage to the tip with some of the skin and the strobe light missing. The upper skin was fractured diagonally from STN 210 at the leading edge to STN 187 at the trailing edge. Part of the left aileron from STN 241 to STN 307 remained attached to the outboard wing. The outboard section of the aileron leading edge had impact damage at STN 272 about 11 inches wide by 2 inches deep and at STN 297 about 11 inches wide and 3 inches deep. There was a crease at STN 272 and the aileron was bent down. The aileron horn balance was separated and found in the wooded area. A section of the lower wing skin that

included fuel tank access panel 6 was on the ground beneath the tree the wing was found in. The inboard section of aileron from STN 187 to STN 241, including the attached trim tab, was separated and found forward of the outboard wing section as described earlier. The outboard fourth of the trim tab piano hinge was separated and there was a large impact impression in the leading edge of the aileron at STN 223 about 12 inches wide and 4 inches deep. The aileron was bent about 45°. The balance weight remained attached to the inboard aileron section.

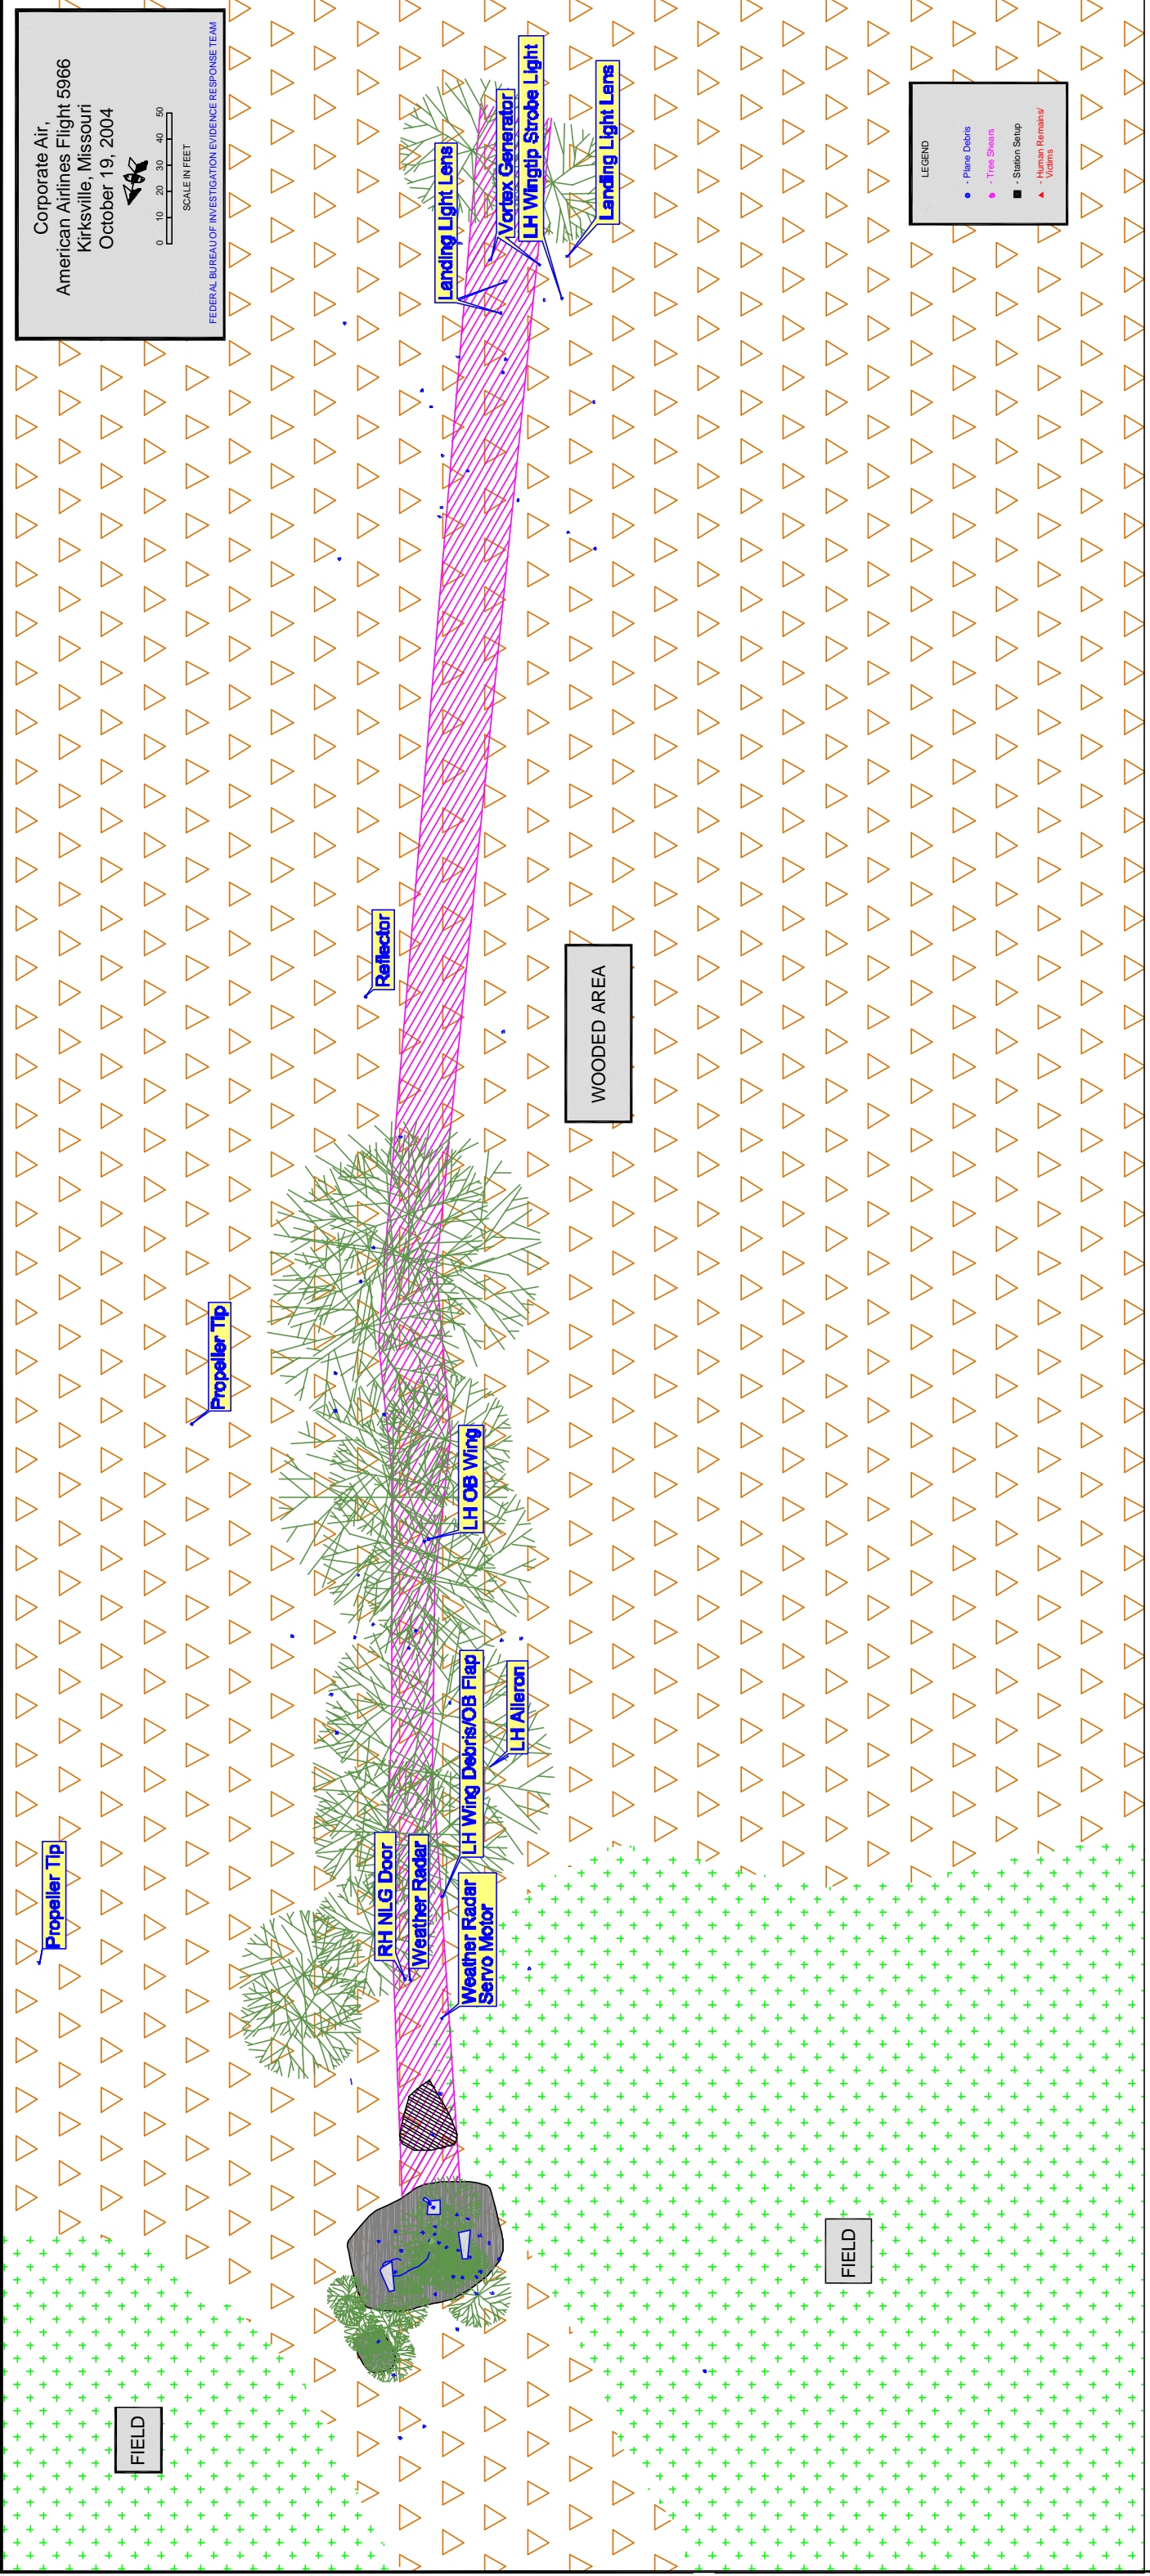
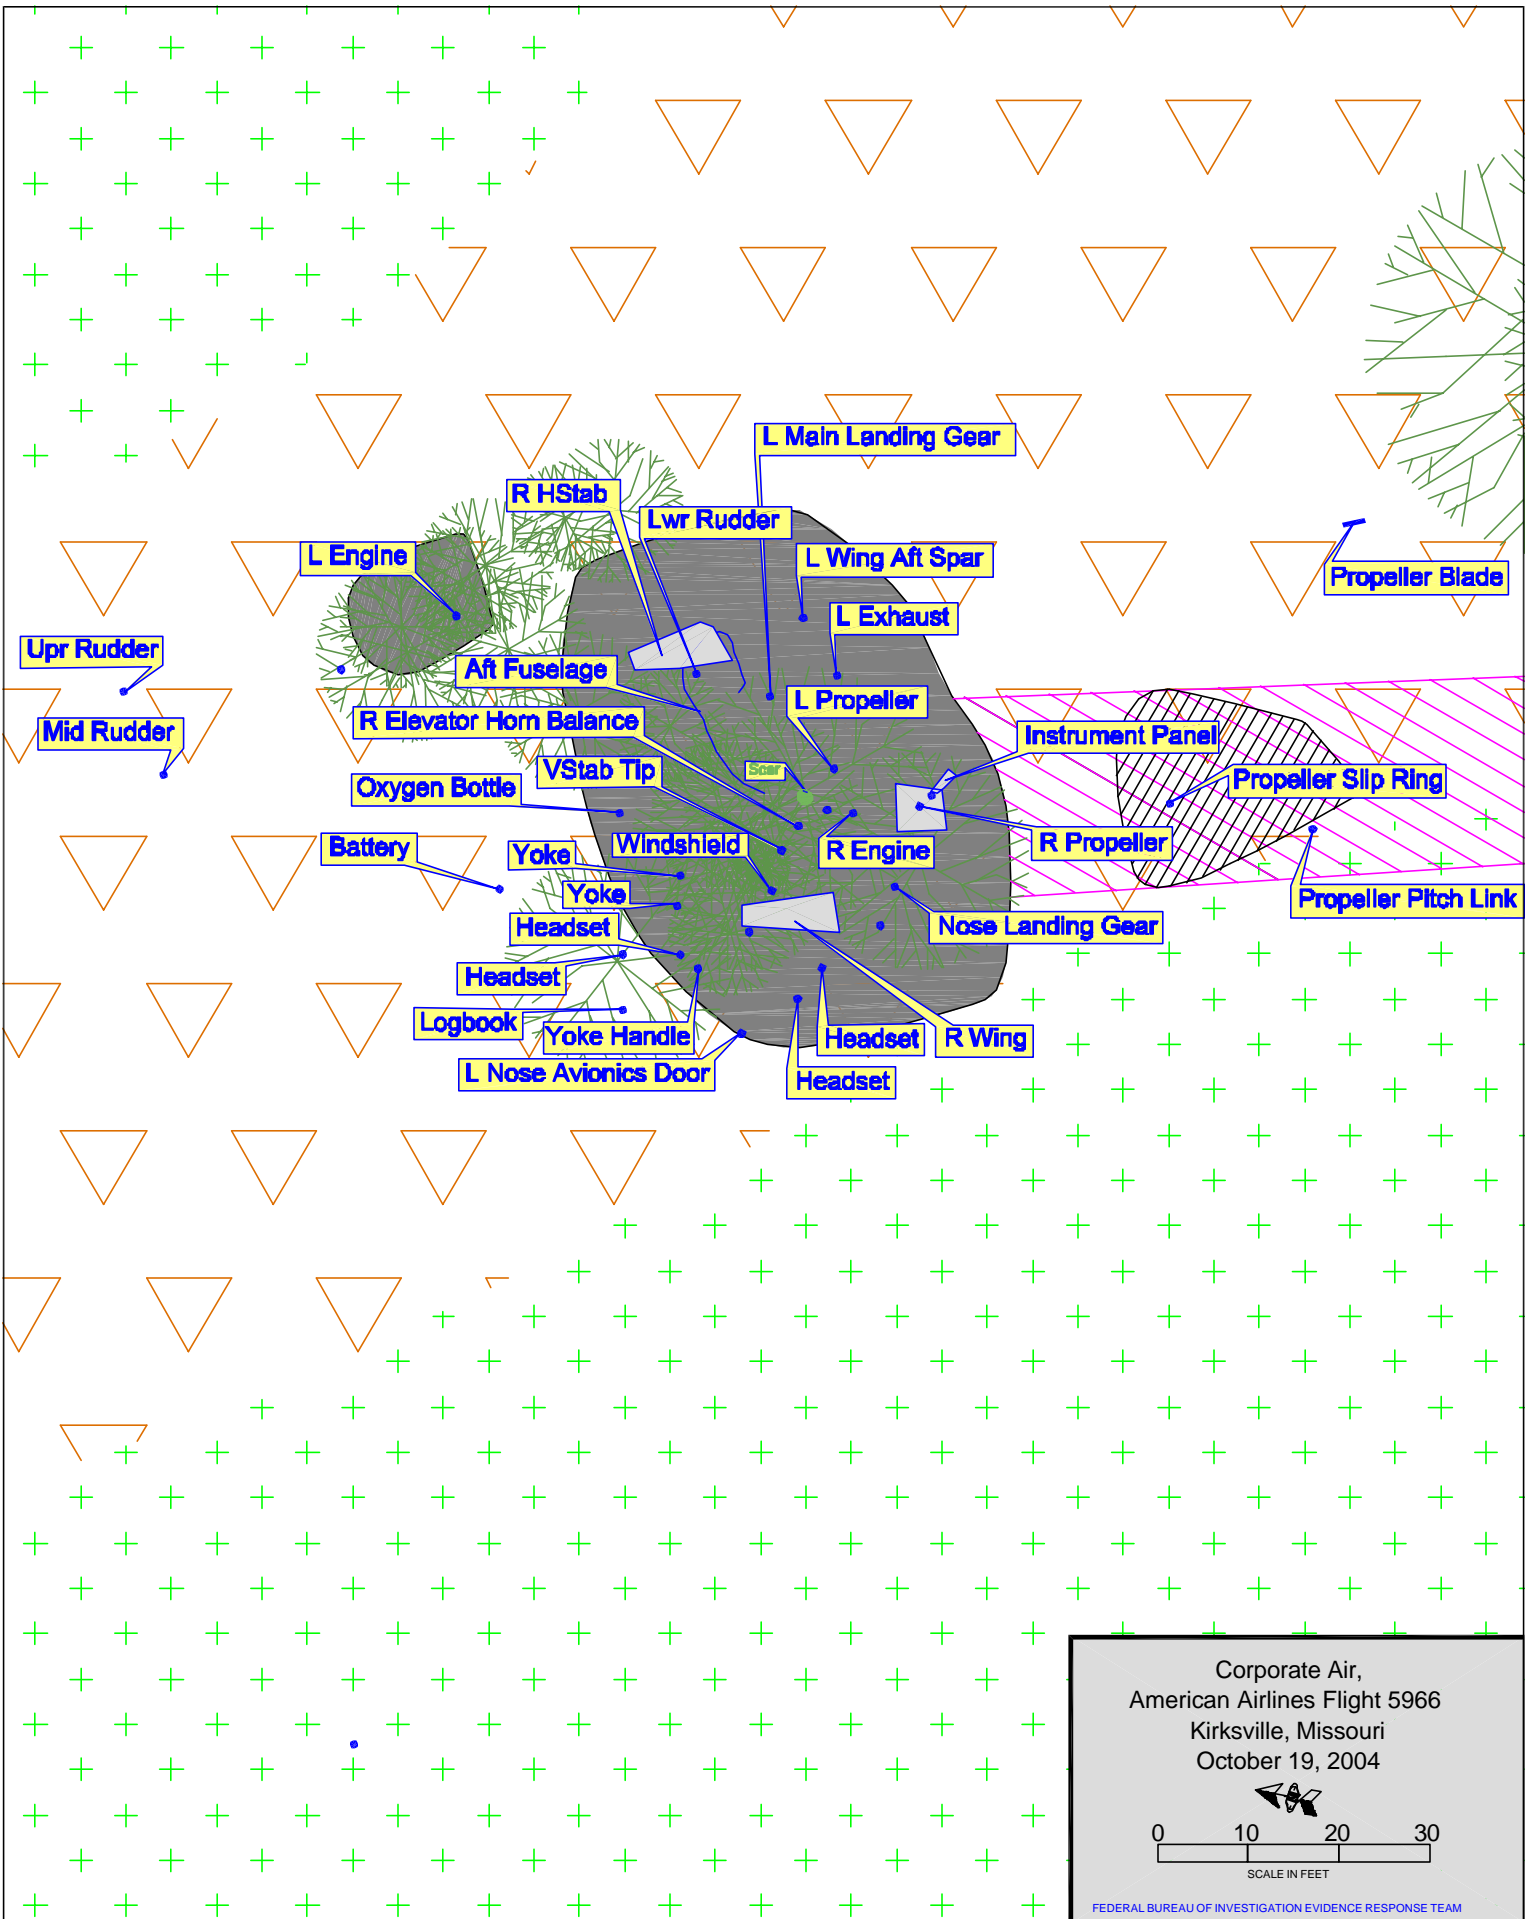
APPENDIX 2  
Wreckage Diagrams

The main wreckage site was defined as an approximately circular area about 30 feet in diameter centered about a small 6-inch diameter tree and exhibited intense fire damage. The center was located at N 40° 03.844', W 92° 32.663' and, based on the USGS Millard Quadrangle topographic map, at an elevation of about 920 feet above mean sea level (MSL). The main wreckage site included a majority of the airplane and was located at the base of several trees in a wooded hollow between two adjacent bean fields about 1.4 miles from the runway 36 threshold that is at an elevation of 964 feet MSL. Remains of the right engine and propeller, the left propeller, the lower, forward fuselage, the left inboard wing, the right wing, the aft fuselage, and the empennage structure were all found here. A majority of the wreckage and the surrounding vegetation was consumed by fire. All of the measurements in this report will be referenced to the main wreckage site and/or the center point. See Appendix 2 for an overall wreckage diagram and a close up diagram of the main wreckage site.
