NATIONAL TRANSPORTATION SAFETY BOARD
Office of Aviation Safety
Washington, D.C. 20594
September 11, 2017

Group Chairman’s Factual Report

STRUCTURES

DCA17MA022

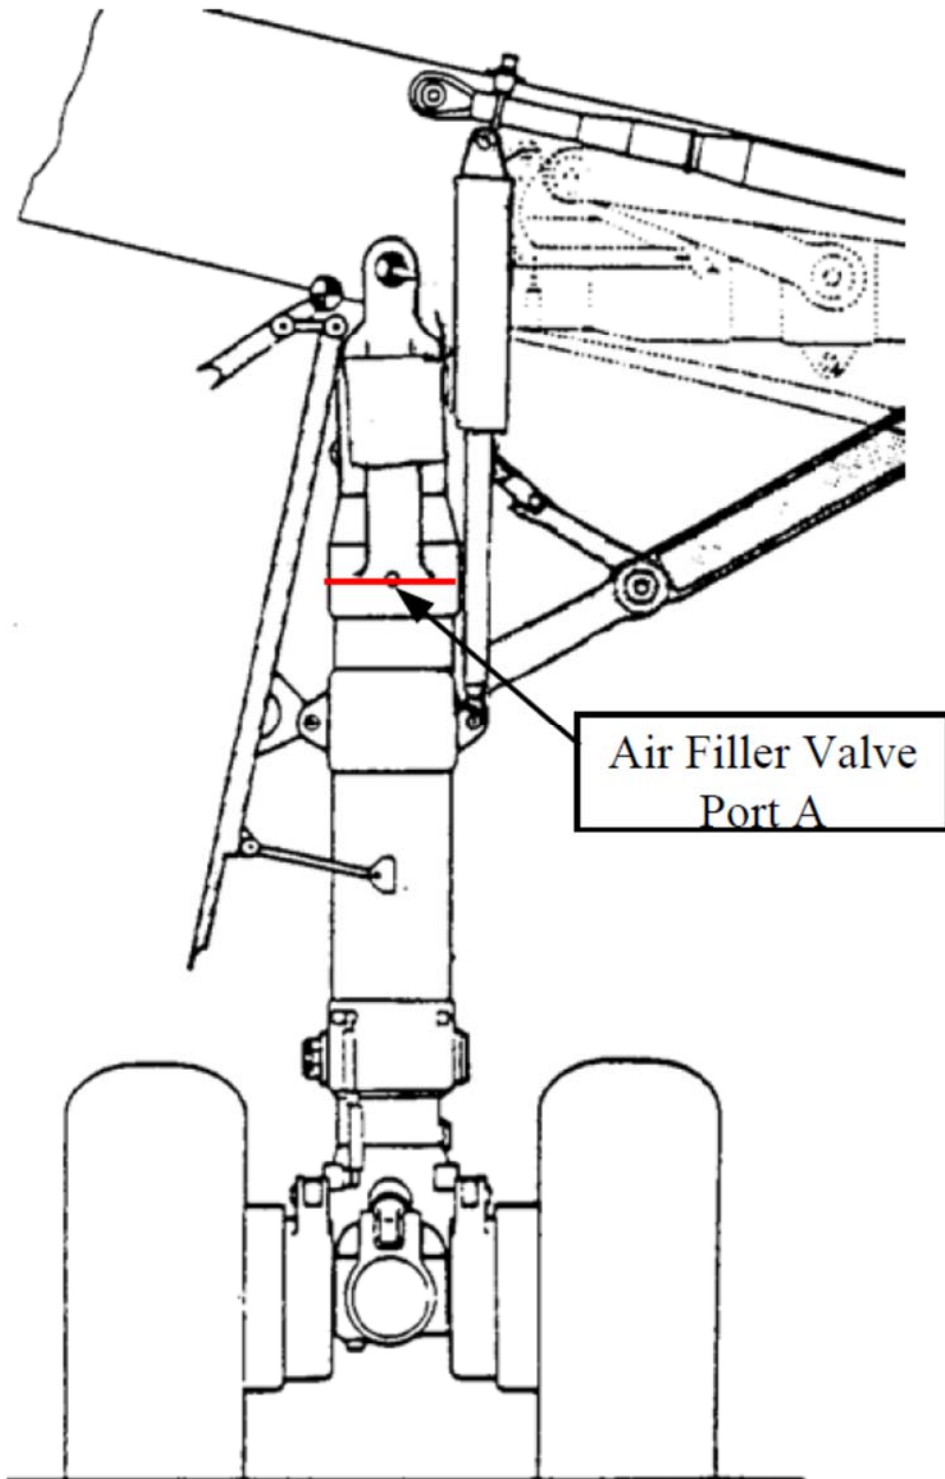
The left hand (LH) main landing gear (MLG) outer cylinder¹ was fractured midway through the air filler valve boss at port A on the aft side of the outer cylinder (Figure 5). The LH side MLG shock strut outer cylinder fractured around its entire circumference (reference Figures 6 and 8). The upper portion of the cylinder remained intact and attached to the airplane at the forward and aft trunnion lugs. The upper portion of the cylinder transitioned from about 13 inches on the outboard side to about 28 inches on the inboard side when measured from the top of cylinder.

Figure 5 – Left hand main landing gear viewed looking forward

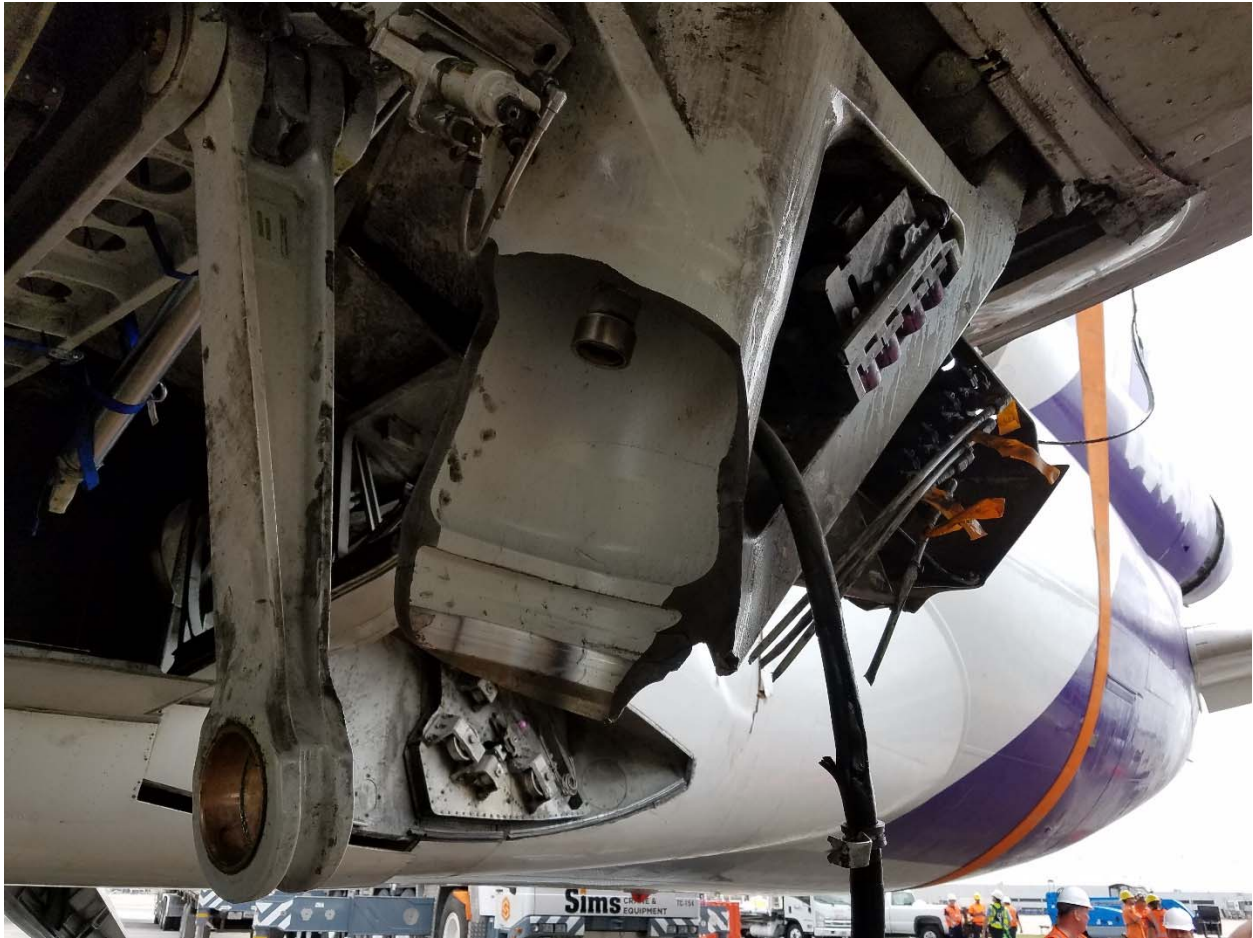
Figure 6 – Upper portion of left main landing gear attached to the airplane

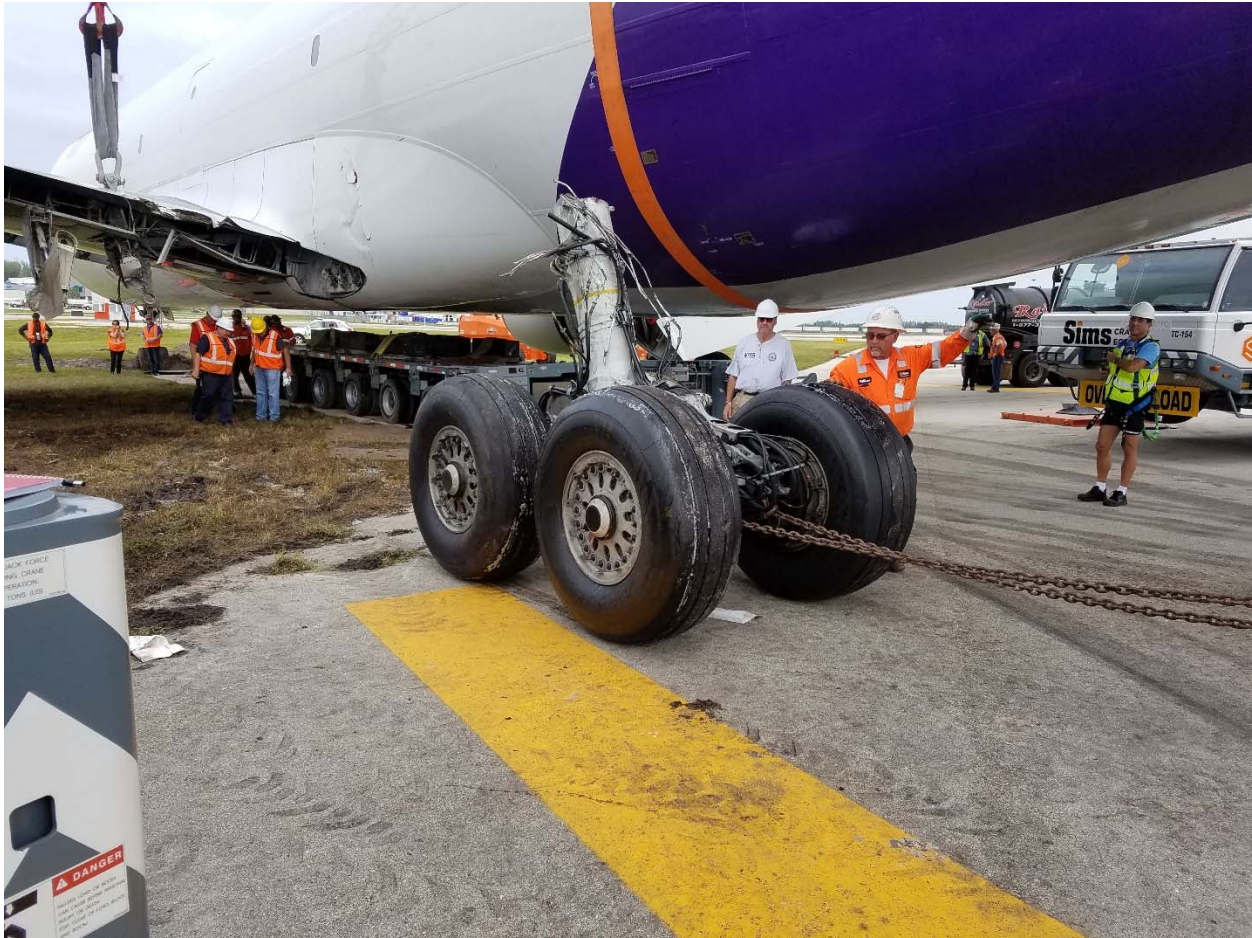
The lower portion of the LH main landing gear remained attached by the side braces. During aircraft recovery, the lower side brace nut was removed, and hydraulic lines and electrical conduit were cut to enable the LH gear lower portion to be removed from the airplane.

Figure 7 – Lower portion of the left main landing gear after being detached from the side brace

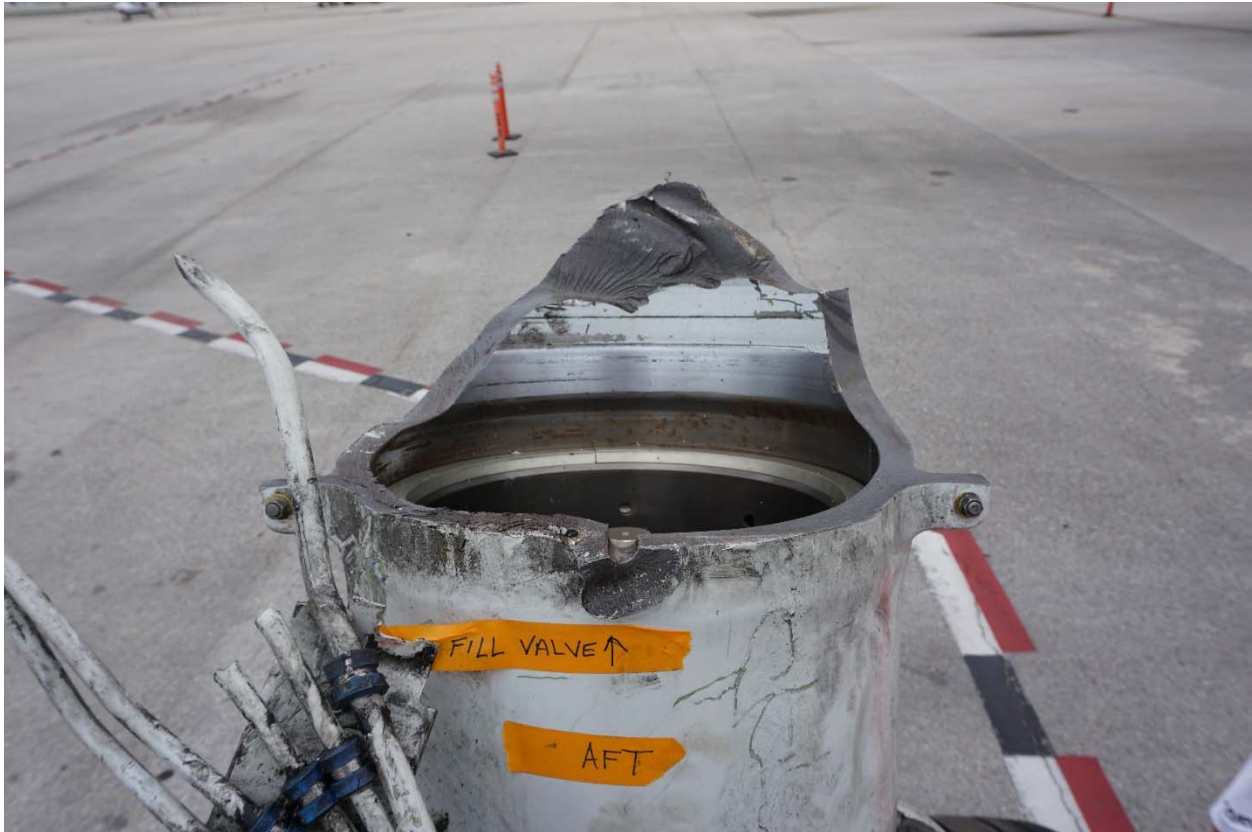
Figure 8 – Aft side of lower section of the main cylinder and fill valve

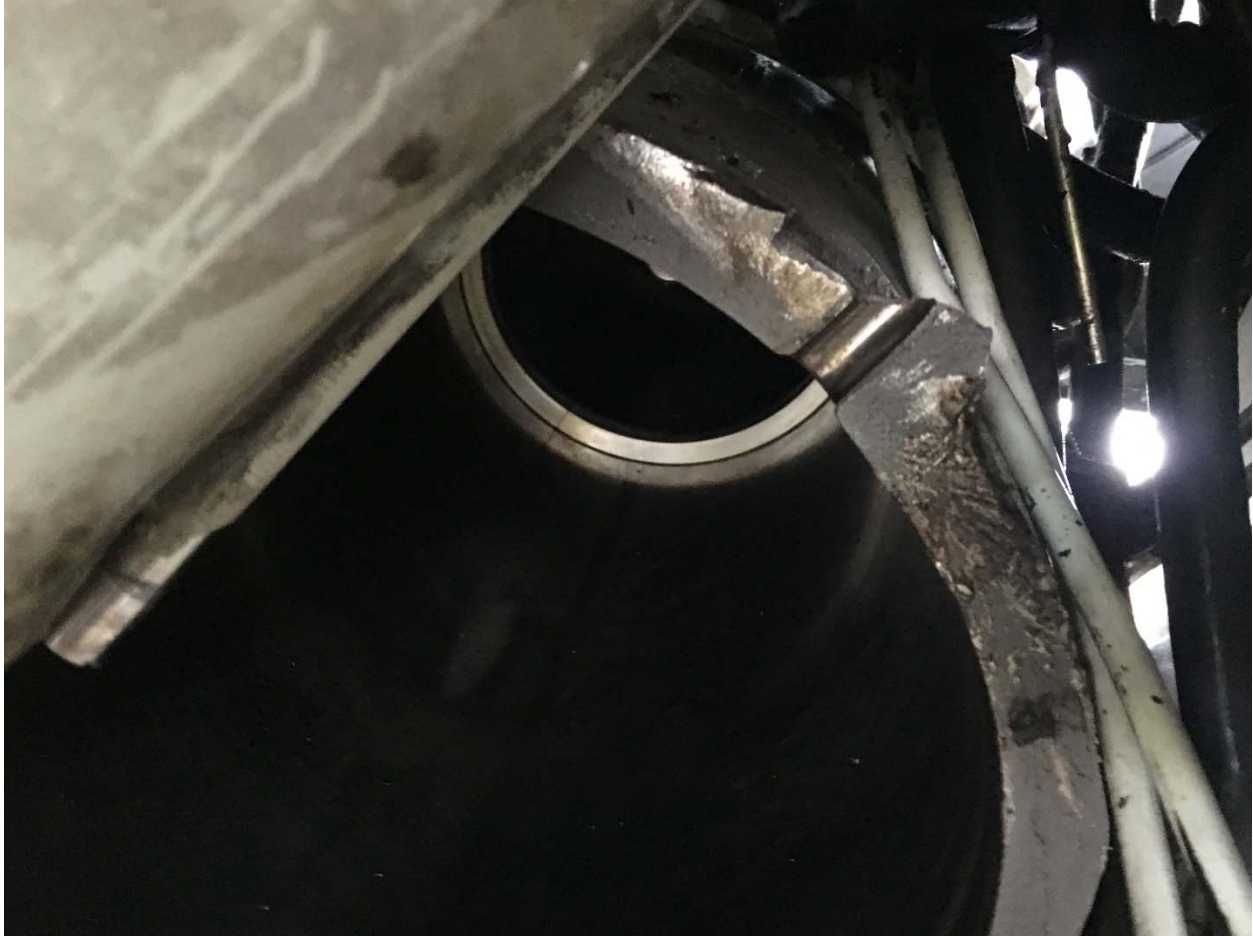
The remaining lower portion of the cylinder transitioned from approximately 55 inches to 63 inches on the forward side as measured from the bottom of the cylinder. The inboard side lugs and bolt and nuts for the retract actuator attach points remained intact. The outboard side lugs and bolt and nut for the fixed door attach points also remained intact. On the aft side of the lower section of the fractured gear, 55 inches from the bottom, approximately half of the upper charging bore was visible (reference Figure 8). The fracture surface on outer cylinder in the area of the charging bore had features consistent with fatigue (reference Figure 9).

Figure 9 – Fracture surface on the lower section of the left main landing gear cylinder exhibiting features consistent with fatigue

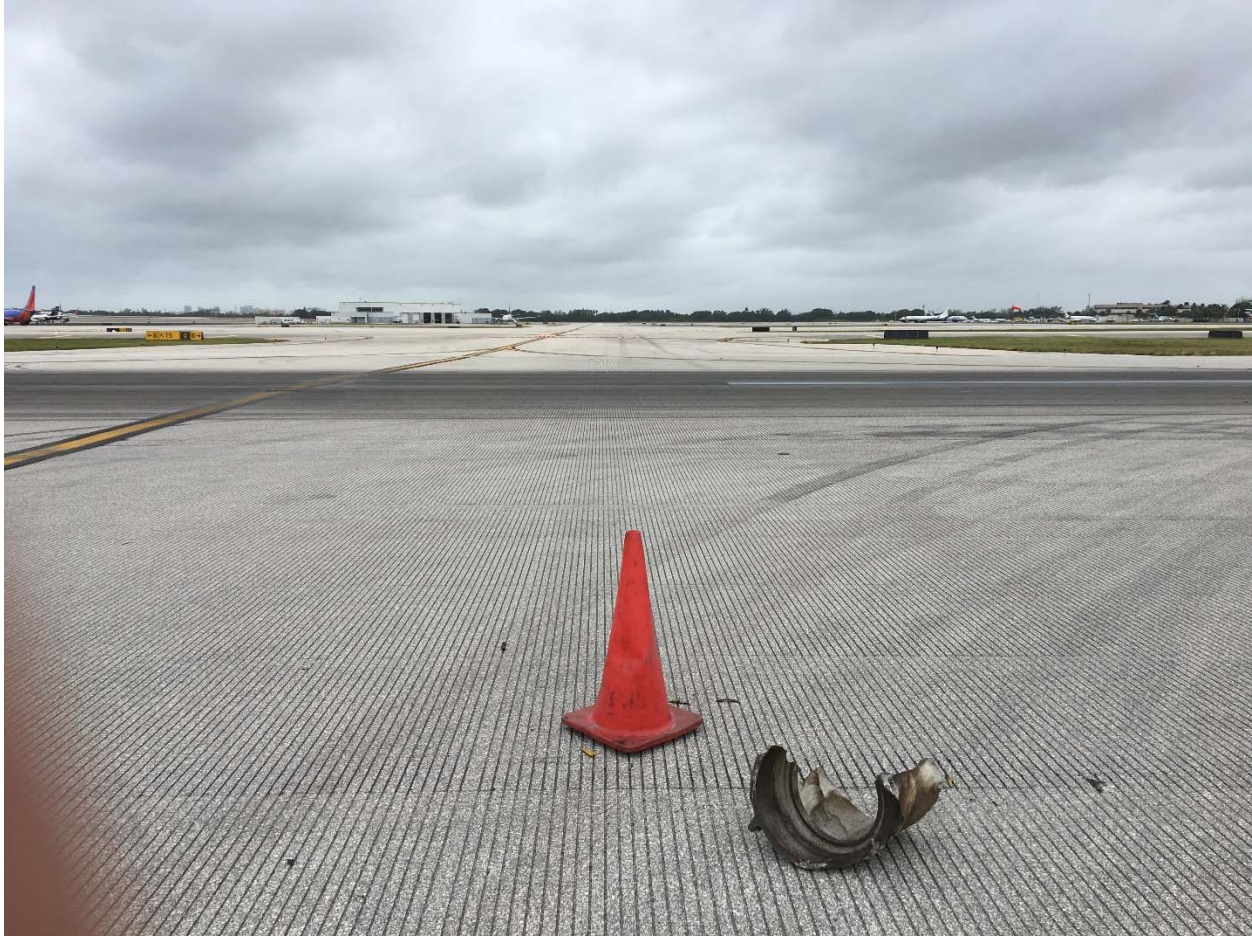
Three pieces of the left hand outer cylinder were found on the runway. One piece measured about 12 to 14 inches longitudinally by about 30 inches circumferentially (reference Figure 10). Two smaller portions, approximately 2 by 2 inches and 3 by 3 inches from the upper charging bore and boss were also found on the runway (reference Figures 11 and 12). The upper charging bore fill valve (shradler valve) was not found. The fracture surface of the 3 by 3 section had features consistent with fatigue in the area of the upper charging bore (reference Figures 13 and 14).

Figure 10 – Large section of main cylinder recovered from the runway

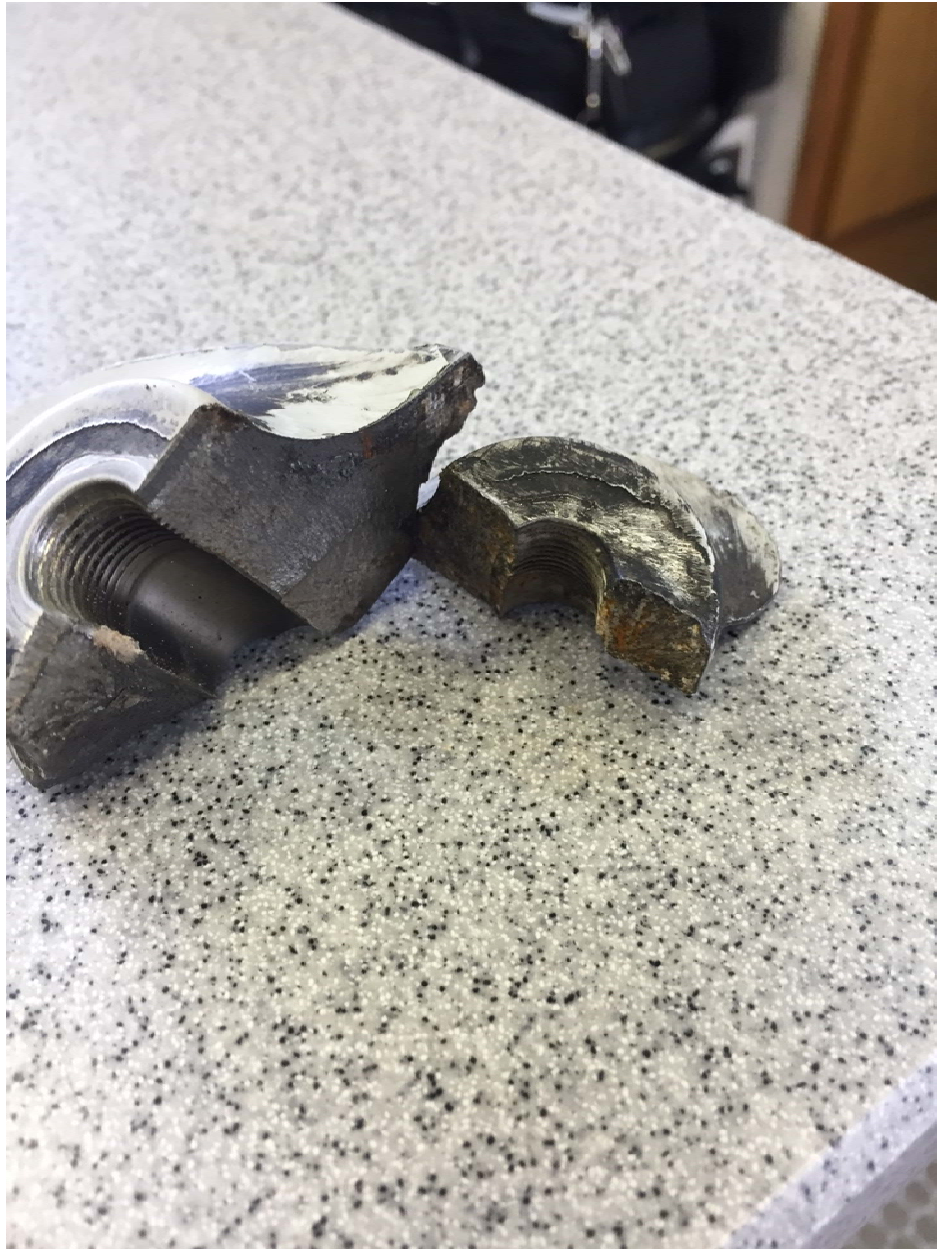
Figure 11 – Main cylinder pieces recovered from the runway

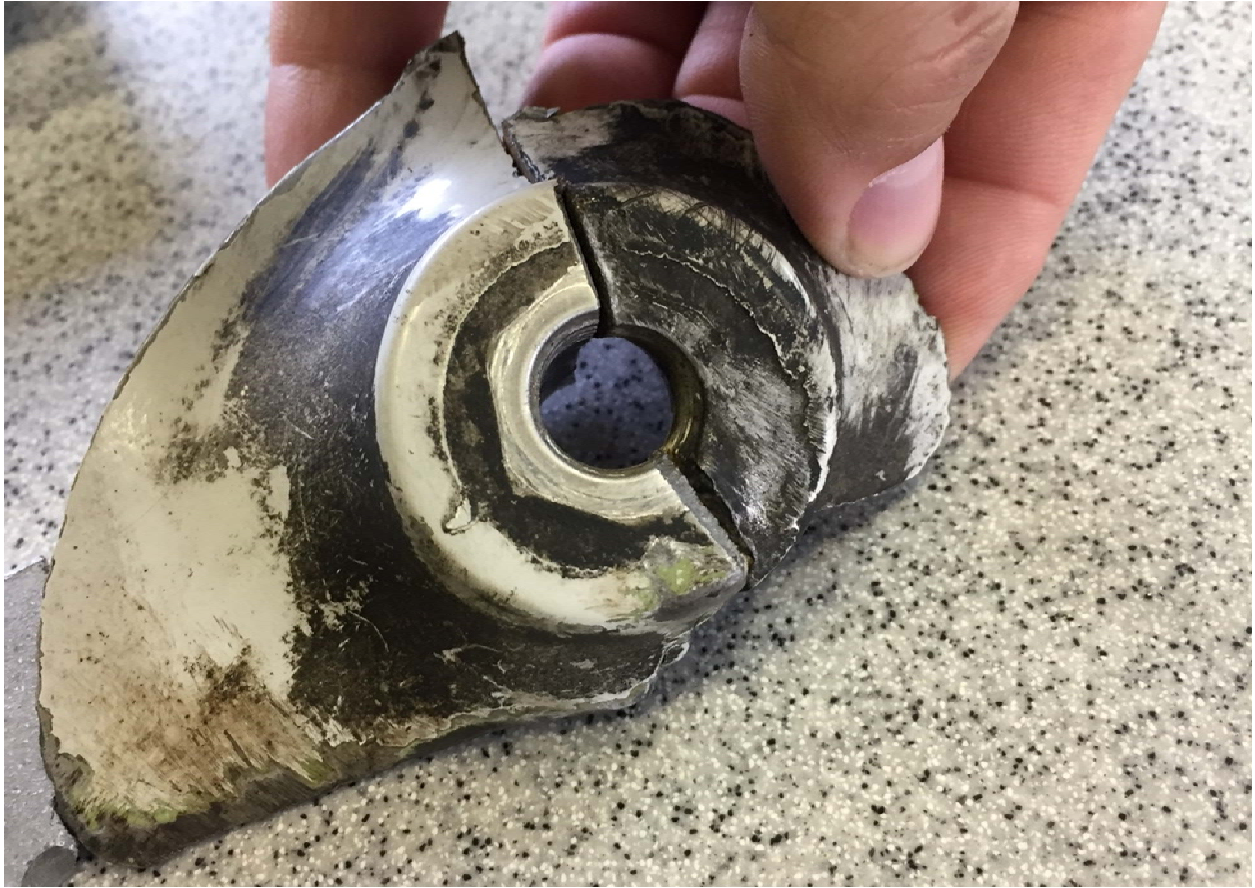
Figure 12 – Main cylinder pieces recovered from the runway

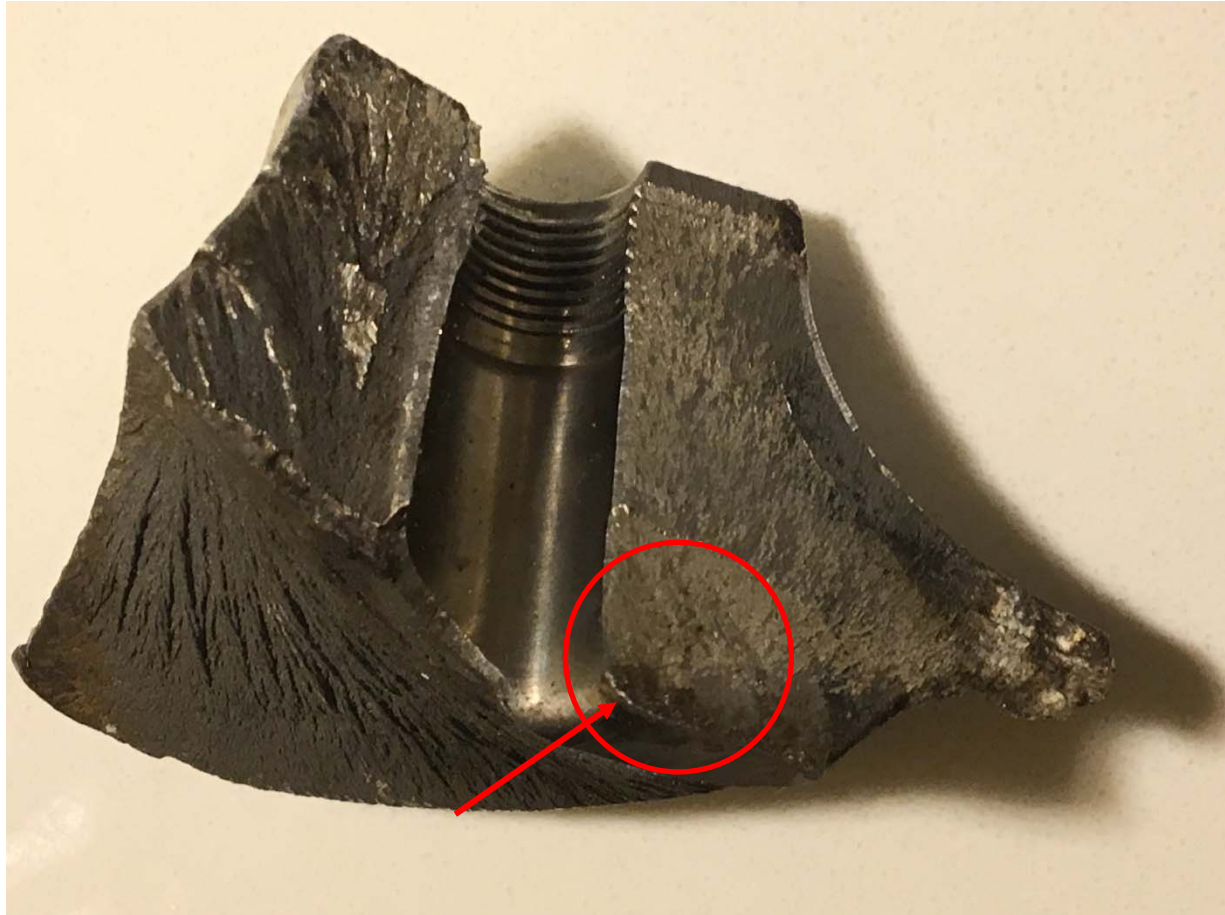
Figure 13 – 3 inch by 3 inch piece of main cylinder exhibiting features consistent with fatigue

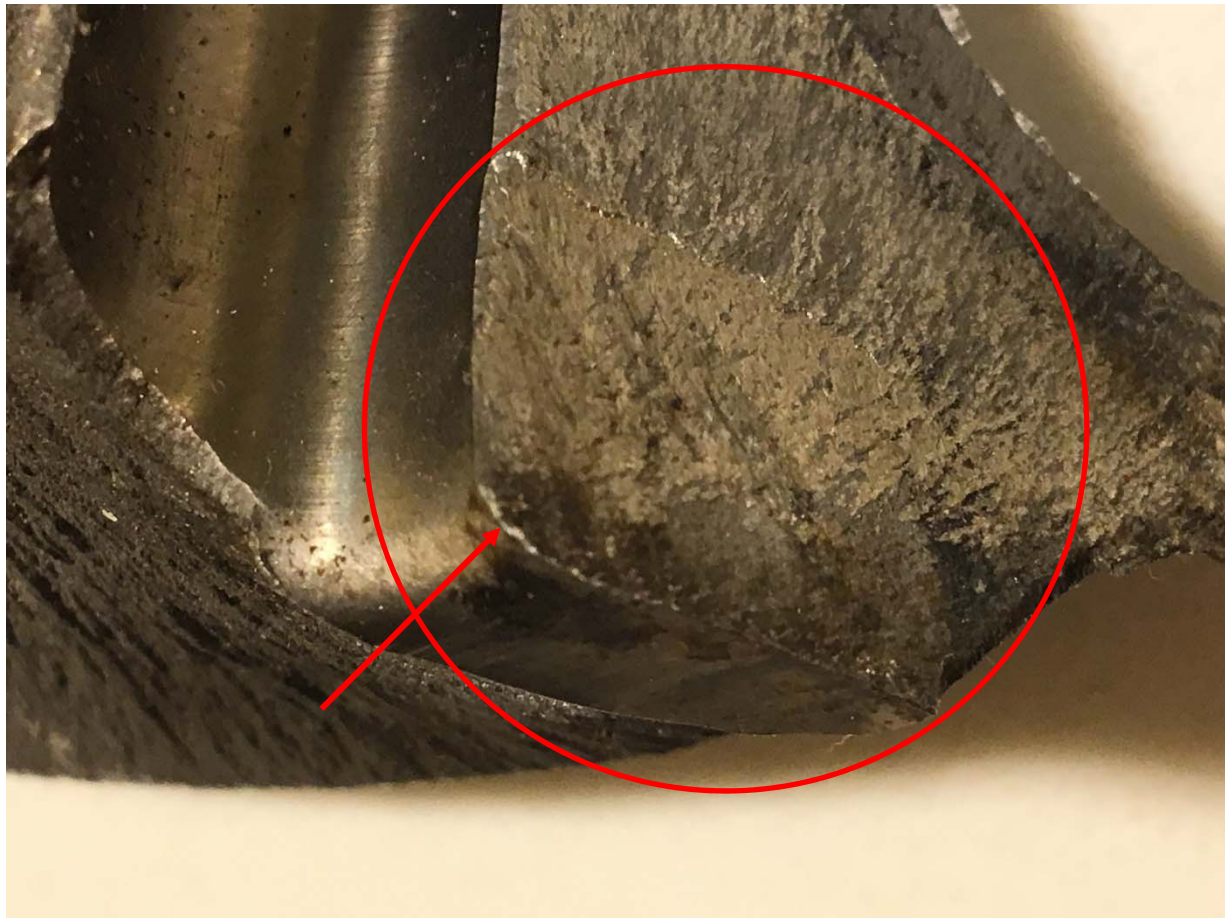
Figure 14 – 3 inch by 3 inch piece of main cylinder exhibiting features consistent with fatigue

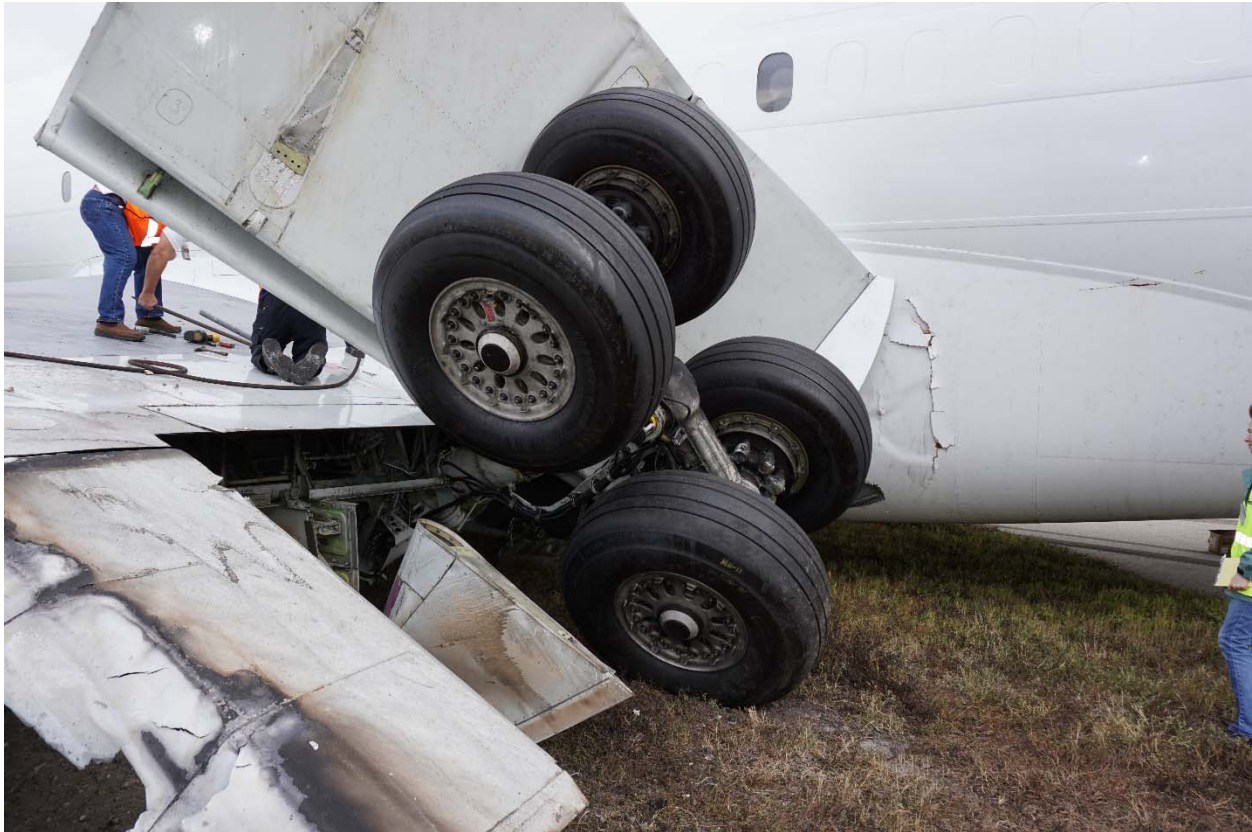
There were no anomalies noted with the trunnion lugs or trunnion bolt attachment points. The lower segment of the landing gear was folded aft into the left hand side inboard flap (reference Figures 15 and 16). The lower portion of the gear remained attached to the MLG side brace assembly.

Figure 15 – Lower portion of the left main landing gear viewed looking inboard

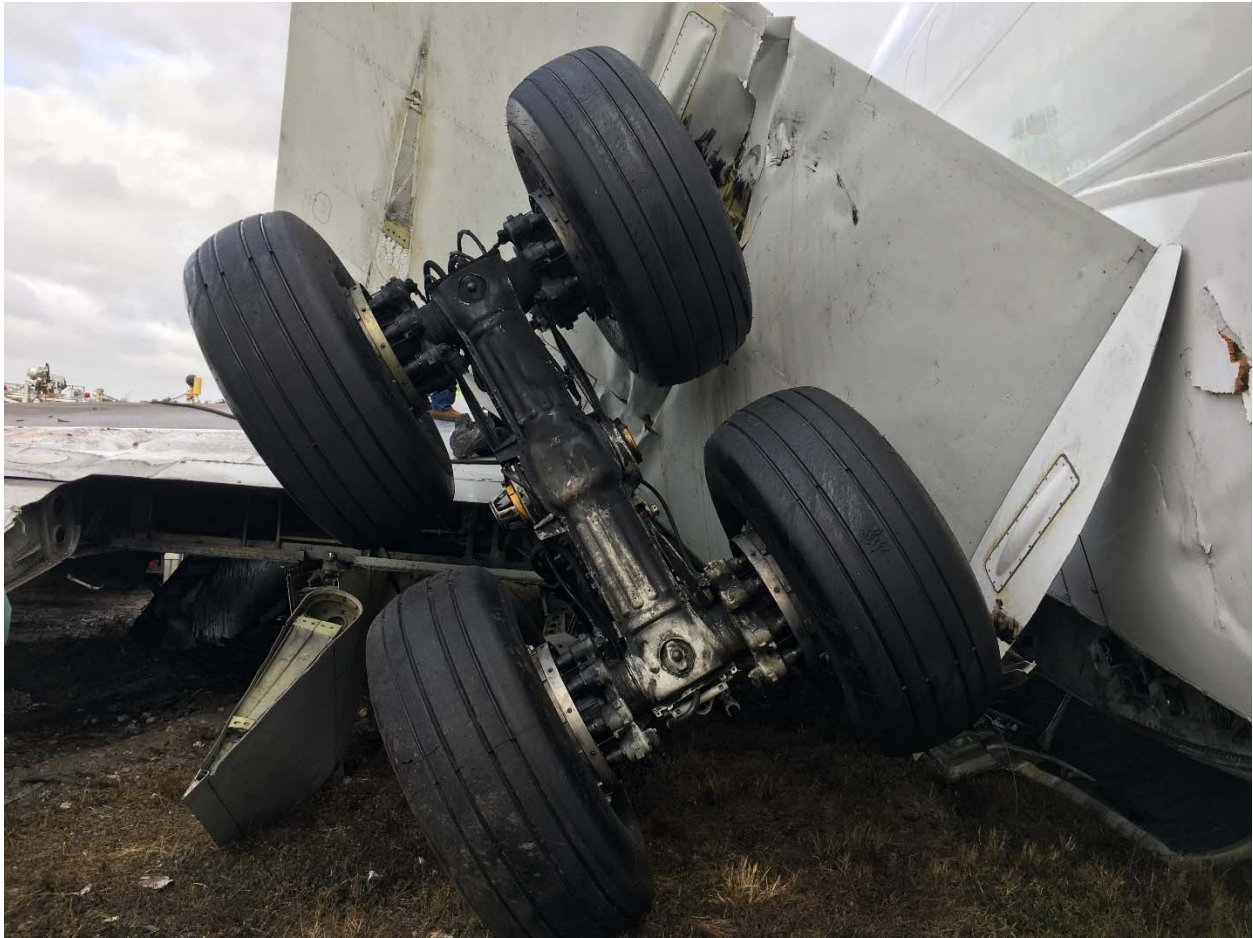
Figure 16 - Lower portion of the left main landing gear viewed looking forward

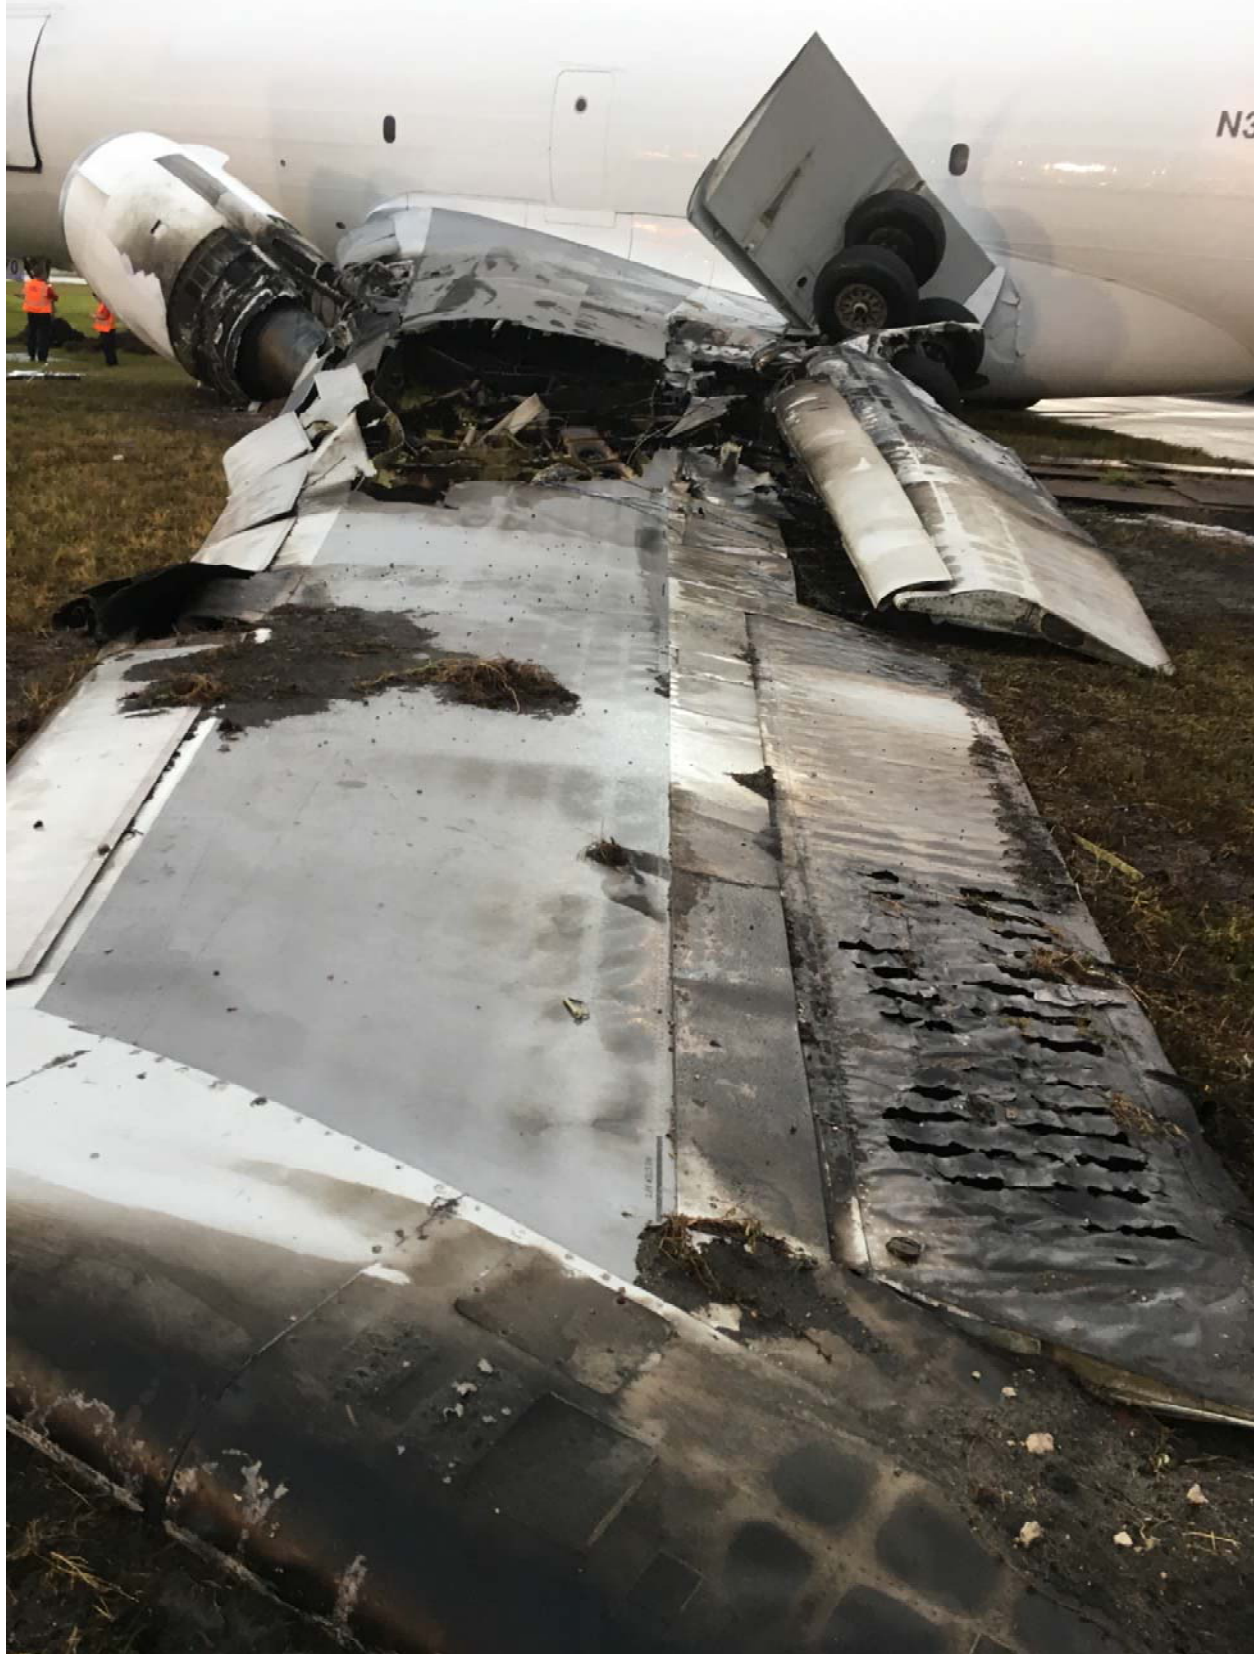
The LH wing sustained fire damage (reference Figures 17 and 18). The structural wing damage extended from inboard of the number one engine pylon outboard to the LH wing tip, and chordwise from the leading edge wing spars to the aft trailing edge wing spars.

Figure 17 – Left wing viewed looking inboard

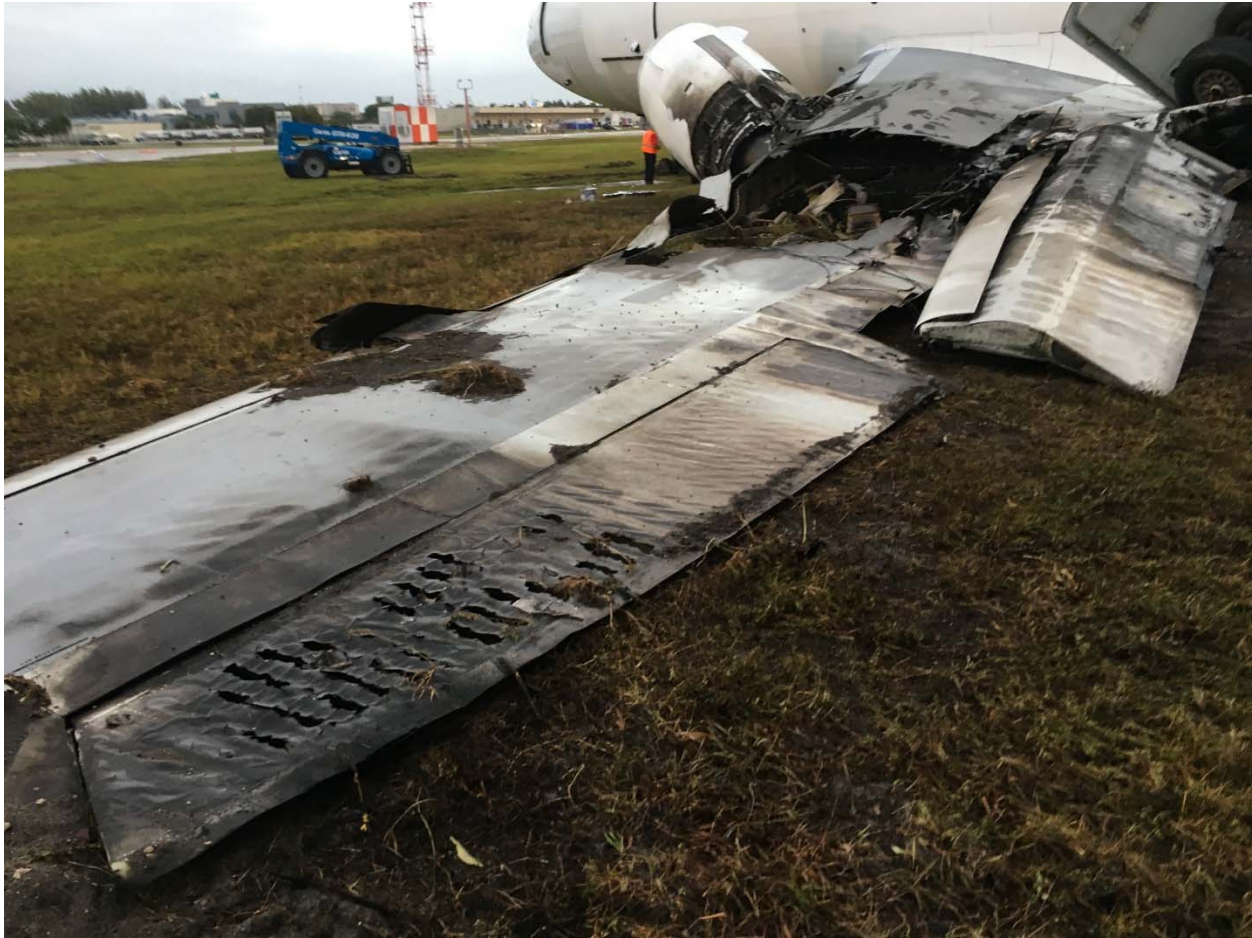
Figure 18 – Left wing viewed looking inboard and forward

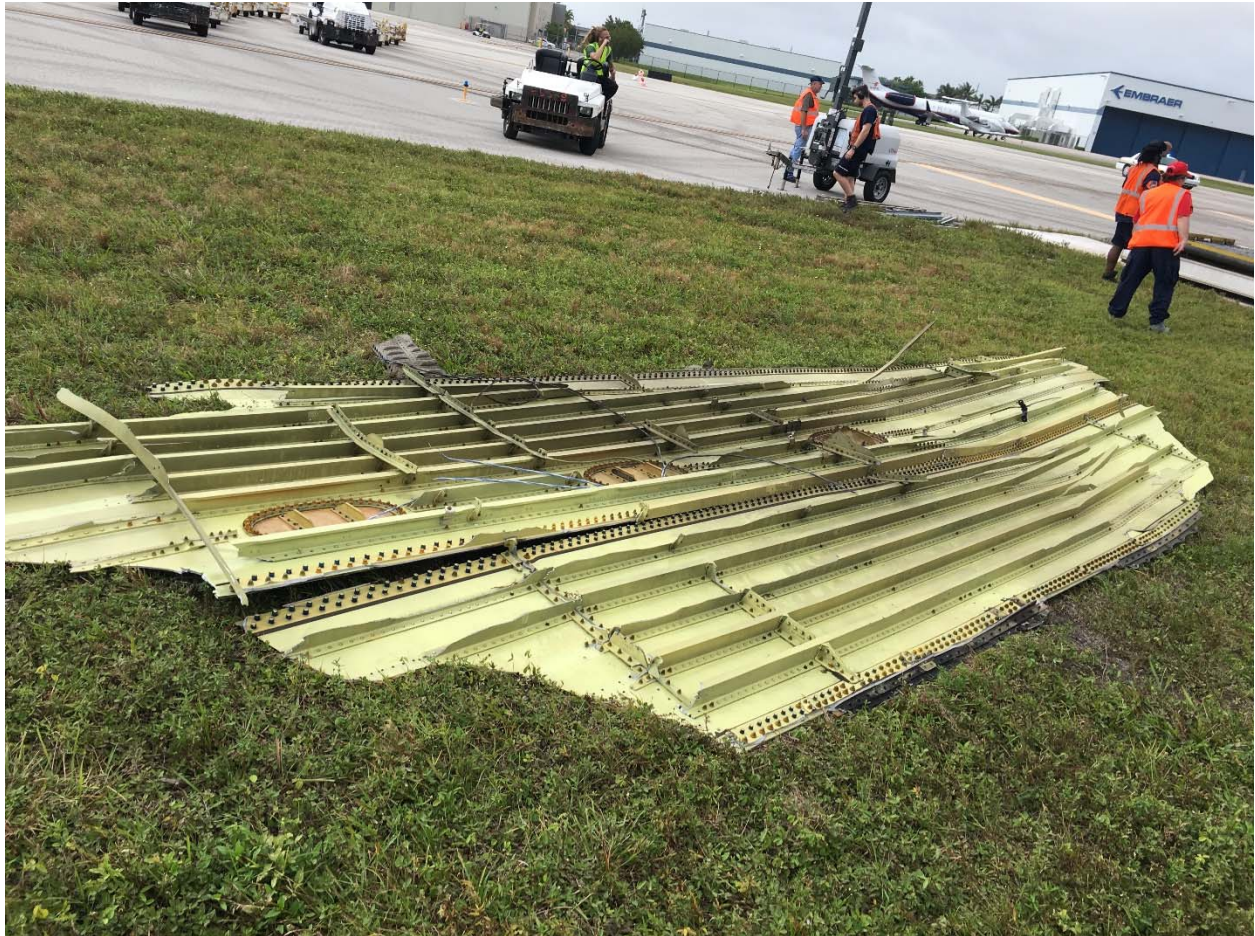
A section of the upper LH wing skin measuring approximately 25-foot spanwise by 8.5 feet chordwise was missing from the upper wing surface (reference Figure 19). It was located just forward and to the left of the airplane. This section of the wing skin spanned from just outboard of the number 1 engine pylon from about wing station 402-433 to about 702-733.

There was fire damage, broken and missing wing stringers and wing ribs when viewed thru the missing wing section. The chordwise bulkheads and ribs along the open section of the wing were charred, bent and twisted outboard.

Figure 19 – Section of the left wing upper skin panel
