National Transportation Safety Board

DCA22MA009

STRUCTURES

Specialist's Factual Report

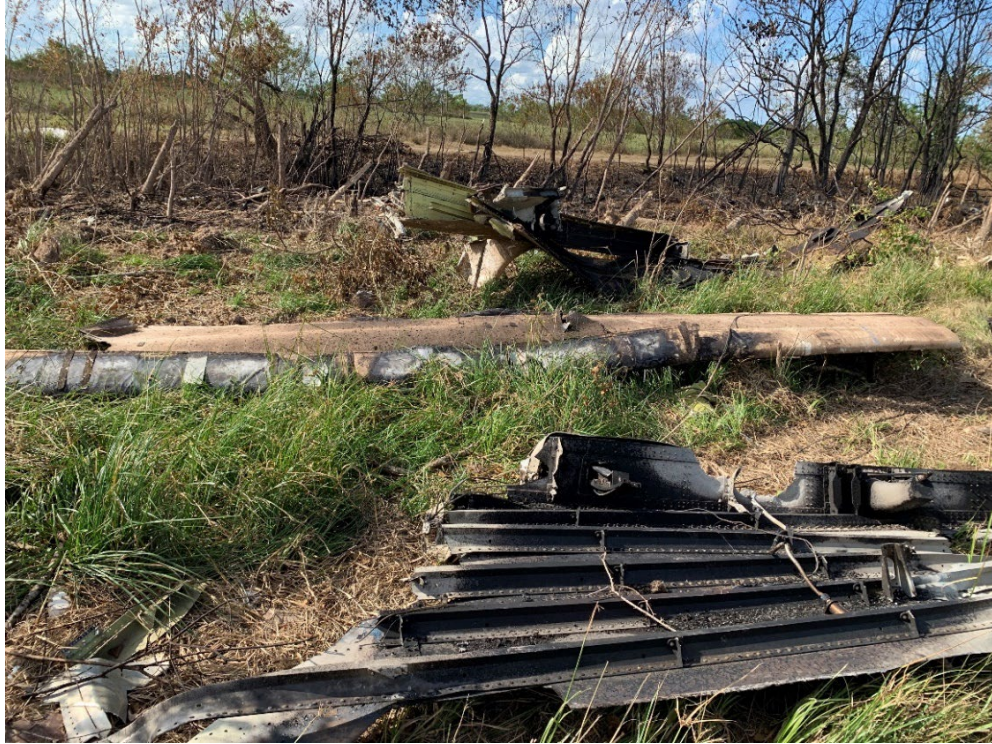
During the accident sequence an outboard portion of the left wing and left wing tip was separated due to contact with several trees and impact with the ground. There was approximately 15 feet of the left wing still attached to the fuselage. The wing was heavily damaged due to the fire. Leading edge control surfaces were found extended and remained attached to the wing but were damaged due to impact.

Figure 5. View of separated left wing as the airplane hit trees during the accident sequence

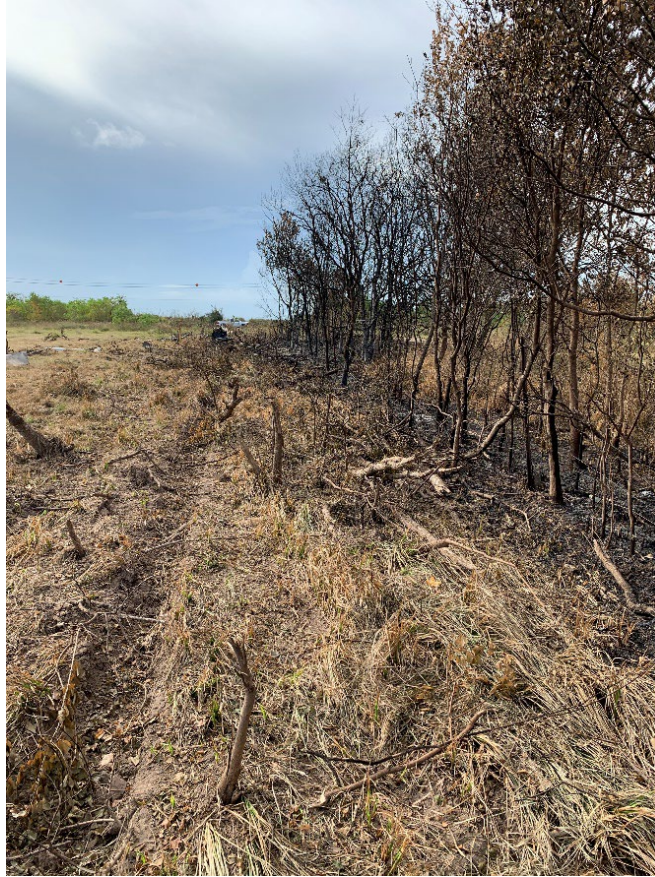
Figure 7. *View looking back towards Morton Road with LH MLG outboard tire marks*

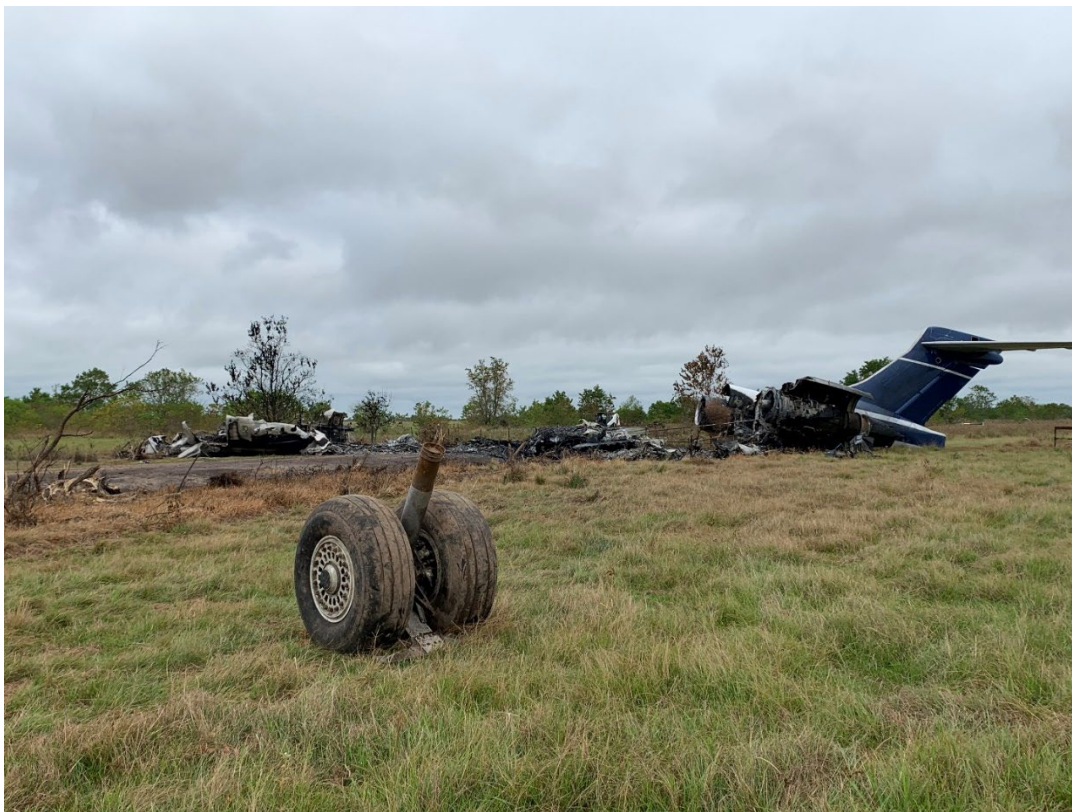
The lower section of the left main landing gear, including the axle, wheels, and inner cylinder was found in the wreckage field, separated from the airplane. The gear departed the aircraft during the aircraft accident sequence and was found approximately 150 feet from the main wreckage. The tires and brake assemblies were still attached to the gear. Both brake wear pins on the left gear wheels showed approximately 1.5 inches of pin extension remaining. Several left main landing gear internal components including inner cylinder static and dynamic seals, and the MLG Shock Strut Restrictor, were found in the wreckage path.

Figure 10. *View of LH MLG separated during the accident sequence*

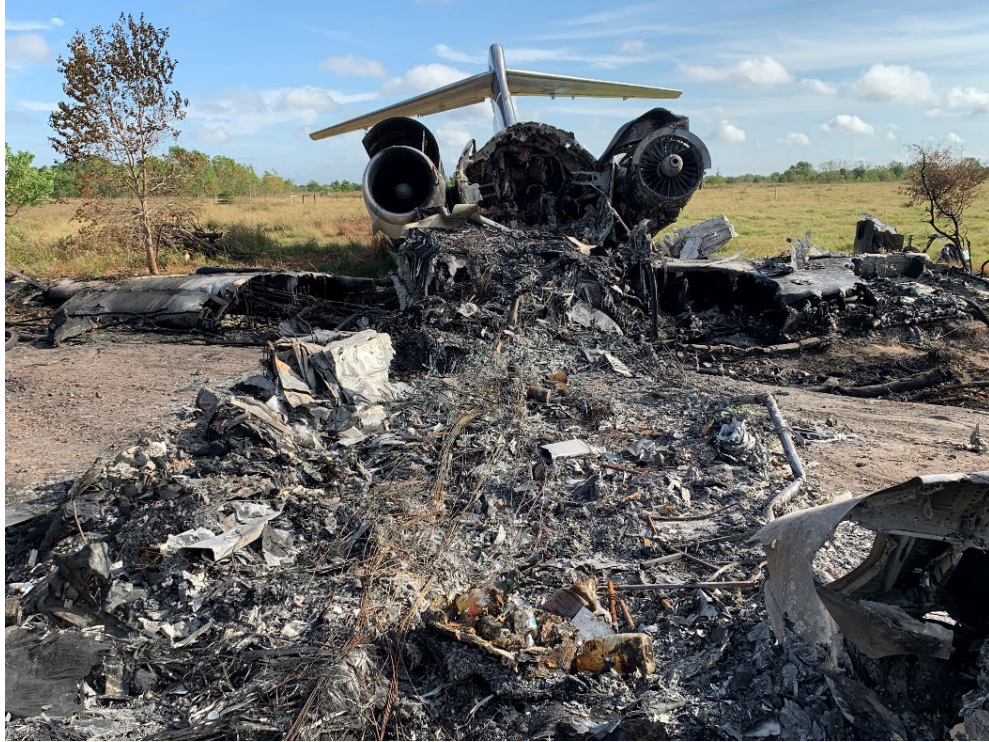
The airplane structure was heavily damaged due to the fire that ensued after the airplane came to rest during the accident sequence. Fire consumed approximately more than two thirds of the structure. All of the upper fuselage structure (except for a small section of the upper nose structure) was consumed by fire.

Figure 13. Fire Damage looking aft

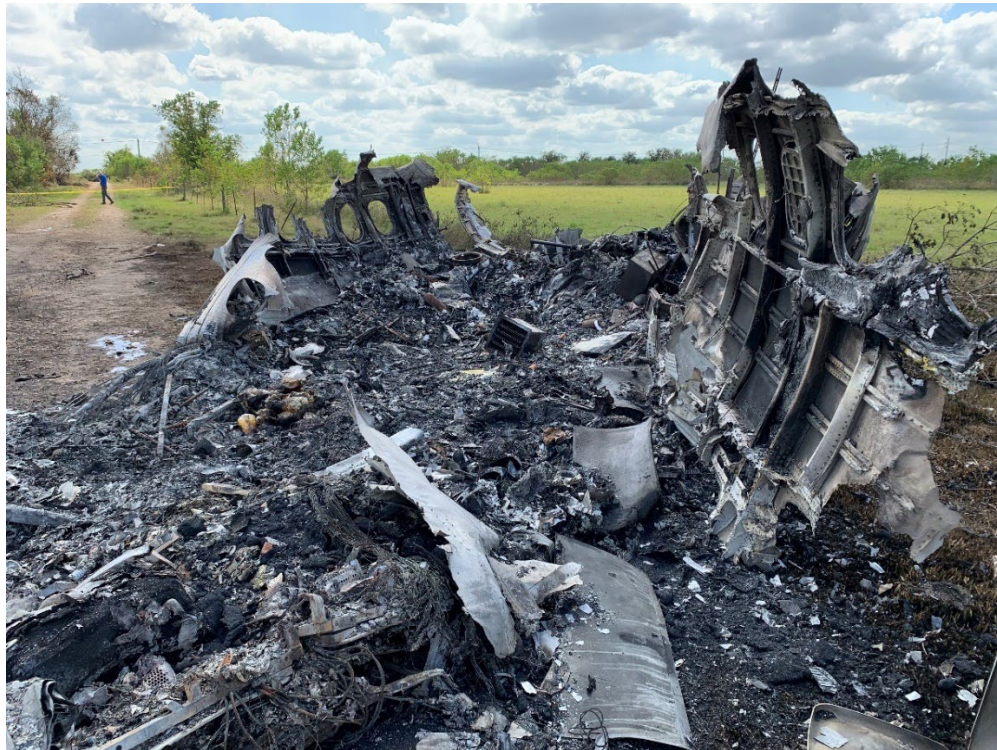
Figure 14. Fire Damage looking forward

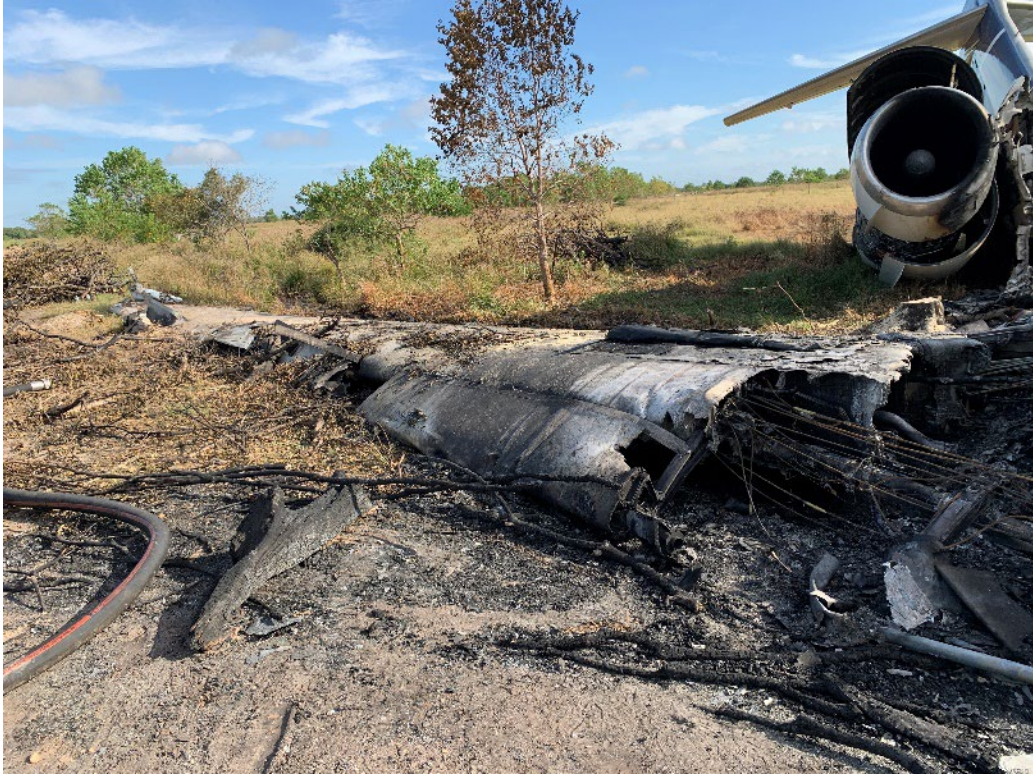
The majority of the right wing remained partially attached to the wing root, but sustained heavy fire damage towards the wing root. Similarly, the wing skin upper surface showed signs of fire damage in the same area. The right tip remained attached to the right wing but was considerably damaged due to impact with the ground. Leading edge control surfaces were found extended and remained attached to the wing but were damaged due to impact.

Figure 15. Right Wing Fire Damage looking aft

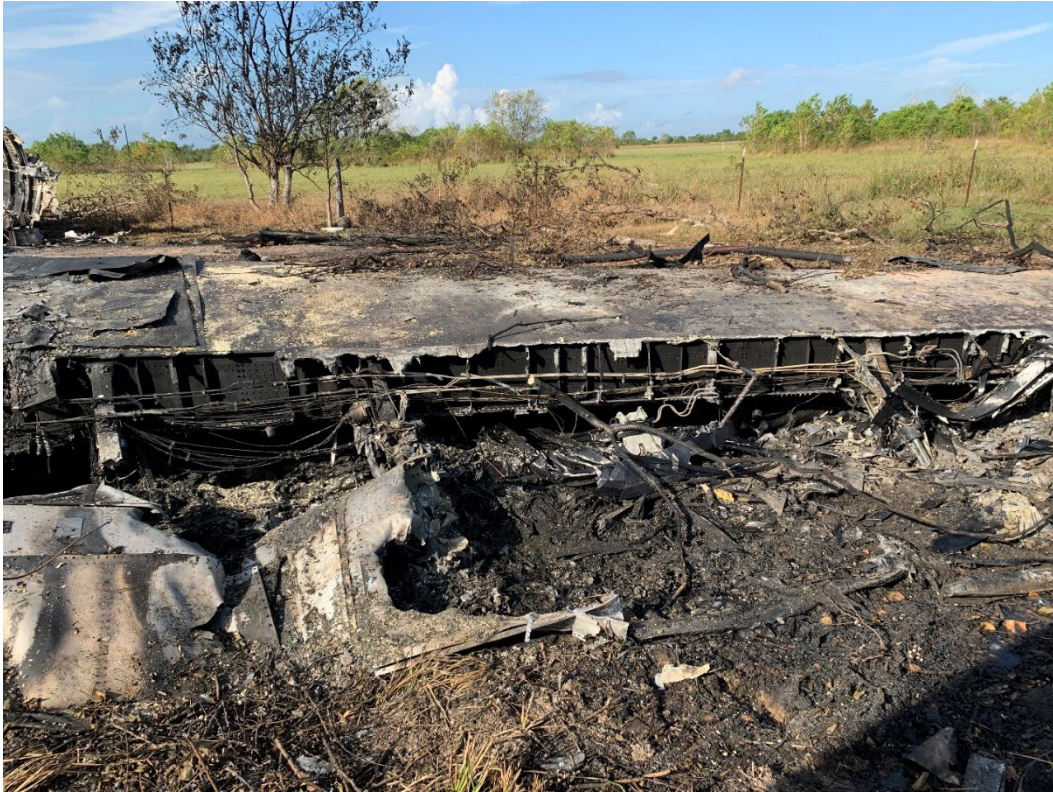
Figure16. Right Wing Fire Damage looking forward

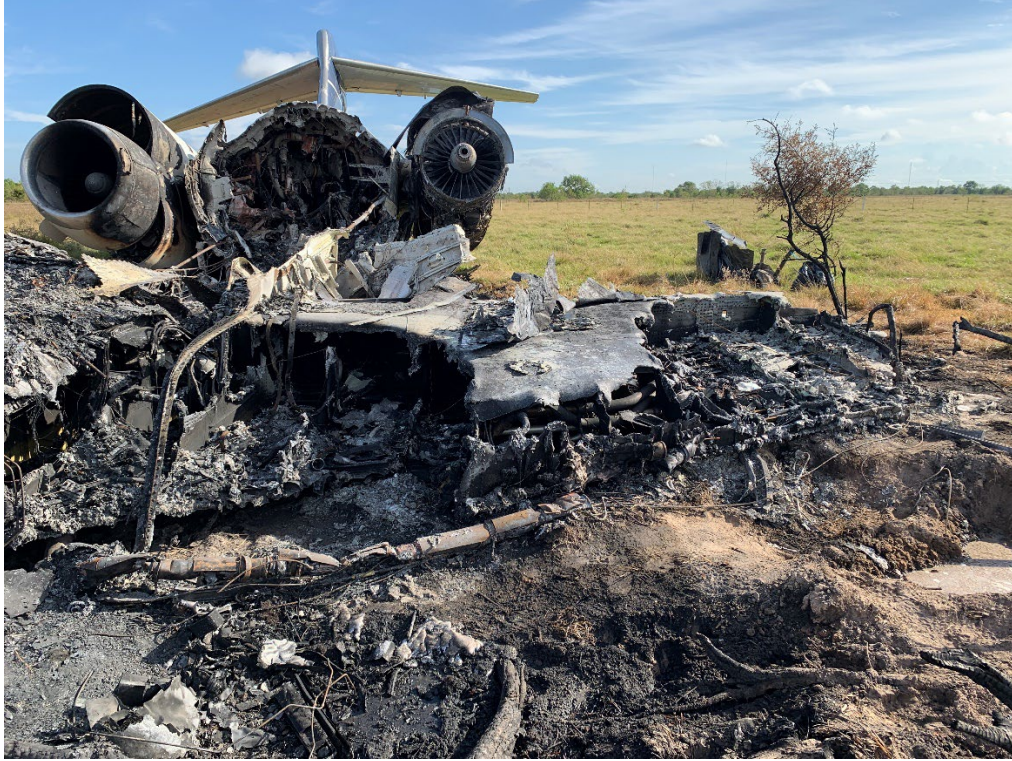
Figure 17. Left Wing Fire Damage looking aft

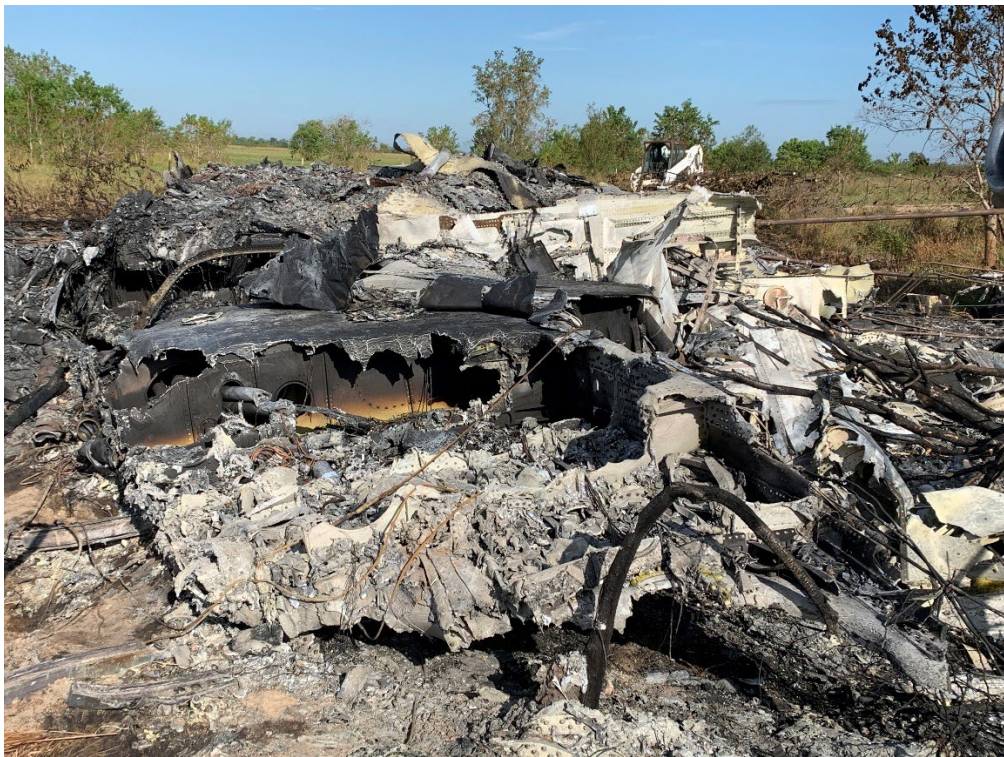
Figure 18. Left Wing Fire Damage looking inboard

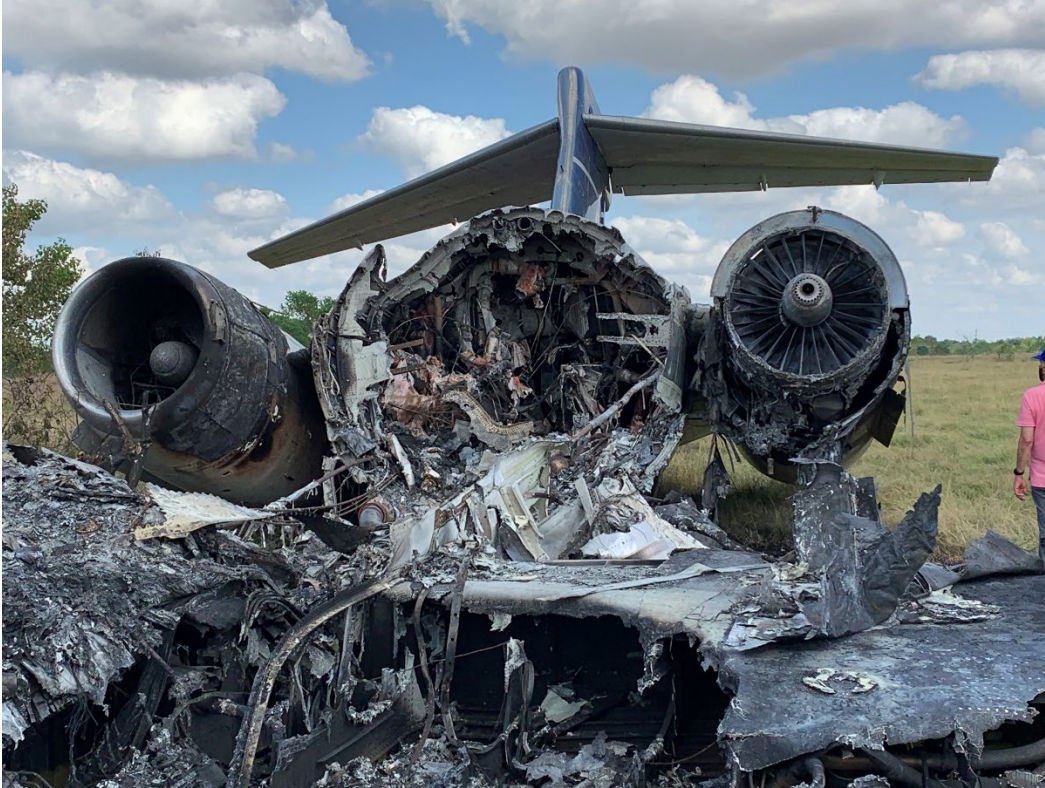
Damaged structure (from approximately STA 41 to approximately STA 351), was visible on the left side of the airplane. The damage in this area encompassed a partial Left Hand Main Entry door opening structure causing the plug forward entry door to sag and lay on the ground. Sooting and fire damage can be found on some of the panel below the window cutouts. Similarly, damage to the right side of the airplane from approximately STA 41 to STA 370 was visible. Heavy sooting and fire damage can be seen toward the forward end of the structure. Much of the aft pressure bulkhead structure at approximately STA 1152 was consumed by fire damage during the accident

Figure 19. Fire Damage on Aft Pressure Bulkhead and Engines

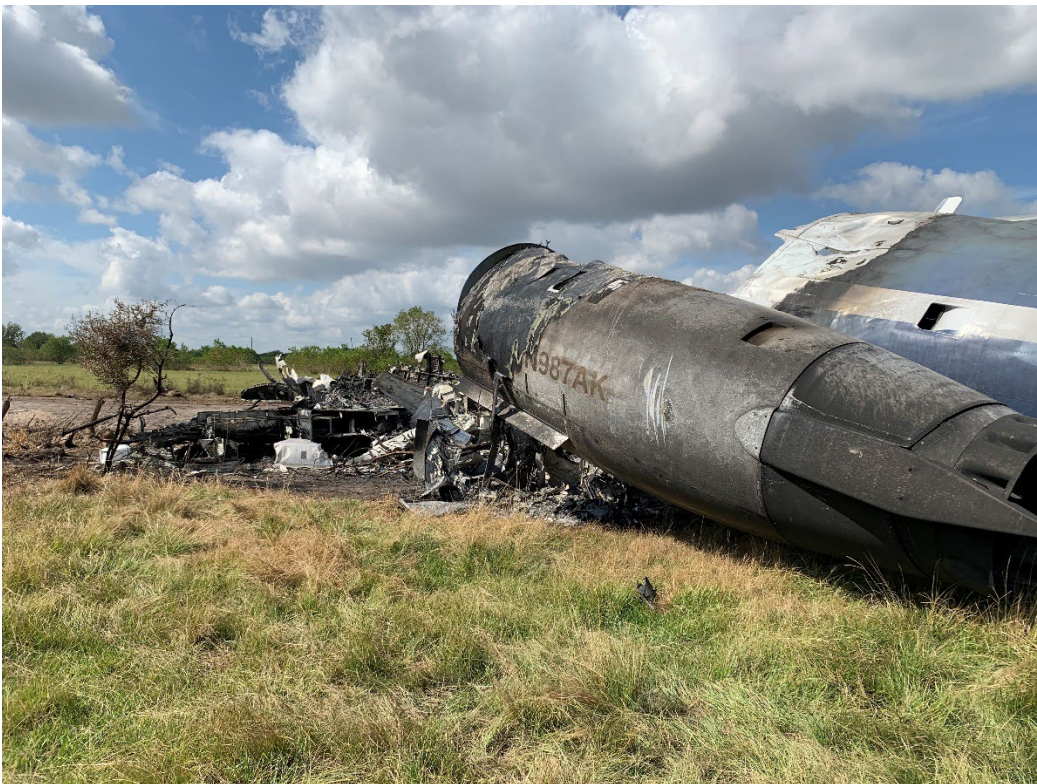
Both left and right engines were still attached to the airplane with damage to the fan cowls of both engines due to the fire/accident sequence. Further information on the engines can be found in the Powerplants Factual Report.

Figure 20. Left Engine Fire Damage looking forward

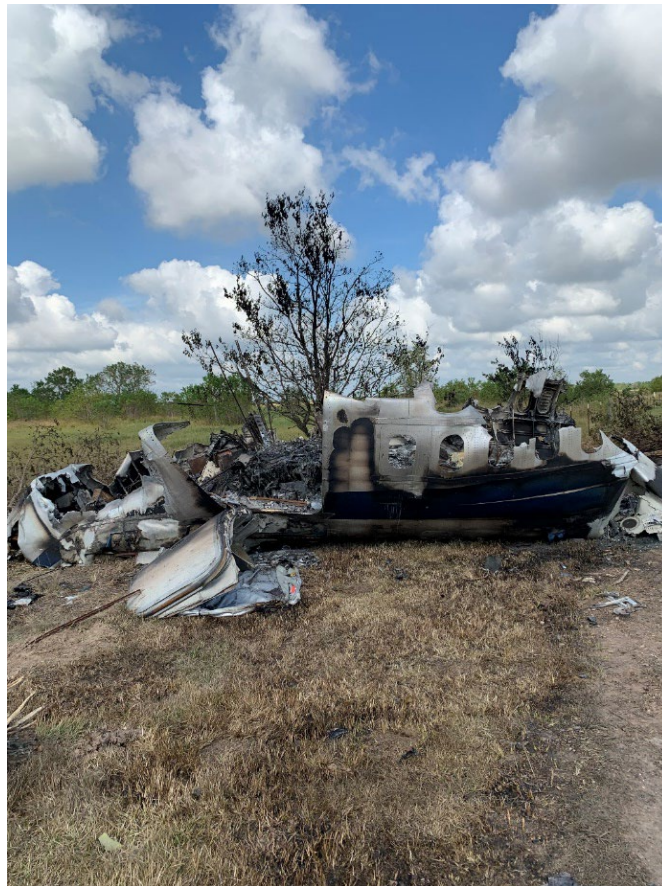
The Left Hand Main Entry Door remained partially attached to the airplane but was heavily damaged due to the fire. The Right Hand Forward Service Door, Four Overwing Emergency Exit Doors, and Cargo Doors (Forward, Mid and Aft) were all consumed by fire. The electrical/electronics compartment door was found detached and under the flight deck wreckage.

Figure 30. *View of left side of airplane fuselage*

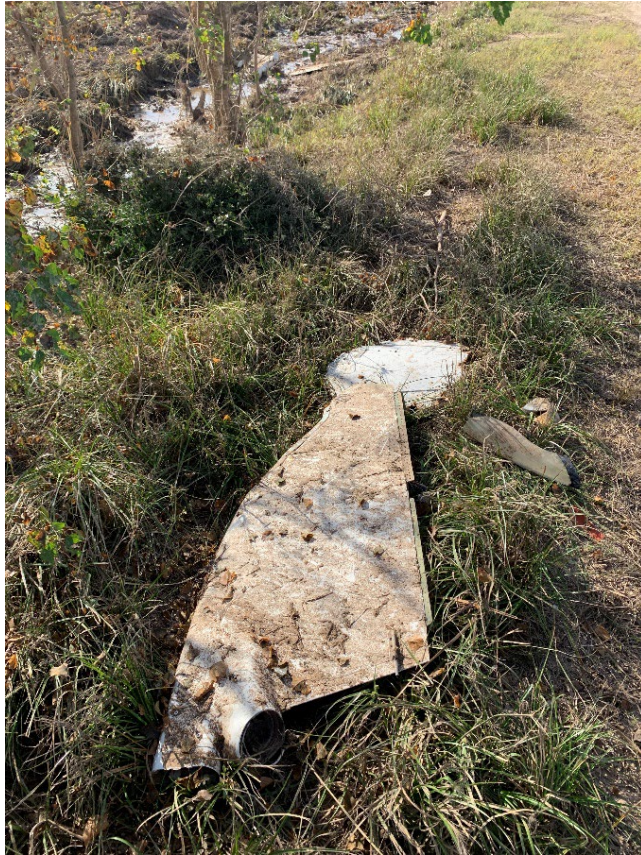
Figure 34. *View of Left Wing Tip*

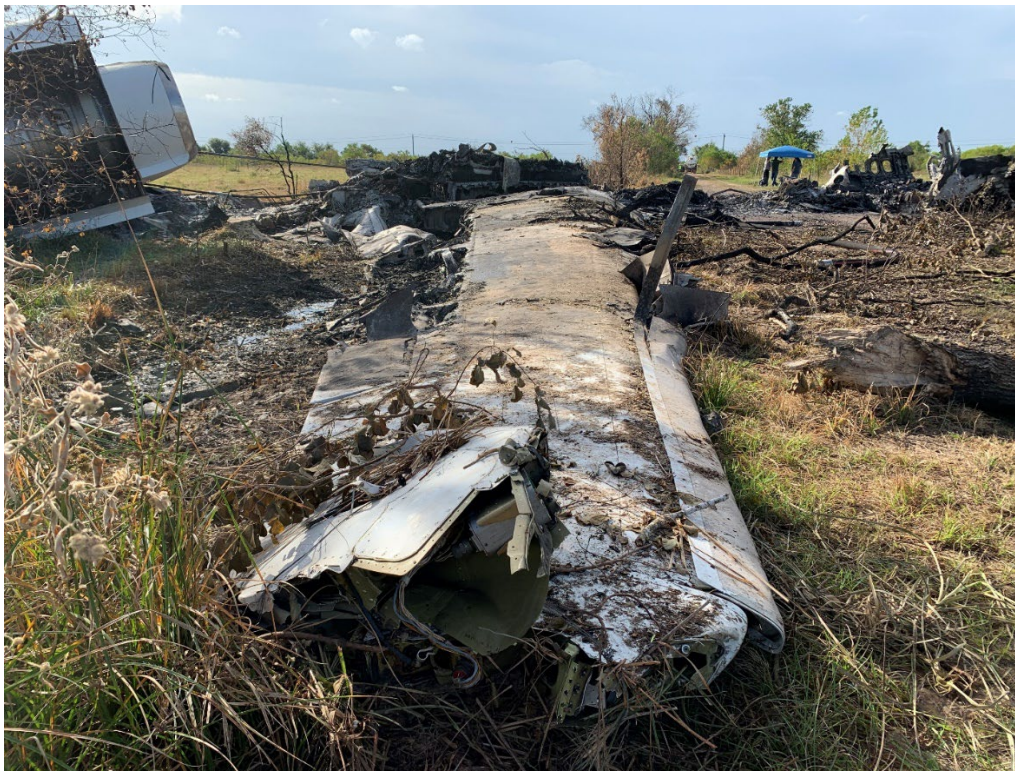
Figure 41. View of Right Wingtip looking inboard

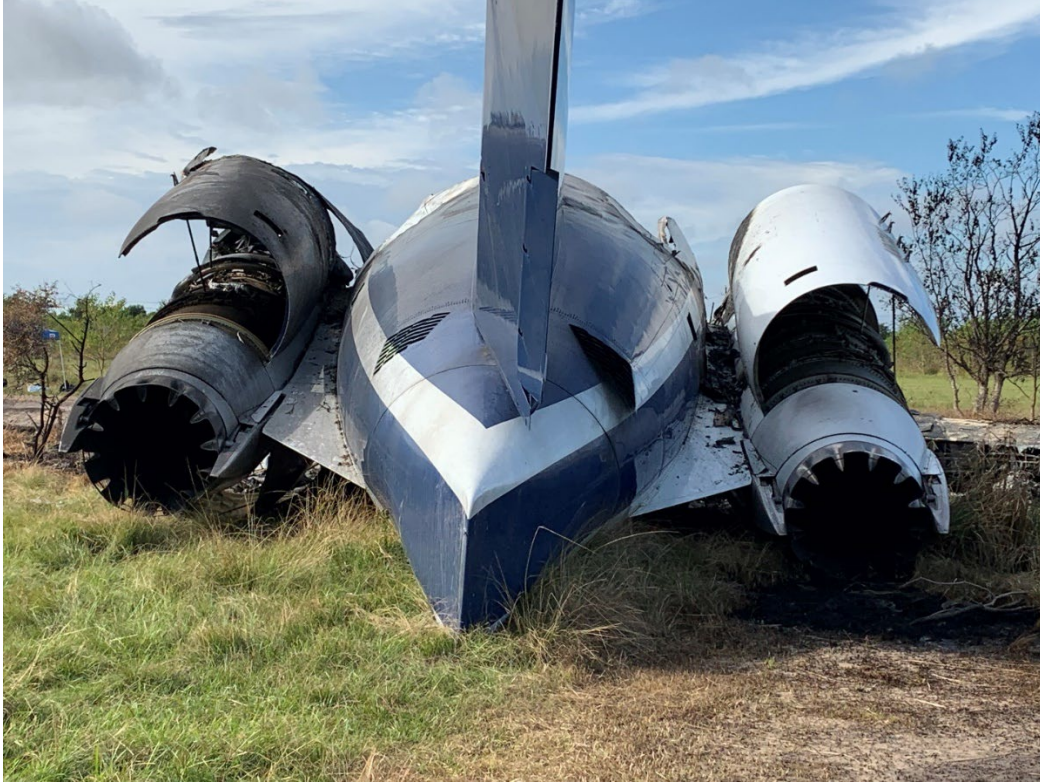
Both the left and right hand pylons were intact and exhibited no evidence of obvious structural damage but showed signs of sooting due to the post-crash fire when viewed from the ground.

Figure 42. View of Left and Right pylon looking forward

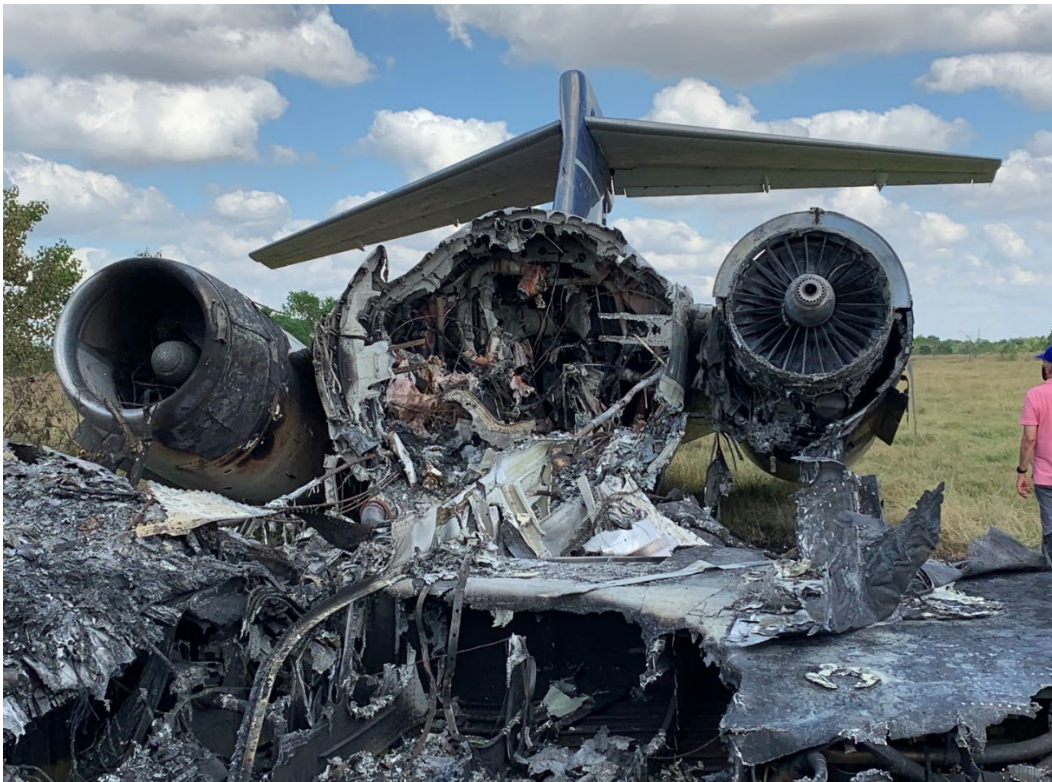
Figure 43. View of left and right engine damage looking aft

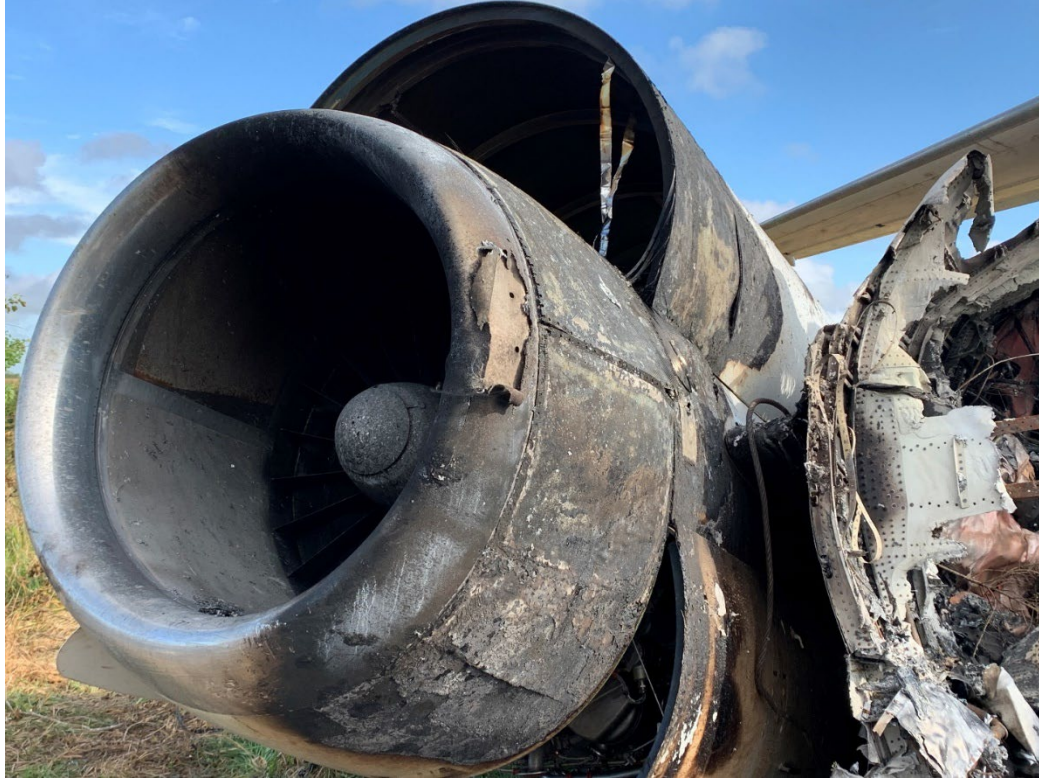
Figure 44. *View of right engine fire damage*

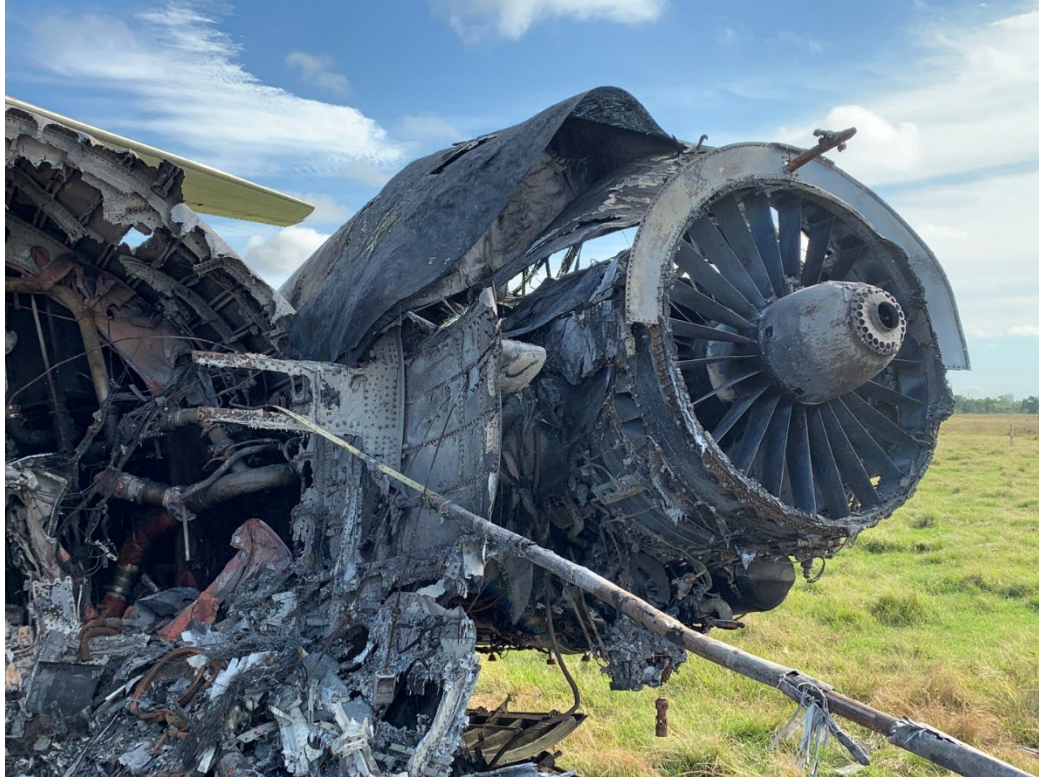
Figure 45. *View of left engine damage*

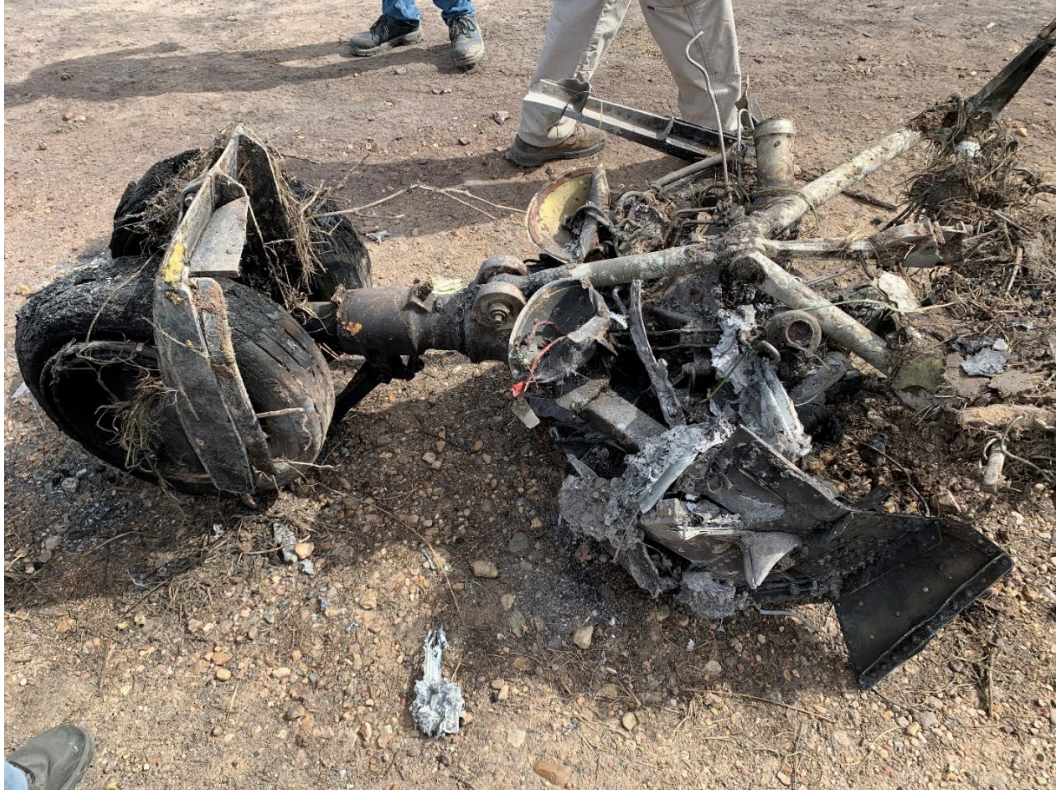
The nose gear was identified in the main wreckage. The gear was found folded aft in the Electrical and Equipment Compartment. The nose landing gear's supporting structure failed with a portion of the structure still attached to the nose gear.

Figure 46. *Nose Landing Gear extracted from Wreckage*

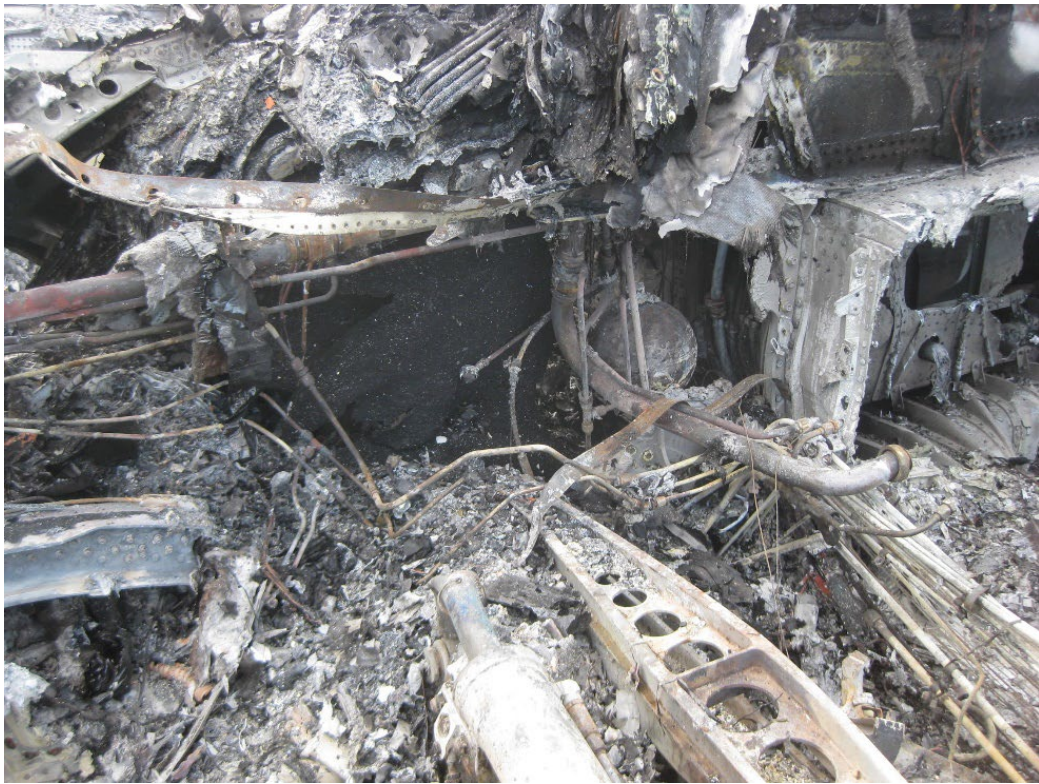
The right main landing gear was found in the right main gear wheel well. The actuating cylinder piston was bent approximately 90 degrees.

Figure 47. *Right MLG in the wheel well*

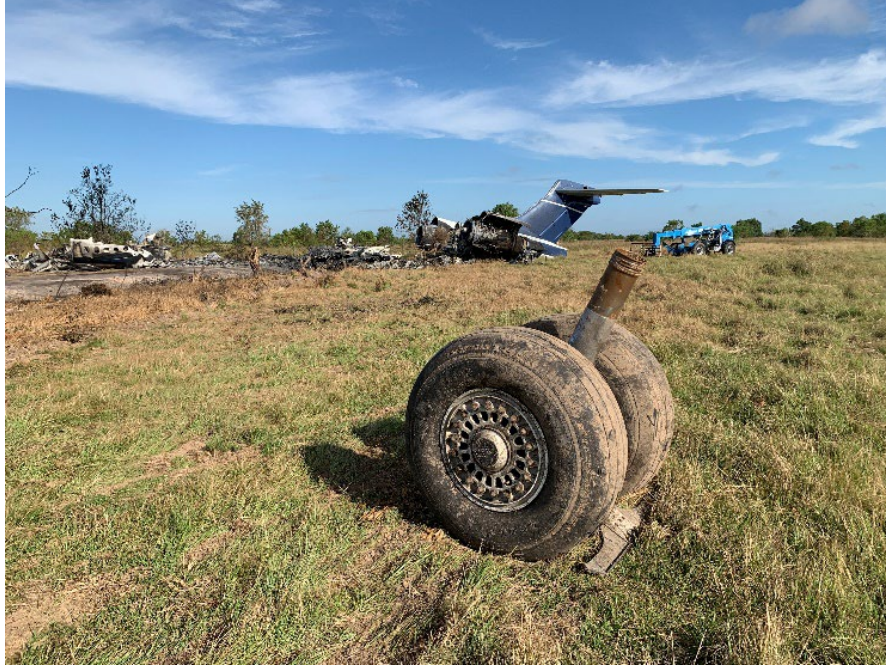
Figure 48. Left MLG Inner Cylinder and Tires

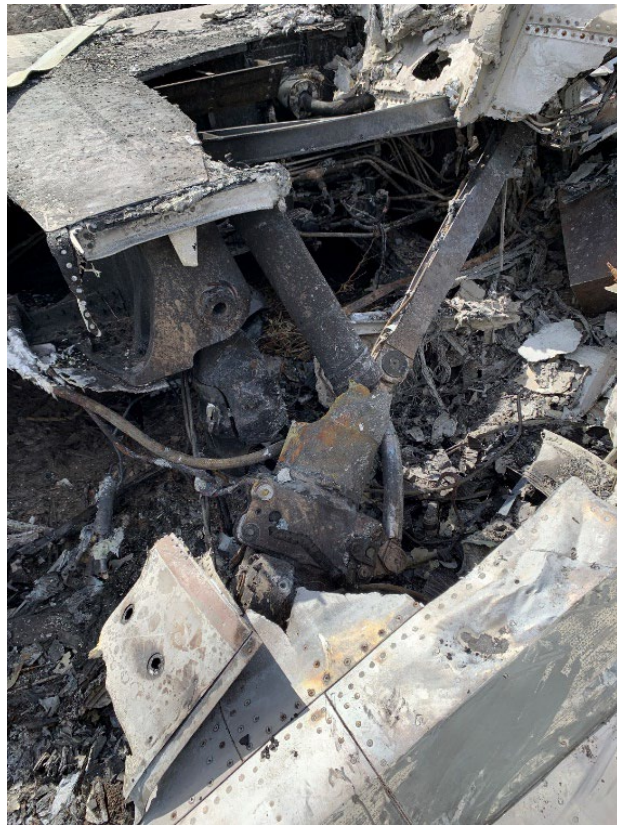
The upper portion of the left main landing gear strut was still connected to the wheel well structure, but the outer cylinder was found failed. The main landing gear actuating cylinder was still connected at the top of the actuator, but the exposed piston was bent.

Figure 49. Left MLG Strut in Wreckage

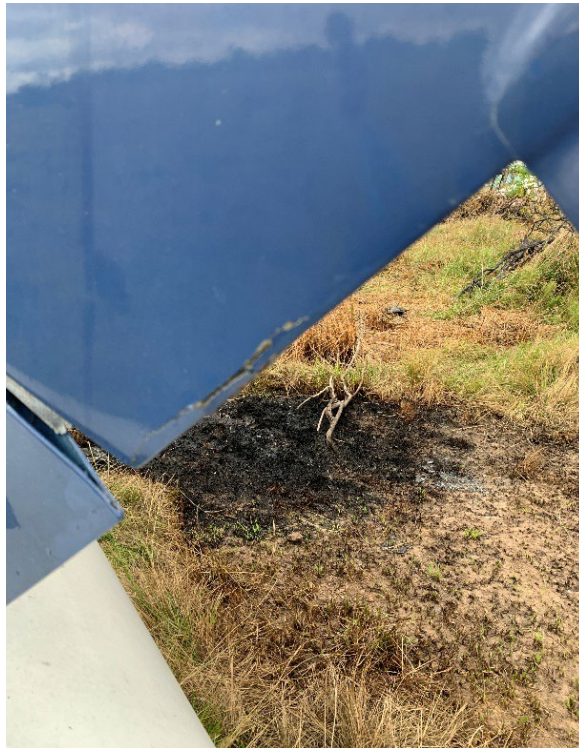
Both the vertical stabilizer and the majority of the rudder exhibited no obvious evidence of structural damage when viewed from the ground. However, the lower aft trailing edge of the rudder tab showed some signs of delamination.

Figure 53. Lower trailing edge of rudder tab

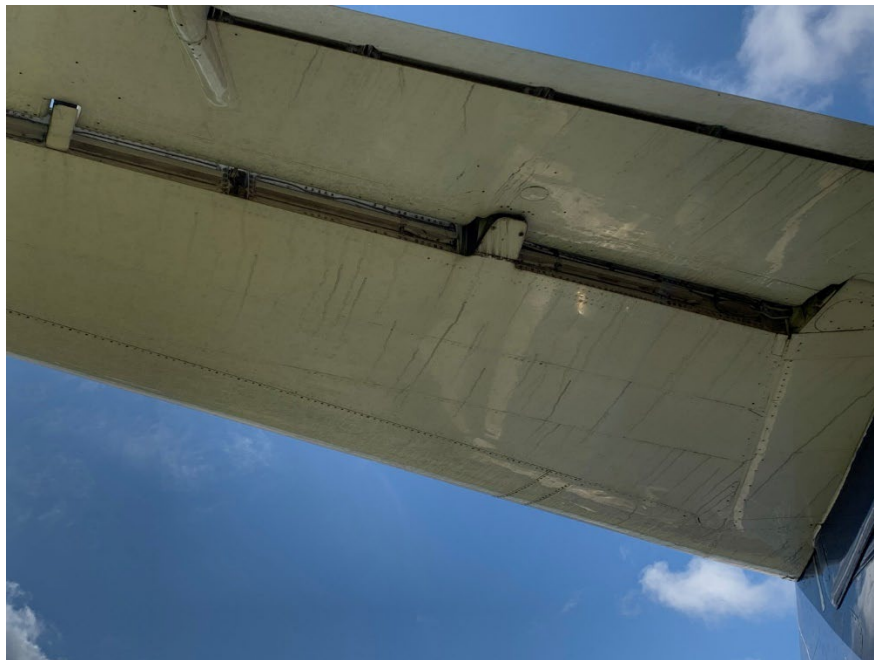
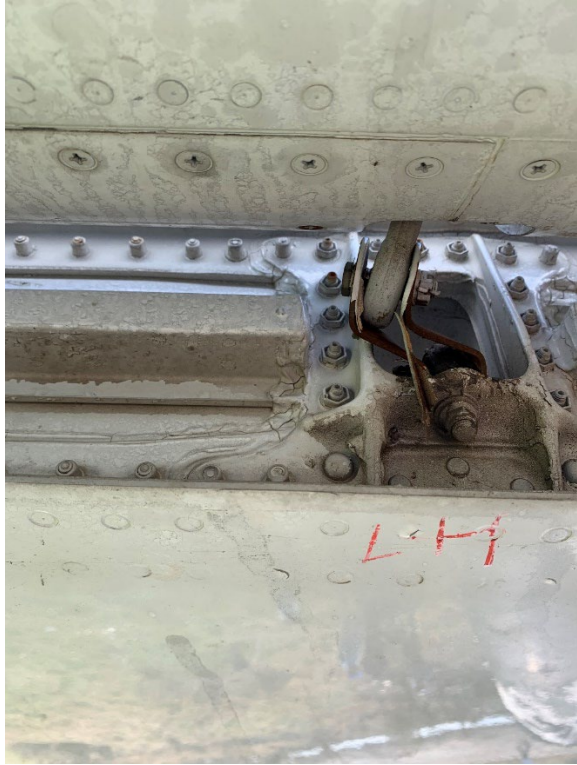
Both the right and left hand stabilizers and elevators exhibited no obvious signs of structural damage when viewed from the ground. Upon closer examination both Left and Right hand control tab hinges were observed deformed/broken. Further examination can be seen in the Systems Group Chairman Factual Report.

Figure 55. LH elevator and elevator control tab

Figure 56. LH elevator's geared tab inboard linkage

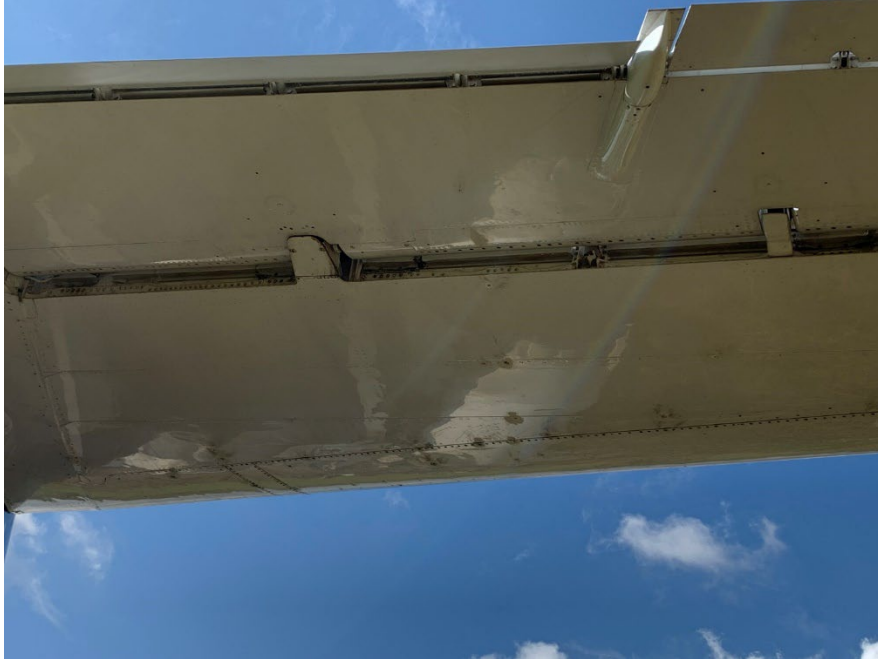
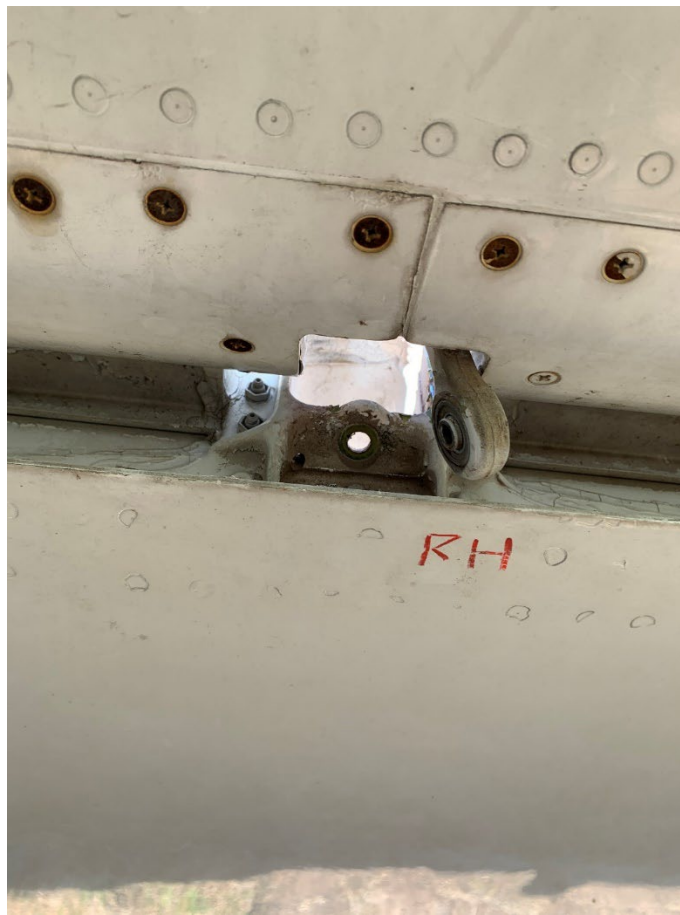
Figure 58. RH elevator and elevator control tab

Figure 59. RH elevator's geared tab inboard linkage
