NATIONAL TRANSPORTATION SAFETY BOARD
Office of Aviation Safety
Washington, D.C. 20594
July 8, 2018

Group Chairman's Factual Report

STRUCTURES

WPR17LA104

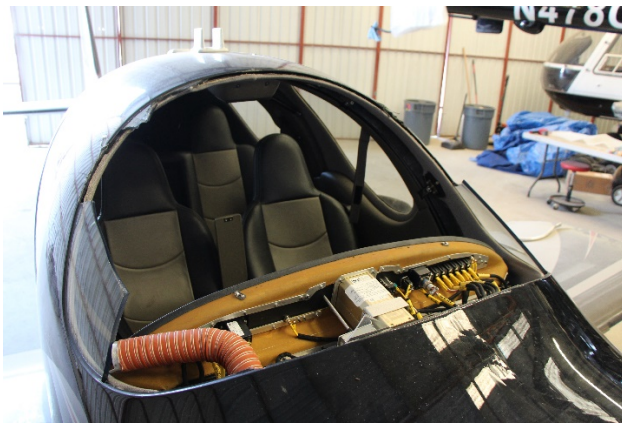
Figure 1 – Windshield prior to removal.

The windshield fractured into numerous pieces. Portions of the windshield that were common to the airframe remained encased in the window frame which is common to the airframe fuselage structure. Three pieces of the windshield along the lower edge of the windshield were easily removed from the window frame common to the airframe. Large portions of the windshield extending beyond the edge of the integral window frame from about the 4 to 6 o'clock and about 6 to 8 o'clock positions remained attached to the airframe. Additional sections of the windshield remained attached to the windshield frame common to the airframe but did not extend beyond the edge of the window frame cutout in the fuselage. The window frame common to the airplane fuselage at the 2, 6 and 10 o'clock positions had visible signs of damage to the composite airframe structure. (Figure 1)

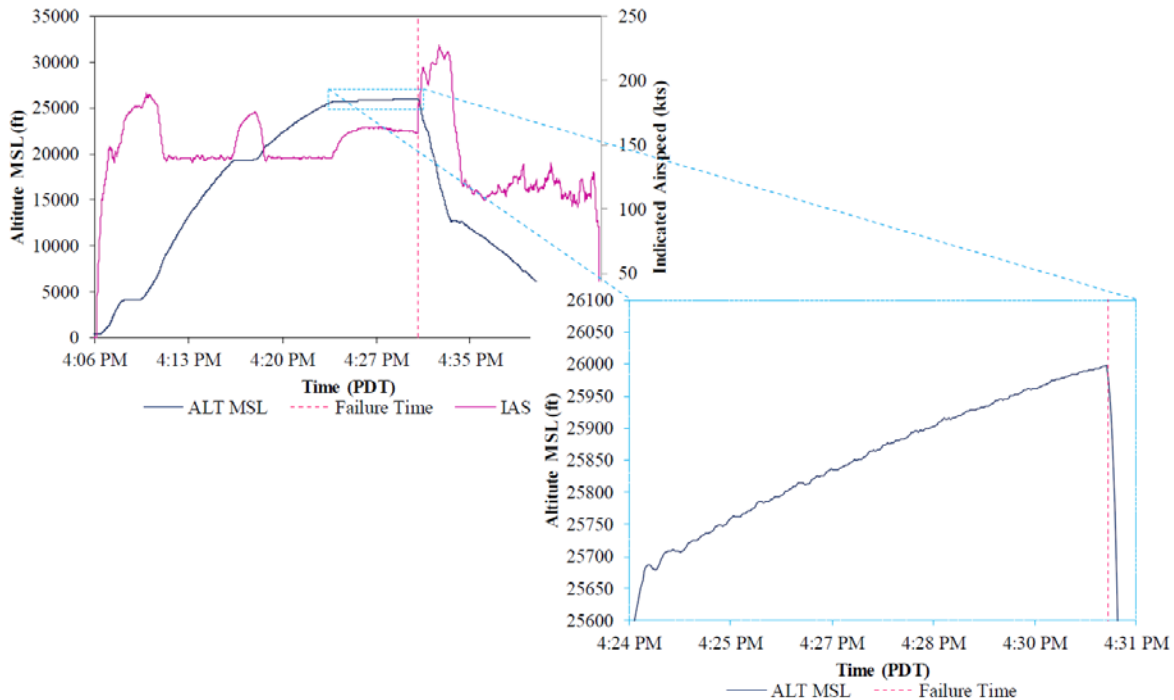
Figure 2 – Altitude (MSL) vs. Time

In-flight data from the flight data recorder (FDR) included the characteristics of the flight profile leading up to the in-flight failure of the windshield. This was reviewed to fully understand the flight characteristics leading up to the windshield failure. FDR data indicated a rapid change in the flight characteristics as the aircraft reached an altitude of 25,998 ft (time stamp of 16:31:02). At this time, the aircraft began to descend and an increase in airspeed was witnessed. Leading up to this apparent time of failure, altitude was steadily increasing, although the rate of climb was reduced significantly as the aircraft approached 25,700 ft (Figure 2).

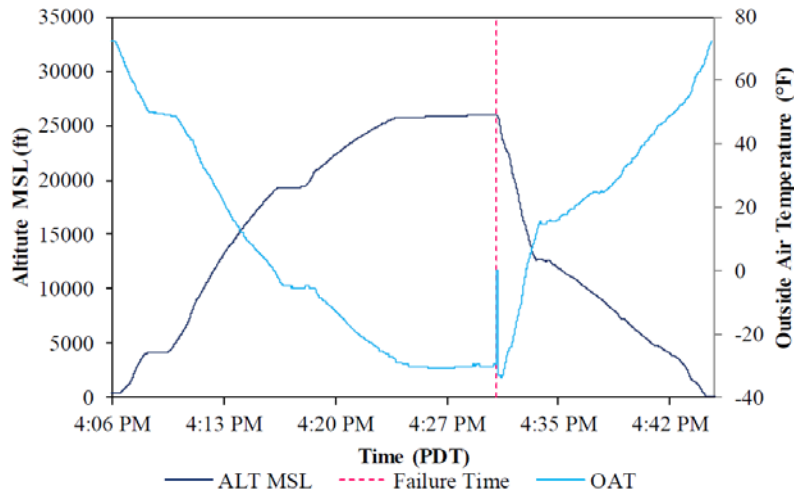
Figure 3 - Altitude (MSL)/Outside Air Temperature vs. Time

At the apparent time of the windshield failure, the outside air temperature was recorded as approximately -30°F (-34°C). The airframe was exposed to this constant temperature for approximately 6 minutes leading up to the apparent time of failure (Figure 3). At the apparent time of failure, outside air temperature data was lost for approximately 5 seconds.

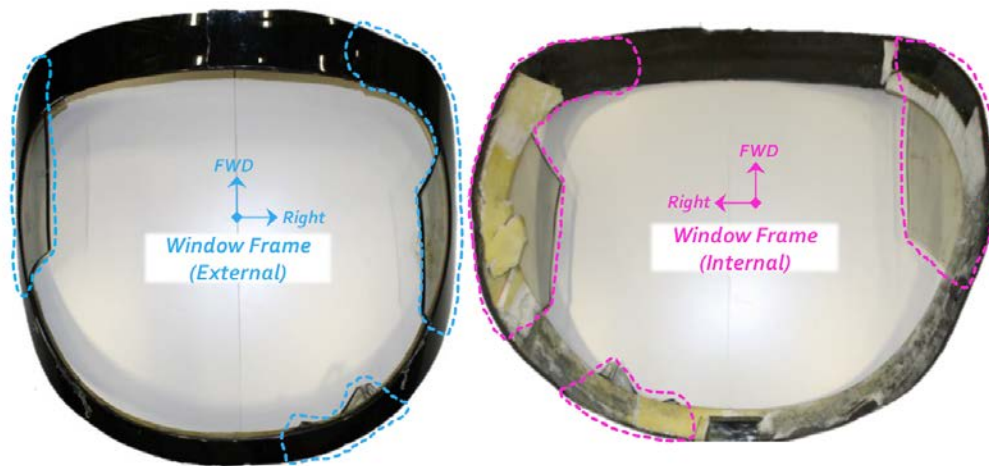
Figure 4 - Windshield Frame Receiving Inspection

Initial examination of the windshield revealed most of the windshield was missing. A total of 12 windshield artifacts were recovered from the event. This included artifacts that were fully separated from the aircraft windshield frame and some artifacts that were easily removed from inside the windshield frame (debonded). Large sections of the windshield that remained in the frame as shown in Figure 3.

The two large sections of windshield shown in Figure 4 were firmly intact with the windshield frame and could not be removed. Although this was the case, gaps witnessed from a visual inspection between the windshield and the frame indicated the remaining portions are not fully bonded in place. The remaining large intact sections of the windshield were documented using a 3-D scanner so that their specific size and location were understood (Figure 5). Furthermore, the location for each windshield artifact was determined, and the fracture surfaces were documented. This created the opportunity to compare the fracture pattern with stress analysis to supplement proposed failure scenarios.

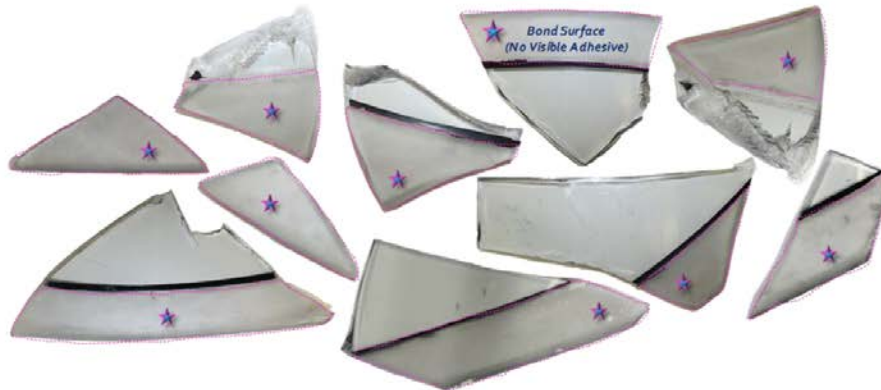
Figure 6 - Windshield Artifacts

A total of 10 out of the 12 windshield artifacts recovered contained a region that was previously bonded to the windshield frame prior the failure event. All the recovered artifacts showed no visible presence of adhesive on the windshield bond surfaces consistent with an adhesive failure between the windshield and the windshield frame (Figure 6).

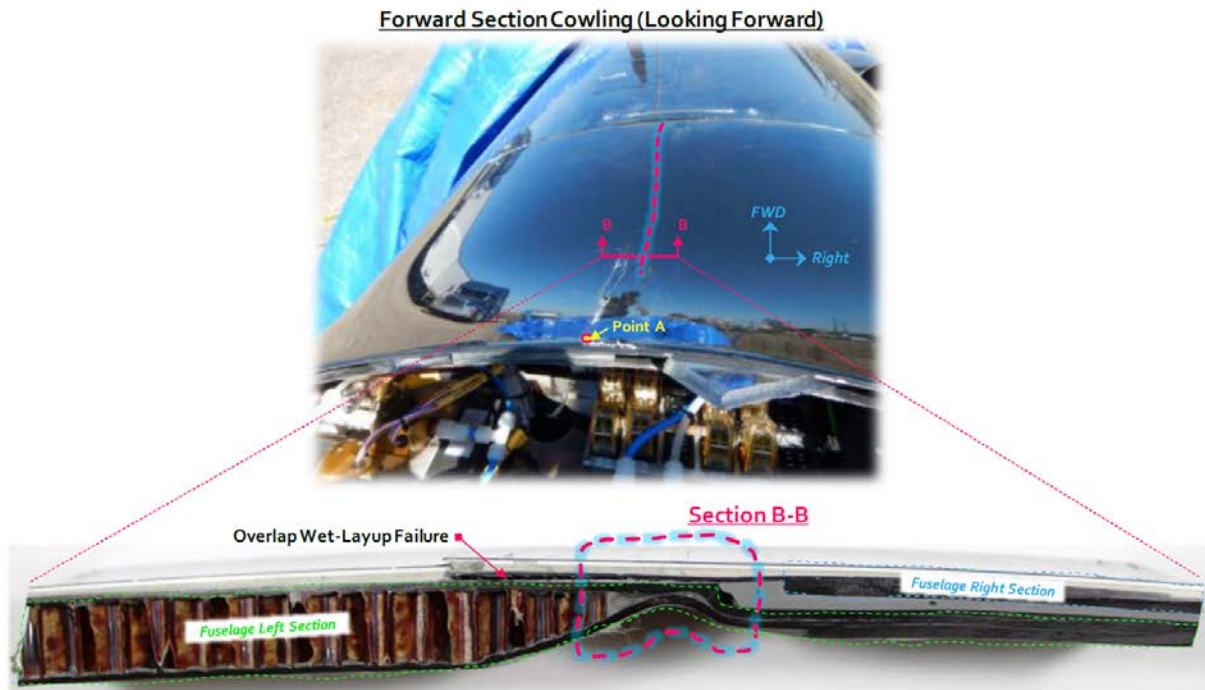
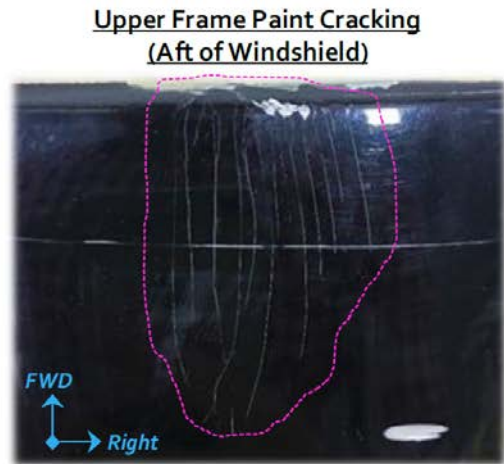
Paint cracking was observed both forward and aft of the windshield frame (Figure 7 & Figure 8). The paint cracking observed forward of the windshield frame extended from the windshield frame to the firewall. This occurred near the center of the fuselage where the left and right fuselage halves are joined. A section cut revealed the paint cracking occurred over the sharp transition near the edge of the ramped sandwich construction (circled in Figure 7). A failure through the thickness of the windshield frame was observed at point A as shown in Figure 7.

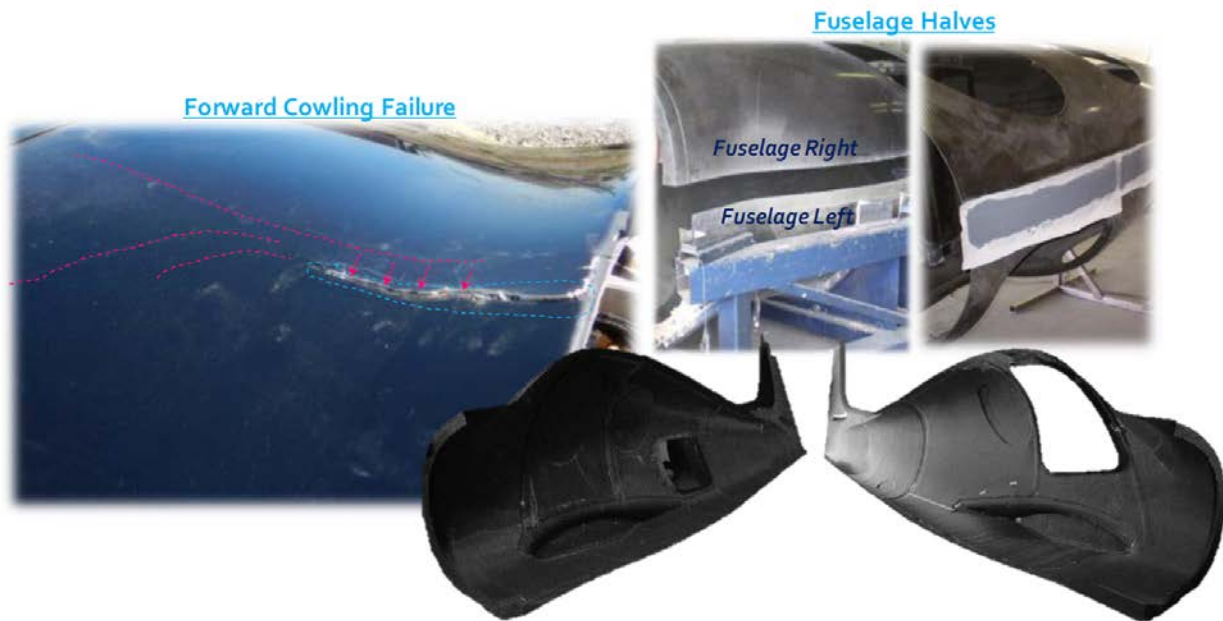
Figure 9 - Overlap failure characteristics

To the left there was paint cracking that extended to the firewall, the extensive cracking directly in front of the windshield was coincident with the delamination of the wet-layup plies that were applied to the fuselage after the two fuselage halves are joined together. The application of these plies in the manufacturing process is shown in Figure 9. These findings are consistent with significant structural flexing of the fuselage.

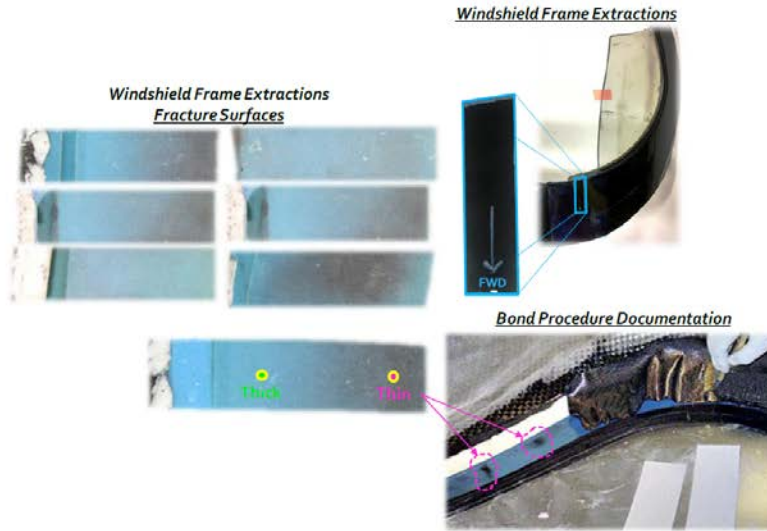
Figure 10 - Windshield frame bondline thickness variation

Thermal analysis was done to evaluate the glass transition temperature (T_g) of the composite windshield frame, acrylic windshield, and paste adhesive used for bonding the windshield to the frame. T_g values were acquired to determine if any of the constituent materials could have been subjected to temperatures above the T_g in operation. When extracting windshield frame samples for testing, the bond surfaces were evaluated prior to the removal of the adhesive for testing. Bond thickness variation was noticed on multiple samples, like the variation witnessed in the bond procure documentation photos (Figure 10). Adhesive surfaces were also noted to be very smooth.

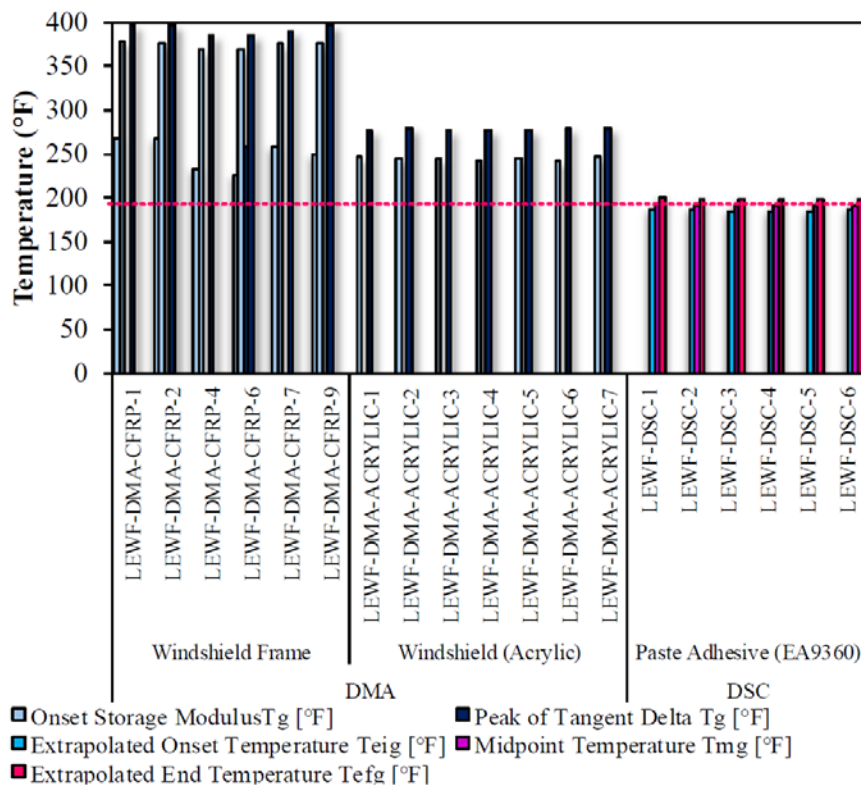
Figure 11 - Tg comparison

Dynamic Mechanical Analysis (DMA) test results for the windshield frame and windshield material were compared to the Differential Scanning Calorimetry (DSC) test results for the paste adhesive in Figure 11. DSC testing was used to determine the T_g of the paste adhesive as limited material was available. The average lowest T_g of 192°F was witnessed for the paste adhesive. As expected, this was the lowest T_g within the evaluated materials.

At the apparent time of the windshield failure, the outside air temperature was recorded as approximately -30°F (-34°C), which had been constant for up to 6 minutes before the failure and the outside air temperature had been under 0°F ($\approx -18^{\circ}\text{C}$) for approximately 15 minutes prior to the failure. Considering only the outside air temperature, this indicates the

windshield frame material was not beyond the T_g at the time of failure due to the extended period the airframe was subjected to low temperatures [2].

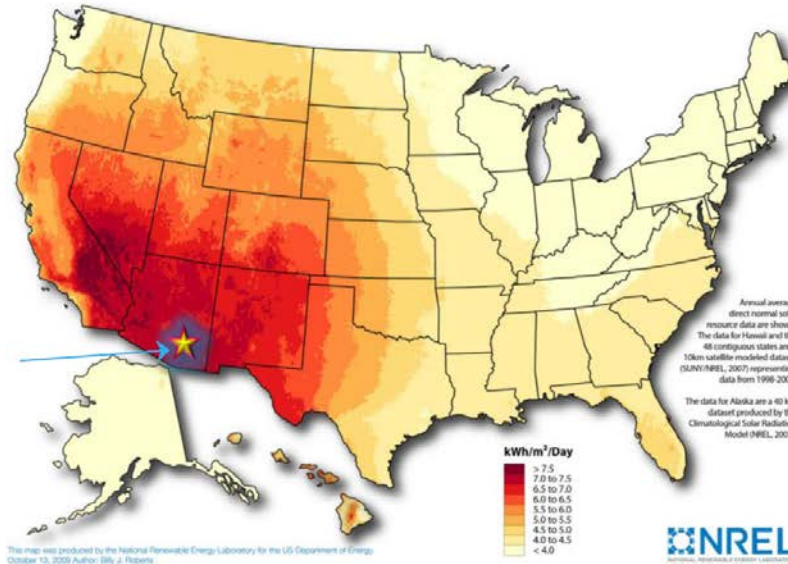
Figure 12 - Solar Resource Distribution for United States [3]

Airframes with coatings that promote the absorption of solar energy (dark colors) can reach temperatures outside of the intended operational temperature. In this particular case, the potential risk for the airframe to reach high temperatures was a concern due to the paint color of the majority of the airframe and the region of the home airport and indicated in Figure 12.

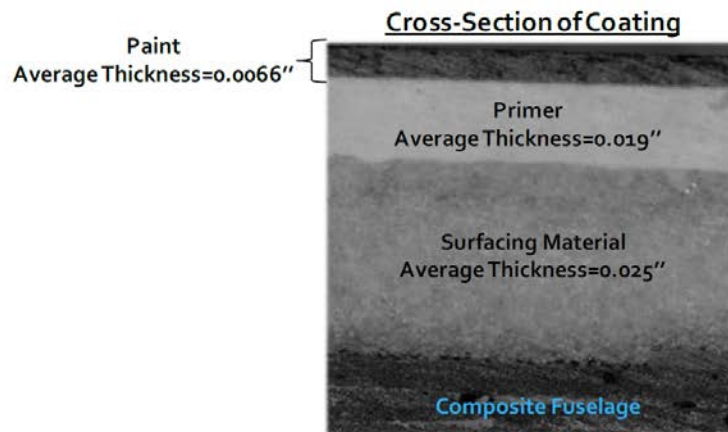
Figure 13 - Coating thickness

Average thicknesses for the paint, primer, and surfacing materials are provide in Figure 13. Averages were derived over a series of 6 extractions at varying locations around the window frame. A high overall thickness was observed.
